ASBESTOS SURVEY REPORT FOR CALL STAND, BARRACKS BANK, SUNDERLAND PORT

Call Stand, Barracks Street, Port of Sunderland

Date: 06 June 2025

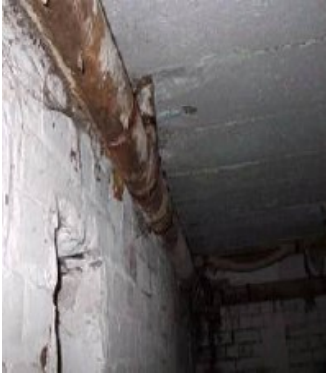
Item 1 – VP002142

The pipe lagging to the sub floor store room does not contain asbestos.

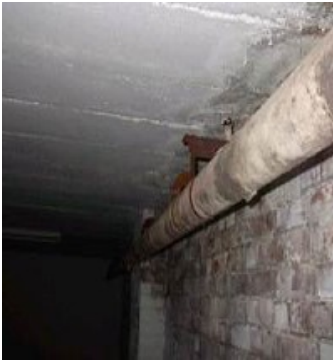
Item 2 – VP002143

The pipe lagging to the sub floor main room does not contain asbestos.

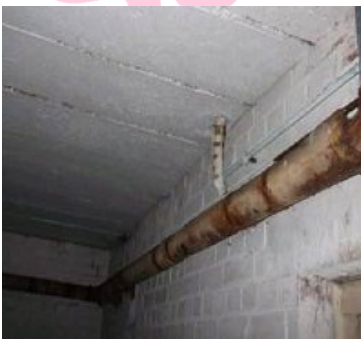
Item 3 – As VP002143

The pipe lagging to the Sub floor rear room does not contain asbestos.

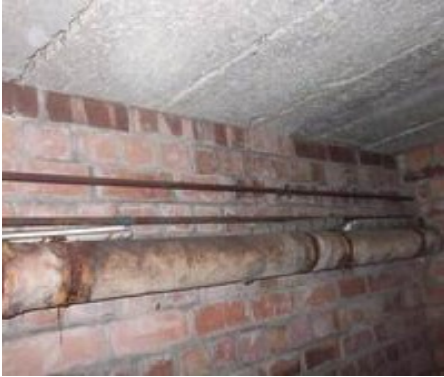
Item 4 – VP002144

The pipe lagging to the sub floor tank room does not contain asbestos.

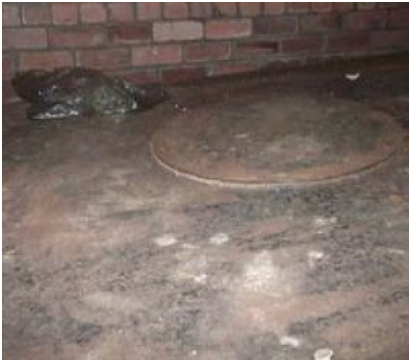
Item 5 – VP002145

The gasket on top of the tank in the sub floor tank room contains asbestos.

This item has been removed

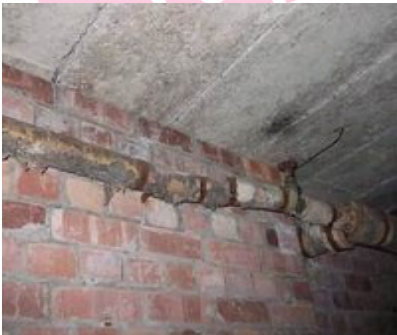
Item 6 – VP002143

The pipe lagging to the Sub floor rear room does not contain asbestos.

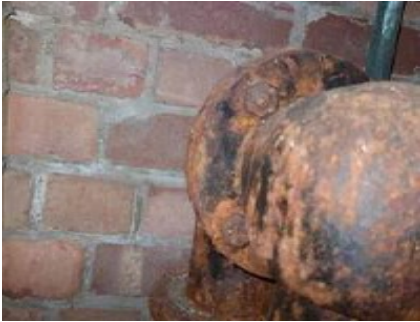
Item 7 – VP002147

The gasket to the pipework under the tank in the sub floor tank room does not contain asbestos.

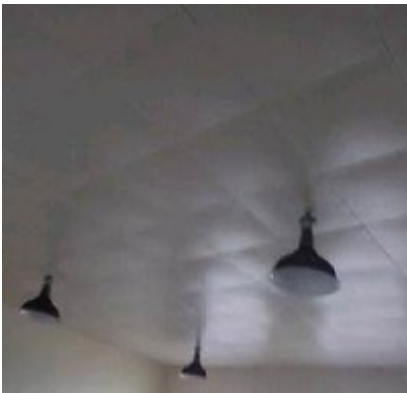
Item 8 – VP002130

The ceiling tiles to the office do not contain asbestos.

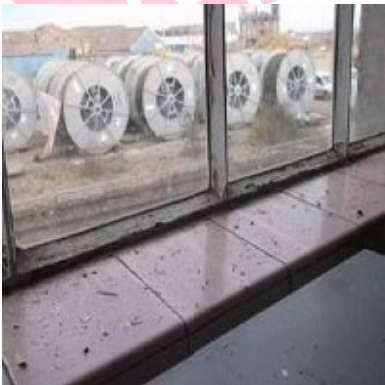
Item 9 – VP002133

The window putty to the office does not contain asbestos.

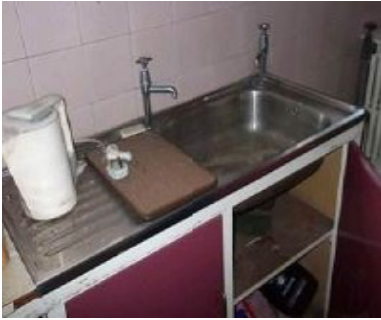
Item 10 – VP002137

The sink pads to the office contain asbestos.

Item 10	Sink pads to Office	Very Low	12 Monthly	03.10.26
<i>Item 11</i>	<i>No Asbestos</i>	<i>Is Present</i>		
<i>Item 12</i>	<i>No Asbestos</i>	<i>Is Present</i>

Any change in appearance should be noted and passed to Property Services.

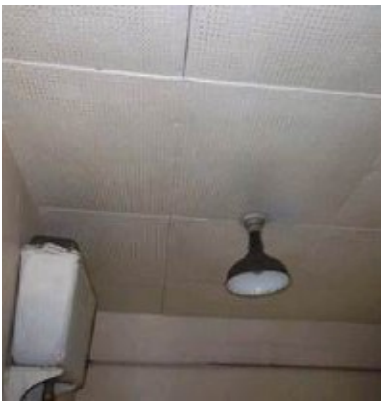
Item 11 – As VP002130

The ceiling tiles to the toilets do not contain asbestos.

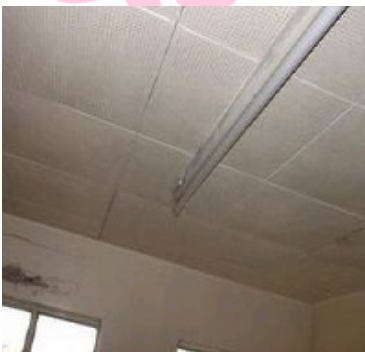
Item 12 – As VP002130

The ceiling tiles to the office do not contain asbestos.

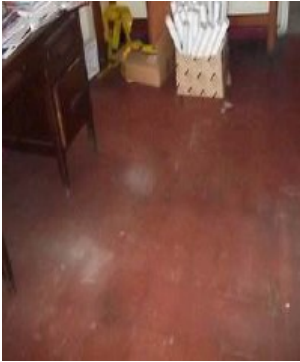
Item 13 – VP002134

The floor tiles to the office contain asbestos.

Removed Sept 21

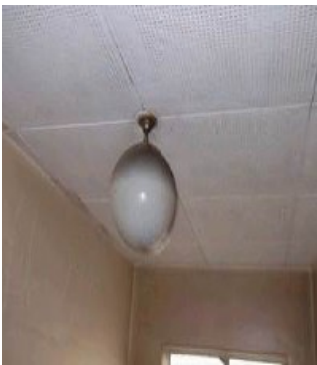
Item 14 – As VP002130

The ceiling tiles to the wash up area do not contain asbestos.

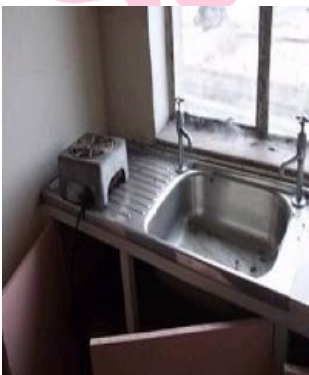
Item 15 – VP002135

The sink pads to the wash up area contain asbestos.

Any change in its appearance should be noted and passed to Property Services.

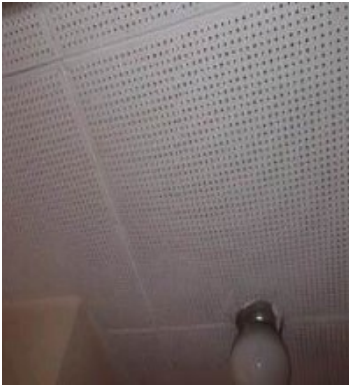
Item 16 AsVP002130

The ceiling tiles to the sink area do not contain asbestos.

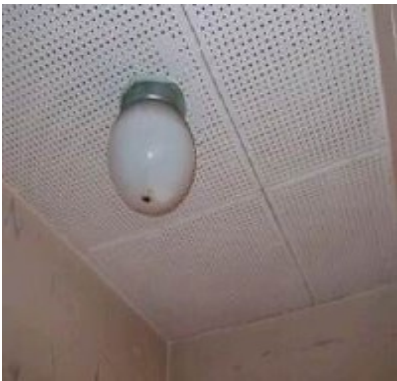
Item 17 – As VP002130

The ceiling tiles to the female wc do not contain asbestos.

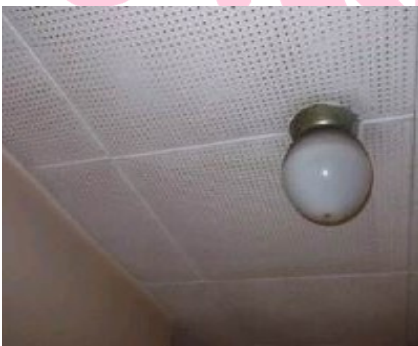
Item 18 As VP002130

The ceiling tiles to the Male WC do not contain asbestos.

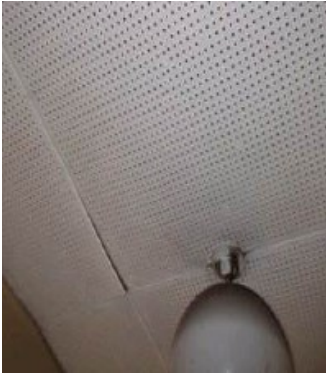
Item 19 As VP002130

The ceiling tiles to the entrance lobby do not contain asbestos.

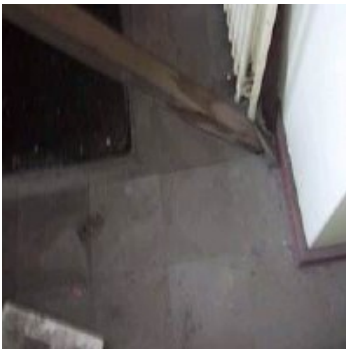
Item 20 Ref – As VP002134

The floor tiles to the entrance lobby contain asbestos.

Removed Sept 21

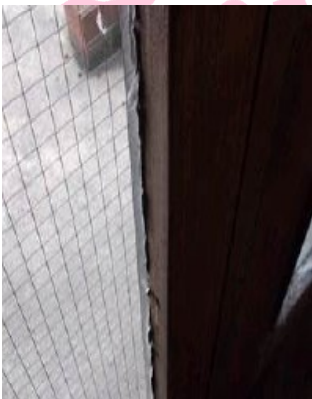
Item 21 ref: VP002136

The putty to the glass in the door in the entrance lobby contains asbestos.

Removed February 2020.

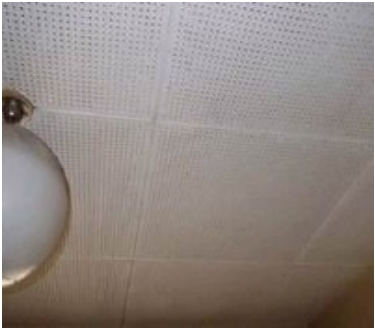
Item 22 Ref: VP002130

The ceiling tiles to the store do not contain asbestos.

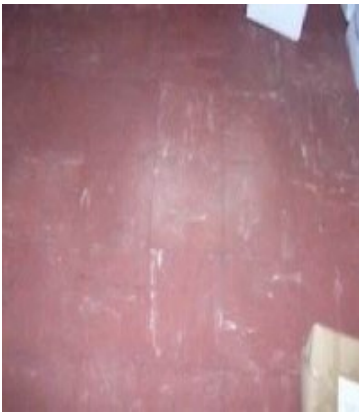
Item 23 As VP002134

The floor tiles to the store contain asbestos.

Removed Sept 21

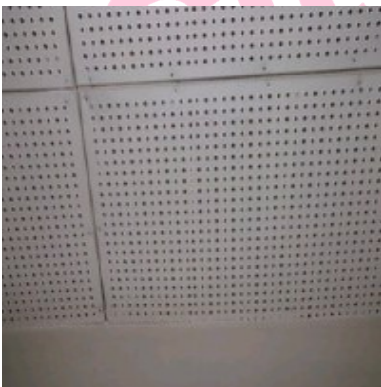
Item 24 ref: VP002136

The ceiling tiles to the store do not contain asbestos.

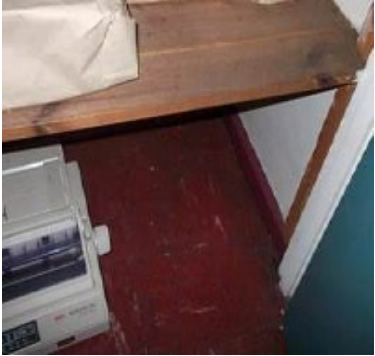
Item 25 As VP002134

The floor tiles to the store room contain asbestos.

Removed Sept 21

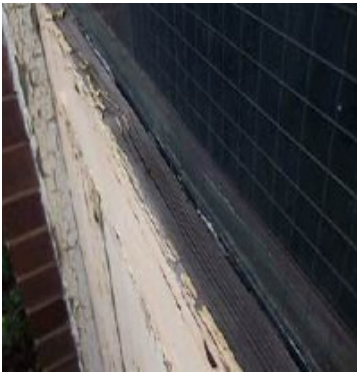
Item 26 Ref: VP002148

The putty to the glass door frame (External) contains asbestos.

Removed February 2020.

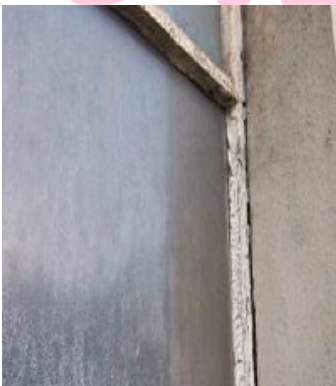
Item 27 Ref: VP002149

The window putty to the external does not contain asbestos.

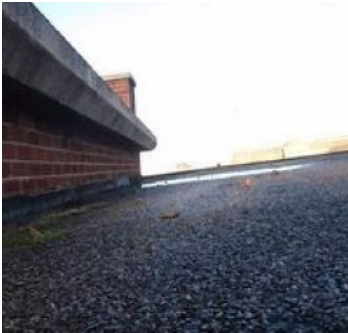
Item 28 Ref: VP002150

The bitumen to the flat roof does not contain asbestos.

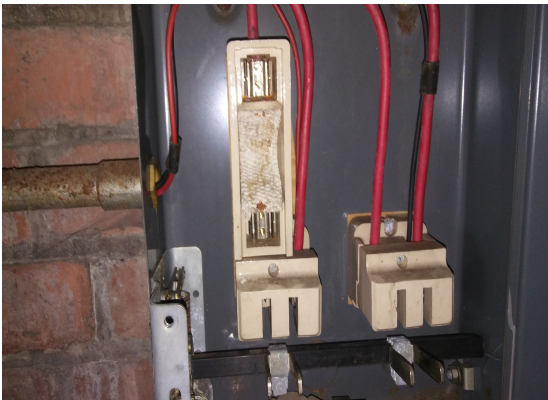
Item 29 Ref: 393067-1

The flashguards to electrics in the former boiler room (Rm 0/001) does contain asbestos.

Removed February 2020.

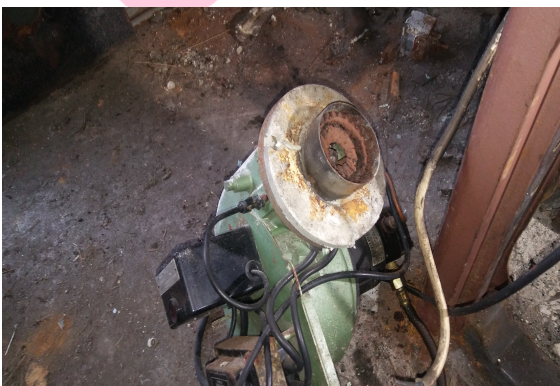
Item 30 Ref: 393067-2

The gasket to pump in the former boiler room (Rm 0/001) does contain asbestos.

Removed February 2020.

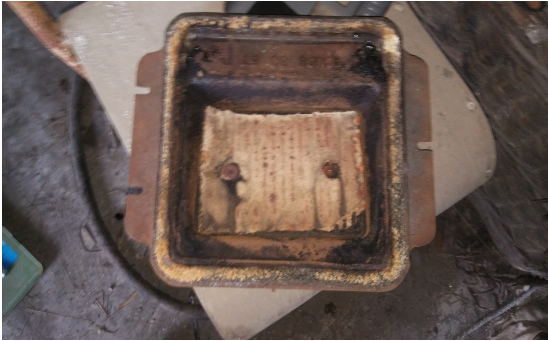
Item 31 Ref: 393067-3

The gasket to boiler door in the former boiler room (Rm 0/001) does contain asbestos.

Removed February 2020.

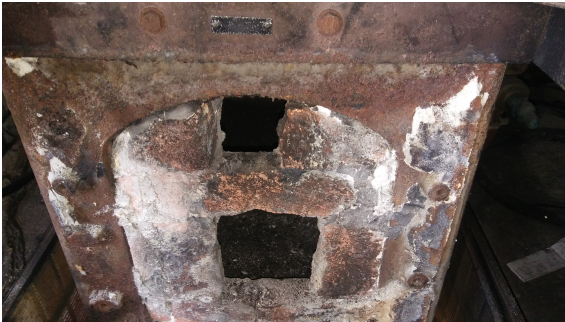
Item 32 Ref: 393067-4

The gasket to front of boiler in the former boiler room (Rm 0/001) does contain asbestos.

Removed February 2020.

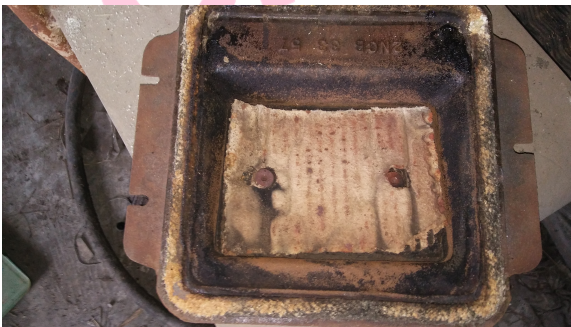
Item 33 Ref: 393067-5

The insulation to boiler door in the former boiler room (Rm 0/001) does contain asbestos.

Removed February 2020.

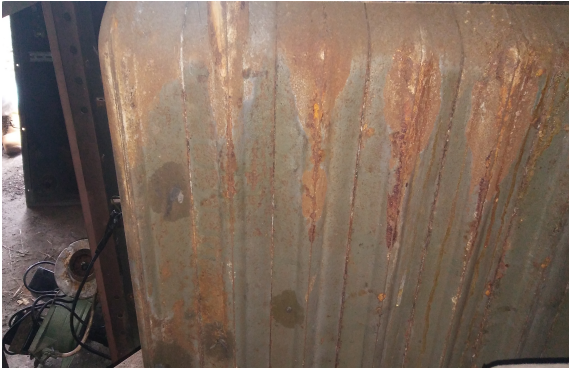
Item 34 Ref: 393067-6

The gasket to boiler joints in the former boiler room (Rm 0/001) does contain asbestos.

Removed February 2020.

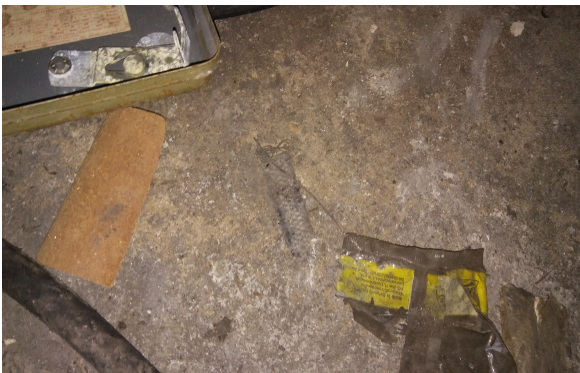
Item 35 Ref: 393067-7

The flashguard to floor in the former boiler room (Rm 0/001) does contain asbestos.

Removed February 2020.

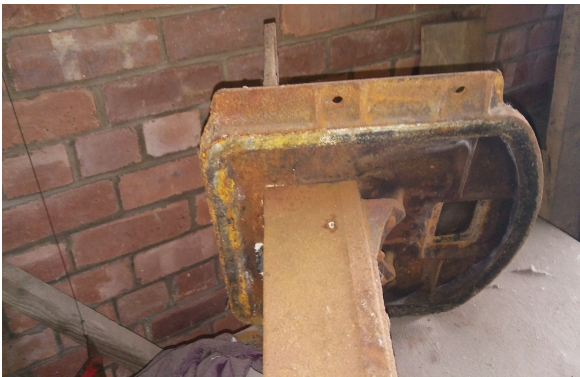
Item 36 Ref: As 393067-3

The gasket to boiler loose boiler part in the former boiler room (Rm 0/001) does contain asbestos.

Removed February 2020.

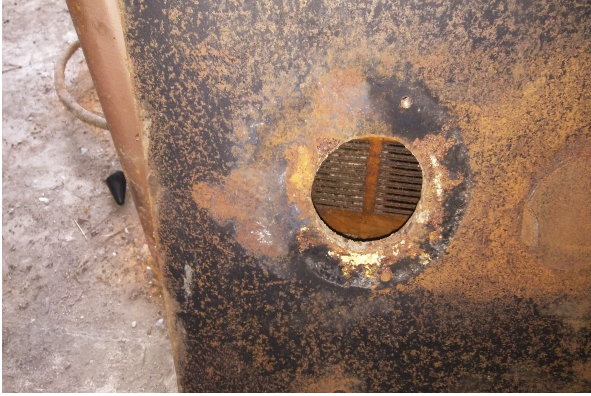
Item 37 Ref: As 393067-2

The residue gasket from pump to boiler part in the former boiler room (Rm 0/001) does contain asbestos.

Removed February 2020.
