### ASBESTOS SURVEY REPORT FOR CONTAINER PARK OFFICES Gr FI 1 EAST SIDE COMMUNITY BLOCK, PORT OF SUNDERLAND

## **Asbestos Register for**

**CONTAINER PARK OFFICES, Gr FI1, EAST SIDE  
HUDSON DOCK, PORT OF SUNDERLAND**

**Date: 8<sup>th</sup> July 2024**

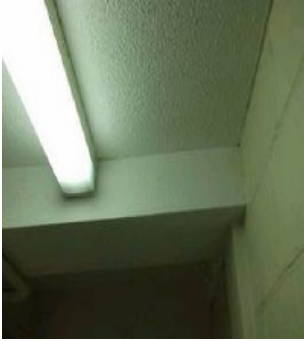
### **Item 1 Ref: VP002100**

The textured coating to the ceiling in the corridor (Room 1) contains asbestos.

Any change in its appearance should be recorded, and passed to Property Services.

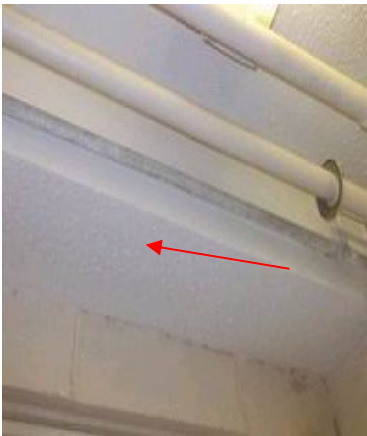
### **Various - Ref VP002102**

The board boxing to the ceiling in the corridor (Room 1) does not contain asbestos.

Similar board boxing is located in rooms: 2, 3, 4, 5, 8, 9, 10, 11, 12, 14, 16, 17 and 18.

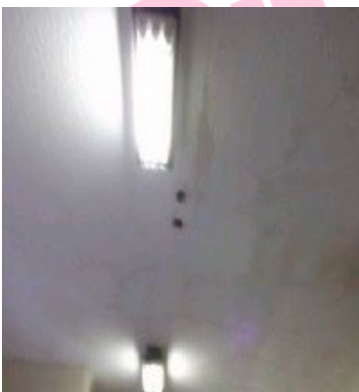
### **Item 3 - Ref: VP002101**

The textured coating to the ceiling in the male WC (Room 2) contains asbestos.

Any change in its appearance should be recorded, and passed to Property Services.

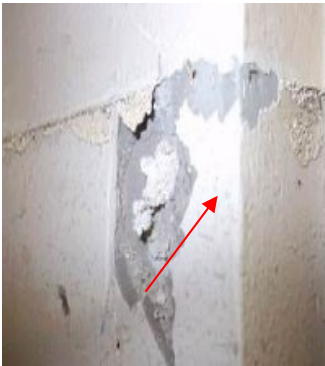
### **Item 7 - Ref: VP002104**

The boxing to the columns in the canteen (Room 3) room does not contain asbestos.

Similar boxing is located in rooms 5, 9, 10, 11, 12, 14, 17 and 18.

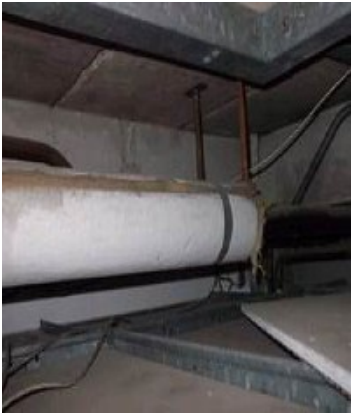
### **Various - Ref: VP002105**

The lagging to the pipework in the office (Room 5) does not contain asbestos.

Similar pipework is located in Rooms: 8, 10 and 18.

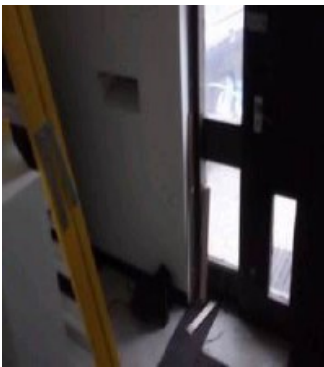
The Ground floor lobby was accessed (Room 6) and no suspect materials were found.

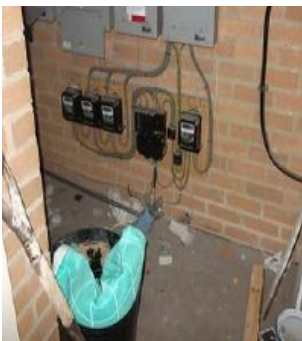
The understairs cupboard was accessed (Room 7) and no suspect materials were found.
