### ASBESTOS SURVEY REPORT FOR CONTAINER PARK OFFICES Gr FI 1 EAST SIDE COMMUNITY BLOCK, PORT OF SUNDERLAND

**CONTAINER PARK OFFICES, Gr FI1, EAST SIDE  
HUDSON DOCK, PORT OF SUNDERLAND**

**Premises Manager / Samo: - Tenant      Date: 31<sup>st</sup> July 2023**

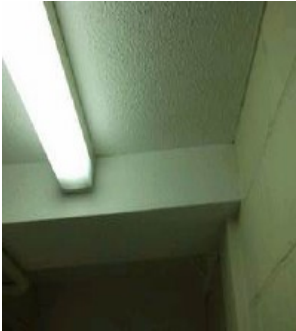
### **Item 1 Ref: VP002100**

The textured coating to the ceiling in the corridor (Room 1) contains asbestos.

Any change in its appearance should be recorded, and passed to Property Services.

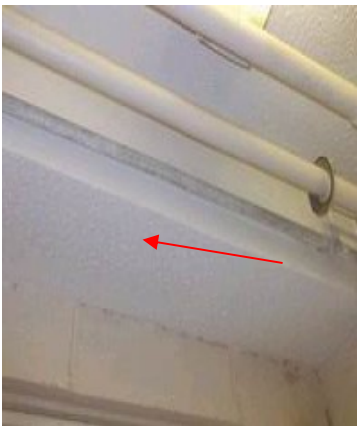
### **Various - Ref VP002102**

The board boxing to the ceiling in the corridor (Room 1) does not contain asbestos.

Similar board boxing is located in rooms: 2, 3, 4, 5, 8, 9, 10, 11, 12, 14, 16, 17 and 18.

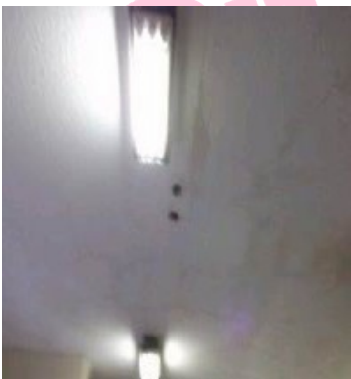
### **Item 3 - Ref: VP002101**

The textured coating to the ceiling in the male WC (Room 2) contains asbestos.

Any change in its appearance should be recorded, and passed to Property Services.

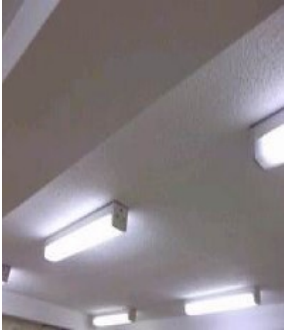
### **Item 5 - As VP002100**

The textured coating to the ceiling in the canteen (Room 3) is presumed to contain asbestos.

Any change in its appearance should be recorded, and passed to Property Services.

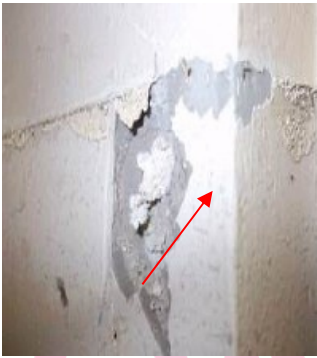
### **Item 7 - Ref: VP002104**

The boxing to the columns in the canteen (Room 3) room does not contain asbestos.

Similar boxing is located in rooms 5, 9, 10, 11, 12, 14, 17 and 18.

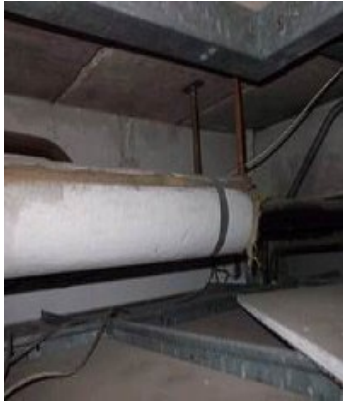
**Various - Ref: VP002105**

The lagging to the pipework in the office (Room 5) does not contain asbestos.

Similar pipework is located in Rooms: 8, 10 and 18.

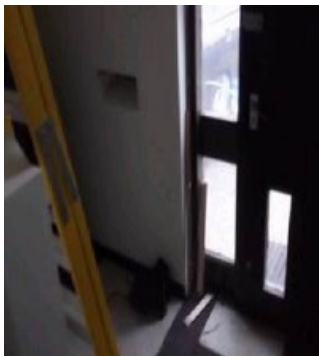
The Ground floor lobby was accessed (Room 6) and no suspect materials were found.

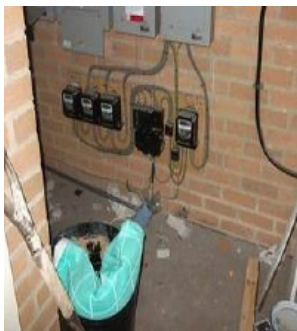
The understairs cupboard was accessed (Room 7) and no suspect materials were found.

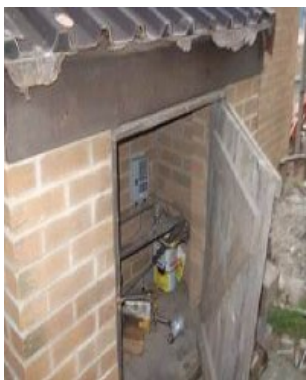
The external of the gas meter cupboard was accessed and no suspect materials were found.
