### ASBESTOS SURVEY REPORT FOR HETTON LE HOLE NURSERY SCHOOL, SUNDERLAND

## Asbestos Register for HETTON LE HOLE NURSERY SCHOOL

**Date: 21 January 2025**

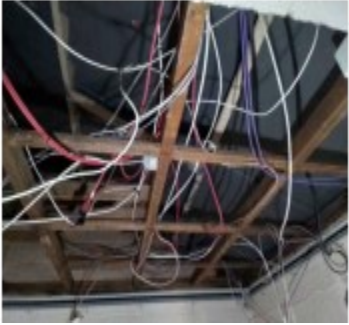
7.	As OQ000481	Ceiling forming roof – flat panels	Room G/004	Very Low Risk
<b>Photo 1: Wide Angle</b>		<b>Photo 2: Close-up</b>

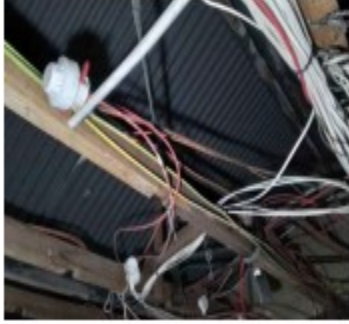
8.	OQ000482	Ceiling forming roof – corrugates panels	Room G/004	Very Low Risk
<b>Photo 1: Wide Angle</b>		<b>Photo 2: Close-up</b>

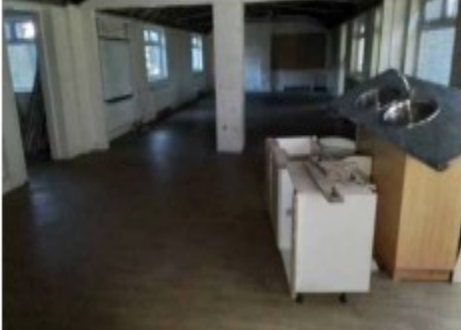
9.	As OQ000485	Floor adhesive remnants under flooring	Main Hall G/007	Very Low Risk
<b>Photo 1: Wide Angle</b>		<b>Photo 2: Close-up</b>

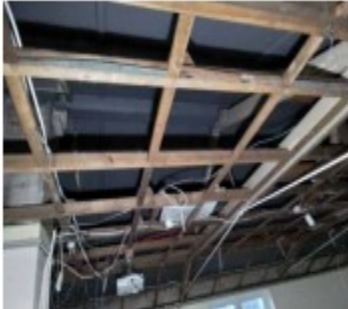
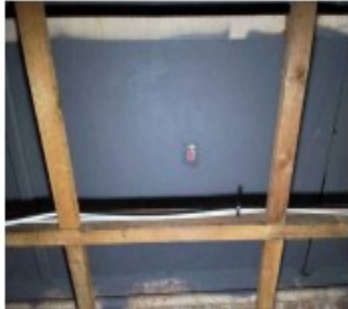
10.	As OQ000481	Ceiling forming roof – flat panels	Main Hall G/007	Very Low Risk
<b>Photo 1: Wide Angle</b>		<b>Photo 2: Close-up</b>

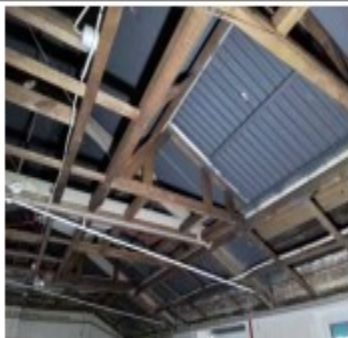
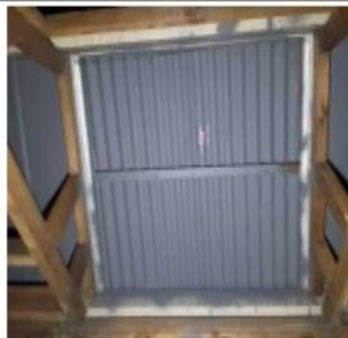
11.	As OQ000482	Ceiling forming roof – corrugates panels	Main Hall G/007	Very Low Risk
<b>Photo 1: Wide Angle</b>		<b>Photo 2: Close-up</b>

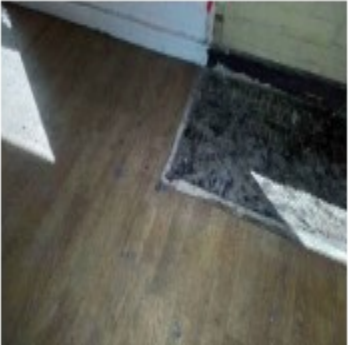
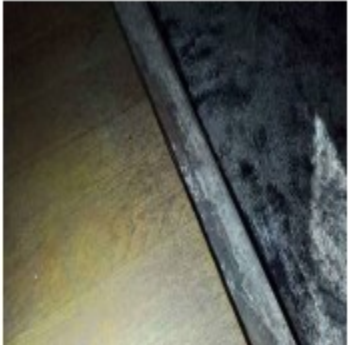
12.	OQ000483	Floor – covering beneath top layer, remnants	Main Hall G/007	Very Low Risk
<b>Photo 1: Wide Angle</b>		<b>Photo 2: Close-up</b>

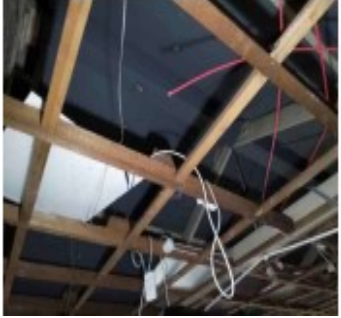
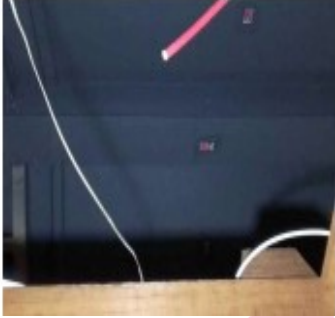
13.	As OQ000481	Beam Cladding – protection to apex beams	Main Hall G/007	Very Low Risk
<b>Photo 1: Wide Angle</b>		<b>Photo 2: Close-up</b>

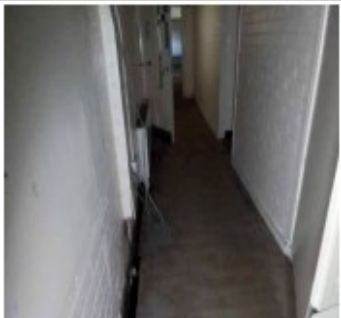
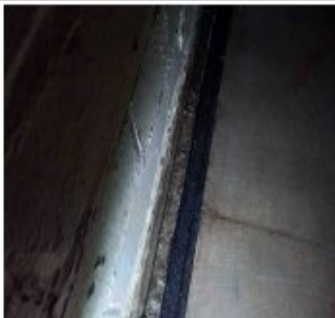
14.	As OQ000485	Floor adhesive remnants under flooring	Hallway/Passageway G/008	Very Low Risk
<b>Photo 1: Wide Angle</b>		<b>Photo 2: Close-up</b>

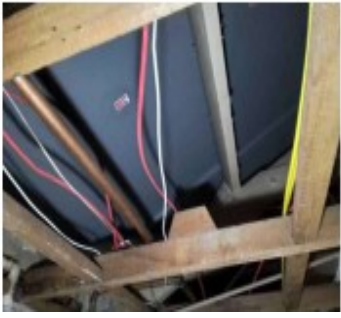
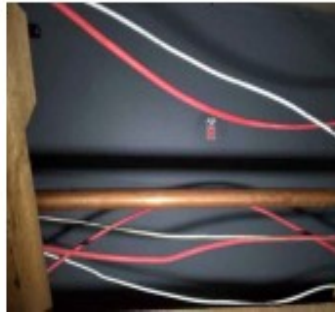
15.	As OQ000481	Ceiling forming roof – flat panels	Hallway/Passageway G/008	Very Low Risk
<b>Photo 1: Wide Angle</b>		<b>Photo 2: Close-up</b>

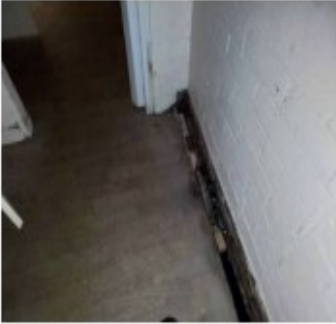
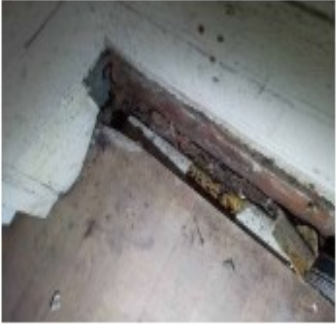
16.	OQ000484	Floor – covering beneath top layer, remnants	Hallway/Passageway G/008	Very Low Risk
<b>Photo 1: Wide Angle</b>		<b>Photo 2: Close-up</b>

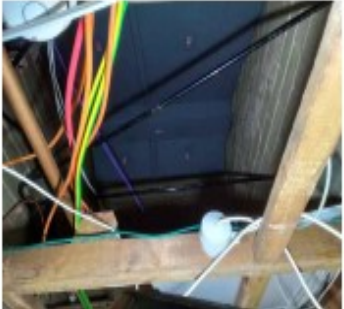
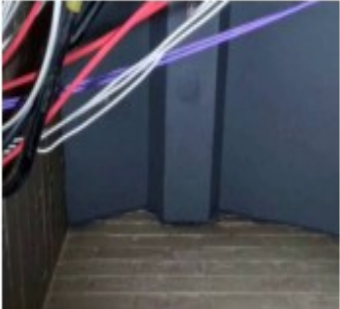
17.	As OQ000481	Beam Cladding – protection to apex beams	Hallway/Passageway G/008	Very Low Risk
<b>Photo 1: Wide Angle</b>		<b>Photo 2: Close-up</b>

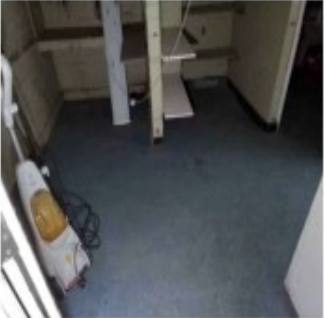
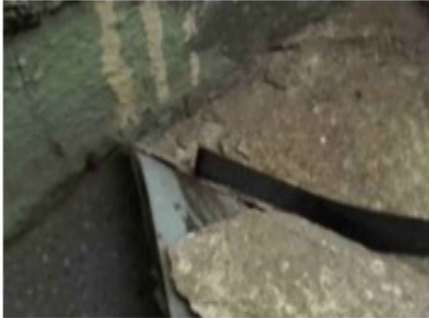
18.	As OQ000485	Floor covering beneath top layer remnants	Store Room G/009	Very Low Risk
<b>Photo 1: Wide Angle</b>		<b>Photo 2: Close-up</b>

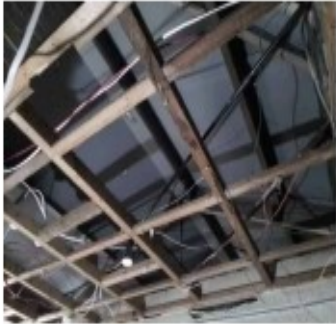
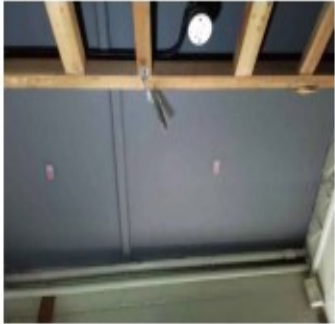
19.	As OQ000481	Ceiling forming roof – flat panels	Store Room G/009	Very Low Risk
<b>Photo 1: Wide Angle</b>		<b>Photo 2: Close-up</b>

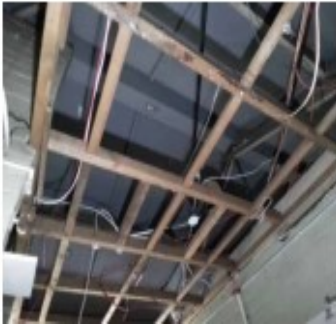
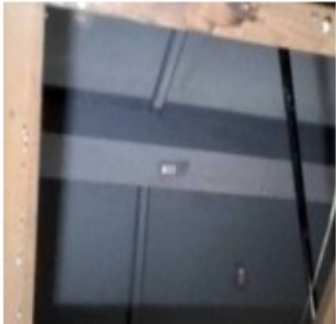
20.	OQ000487	Beam Cladding – protection to apex beams	Store Room G/009	Very Low Risk
<b>Photo 1: Wide Angle</b>		<b>Photo 2: Close-up</b>

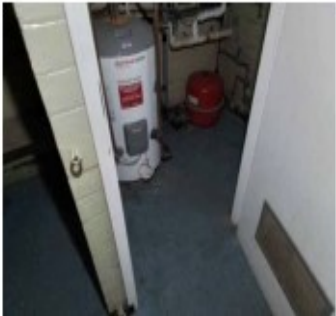
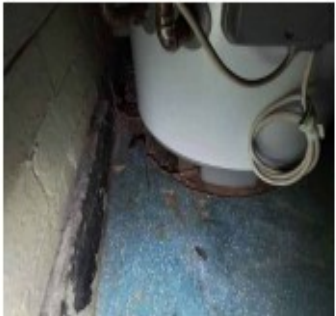
21.	OQ000485	Floor adhesive remnants under flooring	Boiler Room G/010	Very Low Risk
<b>Photo 1: Wide Angle</b>		<b>Photo 2: Close-up</b>

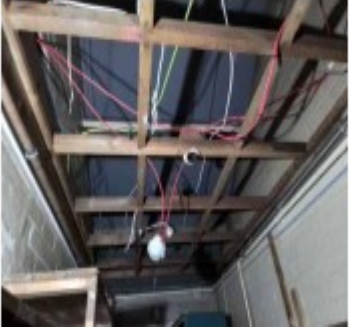
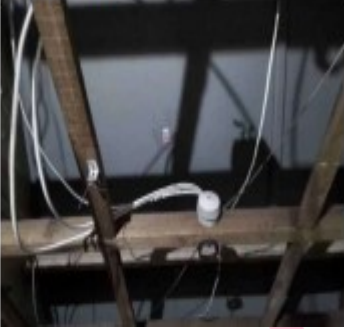
31.	OQ000488	Ceiling forming roof – flat panels	Store Room G/017	Very Low Risk
<b>Photo 1: Wide Angle</b>		<b>Photo 2: Close-up</b>

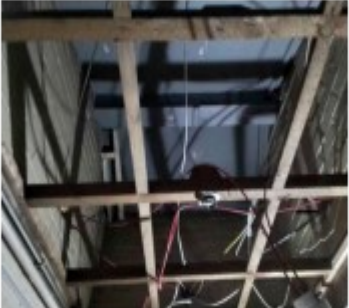
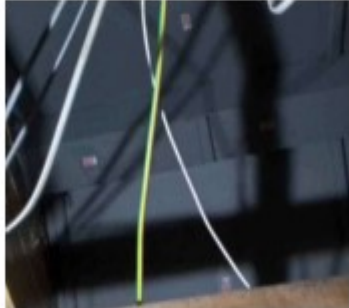
32.	As OQ000487	Beam Cladding – protection to apex beams	Store Room G/017	Very Low Risk
<b>Photo 1: Wide Angle</b>		<b>Photo 2: Close-up</b>

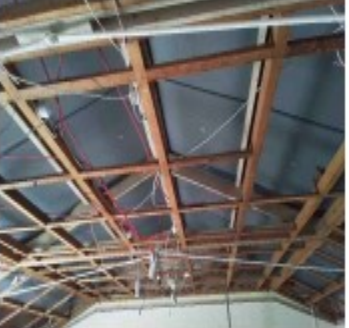
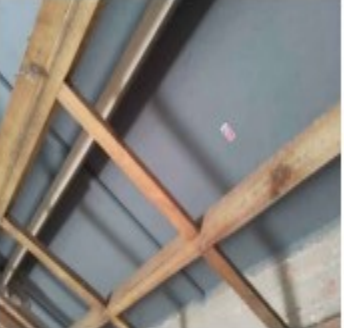
33.	As OQ000488	Ceiling forming roof – flat panels	Classroom G/018	Very Low Risk
<b>Photo 1: Wide Angle</b>		<b>Photo 2: Close-up</b>

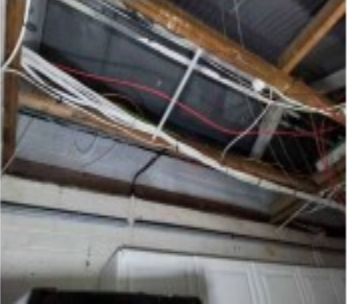
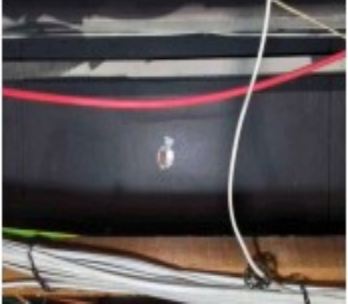
37.	As OQ000481	Ceiling forming roof – flat panels	Kitchen G/027	Very Low Risk
<b>Photo 1: Wide Angle</b>		<b>Photo 2: Close-up</b>

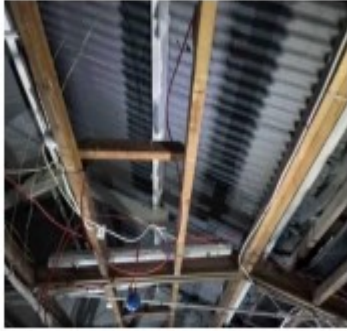
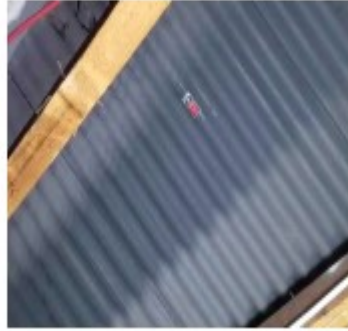
38.	As OQ000482	Ceiling forming roof – corrugates panels	Kitchen G/027	Very Low Risk
<b>Photo 1: Wide Angle</b>		<b>Photo 2: Close-up</b>

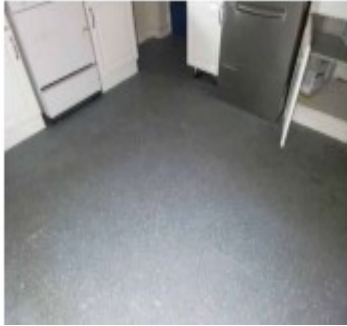
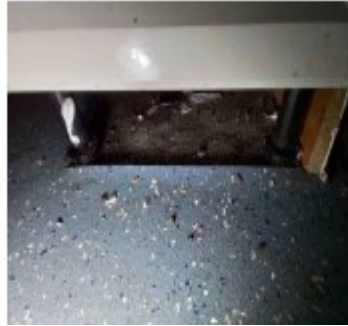
39.	As OQ000485	Floor adhesive remnants under flooring	Kitchen G/027	Very Low Risk
<b>Photo 1: Wide Angle</b>		<b>Photo 2: Close-up</b>

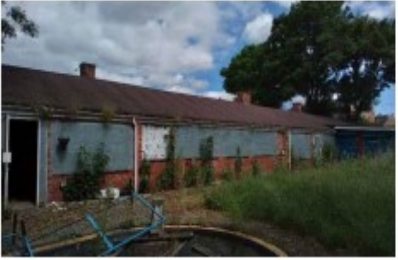
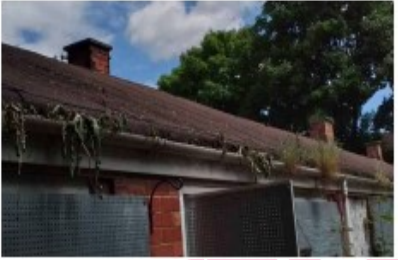
40.	Presumed	Roof felt – consider this material as contaminated due to being adhered to asbestos cement roof	External E/001	Very Low Risk
<p><b>Photo 1: Wide Angle</b></p>

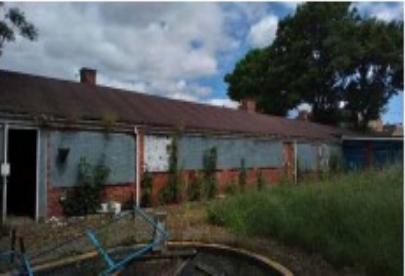
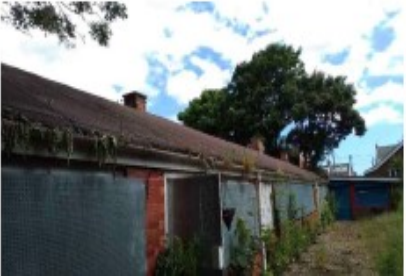
41.	As OQ000482	Roof sheet cladding – located below roof felt	External E/001	Very Low Risk
<p><b>Photo 1: Wide Angle</b></p>
