ASBESTOS SURVEY REPORT FOR RYHOPE CA, SUNDERLAND

RYHOPE COMMUNITY ASSOCIATION, SUNDERLAND

Date: 21 July 2025

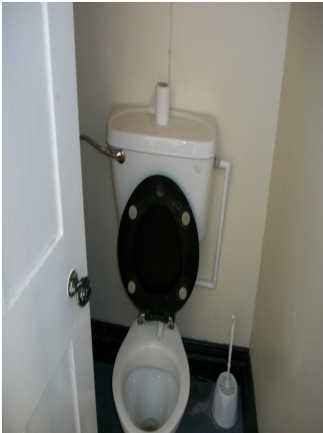
Item 1 Ref: Presumed

The WC seat to the toilet in room 002 is presumed to contain asbestos. Any change in its appearance should be recorded and passed to Property Services.

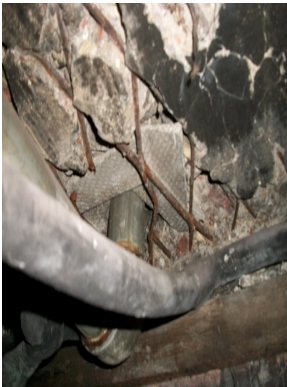
Item 2 - Ref: Sample 10

The packing to pipework in boiler room contains asbestos. Any change in its appearance should be recorded and passed to Property Services.

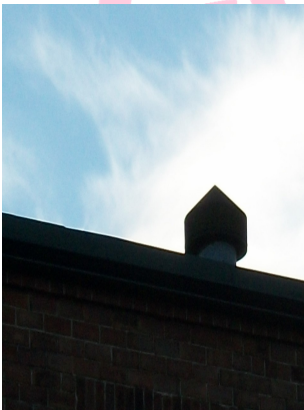
Item 3 - Ref: Presumed

The external roof cowl to the roof is presumed to contain asbestos. Any change in its appearance should be recorded and passed to Property Services.

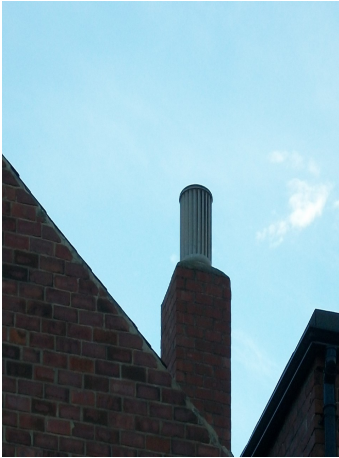
Item 4 - Ref: Presumed

The large external roof cowl to the roof is presumed to contain asbestos. Any change in its appearance should be recorded and passed to Property Services.

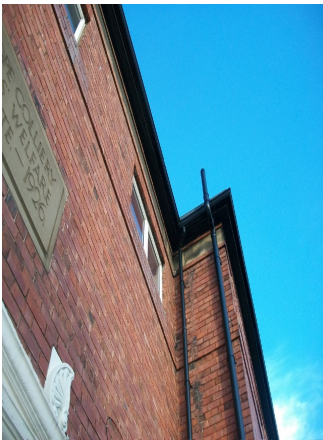
Item 5 - Ref: Presumed

The soffit to the external is presumed to contain asbestos. Any change in its appearance should be recorded and passed to Property Services.

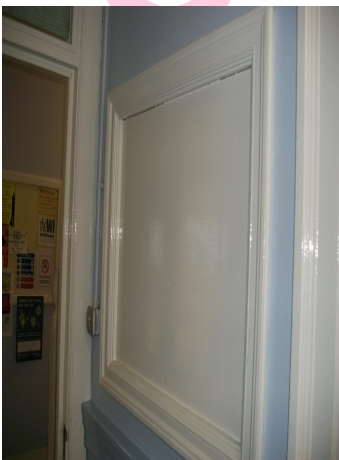
Items 6 & 10- Ref: Sample 2

The wall panel outside the male wc (Rm 004) does not contain asbestos.

Similar wall panel is located outside female wc.

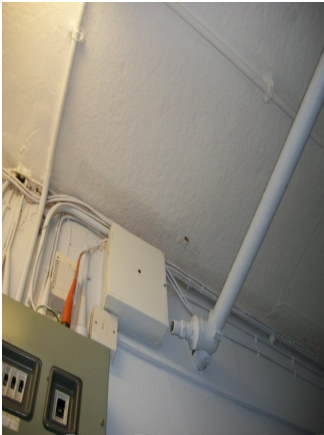
Item 7 - Ref: Sample 03

The ceiling board to room 004 does not contain asbestos.

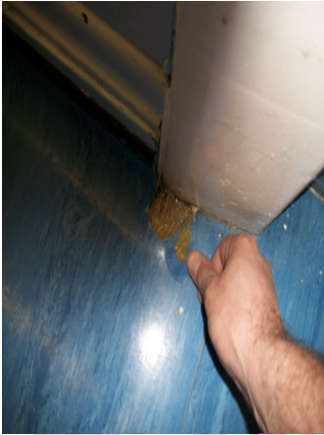
Item 8 & 11 - Ref: Sample 04

The floor covering under the lino in the entrance and corridor (Area 004) does not contain asbestos.

Similar floor covering is located in area 007.

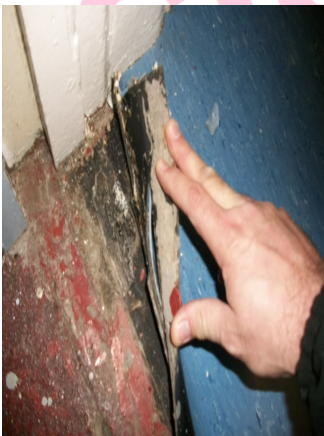
Item 9 - Ref: Sample 01

The vinyl floor tiles to the corridor (Area 005) do not contain asbestos.

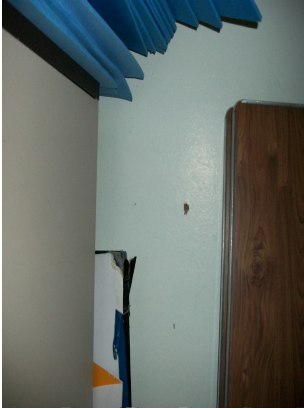
Item 12 - Ref: Sample 05

The board to the rear wall in the cupboard (Area 011) does not contain asbestos.

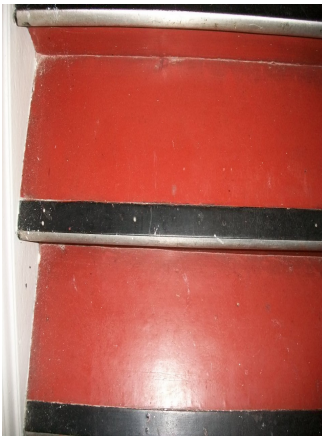
Item 13 - Ref: Sample 06

The floor covering to the stairs (Area 012) does not contain asbestos.

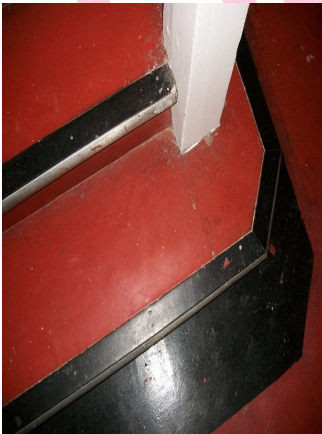
Item 14 - Ref: Sample 07

The stair nosing to the stairs (Area 012) does not contain asbestos.

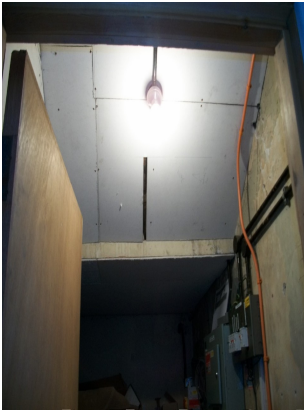
Item 15 - Ref: Sample 08

The walls and ceiling to the electrical cupboard (Room 014) do not contain asbestos.

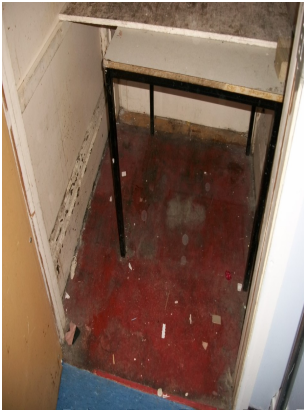
Item 16, 19, 20 & 24 - Ref: Sample 12

The floor covering to the cupboard (Rm 003) does not contain asbestos.

Similar flooring is located in Rm 006, 007 and 001.

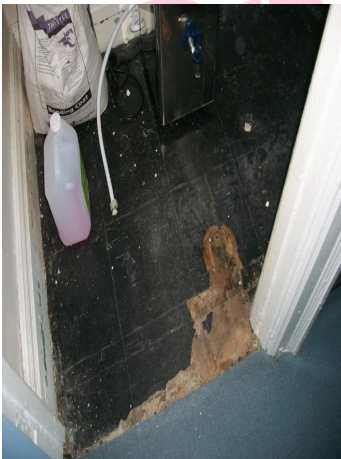
Item 17 - Ref: Sample 13

The floor tiles to the cupboard in the kitchen (Room 004) do not contain asbestos.

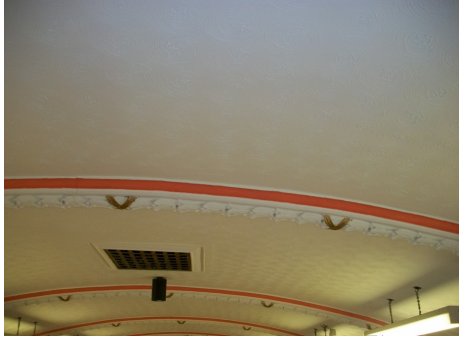
Item 18 - Ref: Sample 14

The dance hall ceiling (Area 005) does not contain asbestos.

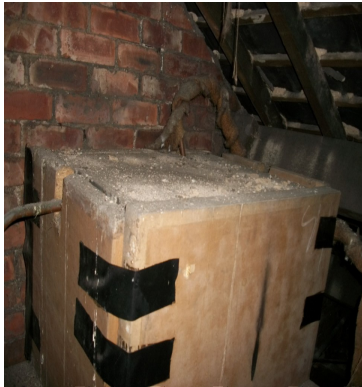
Item 21 - Ref: Sample 15

The water tank insulation in the loft space above the kitchen (Area 009) does not contain asbestos.

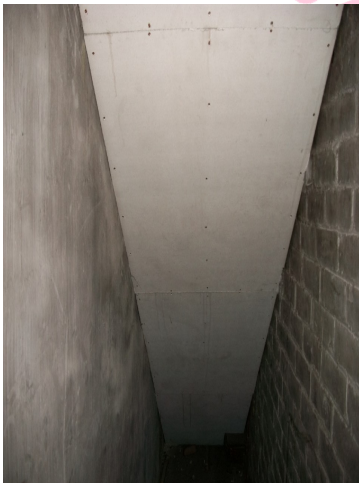
Item 22 - Ref: Sample 11

The board above the stairs in the boiler room (Are 001) does not contain asbestos.

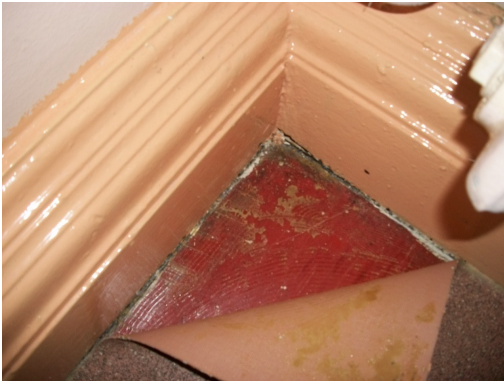
Item 24 Ref: As Sample 12

The floor covering (Rm 001) does not contain asbestos

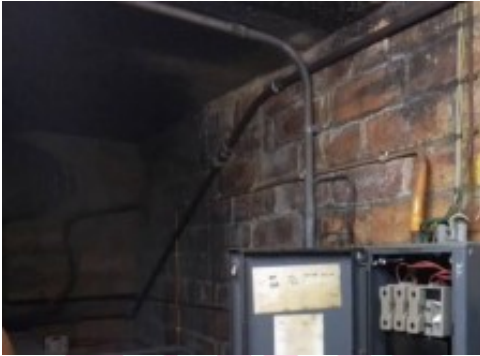
Item 27 Ref: PZ000693

The fuses/flashguards in the Boiler Room (Z1/001) contain asbestos.

Removed 22/11/2023
