ASBESTOS SURVEY REPORT FOR RYHOPE CA, SUNDERLAND

RYHOPE COMMUNITY ASSOCIATION, SUNDERLAND

Date: 20 January 2025

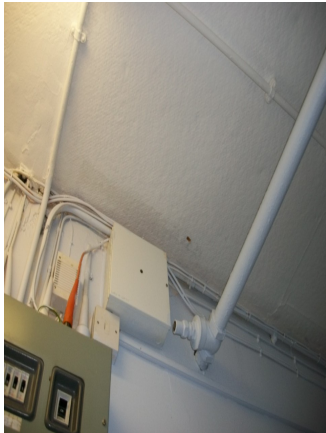
Item 7 - Ref: Sample 03

The ceiling board to room 004 does not contain asbestos.

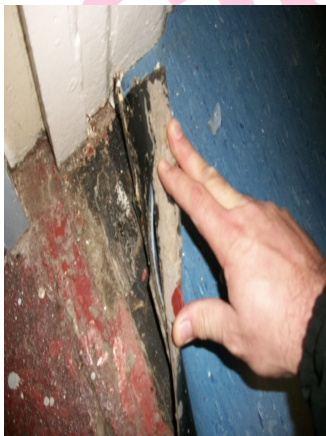
Item 9 - Ref: Sample 01

The vinyl floor tiles to the corridor (Area 005) do not contain asbestos.

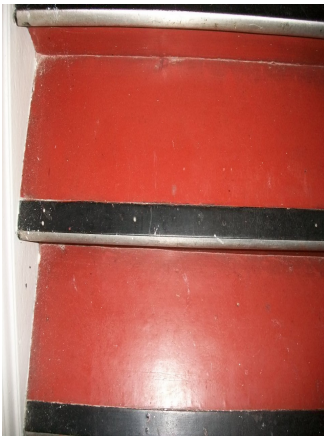
Item 13 - Ref: Sample 06

The floor covering to the stairs (Area 012) does not contain asbestos.

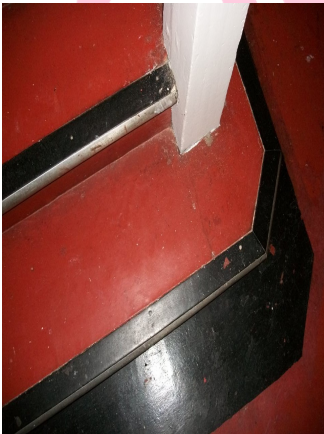
Item 14 - Ref: Sample 07

The stair nosing to the stairs (Area 012) does not contain asbestos.

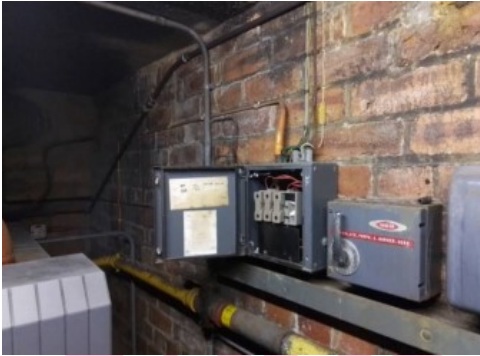
Item 27 Ref: PZ000693

The fuses/flashguards in the Boiler Room (Z1/001) contain asbestos.

Removed 22/11/2023
