### **ASBESTOS SURVEY REPORT FOR 56a HIGH STREET, SUNDERLAND, SR1 3DP**

## Asbestos Register for

**56a High Street, Sunderland, SR1 3DP**

**Date: 16 July 2025**

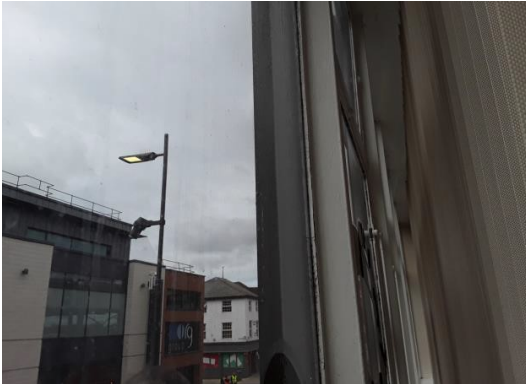
### **Item 1 Ref: 21-35341-1**

The window mastic (Floor 1 Room 3) does not contain asbestos.

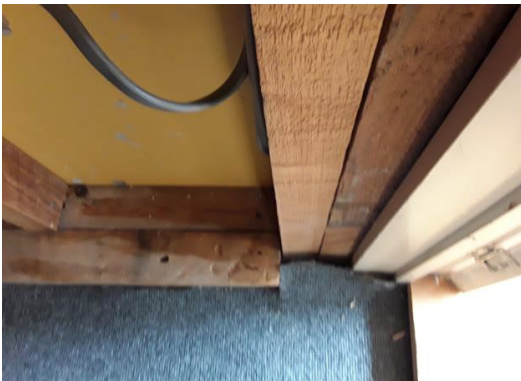
### **Item 2 Ref: 21-35341-2**

The vinyl floor (Floor 1 Room 4) does not contain asbestos.

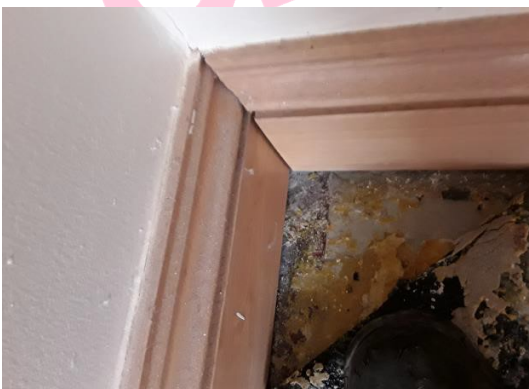
### **Item 3 Ref: 21-35341-2**

The vinyl floor (Floor 1 Room 5) does not contain asbestos.

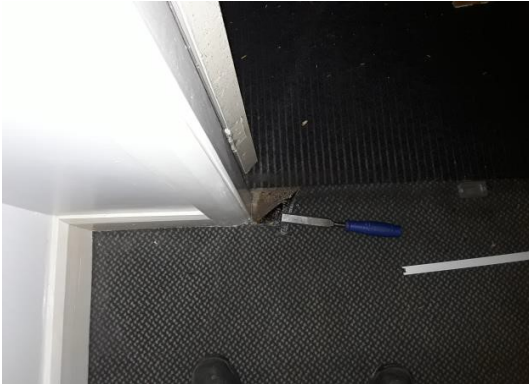
### **Item 4 Ref: 21-35341-2**

The vinyl floor (Floor 1 Room 6) does not contain asbestos.

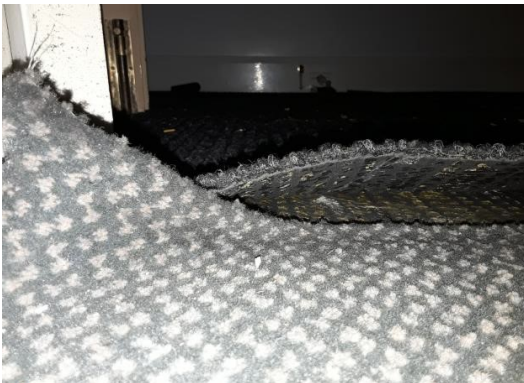
### **Item 5 Ref: 21-35341-2**

The vinyl floor (Floor 1 Room 7) does not contain asbestos.

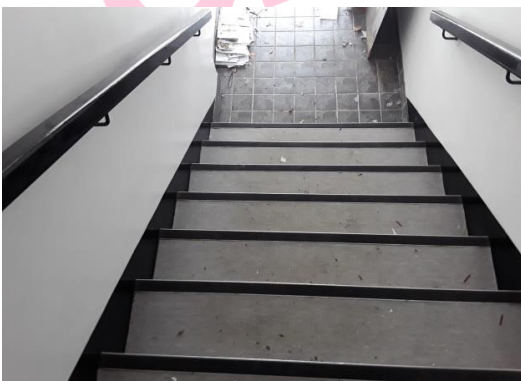
### **Item 6 Ref: 21-35341-3**

The stair nosings (Floor G/1 Room 9) does not contain asbestos.

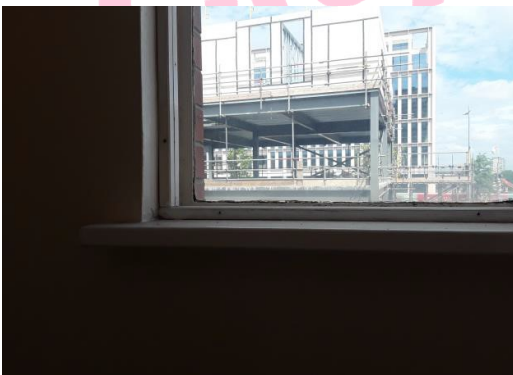
### **Item 9 Ref: 21-35341-1**

The window mastic (Floor 1 Room 17) does not contain asbestos.

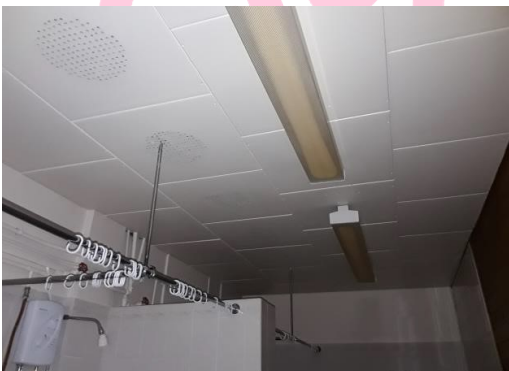
#### **Item 12 Ref: 21-35341-5**

The suspended ceiling tiles (Floor 1 Room 19) does not contain asbestos.

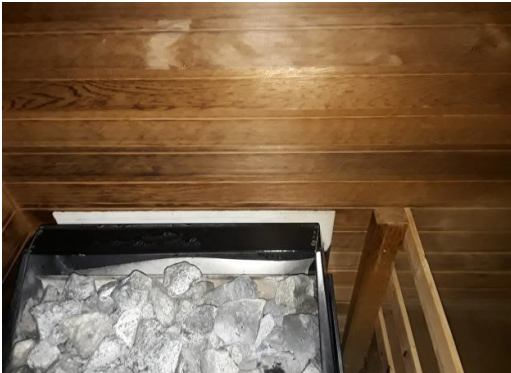
#### **Item 13 Ref: 21-35341-6**

- (Item 13) Ref: 21-35341-6 – Board to wall behind hot coals (Floor 1 Room 20) – Low Risk
- (Item 14) Ref: 21-35341-7 – Ceiling (Floor 1 Room 21) – No Risk

The board to wall behind hot coals (Floor 1 Room 20) contains asbestos.

Item 10	No asbestos	Is present		
Item 11	No asbestos	Is present		
Item 12	No asbestos	Is present		
<b>Item 13</b>	<b>Board to wall behind hot coals (Floor 1 Room 20)</b>	<b>Low Risk</b>	<b>6 monthly</b>	<b>27/01/2026</b>

Any change in its appearance should be recorded and passed to Property Services.

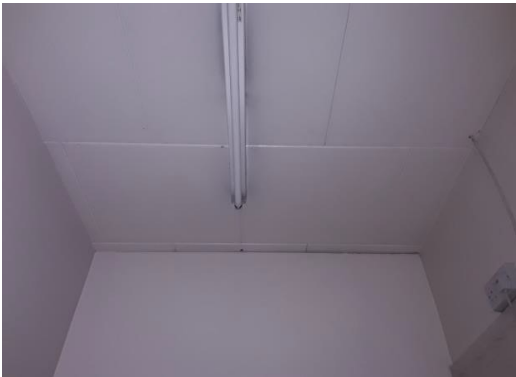
#### **Item 14 Ref: 21-35341-7**

The ceiling (Floor 1 Room 21) does not contain asbestos.

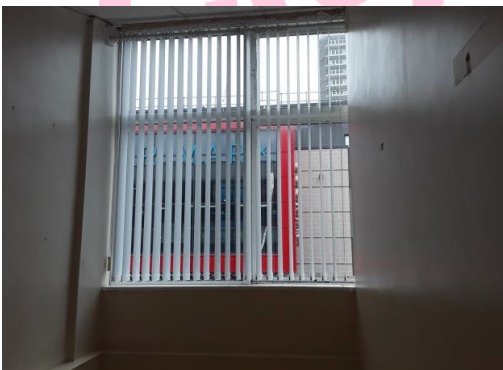
#### **Item 15 Ref: 21-35341-1**

The window mastic (Floor 1 Room 25) does not contain asbestos.

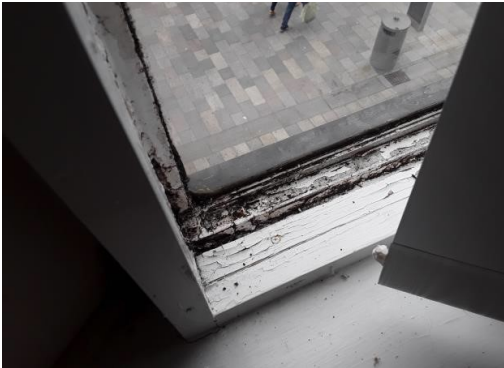
#### **Item 16 Ref: 21-35341-1**

The window mastic (Floor 1 Room 26) does not contain asbestos.

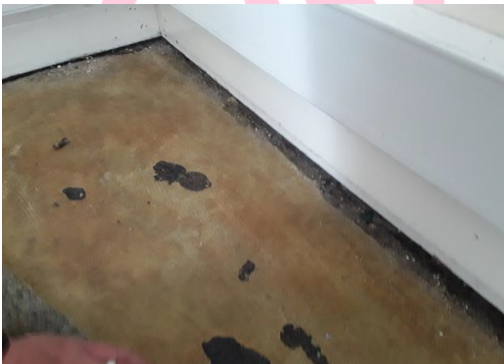
#### **Item 18 Ref: 21-35341-8**

- (Item 18) Ref: 21-35341-8 – Residual adhesive to floor (Floor 2 Room 28) – Very Low Risk
- (Item 19) Ref: 21-35341-1 – Window mastic (Floor 2 Room 30) – No Risk

The residual adhesive to floor (Floor 2 Room 28) contains asbestos.

Item 14	No asbestos	Is present		
Item 15	No asbestos	Is present		
Item 16	No asbestos	Is present		
Item 17	No asbestos	Is present		
<b>Item 18</b>	<b>Residual adhesive to floor (Floor 2 Room 28)</b>	<b>Very Low Risk</b>	<b>12 monthly</b>	<b>27/7/2026</b>

Any change in its appearance should be recorded and passed to Property Services.

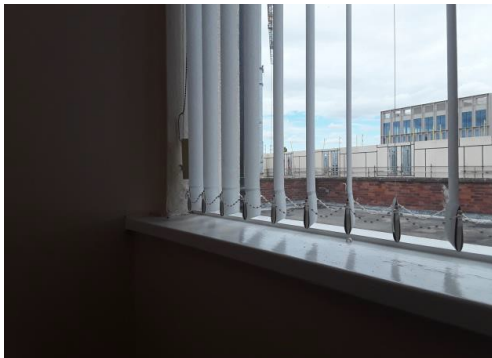
### **Item 19 Ref: 21-35341-1**

The window mastic (Floor 2 Room 30) does not contain asbestos.

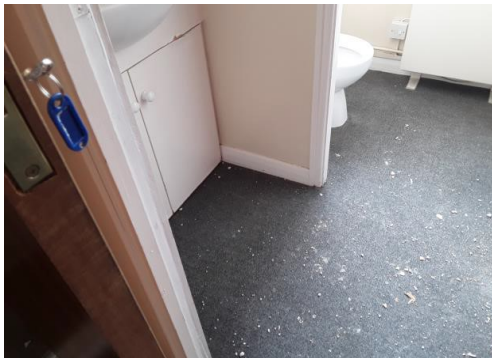
### **Item 20 Ref: 21-35341-8**

- (Item 20) Ref: 21-35341-8 – Floor (Floor 2 Room 30) – Very Low Risk
- (Item 21) Ref: 21-35341-10 – Felt to rear walkway on roof (External) – No Risk
- (Item 22) Ref: 21-35341-11 – Downpipes (External) – No Risk

The floor (Floor 2 Room 30) contains asbestos.

Item 19	No asbestos	Is present		
<b>Item 20</b>	<b>Floor (Floor 2 Room 30)</b>	<b>Very Low Risk</b>	<b>12 monthly</b>	<b>27/7/2026</b>
Item 21	No asbestos	Is present

Any change in its appearance should be recorded and passed to Property Services.

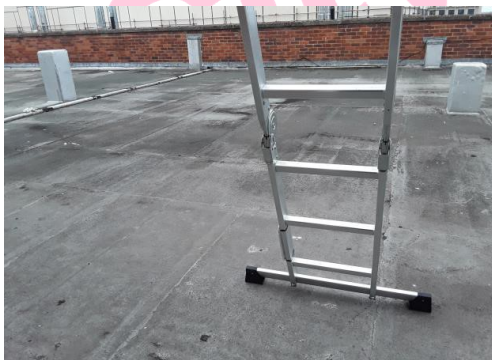
### **Item 21 Ref: 21-35341-10**

The felt to rear walkway on roof (External) does not contain asbestos.

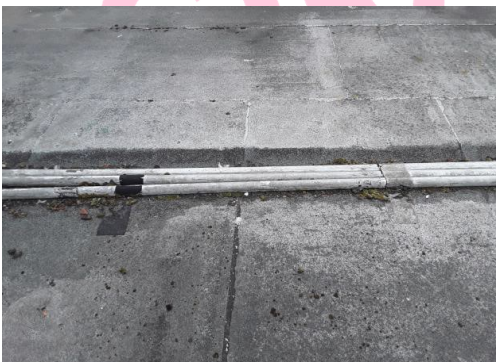
### **Item 24 Ref: 21-35341-13**

The flashing to roof floor (External) does not contain asbestos.

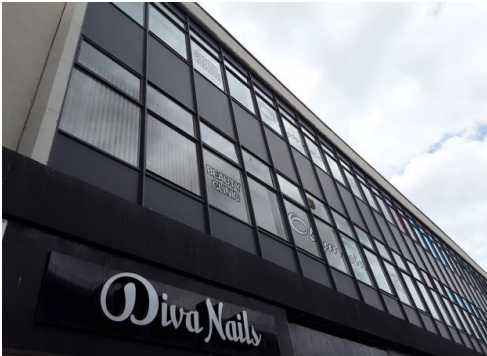
#### **Item 24 Ref: 21-35341-14**

The infill panel (External) does not contain asbestos.

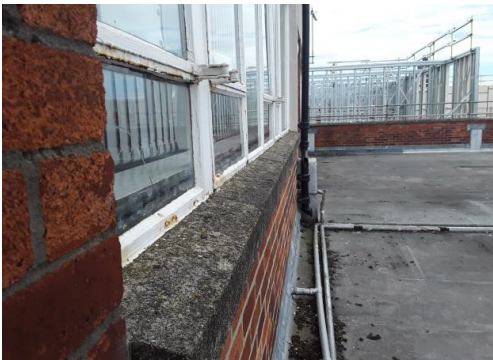
#### **Item 25 Ref: 21-35341-9**

The window putty (External) does not contain asbestos.
