ASBESTOS SURVEY REPORT FOR 56a HIGH STREET, SUNDERLAND, SR1 3DP

Asbestos Register for

56a High Street, Sunderland, SR1 3DP

Date: 14 January 2025

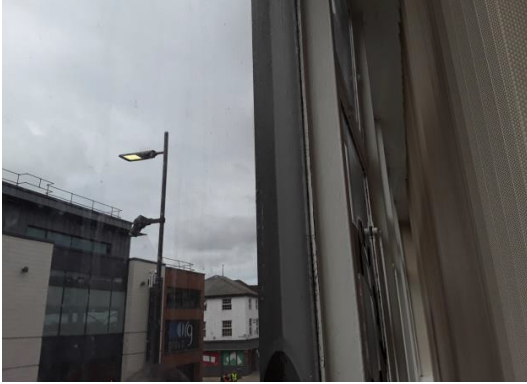
Item 1 Ref: 21-35341-1

- (Item 1) Ref: 21-35341-1 – Window mastic (Floor 1 Room 3) – No Risk
- (Item 2) Ref: 21-35341-2 – Vinyl floor (Floor 1 Room 4) – No Risk
- (Item 3) Ref: 21-35341-2 – Vinyl floor (Floor 1 Room 5) – No Risk

The window mastic (Floor 1 Room 3) does not contain asbestos.

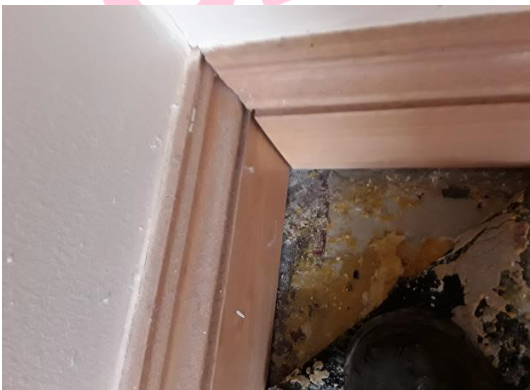
Item 3 Ref: 21-35341-2

The vinyl floor (Floor 1 Room 5) does not contain asbestos.

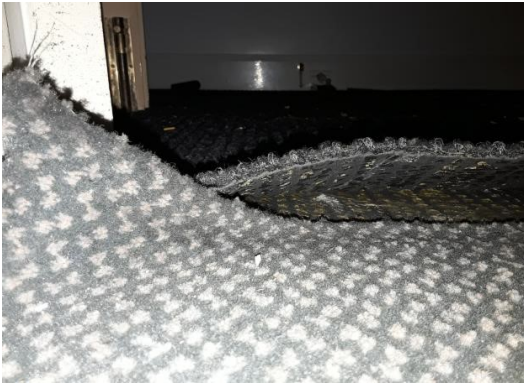
Item 5 Ref: 21-35341-2

The vinyl floor (Floor 1 Room 7) does not contain asbestos.

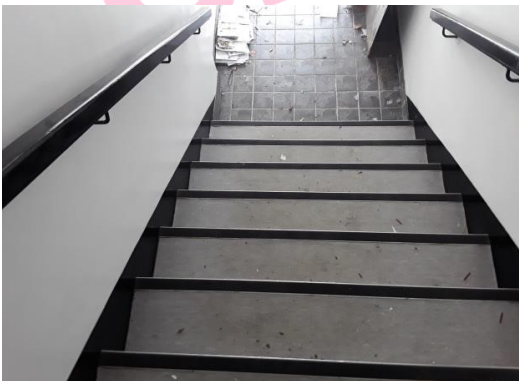
Item 6 Ref: 21-35341-3

The stair nosings (Floor G/1 Room 9) does not contain asbestos.

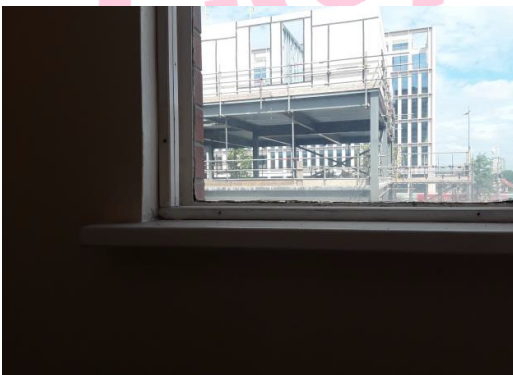
Item 9 Ref: 21-35341-1

The window mastic (Floor 1 Room 17) does not contain asbestos.

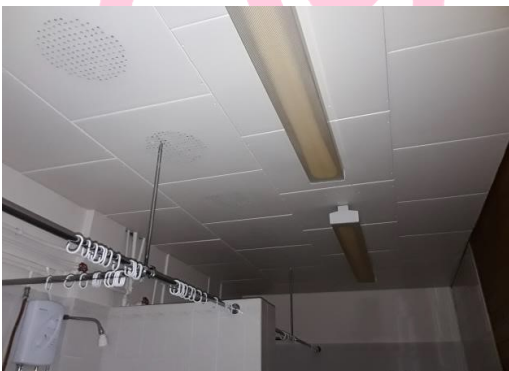
Item 12 Ref: 21-35341-5

The suspended ceiling tiles (Floor 1 Room 19) does not contain asbestos.

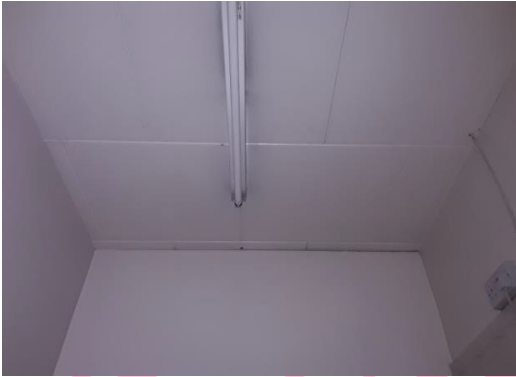
Item 14 Ref: 21-35341-7

The ceiling (Floor 1 Room 21) does not contain asbestos.

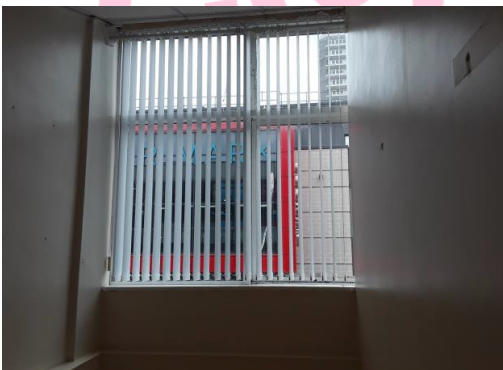
Item 15 Ref: 21-35341-1

The window mastic (Floor 1 Room 25) does not contain asbestos.

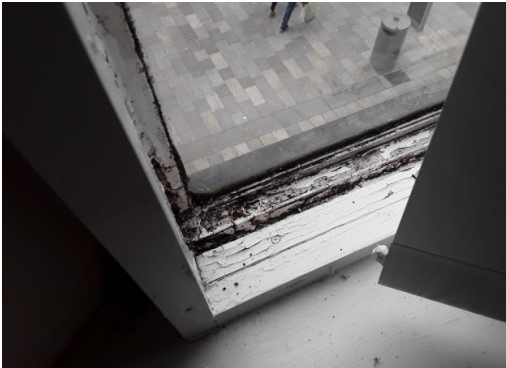
Item 16 Ref: 21-35341-1

The window mastic (Floor 1 Room 26) does not contain asbestos.

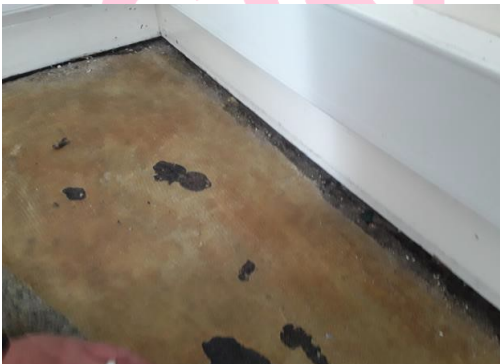
Item 18 Ref: 21-35341-8

- (Item 18) Ref: 21-35341-8 – Residual adhesive to floor (Floor 2 Room 28) – Very Low Risk
- (Item 19) Ref: 21-35341-1 – Window mastic (Floor 2 Room 30) – No Risk

The residual adhesive to floor (Floor 2 Room 28) contains asbestos.

Any change in its appearance should be recorded and passed to Property Services.

Item 18	Residual adhesive to floor (Floor 2 Room 28)	Very Low Risk	12 monthly	27/7/2025
<i>Item 19</i>	<i>No asbestos</i>	<i>Is present</i>		
Item 20	Floor (Floor 2 Room 30)	Very Low Risk	12 monthly	27/7/2025
<i>Item 21</i>	<i>No asbestos</i>	<i>Is present</i>		
<i>Item 22</i>	<i>No asbestos</i>	<i>Is present</i>

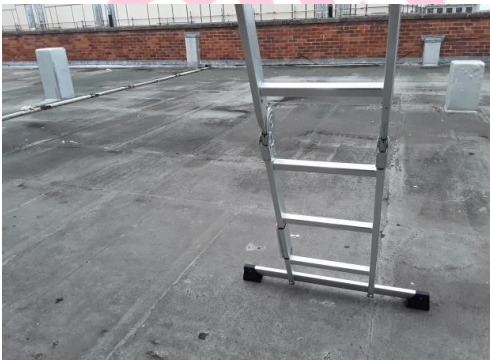
Item 21 Ref: 21-35341-10

The felt to rear walkway on roof (External) does not contain asbestos.

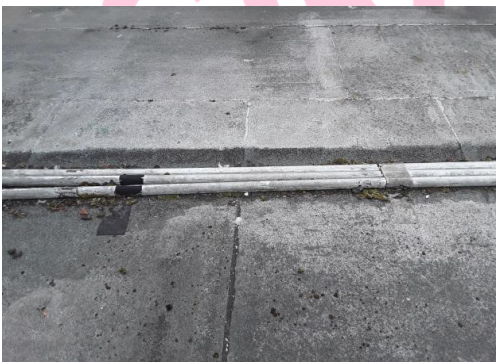
Item 24 Ref: 21-35341-13

The flashing to roof floor (External) does not contain asbestos.
