ASBESTOS SURVEY REPORT FOR 19 VILLIERS STREET, SUNDERLAND SR1 1EJ

Asbestos Register for 19 Villiers Street, Sunderland SR1 1EJ

Date: 07 May 2025

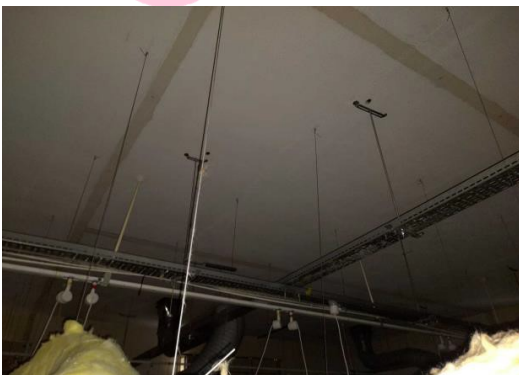
Item 3 Ref: Presumed

The ceiling (Textured Coating), Area: 2 (Common ceiling void) is presumed to contain asbestos.

Any change in its appearance should be recorded and passed to Property Services.

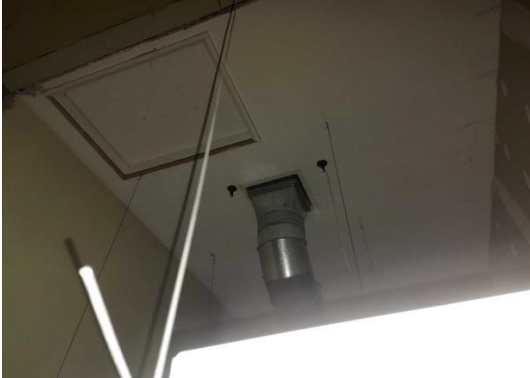
Item 4 Ref: Presumed

The ceiling (Textured Coating), Area: 6 (Kitchen) is presumed to contain asbestos.

Any change in its appearance should be recorded and passed to Property Services.

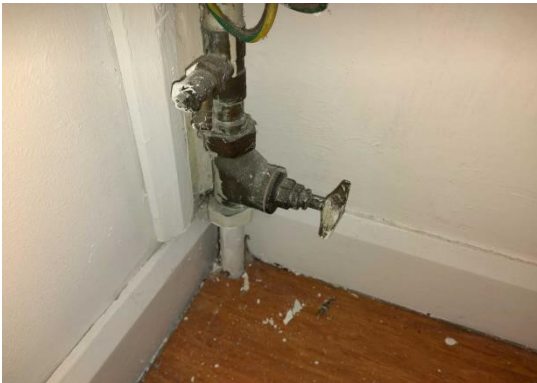
Item 5 Ref: 22-55202-5

The pipes - gasket to stop tap, Area: 8 (Female wc & lobby) do not contain asbestos.

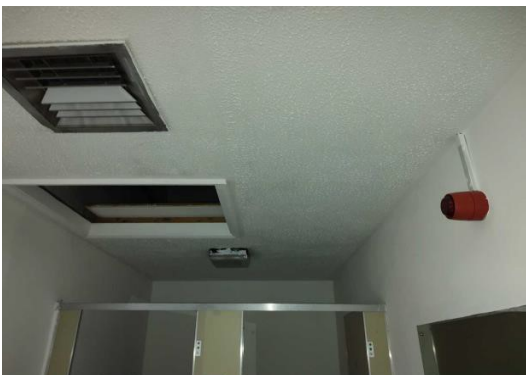
Item 6 Ref: 22-55202-6

The ceiling (Textured Coating), Area: 8 (Female wc & lobby) does not contain asbestos.

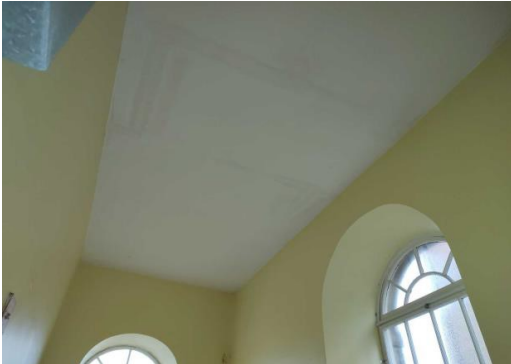
Item 10 Ref: 22-55202-6

The ceiling (Textured Coating), Area: 16 (Fire exit stairwell) does not contain asbestos.

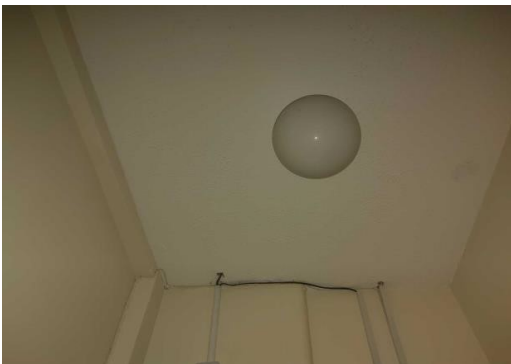
Item 11 Ref: 22-55202-8

The ceiling (Textured Coating), Area: 19 (Corridor) does not contain asbestos.

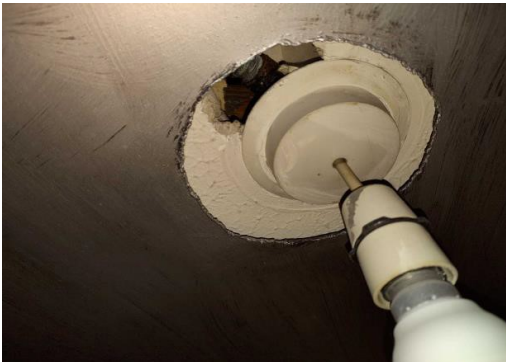
Item 14 Ref: 22-55202-8

The ceiling (Textured Coating), Area: 21 (Cupboard - Understairs) does not contain asbestos.

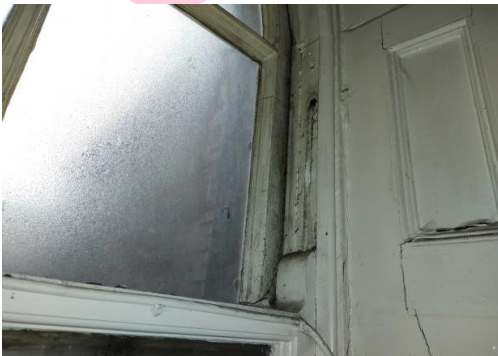
Item 15 Ref: 22-55202-11

The window - sash window cords, Area: 23 (Side lobby) does not contain asbestos.

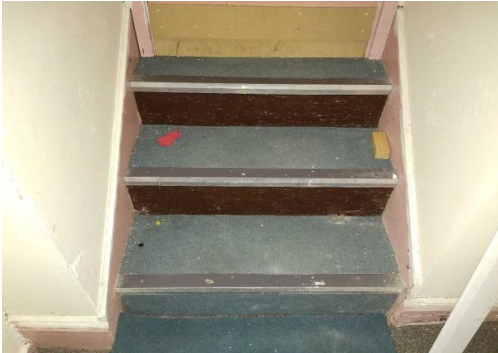
Item 16 Ref: 22-55202-12

The floor - stair nosing strips, Area: 23 (Side lobby) does not contain asbestos.

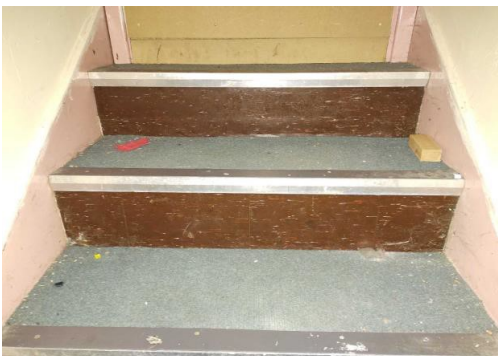
Item 17 Ref: 22-55202-13

The floor to stairs (Tiles & Adhesive), Area: 23 (Side lobby) does not contain asbestos.

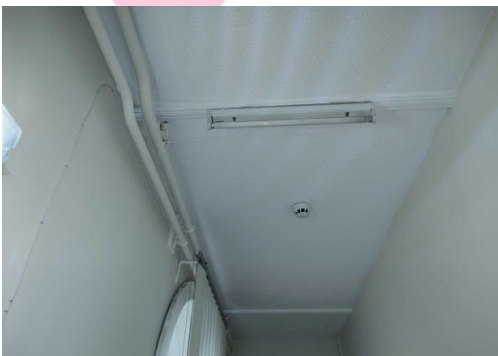
Item 18 Ref: 22-55202-8

The ceiling (Textured Coating), Area: 23 (Side lobby) does not contain asbestos.

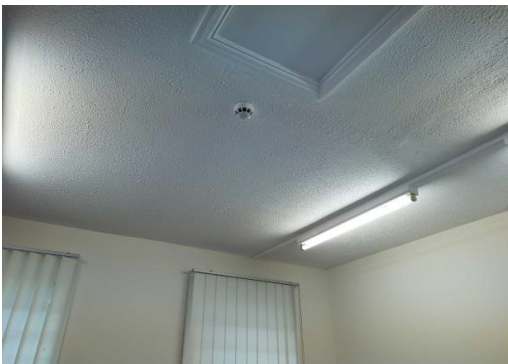
Item 20 Ref: 22-55202-8

The ceiling (Textured Coating), Area: 25 (Music office) does not contain asbestos.

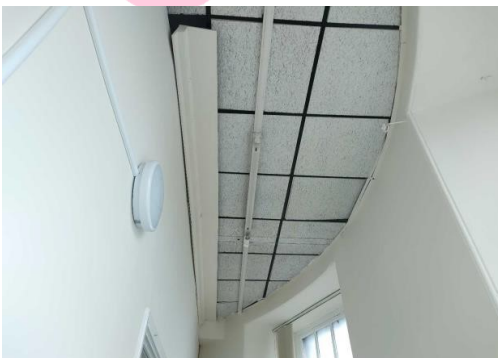
Item 21 Ref: 22-55202-9

The ceiling - suspended ceiling tiles, Area: 27 (Storage area) does not contain asbestos.

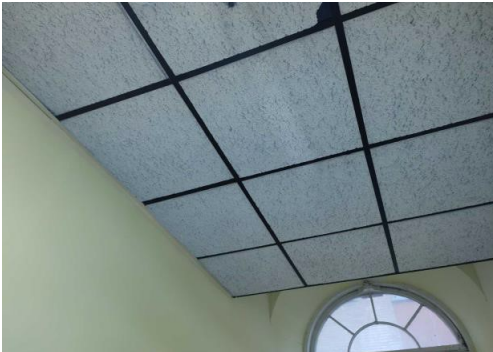
Item 23 Ref: 22-55202-9

The ceiling - suspended ceiling tiles, Area: 28 (Rear corridor) does not contain asbestos.

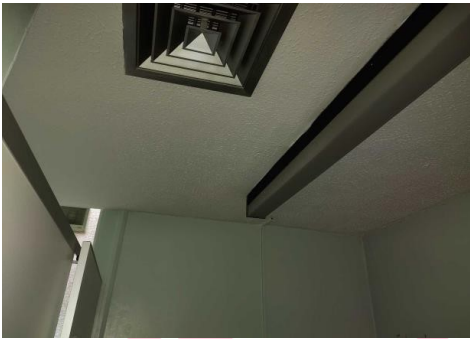
Item 26 Ref: 22-55202-15

The ceiling (Textured Coating), Area: 30 (Female wc/ baby change & lobby) does not contain asbestos.

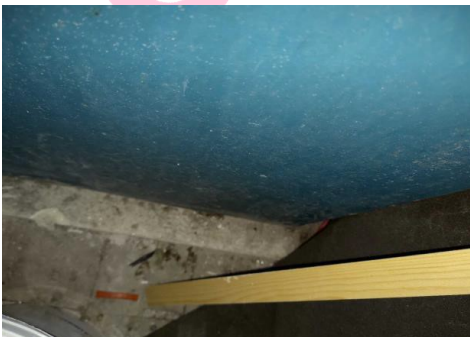
Item 30 Ref: 22-55202-17

The floor - boiler plinth, Area: 33 (Boiler cupboard) does not contain asbestos.

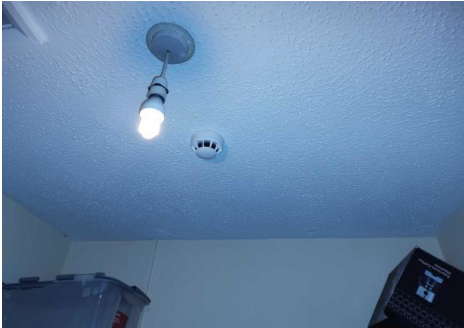
Item 31 Ref: 22-55202-15

The ceiling (Textured Coating), Area: 34 (Store cupboard) does not contain asbestos.

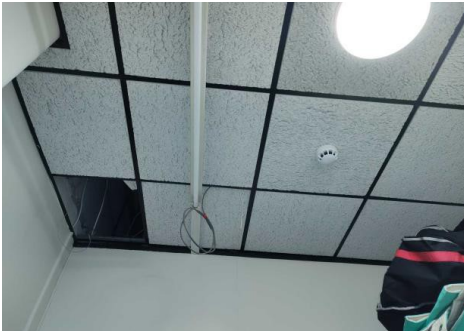
Item 32 Ref: 22-55202-9

The ceiling - suspended ceiling tiles, Area: 36 (Store cupboard 2) does not contain asbestos.

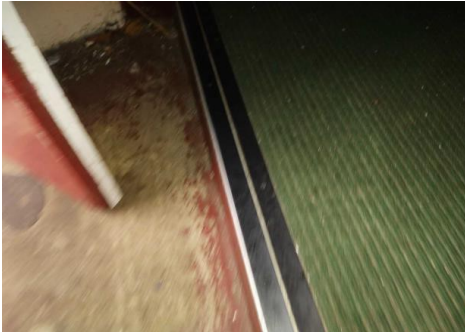
Item 34 Ref: 22-55202-18

The Floor - Stair nosing strip, Area: 37 (Front Lobby) does not contain asbestos.
