ASBESTOS SURVEY REPORT FOR 19 VILLIERS STREET, SUNDERLAND  
SR1 1EJ

**19 Villiers Street, Sunderland SR1 1EJ**

**Date: 22 November 2024**

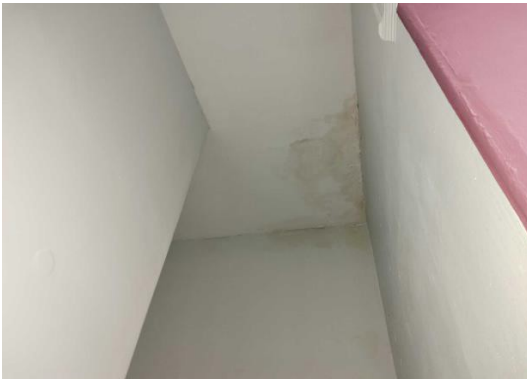
### **Item 1 Ref: Presumed**

The ceiling (Textured Coating), Area: 1 (Landing and Stairs) is presumed to contain asbestos.

Any change in its appearance should be recorded and passed to Property Services.

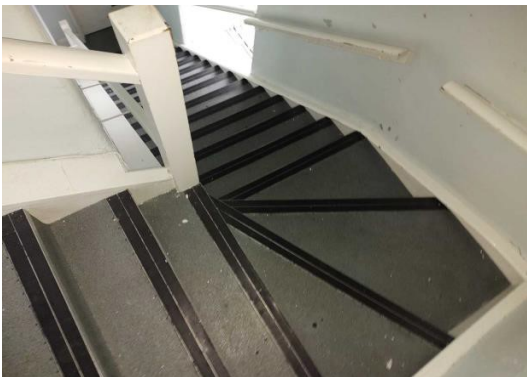
### **Item 2 Ref: 22-55202-2**

The floor – stair nosing, Area: 1 (Landing and Stairs) does not contain asbestos.

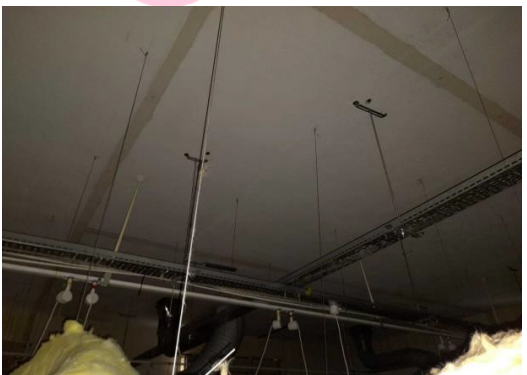
### **Item 3 Ref: Presumed**

The ceiling (Textured Coating), Area: 2 (Common ceiling void) is presumed to contain asbestos.

Any change in its appearance should be recorded and passed to Property Services.

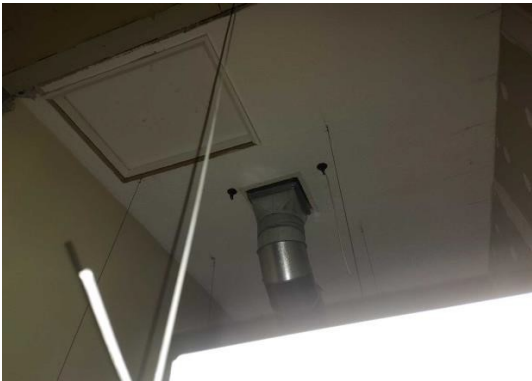
### **Item 4 Ref: Presumed**

The ceiling (Textured Coating), Area: 6 (Kitchen) is presumed to contain asbestos.

Any change in its appearance should be recorded and passed to Property Services.

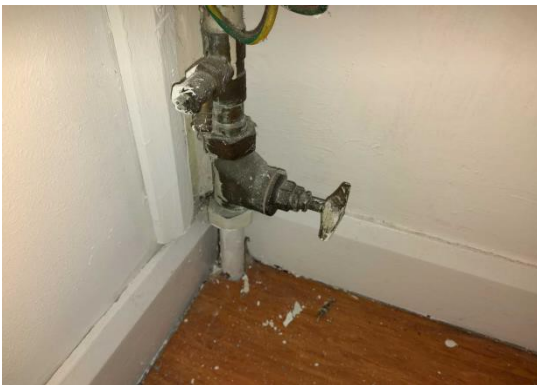
### **Item 5 Ref: 22-55202-5**

The pipes - gasket to stop tap, Area: 8 (Female wc & lobby) do not contain asbestos.

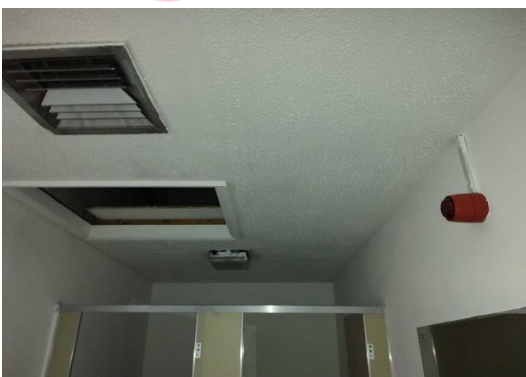
### **Item 6 Ref: 22-55202-6**

The ceiling (Textured Coating), Area: 8 (Female wc & lobby) does not contain asbestos.

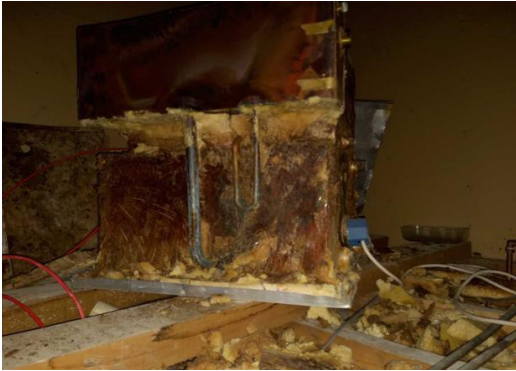
### **Item 7 Ref: Presumed**

The vessels - gasket to flange, Area: 9 (Void above female wc) is presumed to contain asbestos.

Any change in its appearance should be recorded and passed to Property Services.

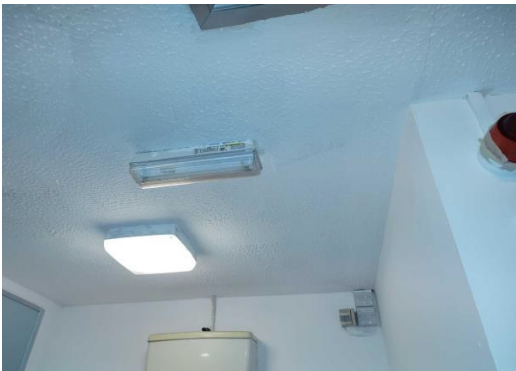
### **Item 8 Ref: 22-55202-6**

The ceiling (Textured Coating), Area: 11 (Male wc & lobby) does not contain asbestos.

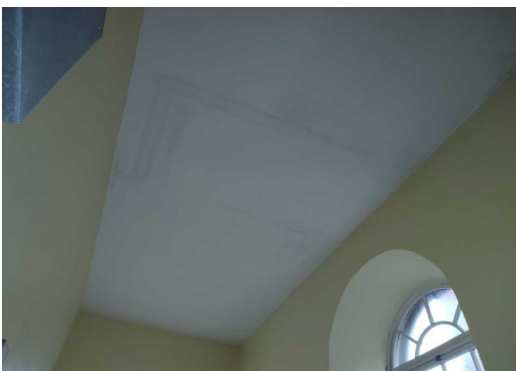
### **Item 9 Ref: 22-55202-6**

The ceiling (Textured Coating), Area: 16 (Fire exit stairwell) does not contain asbestos.

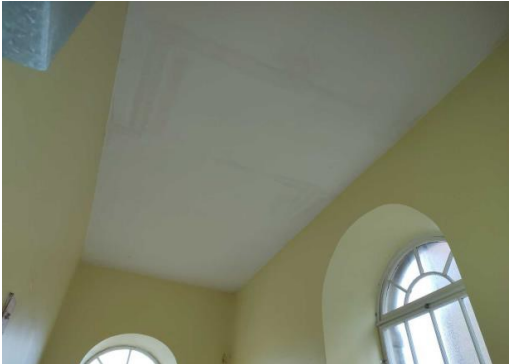
### **Item 10 Ref: 22-55202-6**

The ceiling (Textured Coating), Area: 16 (Fire exit stairwell) does not contain asbestos.

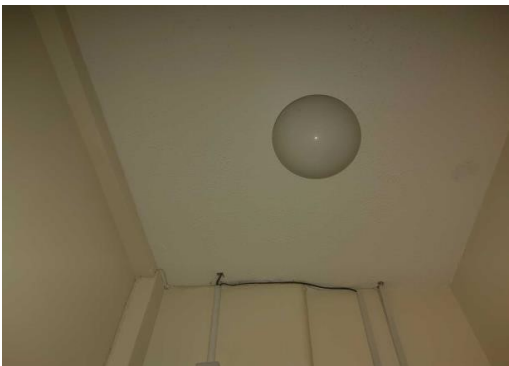
### **Item 11 Ref: 22-55202-8**

The ceiling (Textured Coating), Area: 19 (Corridor) does not contain asbestos.

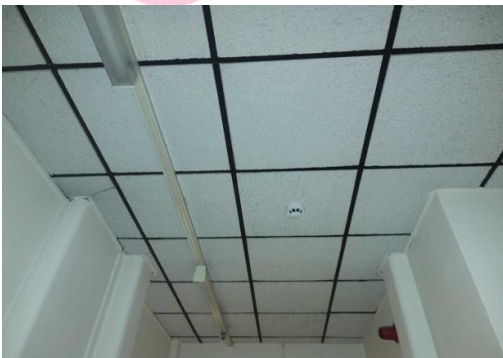
### **Item 12 Ref: 22-55202-9**

The ceiling - suspended ceiling tiles, Area: 19 (Corridor) do not contain asbestos.

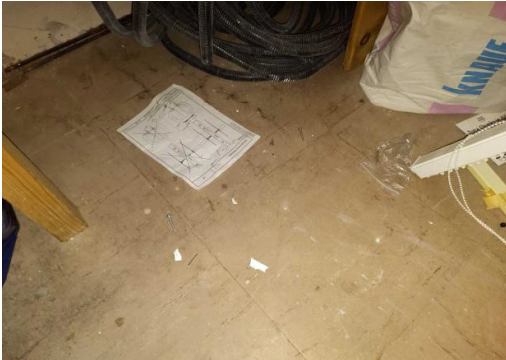
**Item 13 Ref: 22-55202-10**

The floor (Tiles & Adhesive), Area: 21 (Cupboard - Understairs) does not contain asbestos.

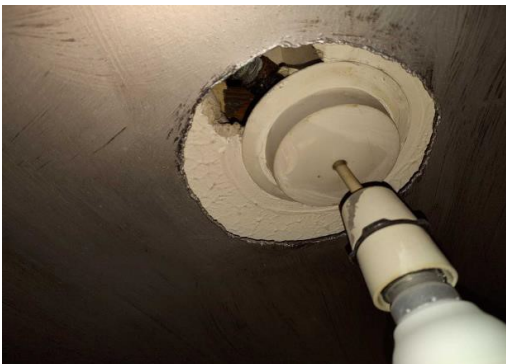
**Item 14 Ref: 22-55202-8**

The ceiling (Textured Coating), Area: 21 (Cupboard - Understairs) does not contain asbestos.

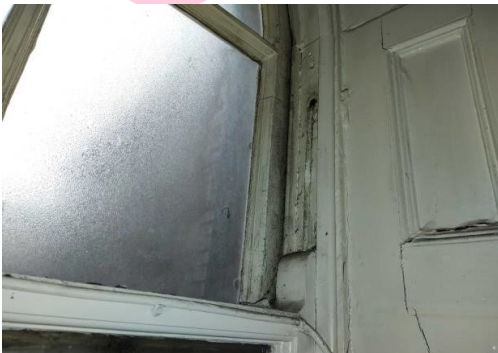
**Item 15 Ref: 22-55202-11**

The window - sash window cords, Area: 23 (Side lobby) does not contain asbestos.

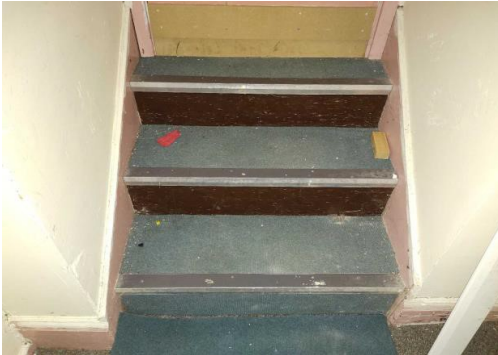
### **Item 16 Ref: 22-55202-12**

The floor - stair nosing strips, Area: 23 (Side lobby) does not contain asbestos.

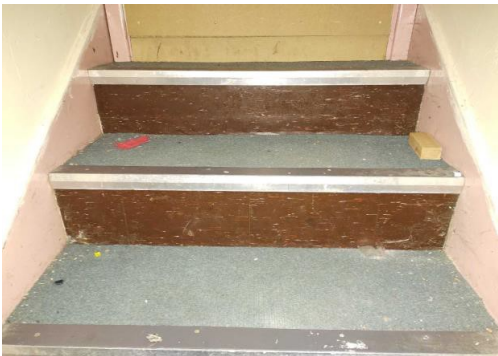
### **Item 17 Ref: 22-55202-13**

The floor to stairs (Tiles & Adhesive), Area: 23 (Side lobby) does not contain asbestos.

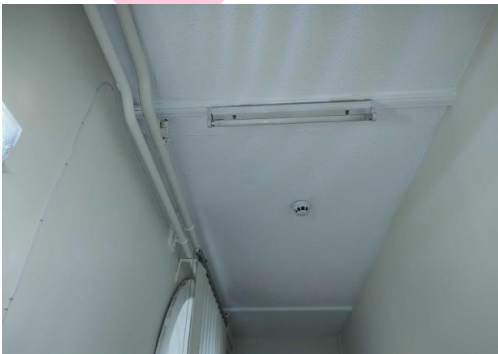
### **Item 18 Ref: 22-55202-8**

The ceiling (Textured Coating), Area: 23 (Side lobby) does not contain asbestos.

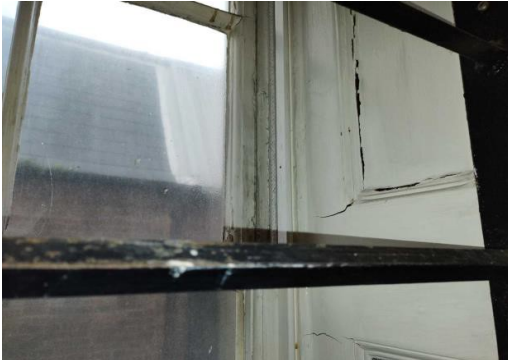
**Item 19 Ref: 22-55202-11**

The window - sash window cords, Area: 25 (Music office) does not contain asbestos.

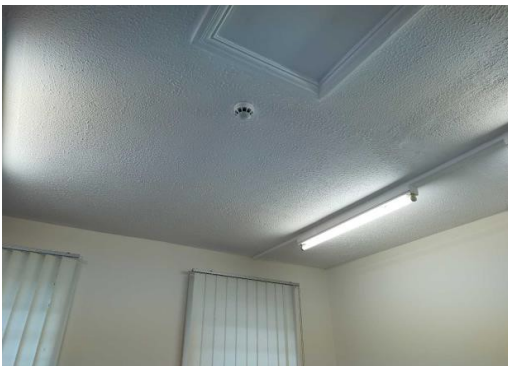
**Item 20 Ref: 22-55202-8**

The ceiling (Textured Coating), Area: 25 (Music office) does not contain asbestos.

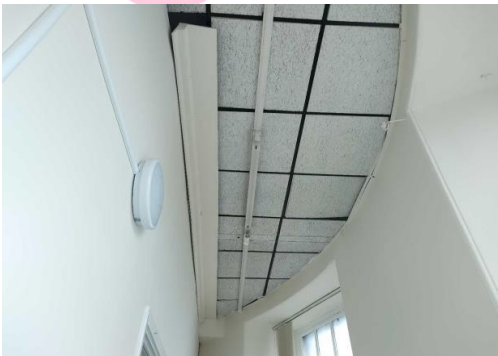
**Item 21 Ref: 22-55202-9**

The ceiling - suspended ceiling tiles, Area: 27 (Storage area) does not contain asbestos.

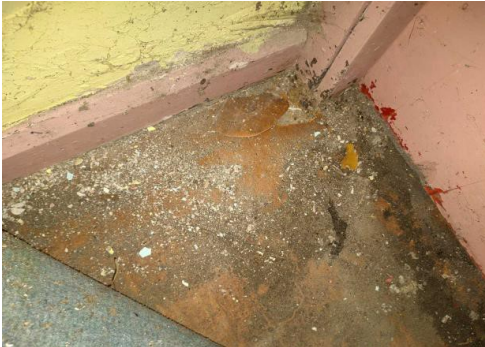
**Item 22 Ref: 22-55202-14**

The floor (Vinyl), Area: 28 (Rear corridor) does not contain asbestos.

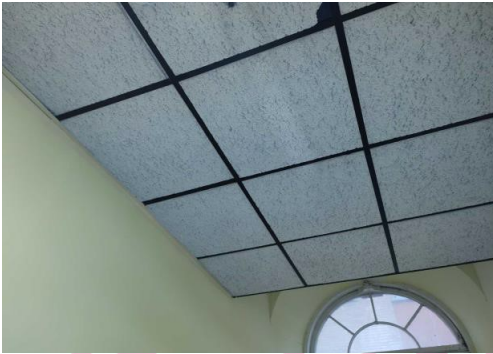
**Item 23 Ref: 22-55202-9**

The ceiling - suspended ceiling tiles, Area: 28 (Rear corridor) does not contain asbestos.

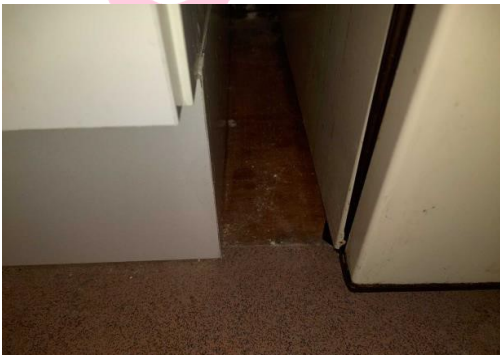
**Item 24 Ref: 22-55202-14**

The floor - beneath modern vinyl, Area: 29 (Kitchen) does not contain asbestos.

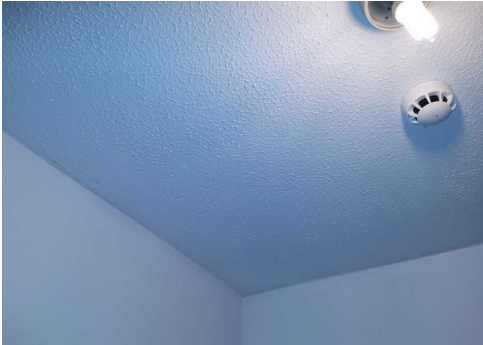
**Item 25 Ref: 22-55202-15**

The ceiling (Textured Coating), Area: 29 (Kitchen) does not contain asbestos.

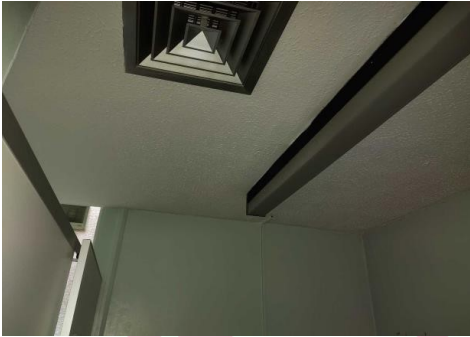
**Item 26 Ref: 22-55202-15**

The ceiling (Textured Coating), Area: 30 (Female wc/ baby change & lobby) does not contain asbestos.

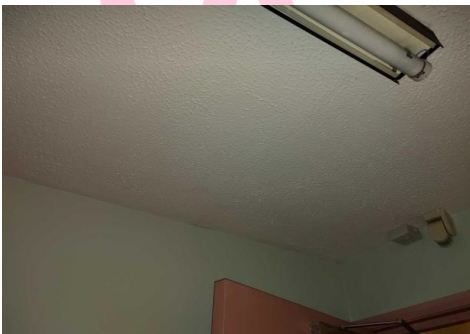
**Item 27 Ref: 22-55202-15**

The ceiling (Textured Coating), Area: 31 (Male wc & lobby) does not contain asbestos.

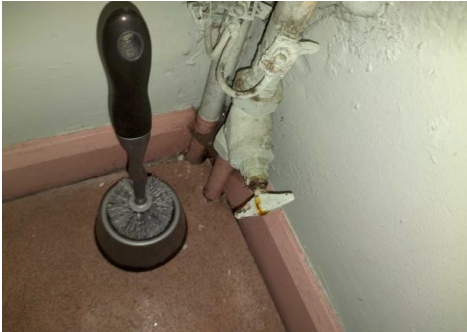
### **Item 28 Ref: 22-55202-5**

The pipes - gasket to stop tap, Area: 31 (Male wc & lobby) does not contain asbestos.

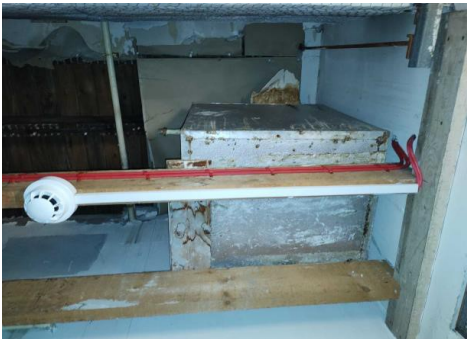
### **Item 29 Ref: Presumed**

The Vessels - Gasket to redundant tank flange, Area: 33 (Boiler cupboard) are presumed to contain asbestos.

Any change in its appearance should be recorded and passed to Property Services.

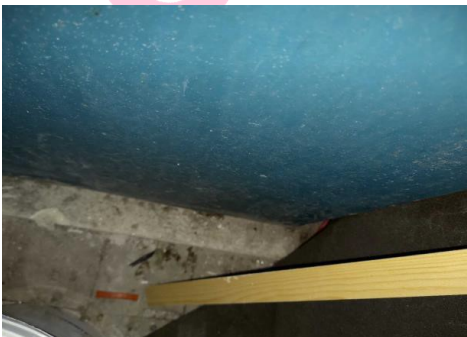
### **Item 30 Ref: 22-55202-17**

The floor - boiler plinth, Area: 33 (Boiler cupboard) does not contain asbestos.

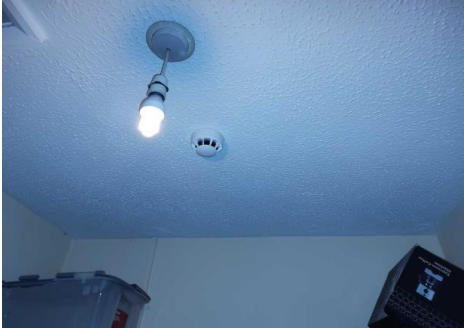
### **Item 31 Ref: 22-55202-15**

The ceiling (Textured Coating), Area: 34 (Store cupboard) does not contain asbestos.

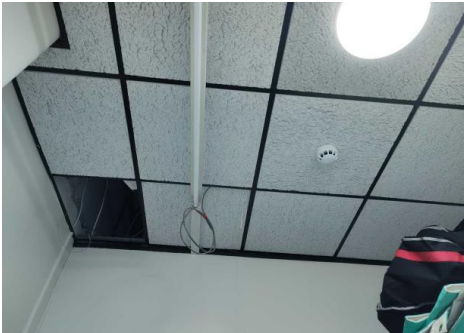
### **Item 32 Ref: 22-55202-9**

The ceiling - suspended ceiling tiles, Area: 36 (Store cupboard 2) does not contain asbestos.

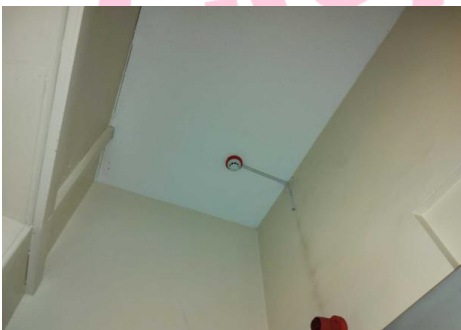
### **Item 33 Ref: 22-55202-15**

The ceiling (Textured Coating), Area: 37 (Front Lobby) does not contain asbestos.

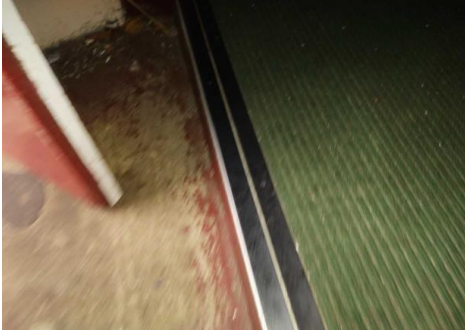
### **Item 34 Ref: 22-55202-18**

The Floor - Stair nosing strip, Area: 37 (Front Lobby) does not contain asbestos.

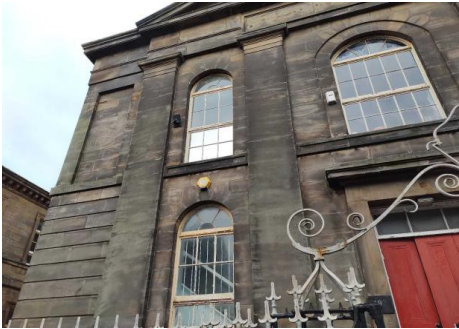
### **Item 35 Ref: 22-55202-19**

The window - putty to glazing, Area: 38 (External) does not contain asbestos.

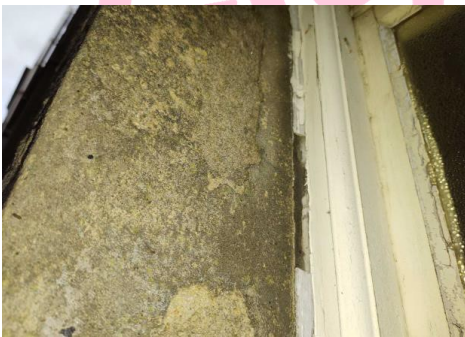
### **Item 36 Ref: 22-55202-20**

The Windows - Sealant to frames, Area: 38 (External) contains asbestos.

Any change in its appearance should be recorded and passed to Property Services.
