ASBESTOS SURVEY REPORT FOR BLOCK 1A – 1C EDWARD THOMPSON SITE, RICHMOND STREET, SUNDERLAND, SR5 1BQ

Asbestos Register for Block 1A – 1C Edward Thompson Site, Richmond Street, Sunderland, SR5 1BQ

Date: 14 February 2025

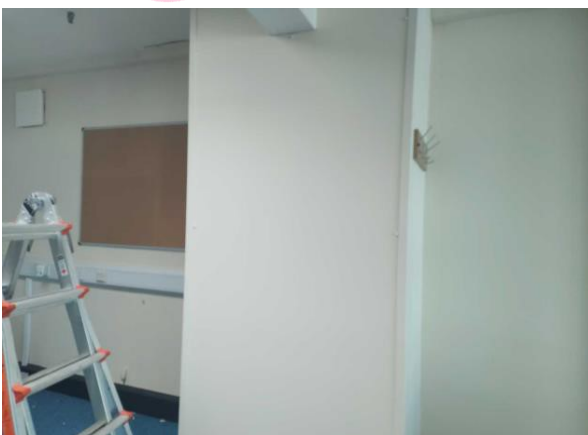
Item 57 Ref: 22-47230-13

The vertical boxing behind wood cladding (insulating board) (Area: Second Floor, Room 20 Office 5) contains asbestos.

Any change in its appearance should be recorded and passed to Property Services.

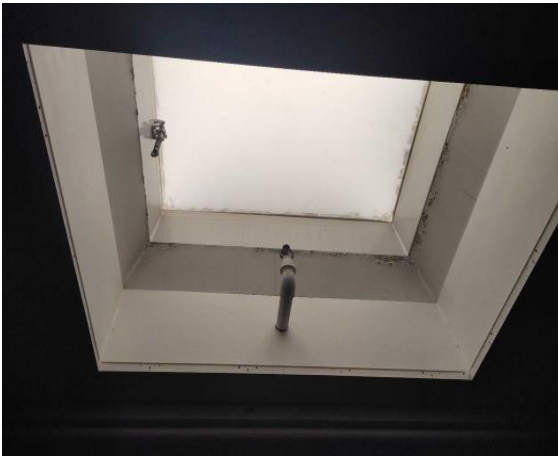
Item 67 Ref: 22-47230-16

The infill panels – upstands to skylight (insulating board)
(Area: Second Floor, Room 23 Office 8) contains asbestos.

Any change in its appearance should be recorded and passed to Property Services.

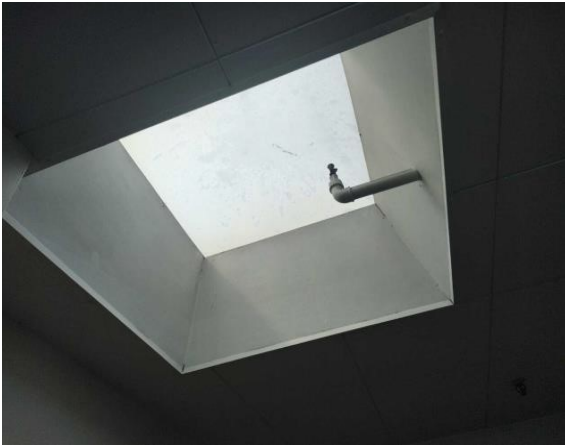
Item 113 Ref: 22-47230-32

The infill panels – upstands to skylights (insulating board) (Area: Second Floor, Room 46 Fire Exit Stairwell 1) contains asbestos.

Any change in its appearance should be recorded and passed to Property Services.

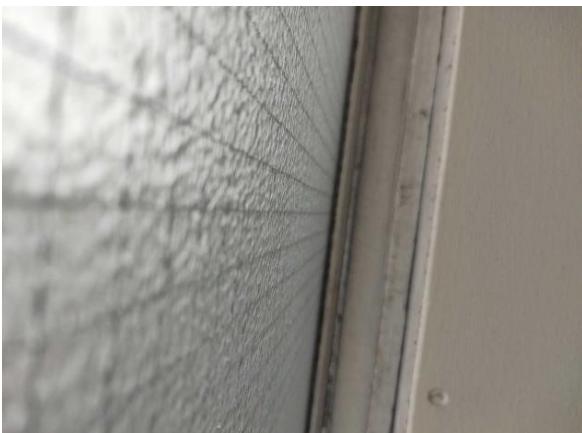
Item 117 Ref: 22-47230-34

The window – fillet to window reveal behind cladded RSJ (insulating board) (Area: Second Floor, Room 47 Comms Room) contains asbestos.

Any change in its appearance should be recorded and passed to Property Services.

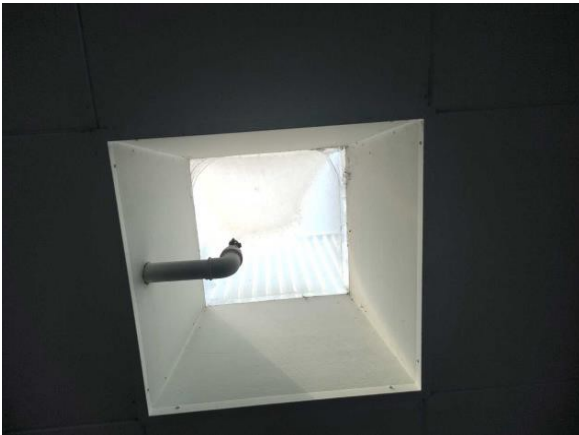
Item 127 Ref: 22-47230-32

The infill panels – upstands to skylights (insulating board) (Area: Second Floor, Room 50 Corridor 6) contains asbestos.

Any change in its appearance should be recorded and passed to Property Services.

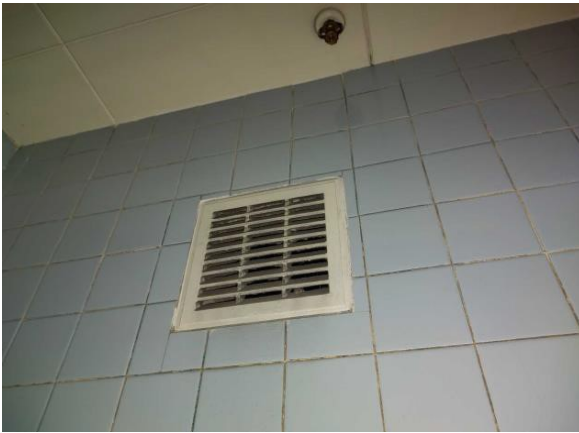
Item 130 Ref: 22-47230-18

The infill panels – lining to vents within wall cavity (insulating board) (Area: Second Floor, Room 51 Female WC and Lobby 2) contains asbestos.

Any change in its appearance should be recorded and passed to Property Services.

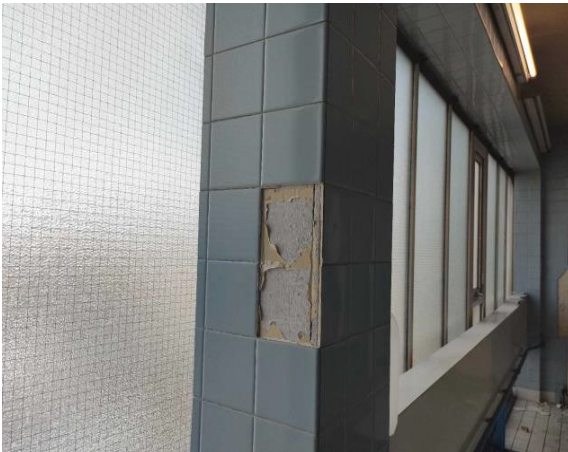
Item 133 Ref: 22-47230-34

The vertical boxing (insulating board) (Area: Second Floor, Room 51 Female WC and Lobby 2) contains asbestos.

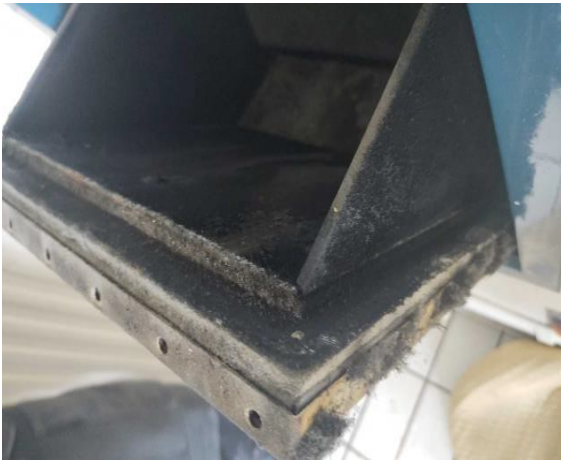
Item 136 Ref: 22-47230-39

The vessels – pad to opening hatch (insulating board) (Area: Second Floor, Room 51 Female WC and Lobby 2) contains asbestos.

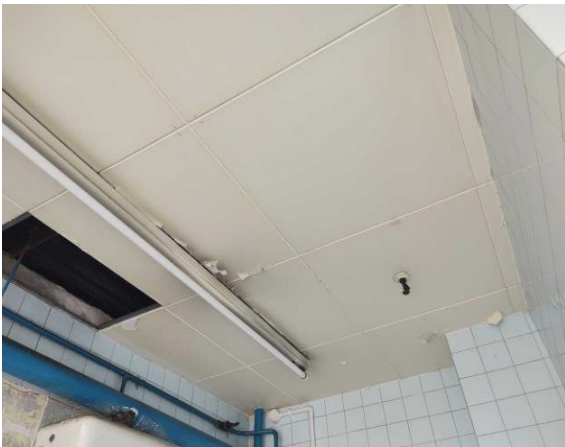
Item 140 Ref: 22-47230-31

The ceiling tiles (insulating board) (Area: Second Floor, Room 52 Male WC and Lobby) contains asbestos.

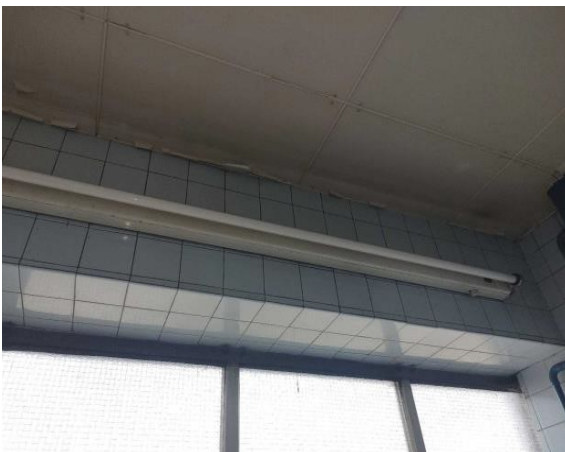
Item 141 Ref: 22-47230-34

The high level horizontal boxing (insulating board) (Area: Second Floor, Room 52 Male WC and Lobby) contains asbestos.

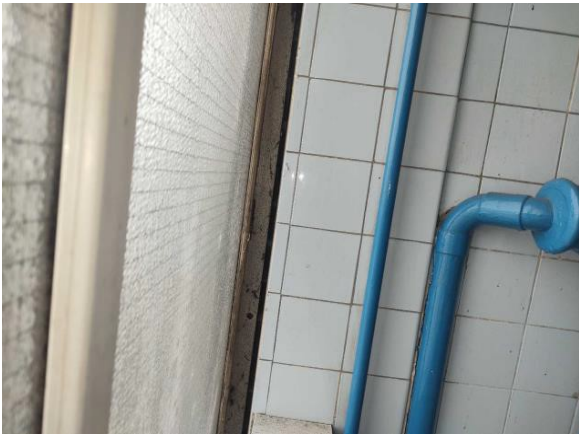
Item 142 Ref: 22-47230-34

The vertical boxing (insulating board) (Area: Second Floor, Room 52 Male WC and Lobby) contains asbestos.

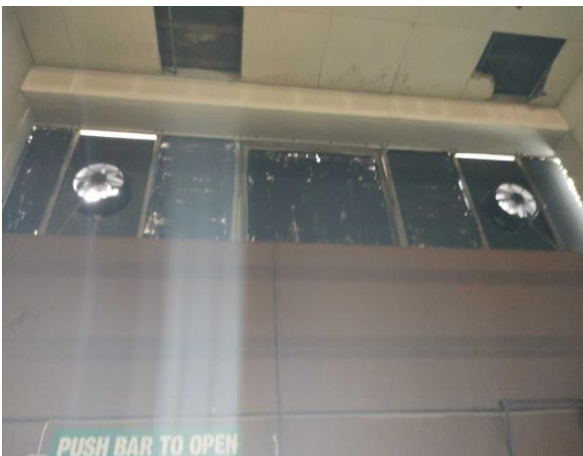
Item 146 Ref: 22-47230-50

The boxing to RSJ's around windows (insulating board) (Area: Second Floor, Room 55 Large Store) contains asbestos.

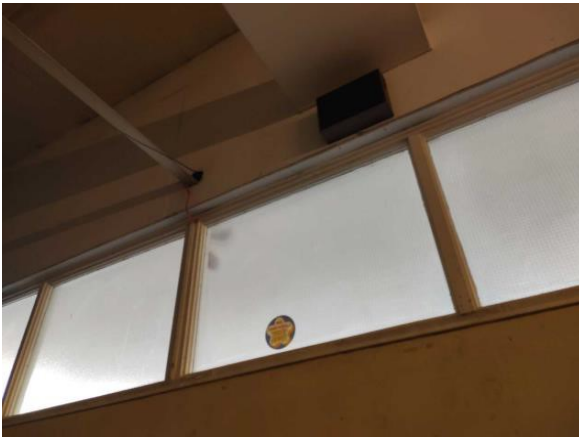
Item 148 Ref: 22-47230-52

The window – beading to high level windows (insulating board) (Area: Second Floor, Room 55 Large Store) contains asbestos.

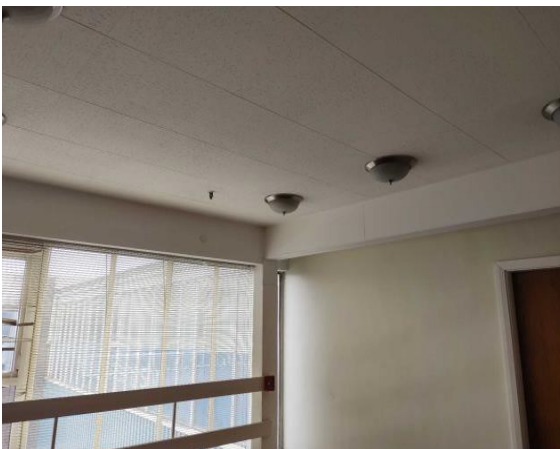
Item 159 Ref: 22-47230-50

The high level horizontal boxing (insulating board) (Area: Second Floor, Room 58 Private Dining Room) contains asbestos.

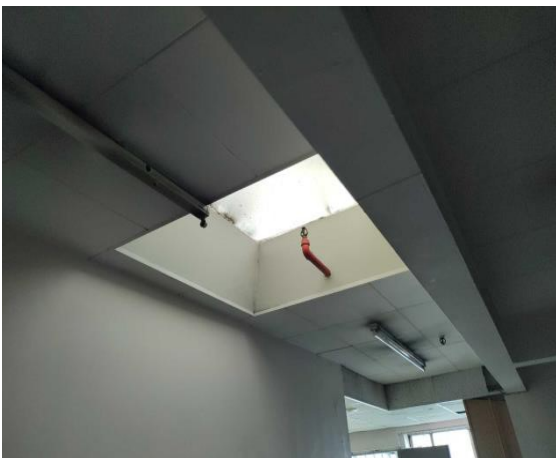
Item 168 Ref: 22-47230-53

The infill panels – upstands to skylights (insulating board) (Area: Second Floor, Room 61 Corridor and Lift Lobby) contains asbestos.

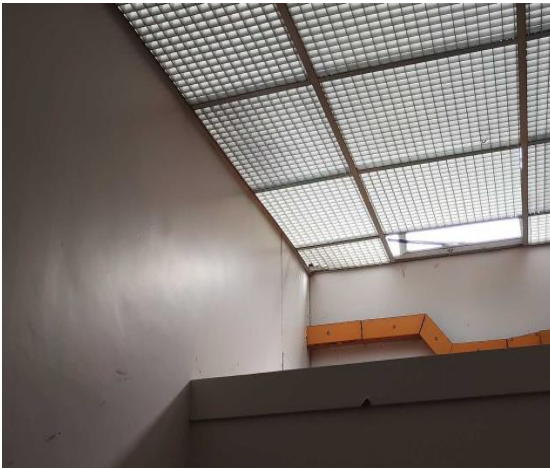
Item 181 Ref: 22-47230-60

The infill panels – panel to pipe penetration (insulating board) (Area: Second Floor, Room 65 Corridor 8) contains asbestos.

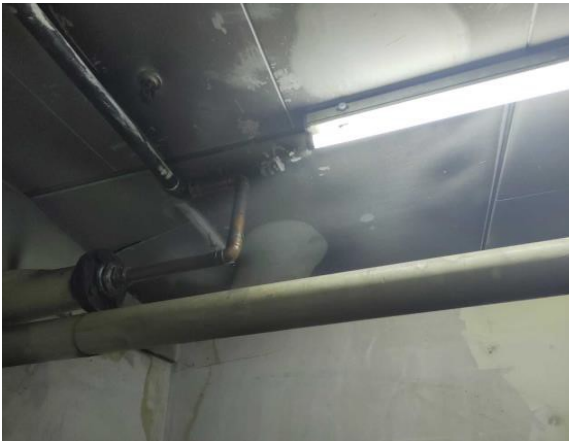
Item 205 Ref: 22-47230-47

The panel to ceiling (insulating board) (Area: Second Floor, Room 72 Tank Cupboard) contains asbestos.

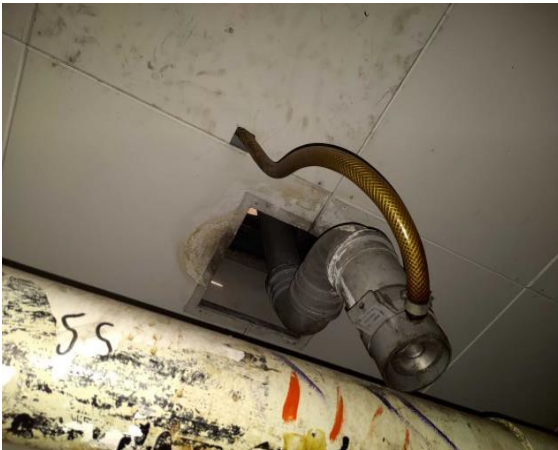
Item 208 Ref: 22-47230-18

The infill panels – extractor fan housing within ceiling void (insulating board) (Area: Second Floor, Room 73 Paint Store) contains asbestos.

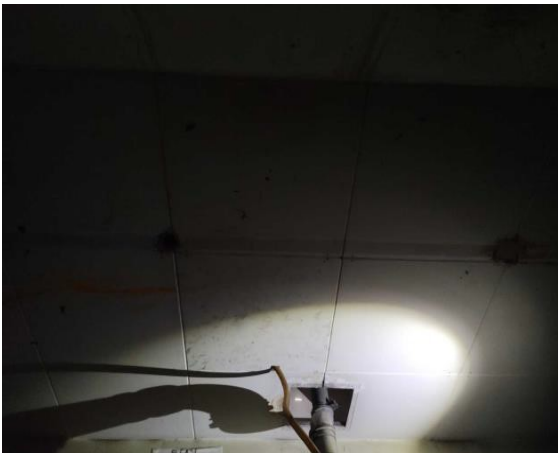
Item 209 Ref: 22-47230-31

The ceiling tiles (insulating board) (Area: Second Floor, Room 73 Paint Store) contains asbestos.

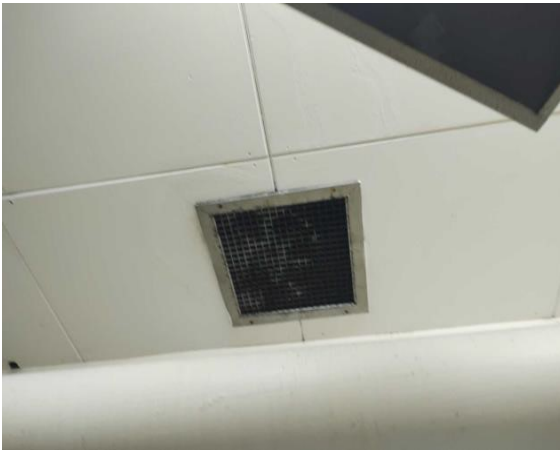
Item 211 Ref: 22-47230-18

The infill panels – extractor fan housing within ceiling void (insulating board) (Area: Second Floor, Room 74 Uniform Store) contains asbestos.

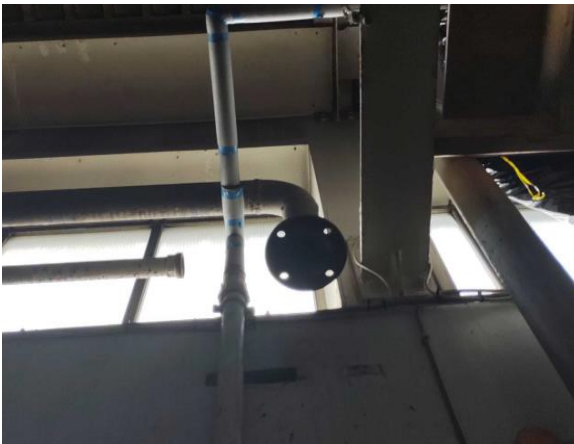
Item 216 Ref: 22-47230-70

The pipes – gasket residues
to open pipe flange (gasket)
(Area: Second Floor, Room 75
Main Workshop) contains
asbestos.

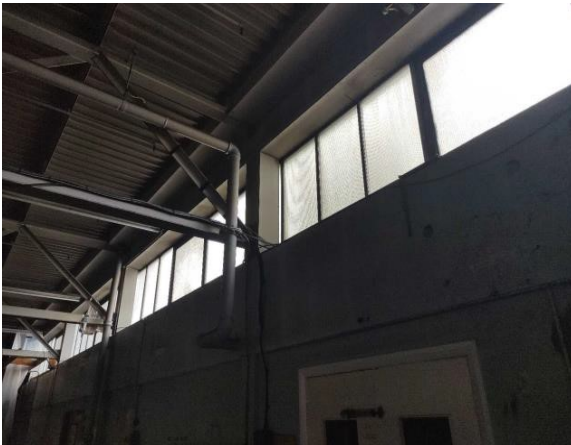
Item 217 Ref: 22-47230-71

The high level horizontal boxing (insulating board) (Area: Second Floor, Room 75 Main Workshop) contains asbestos.

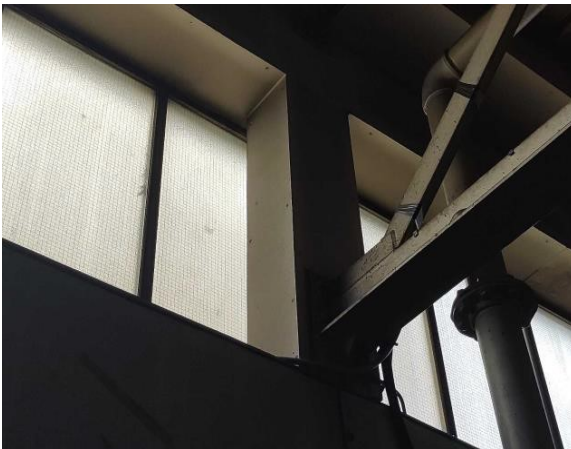
Item 218 Ref: 22-47230-71

The vertical boxing (insulating board) (Area: Second Floor, Room 75 Main Workshop) contains asbestos.

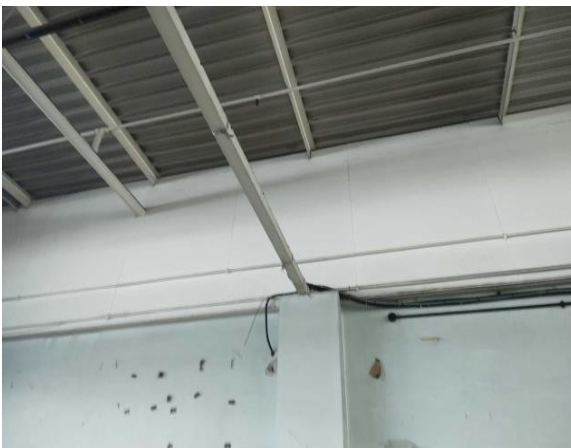
Item 219 Ref: 22-47230-71

The walls – high level panels to walls (insulating board) (Area: Second Floor, Room 75 Main Workshop) contains asbestos.

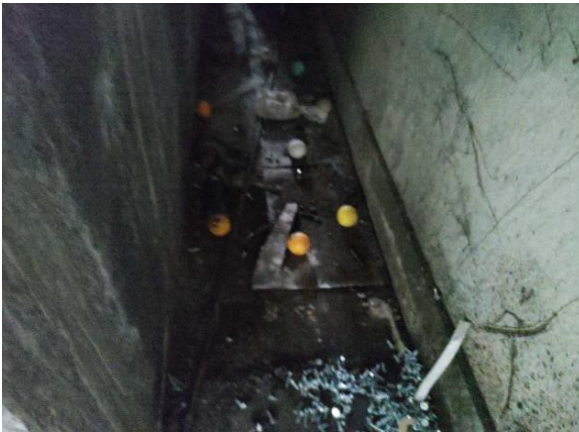
Item 221 Ref: 22-47230-72

221.	22-47230-72	Loose lying panel behind convector heater	Second Floor, Room 75 Main Workshop	Removed 2023
222.	22-47230-72	Debris to floor adjacent Electric Office	Second Floor, Room 75 Main Workshop	Removed 2023

The loose lying panel behind convector heater (insulating board) (Area: Second Floor, Room 75 Main Workshop) contains asbestos.

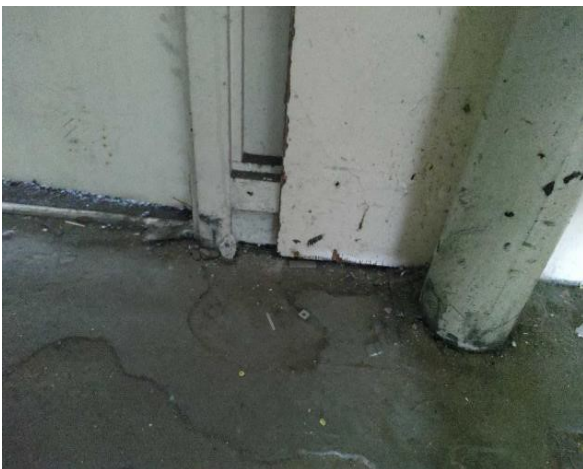
Item 222 Ref: 22-47230-72

The debris to floor adjacent Electric Office (insulating board) (Area: Second Floor, Room 75 Main Workshop) contains asbestos.

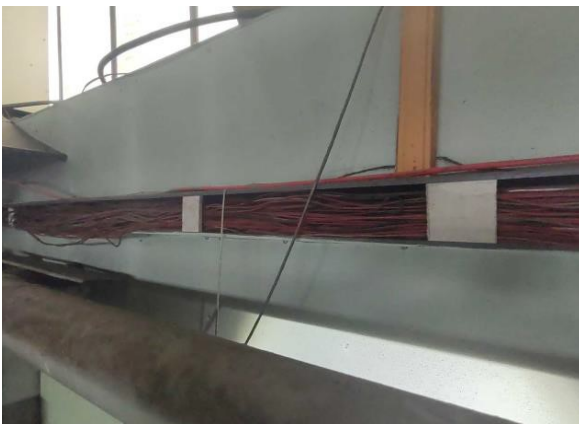
Item 225 Ref: 22-47230-75

225.	22-47230-75	Loose panels within conduits	Second Floor, Room 75 Main Workshop	Medium Risk
226.	22-47230-76	Debris to top of doorway	Second Floor, Room 75 Main Workshop	Removed 2023

The loose panels within conduits (used as fascia screw panels) (insulating board) (Area: Second Floor, Room 75 Main Workshop) contains asbestos.

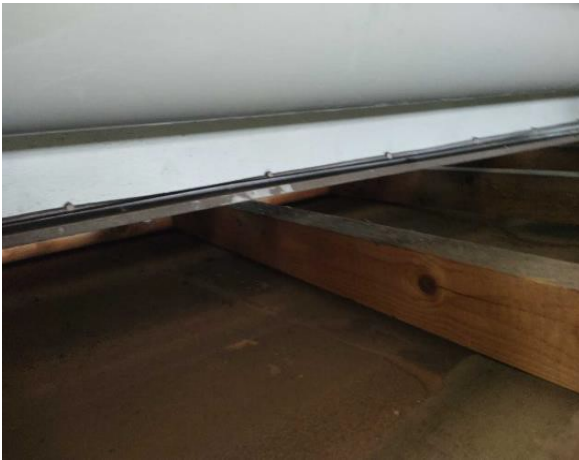
Item 226 Ref: 22-47230-76

The debris to top of doorway bulkhead (insulating board) (Area: Second Floor, Room 75 Main Workshop) contains asbestos.

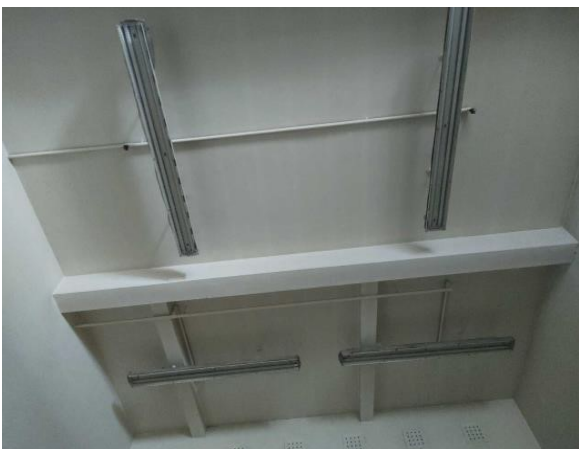
The boxing to high level
beams (insulating board)
(Area: First Floor, Room 81
Squash Court) contains
asbestos.

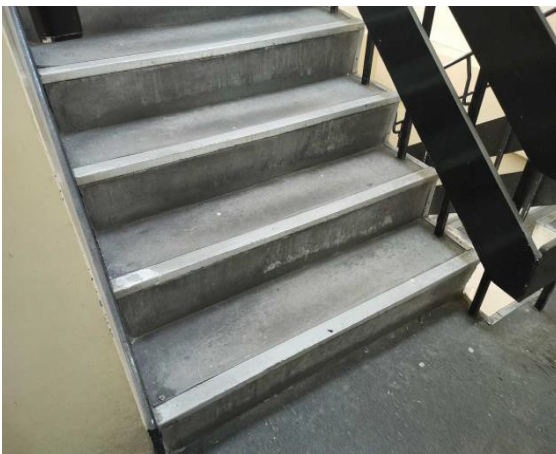
Item 237 Ref: 22-47230-84

The floor – stair nosings (composite) (Area: First Floor, Room 85 Fire Exit Stairwell 1) contains asbestos.

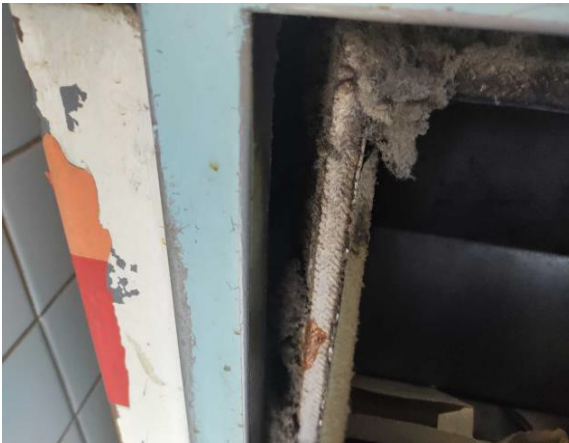
Item 238 Ref: 22-47230-38

The rope seal to incinerator (textile) (Area: First Floor, Room 86 Female WC and Lobby) contains asbestos.

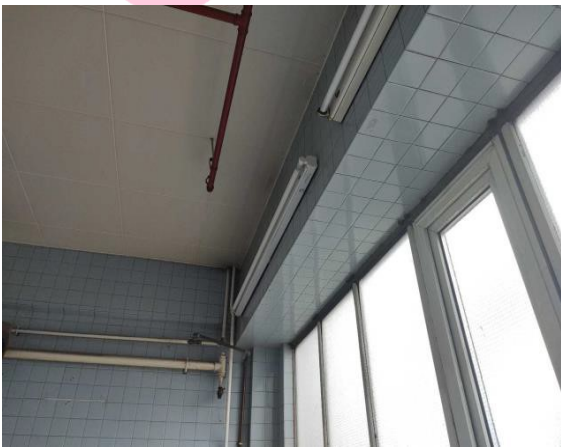
Item 243 Ref: 22-47230-86

The high level horizontal boxing (insulating board) (Area: First Floor, Room 86 Female WC and Lobby) contains asbestos.

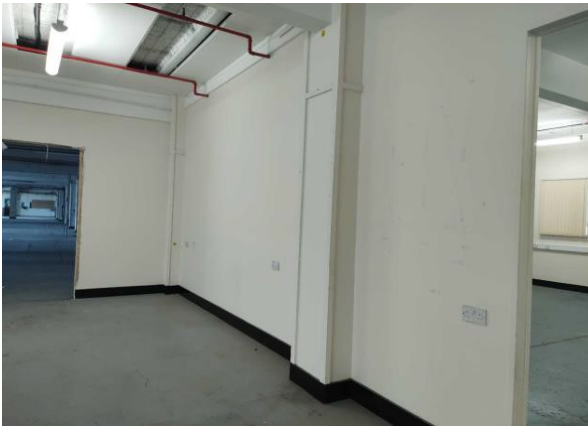
Item 256 Ref: 22-47230-86

The vertical boxing (insulating board) (Area: First Floor, Room 91 Design Room) contains asbestos.

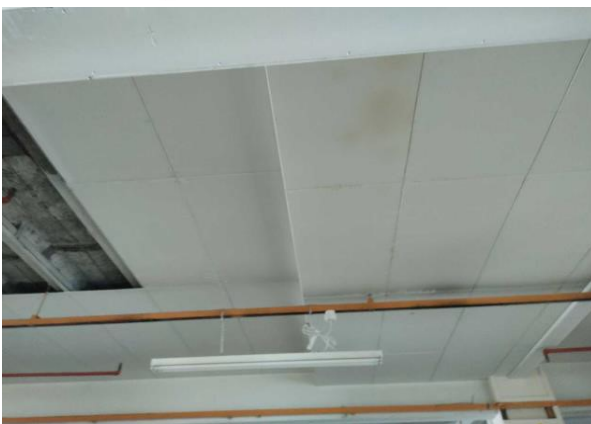
Item 258 Ref: 22-47230-87

The ceiling tiles (insulating board) (Area: First Floor, Room 95 Main Printer Workshop) contains asbestos.

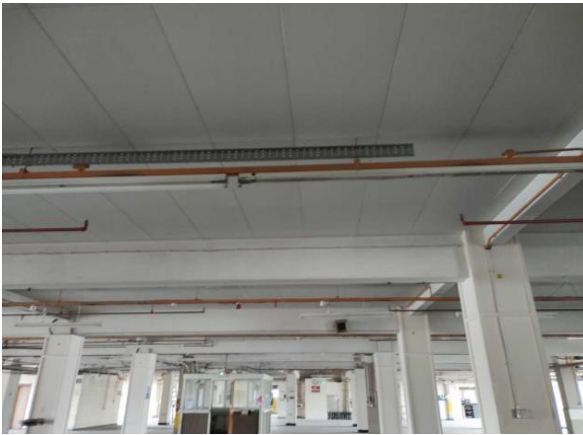
Item 259 Ref: 22-47230-88

The high level horizontal boxing (insulating board) (Area: First Floor, Room 95 Main Printer Workshop) contains asbestos.

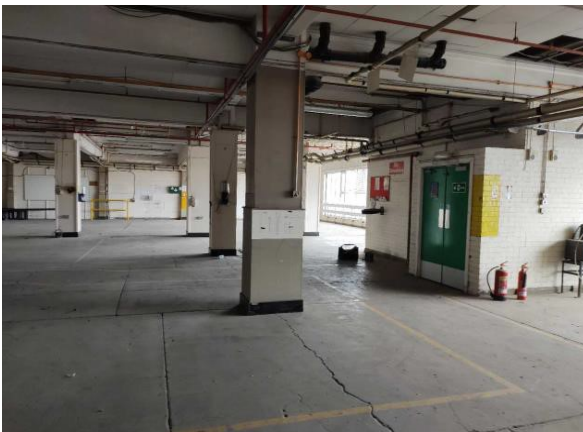
Item 260 Ref: 22-47230-88

The vertical boxing (insulating board) (Area: First Floor, Room 95 Main Printer Workshop) contains asbestos.

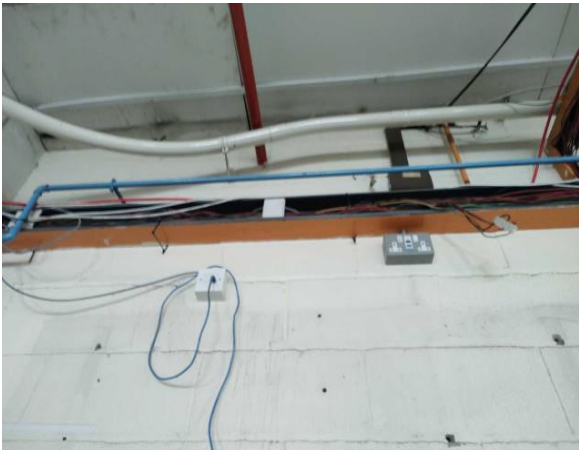
Item 262 Ref: 22-47230-89

262.	22-47230-89	Loose boards within trunking	First Floor, Room 95 Main Printer Workshop	Medium Risk
263.	22-47230-90	Vessels – gasket to boiler	First Floor, Room 95 Main Printer Workshop	Medium Risk

The loose boards within trunking (used as screw boards for fascia) (insulating board) (Area: First Floor, Room 95 Main Printer Workshop) contains asbestos.

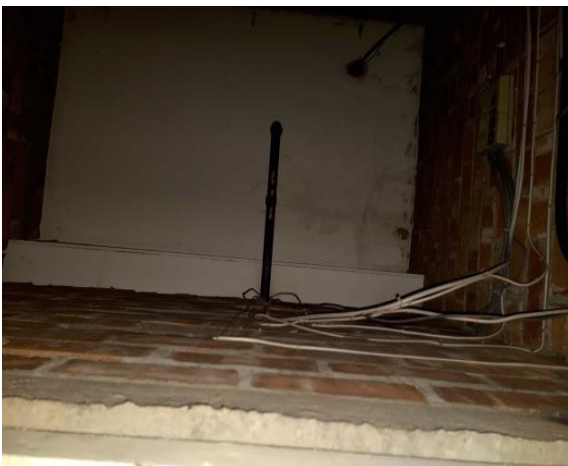
Item 267 Ref: 22-47230-93

The high level horizontal boxing (insulating board) (Area: Ground Floor, Room 98 Lift Motor Room) contains asbestos.

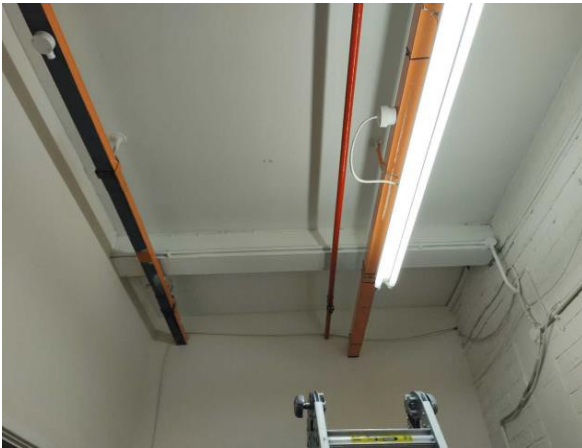
Item 268 Ref: 22-47230-93

The high level horizontal boxing (insulating board) (Area: Ground Floor, Room 99 Office 1) contains asbestos.

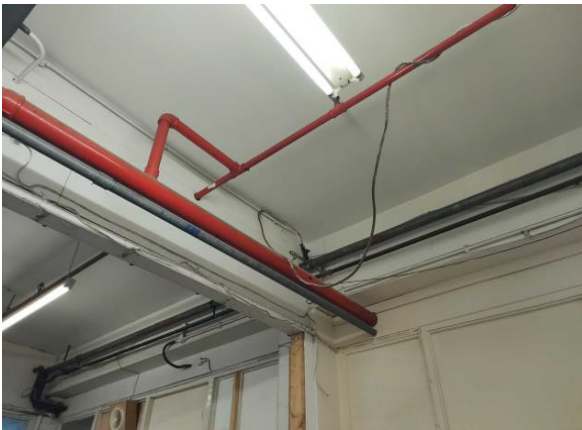
Item 269 Ref: 22-47230-93

The high level horizontal boxing (insulating board) (Area: Ground Floor, Room 101 Maintenance Workshop) contains asbestos.

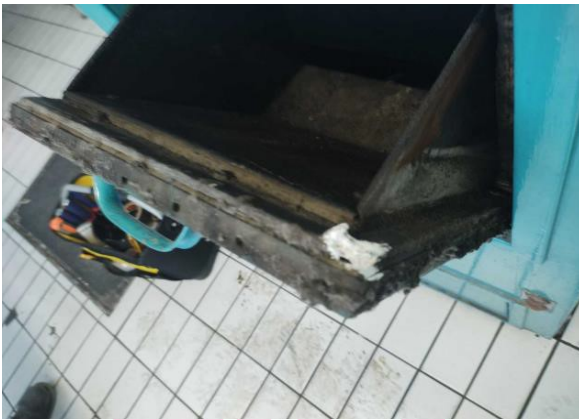
Item 275 Ref: 22-47230-96

274.	22-47230-95	Flue	Ground Floor, Room 105 Female WC & Lobby	Low Risk
275.	22-47230-96	Surround to hatch and burner	Ground Floor, Room 105 Female WC & Lobby	Medium Risk

The surround to hatch and burner (millboard) (Area: Ground Floor, Room 105 Female WC and Lobby) contains asbestos.

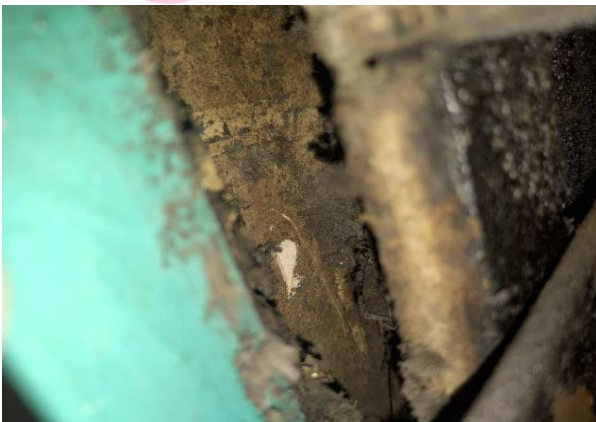
Item 276 Ref: 22-47230-97

The lining to incinerator unit (insulating board) (Area: Ground Floor, Room 105 Female WC and Lobby) contains asbestos.

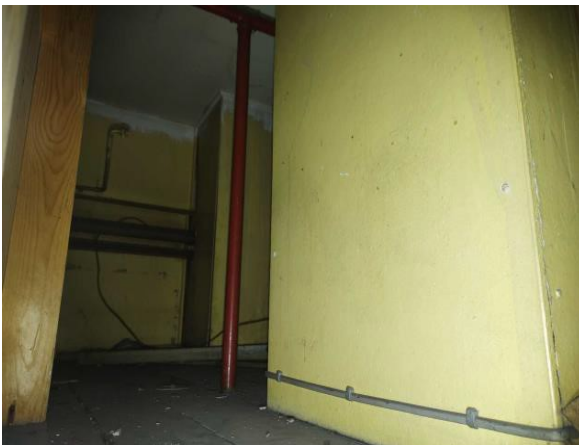
Item 278 Ref: 22-47230-93

The vertical boxing (insulating board) (Area: Ground Floor, Room 106 Male WC and Lobby) contains asbestos.

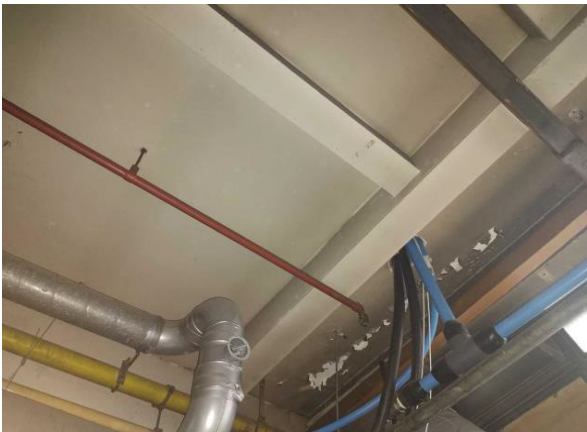
Item 281 Ref: 22-47230-101

The high level horizontal boxing (insulating board) (Area: Ground Floor, Room 110 Gas Intake / Heater Area) contains asbestos.

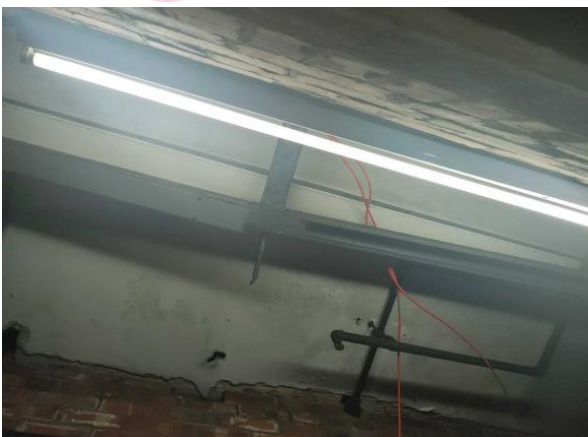
Item 285 Ref: 22-47230-101

The high level horizontal boxing (insulating board) (Area: Ground Floor, Room 114 Lift Motor Room 2) contains asbestos.

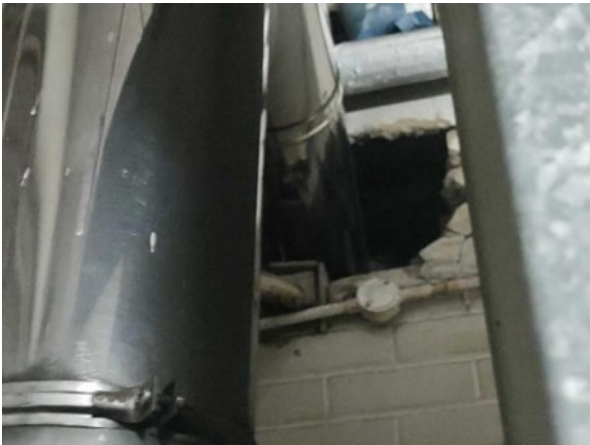
Item 304 Ref: Presumed

The packers below metal flue in pipe penetration behind convector heater (Area: Ground Floor, Room 129: Vehicle Maintenance Area) contains asbestos.

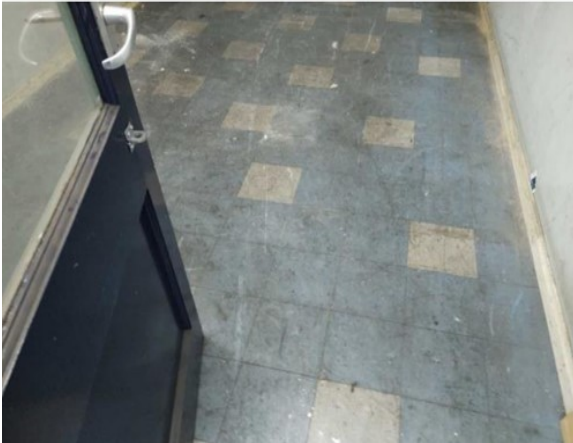
Item 322 Ref: 22-47230-119

The floor (Area: Ground Floor, Room 144: Store Room) contains asbestos.

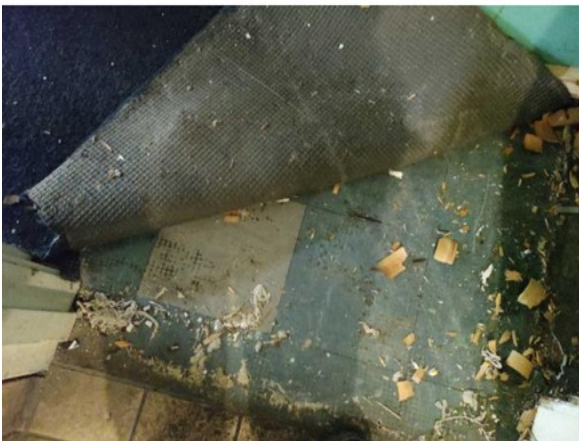
Item 323 Ref: 22-47230-119

The floor (Area: Ground Floor, Room 145: Corridor) contains asbestos.

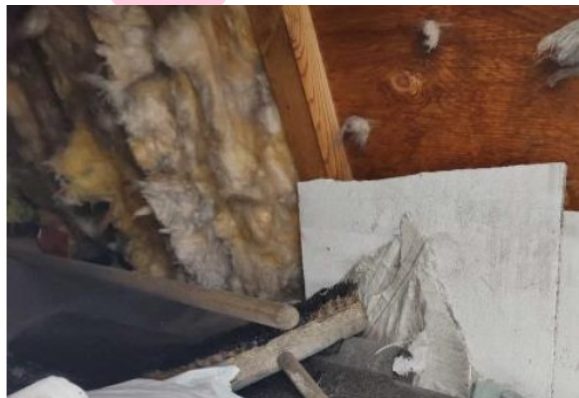
Item 330 Ref: 22-47230-77

329.	22-47230-79	Felt to roof	Floor Roof, Room 149 Roof	No Risk
330.	22-47230-77	Loose lying panels	Floor Roof, Room 150 Header tank room	Medium Risk
331.	22-47230-78	Flue	Floor Roof, Room 150 Header tank room	Low Risk

The loose lying panels (Insulating board) (Area: Floor roof, Room 150: Header tank room) contains asbestos.

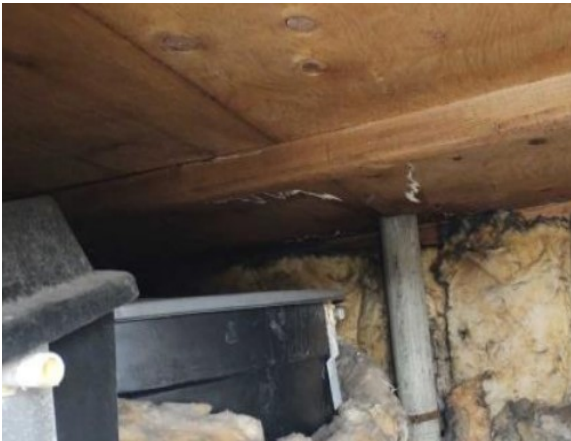
Item 331 Ref: 22-47230-78

The flue (Area: Floor roof, Room 150: Header tank room) contains asbestos.

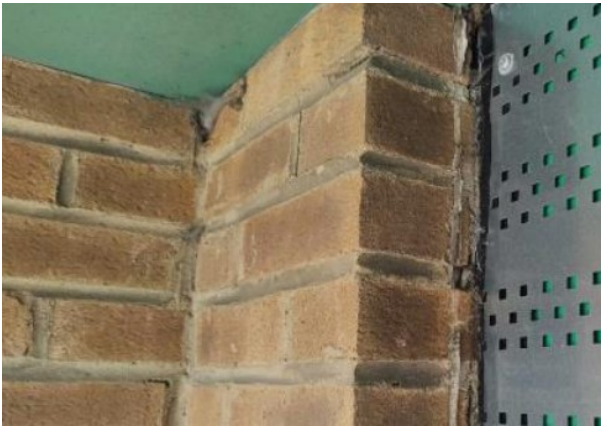
Item 340 Ref: 22-47230-130

The mastic to timber door frames (Area: Floor 0, Room 152: External) contains asbestos.

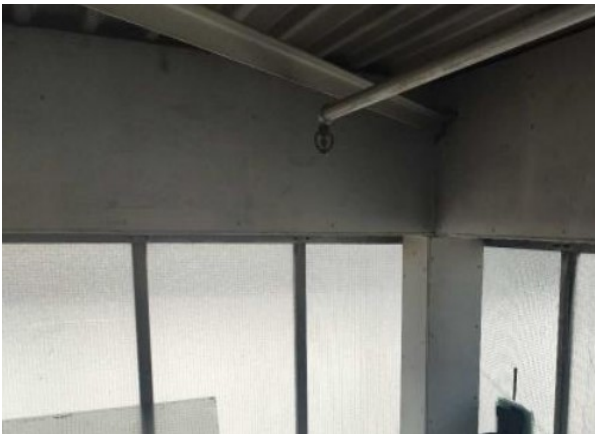
Item 347 Ref: 22-47230-13

The cladding to RSJ's above and below windows (insulating Board) (Area: Mezzanine Floor, Room 27a: above room 27) contains asbestos.

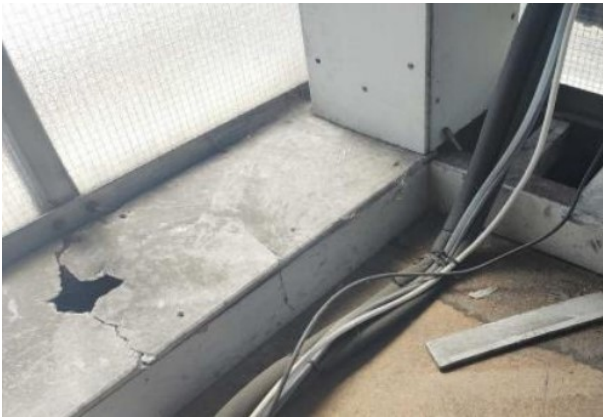
Item 349 Ref: 22-47230-15

The debris to the floor (insulating Board) (Area: Mezzanine Floor, Room 27a: above room 27) contains asbestos.

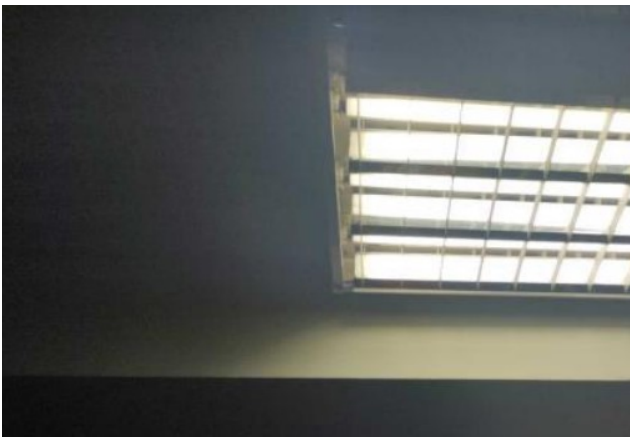
Item 350 Ref: 22-47230-23

The high level horizontal boxing (Insulating board) (Area: Second Floor, Room 37a: Office Lobby) contains asbestos.

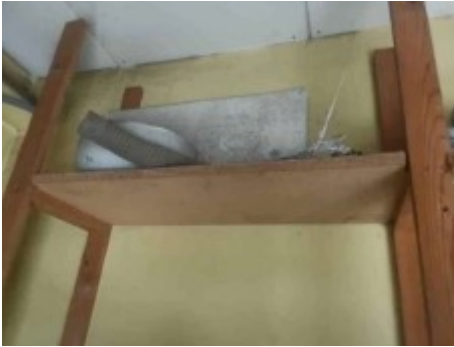
Item 355 Ref: As TL000363

355.	As TL000363	Ceiling Tile solid lying loose to shelving	First Floor Cupboard Store Room 1/078	Low Risk
356.	As TL000363	Ceiling Tile	First Floor Cupboard Store Room 1/078	Low Risk

The ceiling tile solid lying loose to shelving in First Floor Cupboard Store Room 1/078 contains asbestos.

Any change in its appearance should be recorded and passed to Property Services.

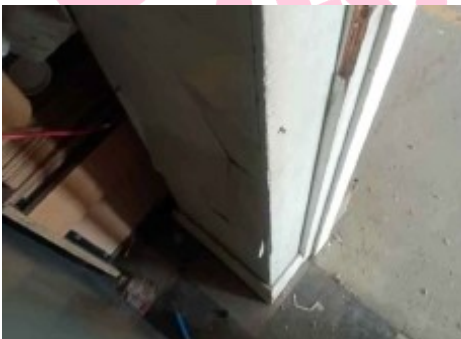
Item 357 Ref: As TL000363

357.	As TL000363	Boxing vertical damaged, enclose or removal required	First Floor Cupboard Store Room 1/078	Low Risk
358.	As TL000363	Ceiling Tile – Solid	First Floor Cupboard Store Room	Low Risk

The boxing vertical damaged (enclose or removal required) in First Floor Cupboard Store Room 1/078 contains asbestos.
