ASBESTOS SURVEY REPORT FOR COACH HOUSE, BARNES PARK, SUNDERLAND

**Asbestos Register for
COACH HOUSE, BARNES PARK, SUNDERLAND**

Date: 07 February 2023

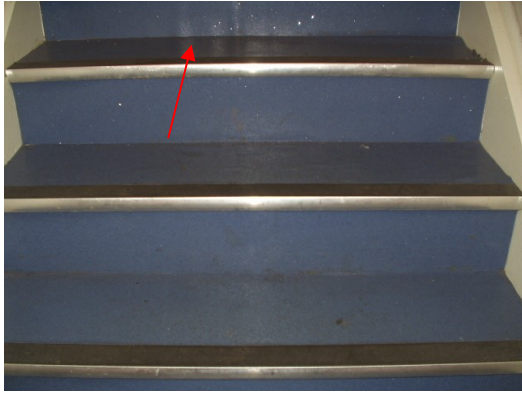
Item 1 - Ref: AW0077/08

The nosing to the stairs on the stairwell of the Coach house (Rm 0/08) does not contain asbestos.

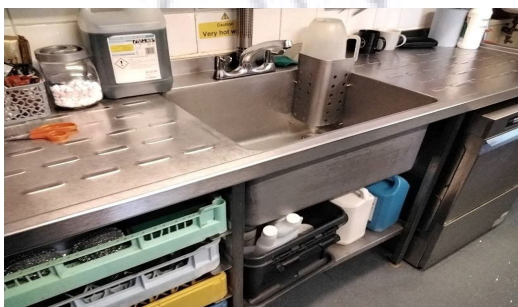
Item 3 Ref: KX000462/009

The Under Sink Mat in The Coach House G/002 - Kitchen does not contain asbestos.

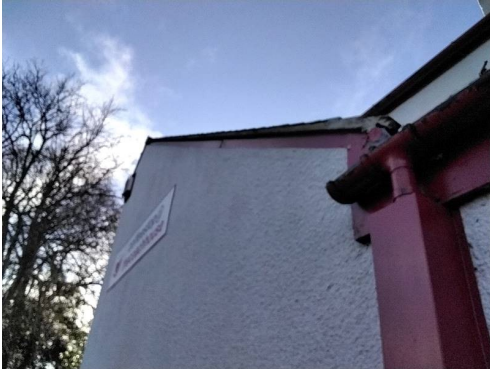
Item 4 Ref: KX000463/013

The Undercloak - to rear staircase in The Coach House E/001 – External does not contain asbestos.
