ASBESTOS SURVEY REPORT FOR BARNWELL ACADEMY CARETAKERS HOUSE, PENSHAW

**BARNWELL ACADEMY - CARETAKERS HOUSE,
PENSRAW**

Date: 03 April 2025

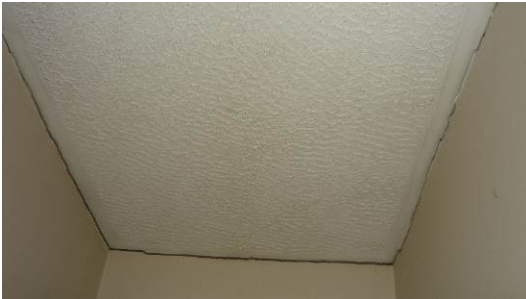
Item 1 Ref: ME1467/10

The textured coating to the ceiling in the porch (Rm 0/01) contains asbestos.

Any change in its appearance should be recorded, and passed to Property Services.

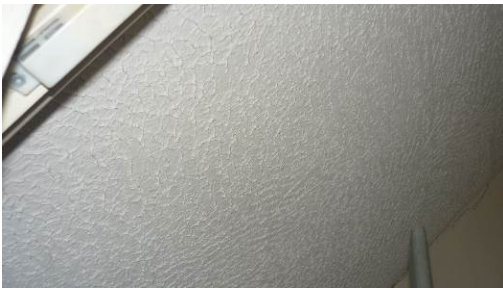
Item 2 – As ME1467/10

The textured coating to the ceiling in the cupboard under the stairs (Rm 0/02) contains asbestos.

Any change in its appearance should be recorded, and passed to Property Services.

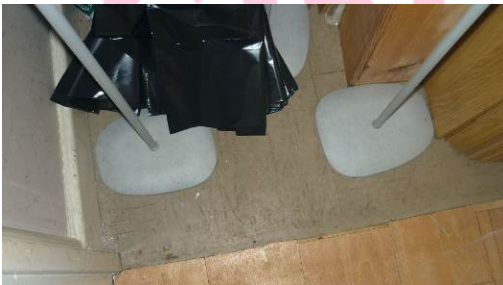
Various - Ref: ME1468/10

The floor tiles to the cupboard under the stairs (Rm 0/02) do not contain asbestos.

Similar floor tiles are located in room 0/03 and 1/06.

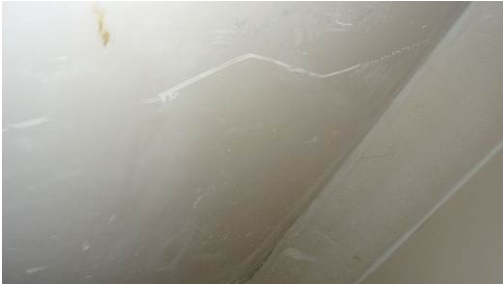
Item 4 - Ref: ME1469/10

The ceiling to the heating cupboard (Rm 0/03) does not contain asbestos.

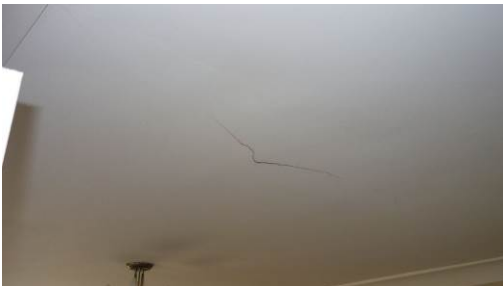
Item 6 - Ref: Presumed

The ceiling coating above the plaster skim in the living room (Rm 0/04) does not contain asbestos.

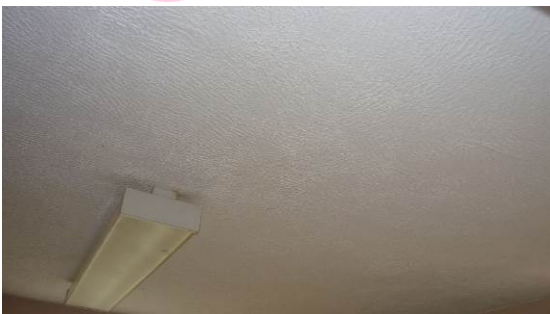
Item 7 – As ME1467/10

The textured coating to the ceiling in the kitchen contains asbestos.

Any change in its appearance should be recorded, and passed to Property Services.

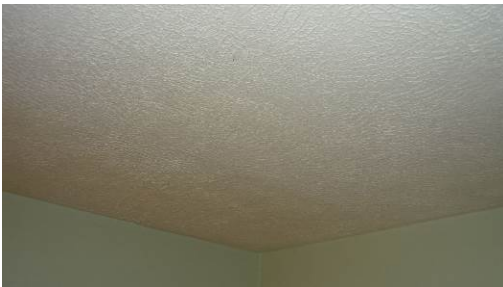
Item 9 – As ME1467/10

The coating to the ceiling in the stairs/landing/hallway (Rm 1/01) contains asbestos.

Any change in its appearance should be recorded, and passed to Property Services.

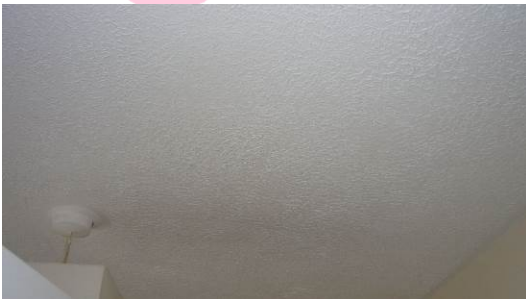
Item 10 – As ME1467/10

The coating to the ceiling in Bedroom 1 (Rm 1/02) contains asbestos.

Any change in its appearance should be recorded, and passed to Property Services.

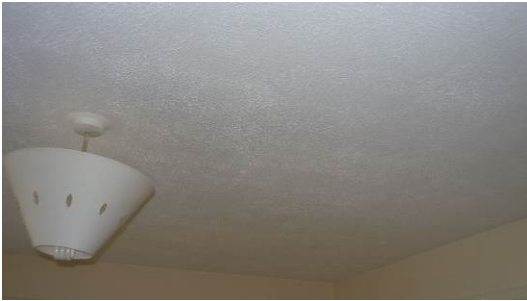
Item 11 – As ME1467/10

The coating to the ceiling in Bedroom 2 (Rm 1/03) contains asbestos.

Any change in its appearance should be recorded, and passed to Property Services.

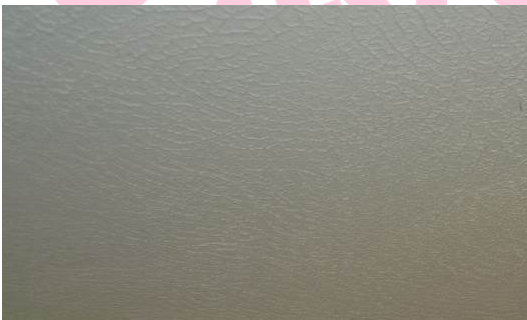
Item 13 – As ME1470/10

The coating to the ceiling in the cupboard to bedroom 3 (Rm 1/06) contains asbestos.

Any change in its appearance should be recorded, and passed to Property Services.

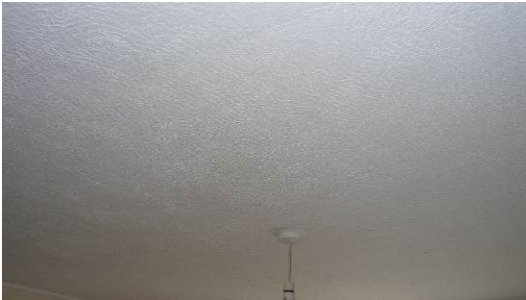
Item 15 – Ref: ME1470/10

The coating to the ceiling in Bedroom 3 (Rm 1/07) contains asbestos.

Any change in its appearance should be recorded, and passed to Property Services.

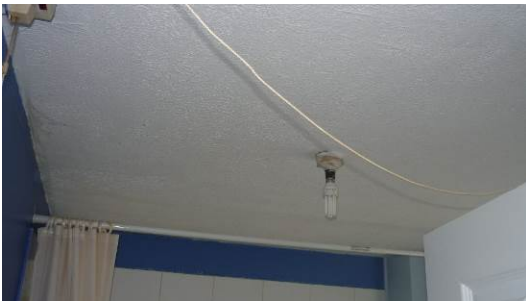
Item 16 – As ME1470/10

The coating to the ceiling in the bathroom (Rm 1/08) contains asbestos.

Any change in its appearance should be recorded, and passed to Property Services.

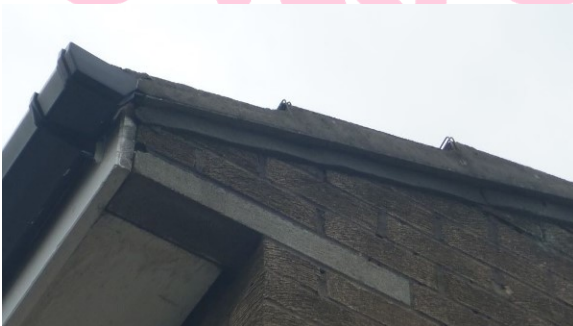
Item 17 – Presumed

The main roof undercloaking to the external of the building is presumed to contain asbestos.

Any change in its appearance should be recorded, and passed to Property Services.

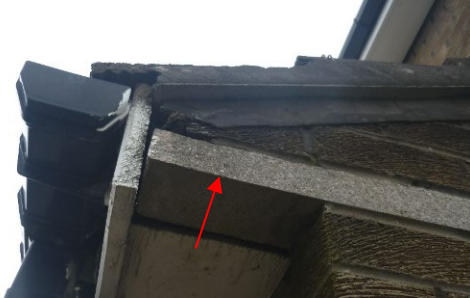
Item 18 – Ref: ME1466/10

The low level undercloaking to the external of the building contains asbestos.

Any change in its appearance should be recorded, and passed to Property Services.
