### **ASBESTOS SURVEY REPORT FOR BARNWELL ACADEMY CARETAKERS HOUSE, PENSHAW**

Barnwell Academy - Ct House – Last Updated 22 August 2024 – Version 2

**BARNWELL ACADEMY - CARETAKERS HOUSE,  
PENSHAW**

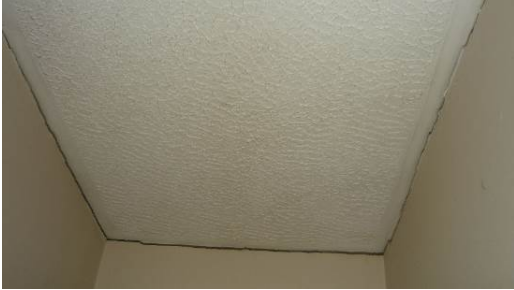
### **Item 1 Ref: ME1467/10**

The textured coating to the ceiling in the porch (Rm 0/01) contains asbestos.

Any change in its appearance should be recorded, and passed to Property Services.

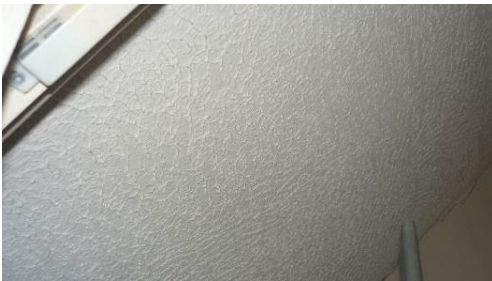
### **Item 2 – As ME1467/10**

The textured coating to the ceiling in the cupboard under the stairs (Rm 0/02) contains asbestos.

Any change in its appearance should be recorded, and passed to Property Services.

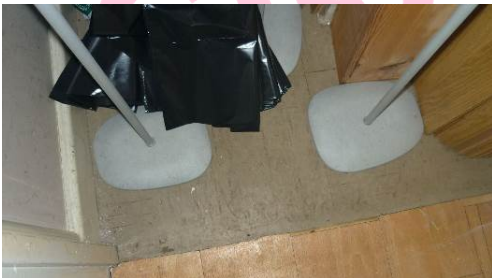
### **Various - Ref: ME1468/10**

The floor tiles to the cupboard under the stairs (Rm 0/02) do not contain asbestos.

Similar floor tiles are located in room 0/03 and 1/06.

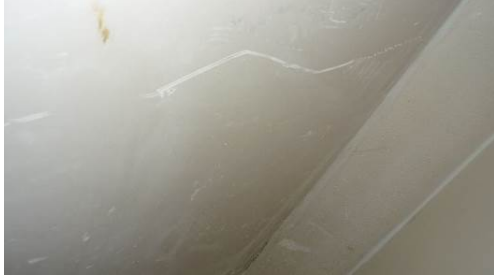
#### **Item 4 - Ref: ME1469/10**

The ceiling to the heating cupboard (Rm 0/03) does not contain asbestos.

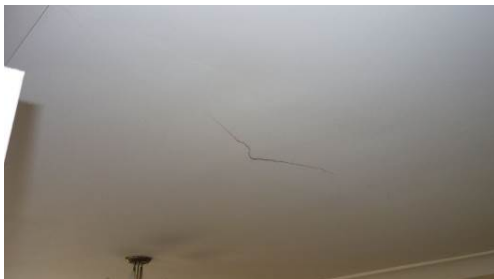
#### **Item 6 - Ref: Presumed**

The ceiling coating above the plaster skim in the living room (Rm 0/04) does not contain asbestos.

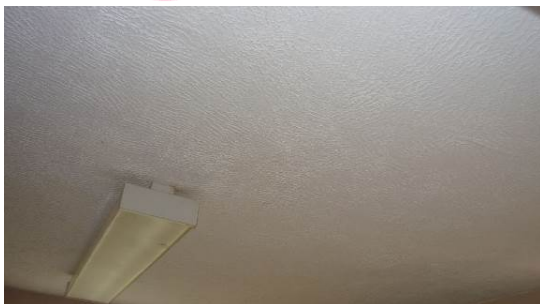
#### **Item 7 – As ME1467/10**

The textured coating to the ceiling in the kitchen contains asbestos.

Any change in its appearance should be recorded, and passed to Property Services.

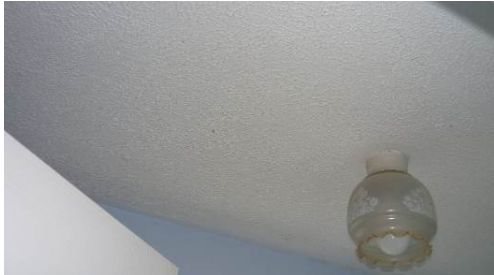
#### **Item 8 – As ME1467/10**

The textured coating to the ceiling in the toilet (Rm 0/06) contains asbestos.

Any change in its appearance should be recorded, and passed to Property Services.

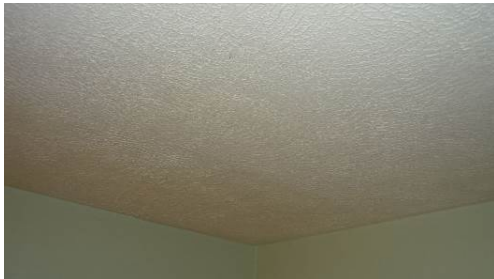
#### **Item 9 – As ME1467/10**

The coating to the ceiling in the stairs/landing/hallway (Rm 1/01) contains asbestos.

Any change in its appearance should be recorded, and passed to Property Services.

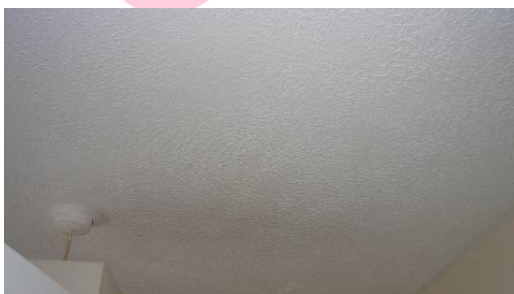
#### **Item 10 – As ME1467/10**

The coating to the ceiling in Bedroom 1 (Rm 1/02) contains asbestos.

Any change in its appearance should be recorded, and passed to Property Services.

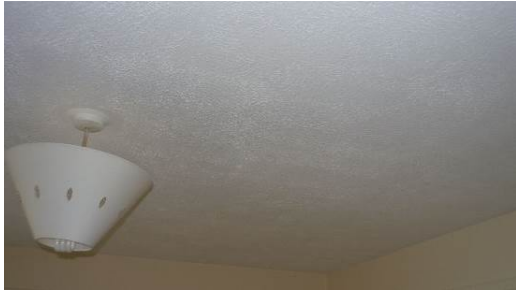
**Item 11 – As ME1467/10**

The coating to the ceiling in Bedroom 2 (Rm 1/03) contains asbestos.

Any change in its appearance should be recorded, and passed to Property Services.

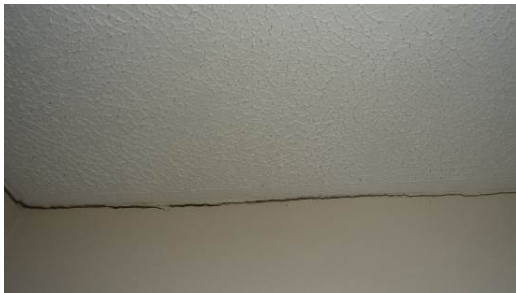
**Item 12 – As ME1470/10**

The coating to the ceiling in the cupboard to the landing (Rm 1/05) contains asbestos.

Any change in its appearance should be recorded, and passed to Property Services.

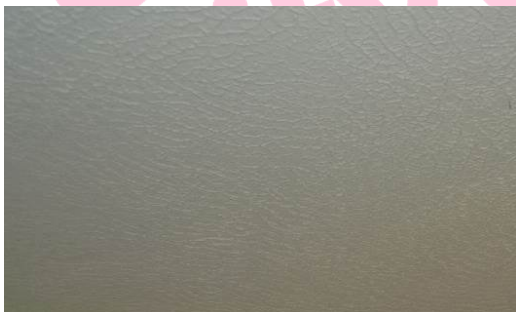
**Item 13 – As ME1470/10**

The coating to the ceiling in the cupboard to bedroom 3 (Rm 1/06) contains asbestos.

Any change in its appearance should be recorded, and passed to Property Services.

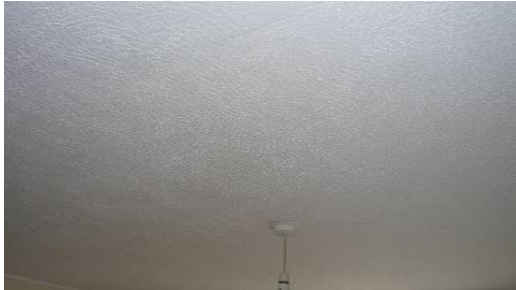
### **Item 15 – Ref: ME1470/10**

The coating to the ceiling in Bedroom 3 (Rm 1/07) contains asbestos.

Any change in its appearance should be recorded, and passed to Property Services.

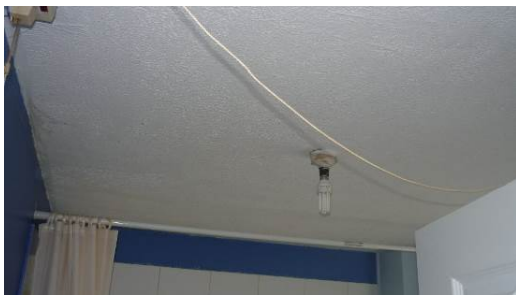
### **Item 16 – As ME1470/10**

The coating to the ceiling in the bathroom (Rm 1/08) contains asbestos.

Any change in its appearance should be recorded, and passed to Property Services.

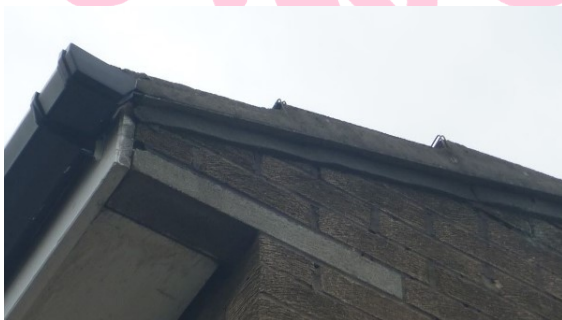
### **Item 17 – Presumed**

The main roof undercloaking to the external of the building is presumed to contain asbestos.

Any change in its appearance should be recorded, and passed to Property Services.

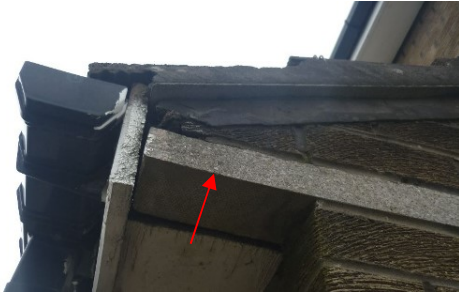
**Item 18 – Ref: ME1466/10**

The low level undercloaking to the external of the building contains asbestos.

Any change in its appearance should be recorded, and passed to Property Services.
