ASBESTOS SURVEY REPORT FOR ASHLEY PRIMARY ACADEMY, TEMPLE PARK ROAD, SOUTH SHIELDS, NE33 0QA

Asbestos Register for ASHLEY PRIMARY ACADEMY, TEMPLE PARK ROAD

Date: 16 June 2025

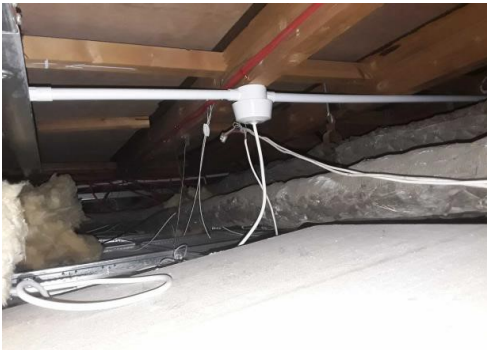
Item 1 Ref: 22-53098-1

The pipes – string to mmmf lagged metal pipes - Ground Floor, Room 1, Entrance Hall - do not contain asbestos

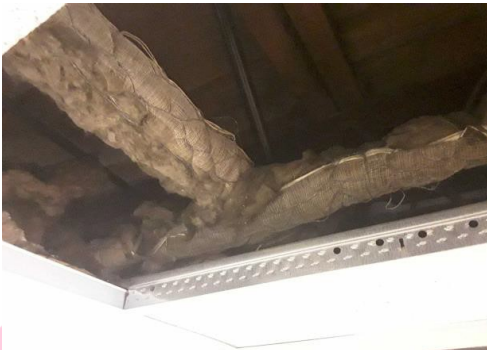
Item 2 Ref: 22-53098-1

The pipes – string to mmmf lagged metal pipes - Ground Floor, Room 1, Entrance Hall - do not contain asbestos

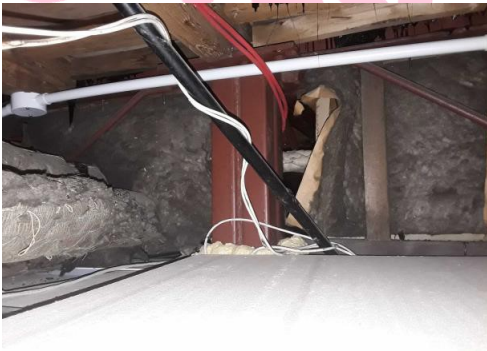
Item 3 Ref: Presumed

The walls – lining inside clasp columns - Ground Floor, Room 1, Entrance Hall - are presumed to contain asbestos.

Any change in its appearance should be recorded and passed to Property Services.

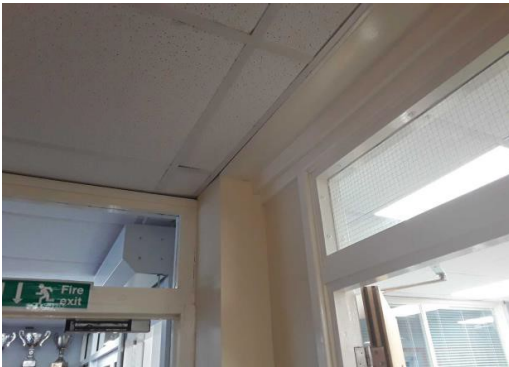
Item 4 Ref: Presumed

The walls – lining inside clasp columns - Ground Floor, Room 2, Corridor - are presumed to contain asbestos.

Any change in its appearance should be recorded and passed to Property Services.

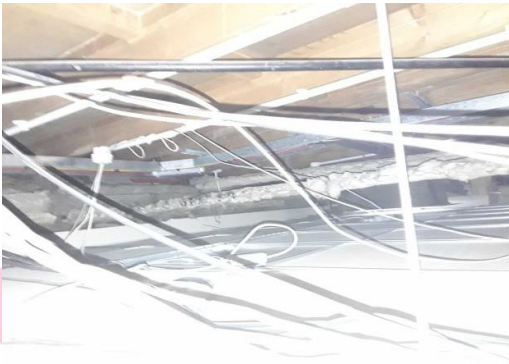
Item 5 Ref: 22-53098-1

The pipes – string to mmmf lagged metal pipes - Ground Floor, Room 3, Staff Room - do not contain asbestos

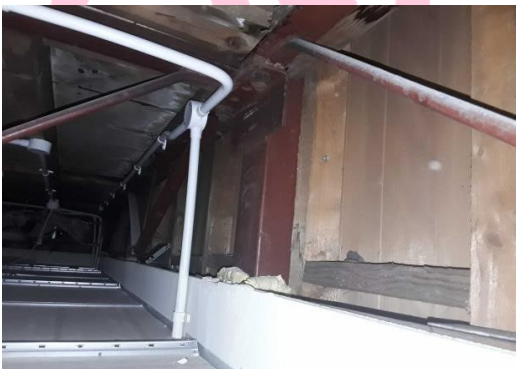
Item 6 Ref: Presumed

The walls – lining inside clasp columns - Ground Floor, Room 3, Staff Room - are presumed to contain asbestos.

Any change in its appearance should be recorded and passed to Property Services.

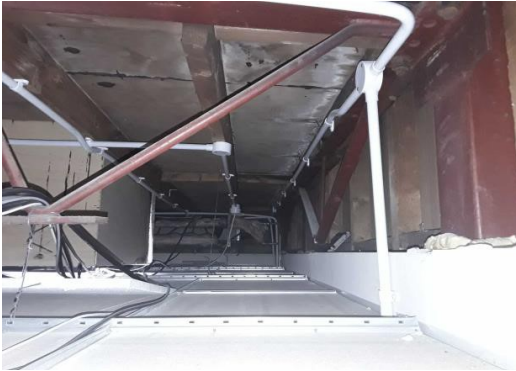
Item 7 Ref: 22-53098-1

The pipes – string to mmmf lagged metal pipes - Ground Floor, Room 4, Reception - do not contain asbestos

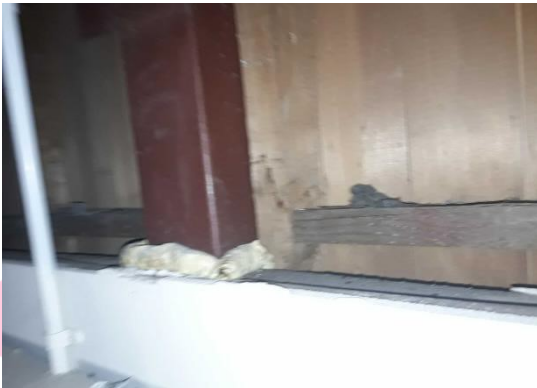
Item 8 Ref: Presumed

The walls – lining inside clasp columns - Ground Floor, Room 4, Reception - are presumed to contain asbestos.

Any change in its appearance should be recorded and passed to Property Services.

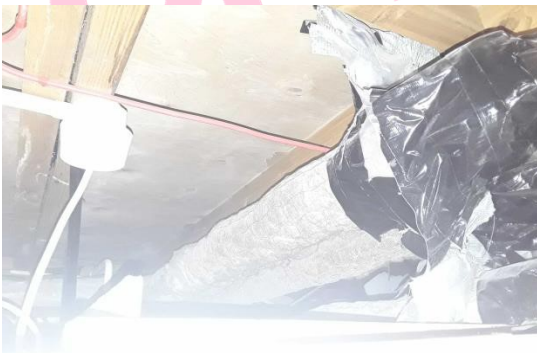
Item 9 Ref: 22-53098-1

The pipes – string to mmmf lagged metal pipes - Ground Floor, Room 5, Ladies Toilets - do not contain asbestos

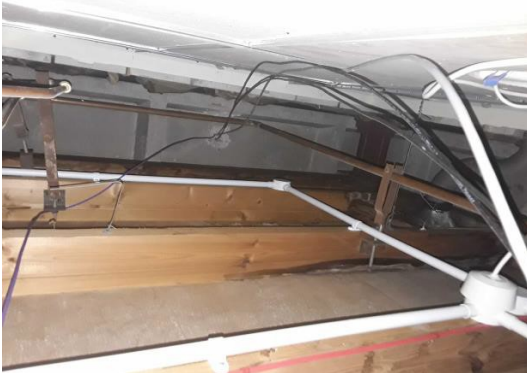
Item 10 Ref: Presumed

The walls – lining inside clasp columns - Ground Floor, Room 5, Ladies Toilets - are presumed to contain asbestos.

Any change in its appearance should be recorded and passed to Property Services.

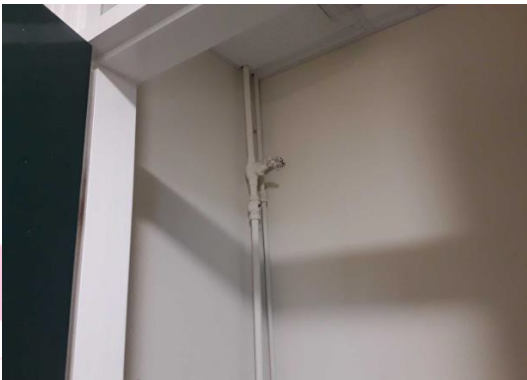
Item 11 Ref: Presumed

The pipes – stop taps (Gaskets) - Ground Floor, Room 5, Ladies Toilets - are presumed to contain asbestos.

Any change in its appearance should be recorded and passed to Property Services.

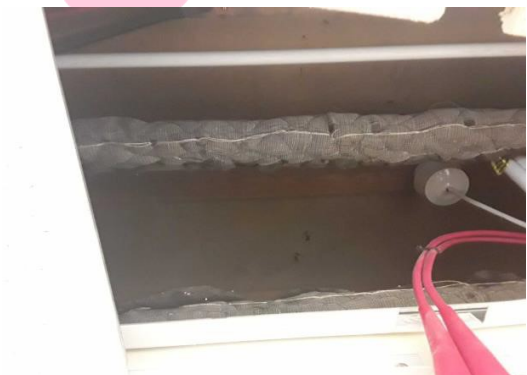
Item 12 Ref: 22-53098-1

The pipes – string to mmmf lagged metal pipes - Ground Floor, Room 6, Disabled Toilets - do not contain asbestos

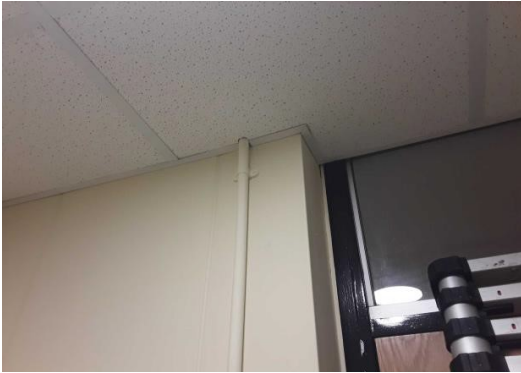
Item 13 Ref: Presumed

The walls – lining inside clasp columns - Ground Floor, Room 6, Disabled Toilets - are presumed to contain asbestos.

Any change in its appearance should be recorded and passed to Property Services.

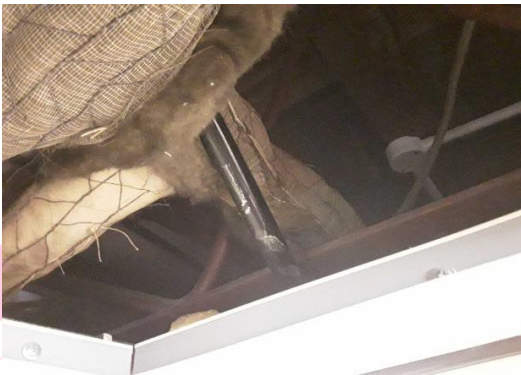
Item 14 Ref: 22-53098-1

The pipes – string to mmmf lagged metal pipes - Ground Floor, Room 7, Head teachers office - do not contain asbestos

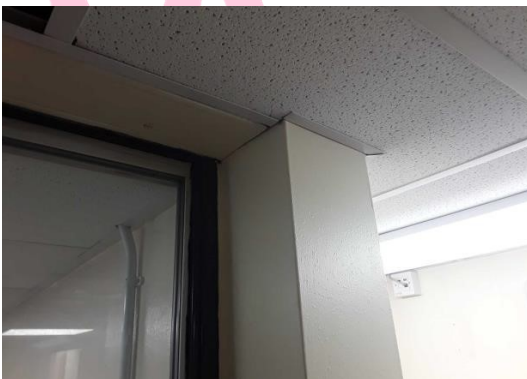
Item 15 Ref: Presumed

The walls – lining inside clasp columns - Ground Floor, Room 7, Head teachers office - are presumed to contain asbestos.

Any change in its appearance should be recorded and passed to Property Services.

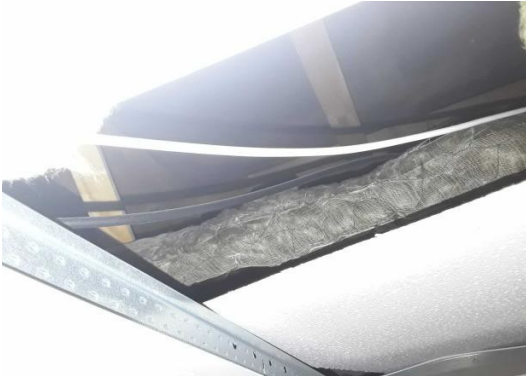
Item 16 Ref: 22-53098-1

The pipes – string to mmmf lagged metal pipes - Ground Floor, Room 8, Hallway - do not contain asbestos

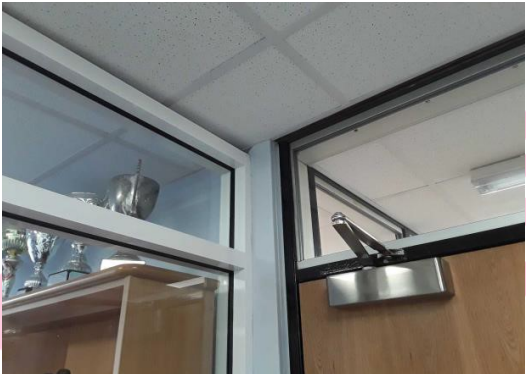
Item 17 Ref: Presumed

The walls – lining inside clasp columns - Ground Floor, Room 8, Hallway - are presumed to contain asbestos.

Any change in its appearance should be recorded and passed to Property Services.

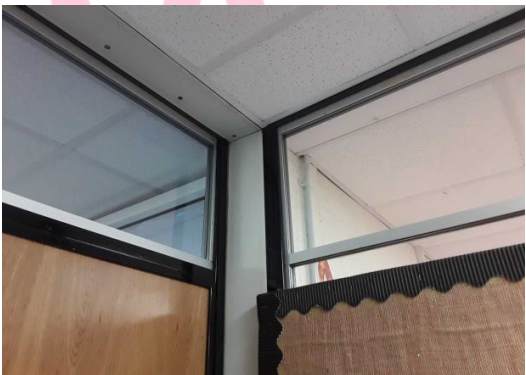
Item 18 Ref: Presumed

The walls – lining inside clasp columns - Ground Floor, Room 9, Corridor - are presumed to contain asbestos.

Any change in its appearance should be recorded and passed to Property Services.

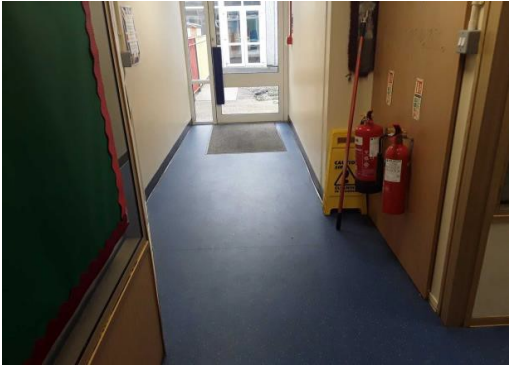
Item 19 Ref: 22-53098-3

The floor – residual adhesive beneath floor screed - Ground Floor, Room 9, Corridor contains asbestos.

Any change in its appearance should be recorded and passed to Property Services.

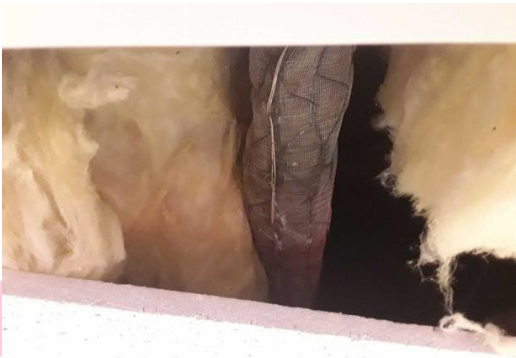
Item 20 Ref: 22-53098-1

The pipes – string to mmmf lagged metal pipes - Ground Floor, Room 10, Classroom - do not contain asbestos

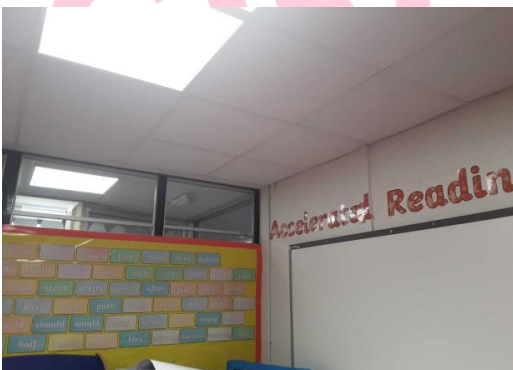
Item 21 Ref: Presumed

The walls – lining inside clasp columns - Ground Floor, Room 10, Classroom - are presumed to contain asbestos.

Any change in its appearance should be recorded and passed to Property Services.

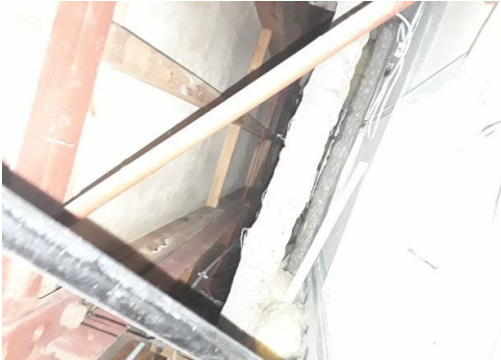
Item 22 Ref: 22-53098-1

The pipes – string to mmmf lagged metal pipes - Ground Floor, Room 11, Classroom - do not contain asbestos

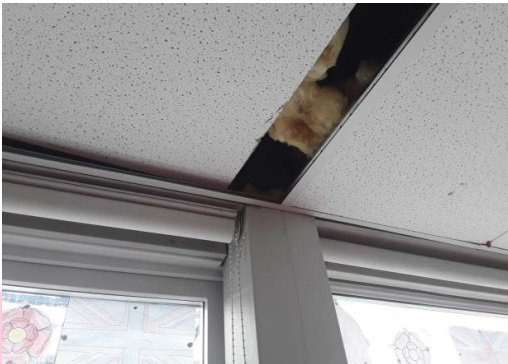
Item 23 Ref: Presumed

The walls – lining inside clasp columns - Ground Floor, Room 11, Classroom - are presumed to contain asbestos.

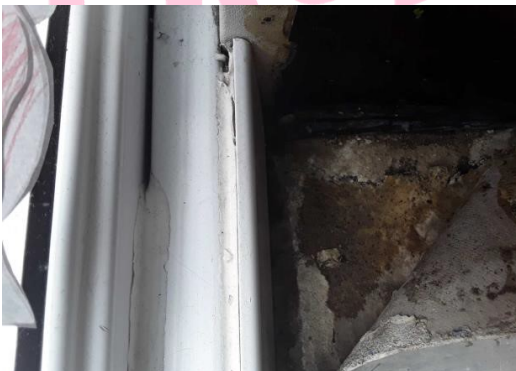
Item 24 Ref: 22-53098-3

The floor – residual adhesive beneath floor screed - Ground Floor, Room 11, Classroom - contains asbestos.

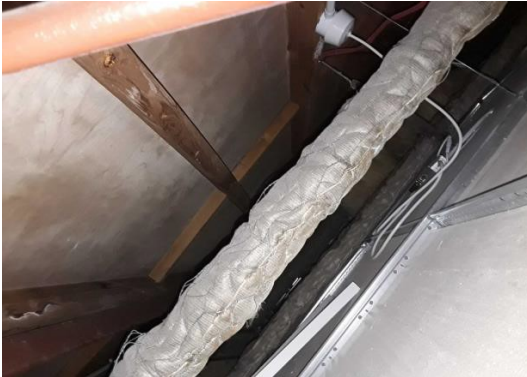
Item 25 Ref: 22-53098-1

The pipes – string to mmmf lagged metal pipes - Ground Floor, Room 12, Classroom store cupboard - do not contain asbestos

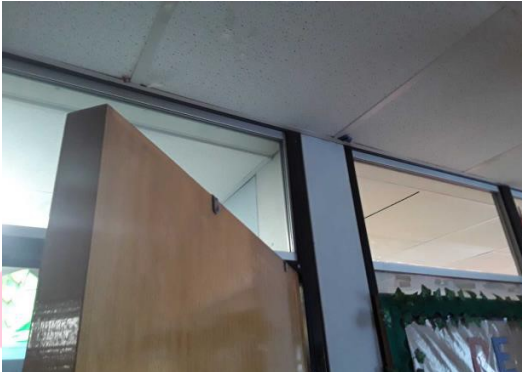
Item 26 Ref: Presumed

The walls – lining inside clasp columns - Ground Floor, Room 12, Classroom store cupboard - are presumed to contain asbestos.

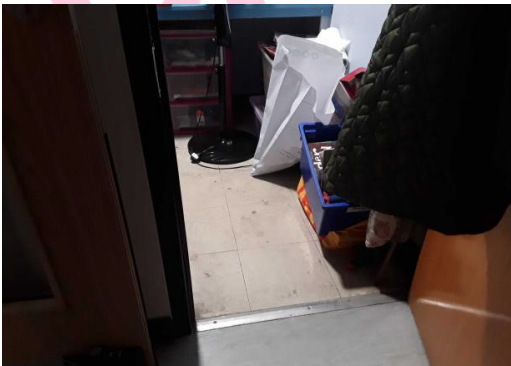
Item 27 Ref: 22-53098-3

The floor – residual adhesive beneath floor screed - Ground Floor, Room 12, Classroom store cupboard - contains asbestos.

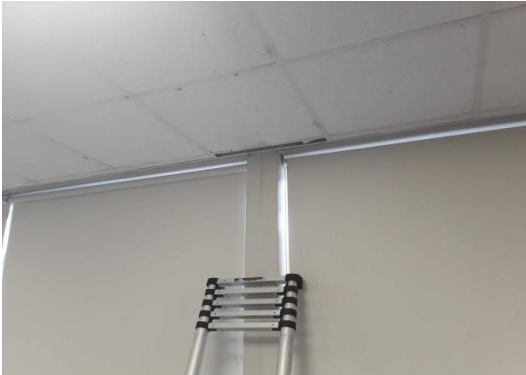
Item 28 Ref: Presumed

The walls – lining inside clasp columns - Ground Floor, Room 13, Classroom – are presumed to contain asbestos.

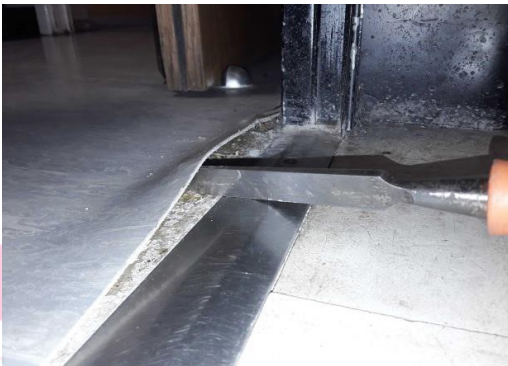
Item 29 Ref: 22-53098-3

The floor – residual adhesive beneath floor screed - Ground Floor, Room 13, Classroom - contains asbestos.

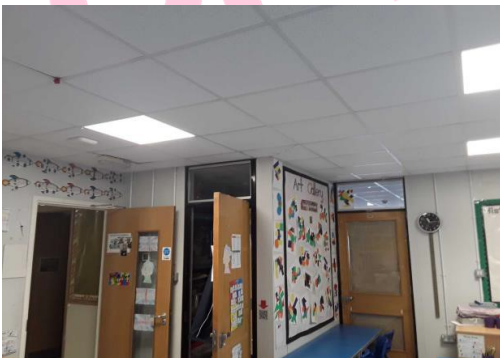
Item 30 Ref: Presumed

The walls – lining inside clasp columns - Ground Floor, Room 14, Classroom – are presumed to contain asbestos.

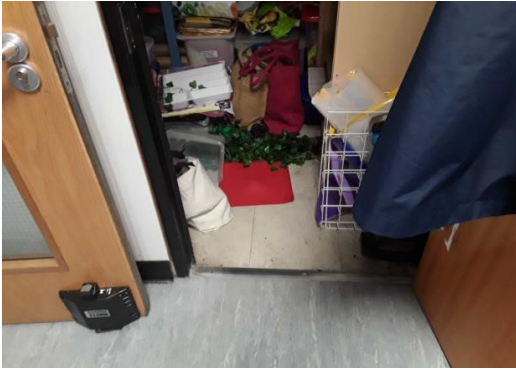
Item 31 Ref: 22-53098-4

The floor – tiles and adhesive – Ground Floor, Room 14, Classroom - contains asbestos.

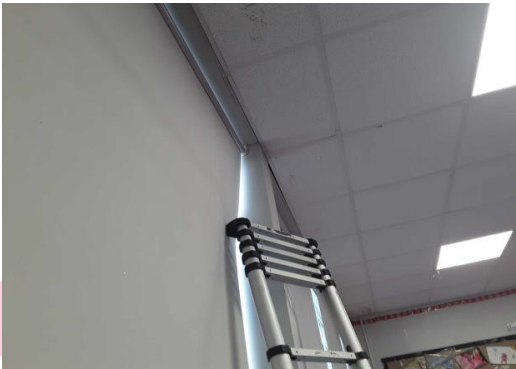
Item 32 Ref: Presumed

The walls – lining inside clasp columns - Ground Floor, Room 15, Classroom – are presumed to contain asbestos.

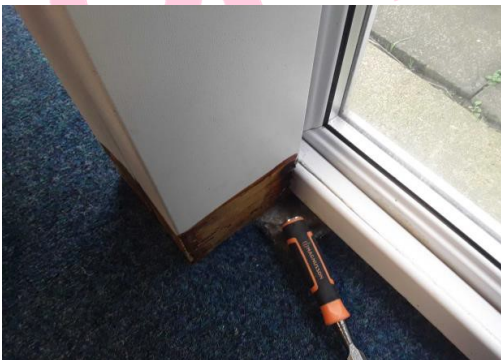
Item 33 Ref: 22-53098-3

The floor – residual adhesive beneath floor screed - Ground Floor, Room 15, Classroom - contains asbestos.

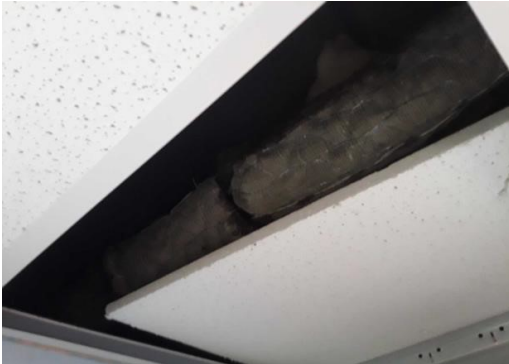
Item 34 Ref: 22-53098-1

The pipes – string to mmmf lagged metal pipes - Ground Floor, Room 12, Classroom store cupboard - do not contain asbestos

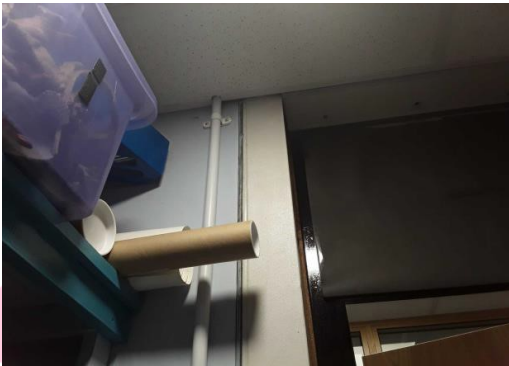
Item 35 Ref: Presumed

The walls – lining inside clasp columns - Ground Floor, Room 16, Corridor Store Cupboard – are presumed to contain asbestos.

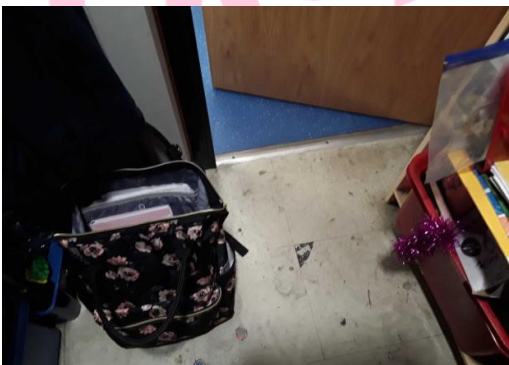
Item 36 Ref: 22-53098-4

The floor – tiles and adhesive - Ground Floor, Room 16, Corridor Store Cupboard - contains asbestos.

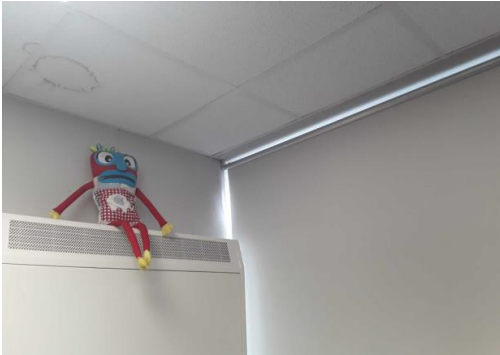
Item 37 Ref: Presumed

The walls – lining inside clasp columns - Ground Floor, Room 17, Corridor Store Cupboard – are presumed to contain asbestos.

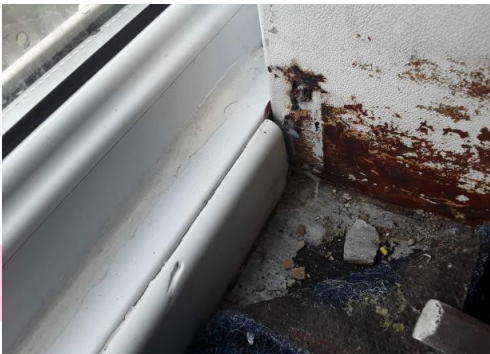
Item 38 Ref: 22-53098-3

The floor – residual adhesive beneath floor screed - Ground Floor, Room 17, Corridor Store Cupboard - contains asbestos.

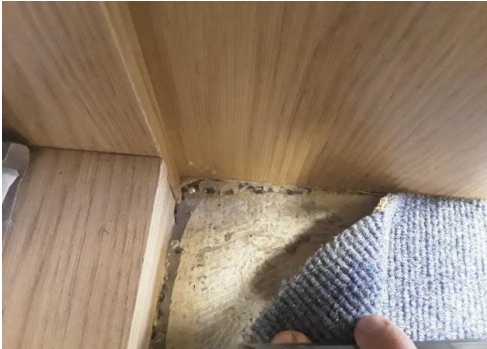
Item 40 Ref: 22-53098-3

The floor – residual adhesive beneath floor screed - Ground Floor, Room 18, Deputy Head teachers office - contains asbestos.

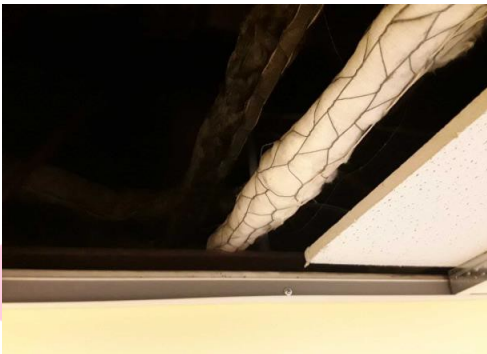
Item 41 Ref: 22-53098-1

The pipes – string to mmmf lagged metal pipes - Ground Floor, Room 19, Fire exit hallway and cloak rooms - do not contain asbestos

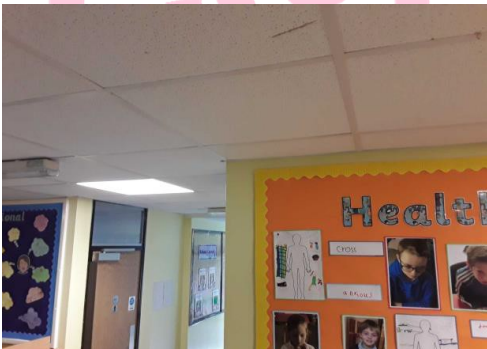
Item 42 Ref: Presumed

The walls – lining inside clasp columns - Ground Floor, Room 19, Fire exit hallway and cloak rooms – are presumed to contain asbestos.

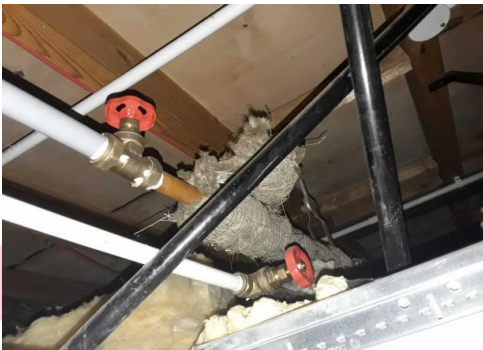
Item 44 Ref: 22-53098-1

The pipes – string to mmmf lagged metal pipes - Ground Floor, Room 20, Boys Toilet - do not contain asbestos

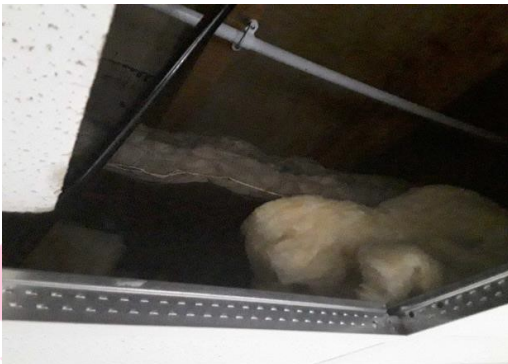
Item 47 Ref: 22-53098-1

The pipes – string to mmmf lagged metal pipes - Ground Floor, Room 21, Girls Toilet - do not contain asbestos

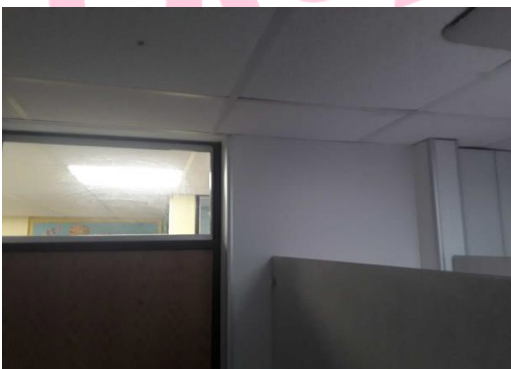
Item 48 Ref: Presumed

The walls – lining inside clasp columns - Ground Floor, Room 21, Girls Toilet – are presumed to contain asbestos.

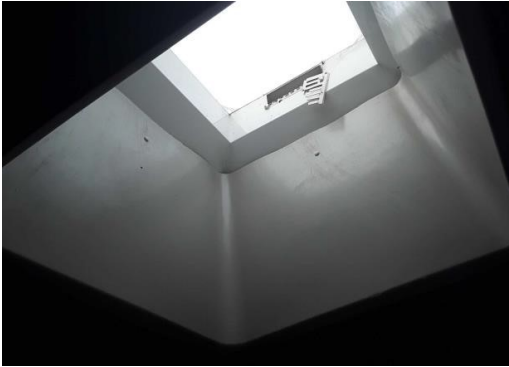
Item 49 Ref: Presumed

The ceiling – textile rope seal to fibreglass skylight - Ground Floor, Room 21, Girls Toilet – is presumed to contain asbestos.

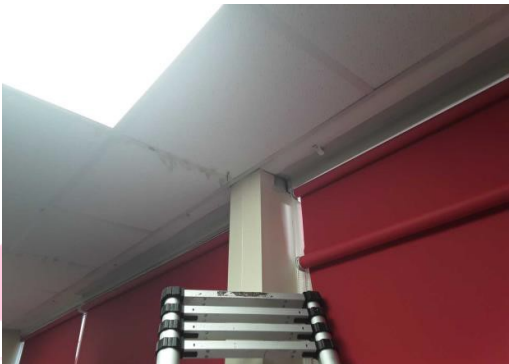
Item 50 Ref: Presumed

The walls – lining inside clasp columns - Ground Floor, Room 22, Classroom – are presumed to contain asbestos.

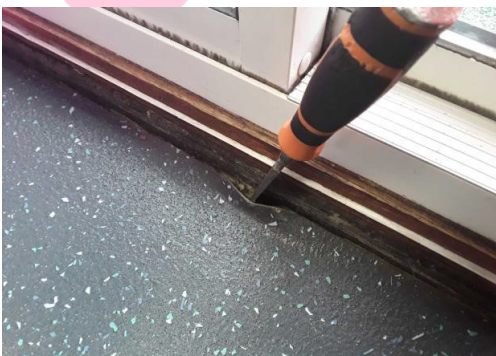
Item 51 Ref: 22-53098-3

The floor – residual adhesive beneath floor screed - Ground Floor, Room 22, Classroom - contains asbestos.

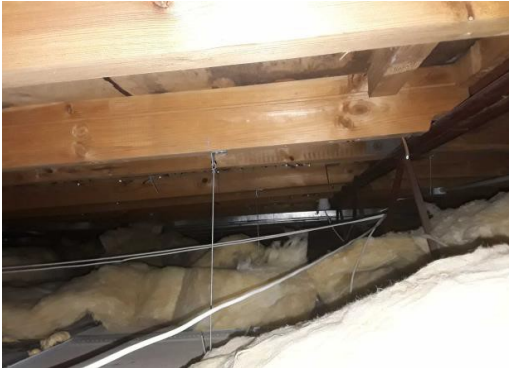
Item 52 Ref: 22-53098-1

The pipes – string to mmmf
lagged metal pipes - Ground
Floor, Room 22, Classroom -
do not contain asbestos

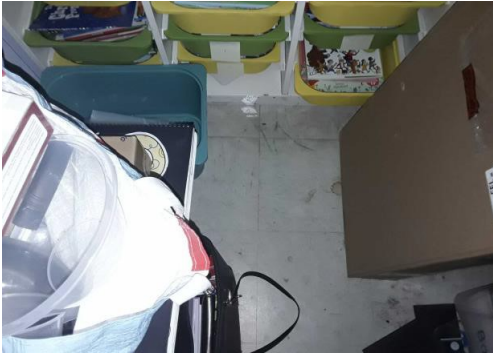
Item 55 Ref: 22-53098-4

The floor – tiles and adhesive
- Ground Floor, Room 25,
Classroom store cupboard -
contains asbestos.

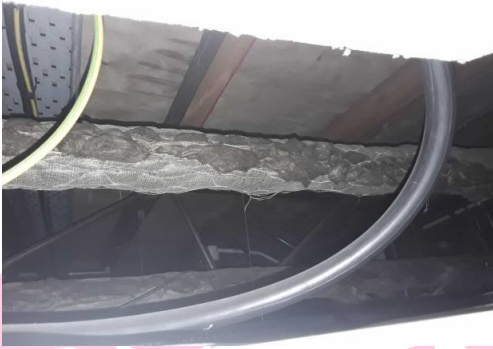
Item 56 Ref: 22-53098-1

The pipes – string to mmmf
lagged metal pipes - Ground
Floor, Room 26, Classroom
store cupboard - do not
contain asbestos

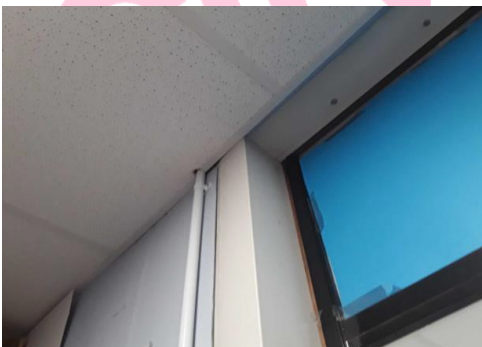
Item 57 Ref: Presumed

The walls – lining inside clasp
columns - Ground Floor,
Room 26, Classroom store
cupboard – are presumed to
contain asbestos.

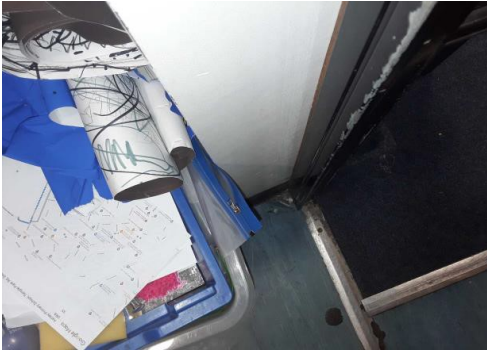
Item 58 Ref: 22-53098-4

The floor – tiles and adhesive
- Ground Floor, Room 26,
Classroom store cupboard -
contains asbestos.

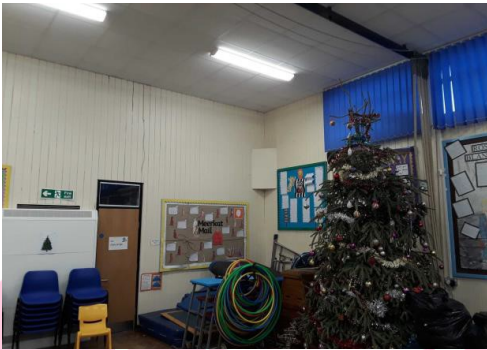
Item 59 Ref: Presumed

The walls – firebreak behind
wood cladding between hall
and boiler room - Ground
Floor, Room 28, Main School
Hall – are presumed to
contain asbestos.

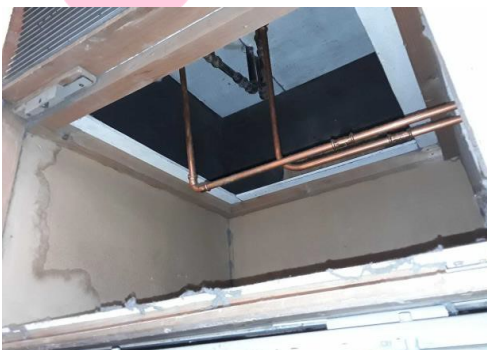
Item 60 Ref: 22-53098-29

The vessels – lining inside
area of old heating unit -
Ground Floor, Room 28, Main
School Hall – does not contain
asbestos.

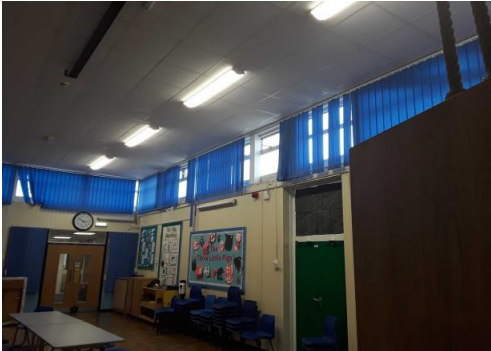
Item 61 Ref: Presumed

The walls – lining inside clasp columns - Ground Floor, Room 28, Main School Hall – are presumed to contain asbestos.

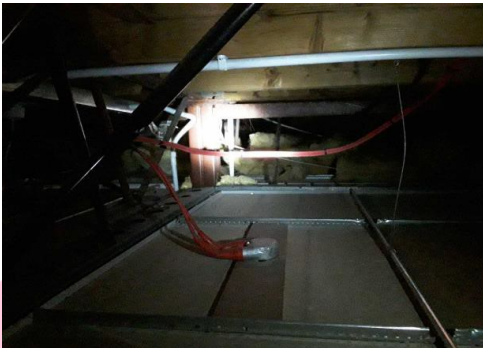
Item 89 Ref: Presumed

The walls – lining inside clasp
columns - Ground Floor,
Room 39, Store Cupboard –
are presumed to contain
asbestos.

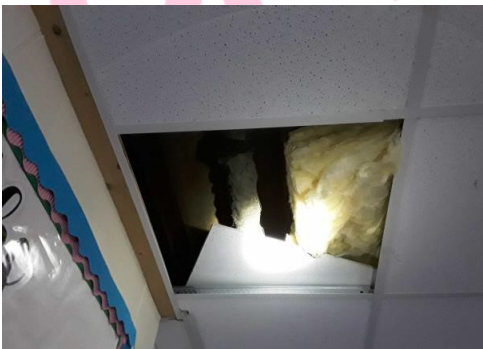
Item 90 Ref: 22-53098-1

The pipes – string to mmmf
lagged metal pipes - Ground
Floor, Room 40, Classroom -
do not contain asbestos

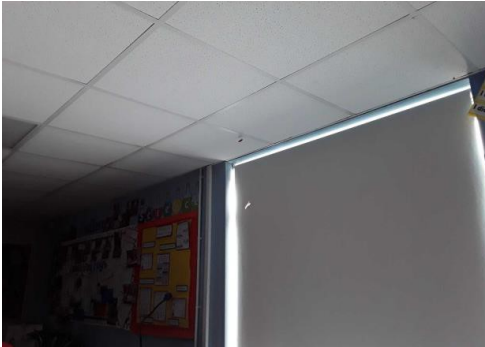
Item 91 Ref: Presumed

The walls – lining inside clasp columns - Ground Floor, Room 40, Classroom – are presumed to contain asbestos.

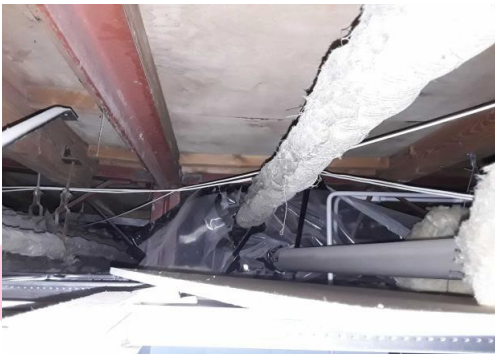
Item 92 Ref: 22-53098-1

The pipes – string to mmf lagged metal pipes - Ground Floor, Room 41, Classroom Cupboard - do not contain asbestos

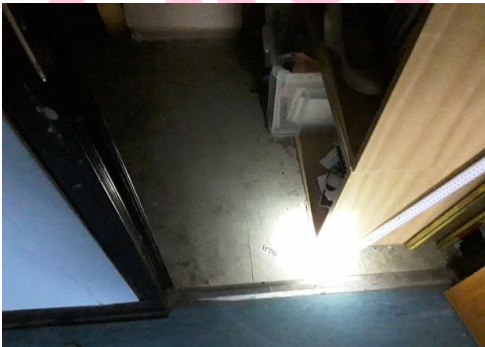
Item 93 Ref: 22-53098-10

The floor – tiles and adhesive - Ground Floor, Room 41, Classroom Cupboard - contains asbestos.

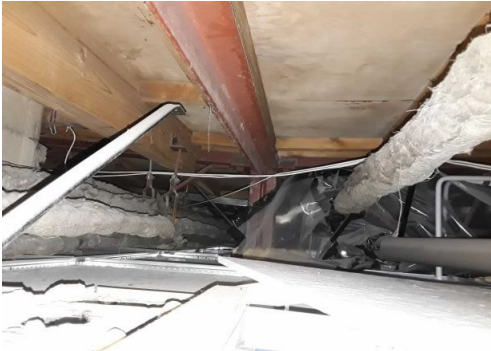
Item 94 Ref: Presumed

The walls – lining inside clasp columns - Ground Floor, Room 41, Classroom Cupboard – are presumed to contain asbestos.

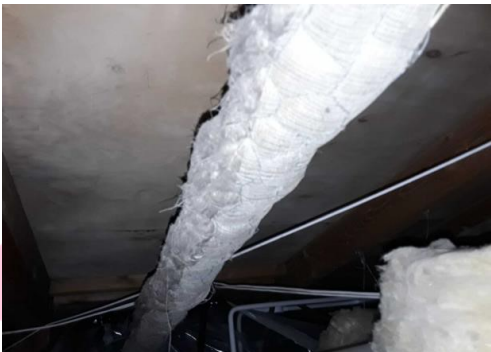
Item 95 Ref: 22-53098-1

The pipes – string to mmmf lagged metal pipes - Ground Floor, Room 42, Classroom Cupboard - do not contain asbestos

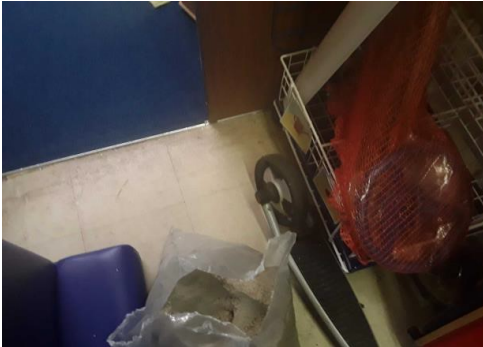
Item 163 Ref: 22-53098-20

The floor – tiles and adhesive
- Ground Floor, Room 89
Nursery area 2 Store
cupboard 1- contains
asbestos.

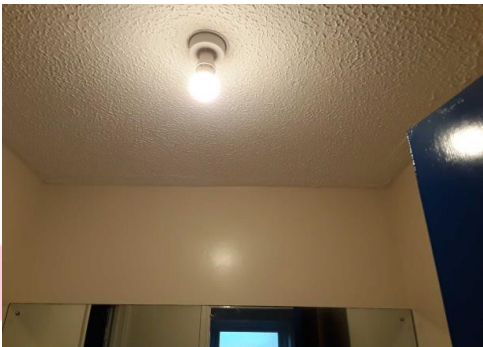
Item 164 Ref: 22-53098-13

The ceiling – textured coating
- Ground Floor, Room 90 Staff
Toilets Nursery - contains
asbestos.

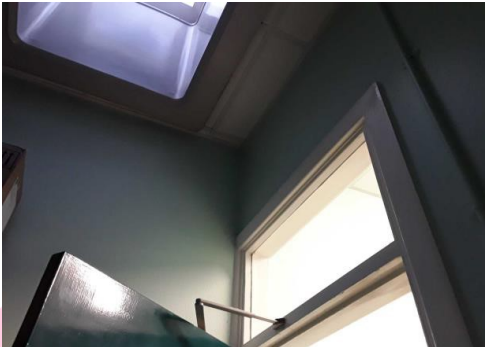
Item 194 Ref: Presumed

The walls – lining inside clasp columns - Ground Floor, Room 110 Kitchen Staff Toilet - are presumed to contain asbestos.

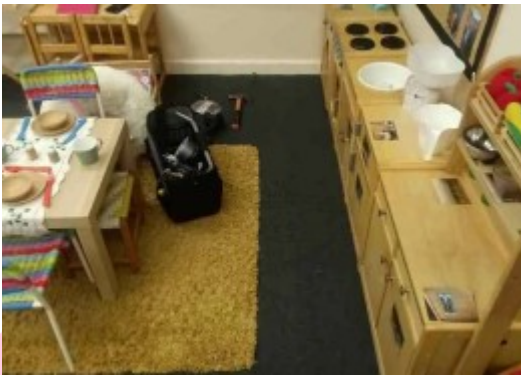
Item 200 Ref: TL000402

The Floor – screed composite sample from opposite ends of room Ground Floor, Rm G/001 Main Nursery Area – does not contain asbestos.

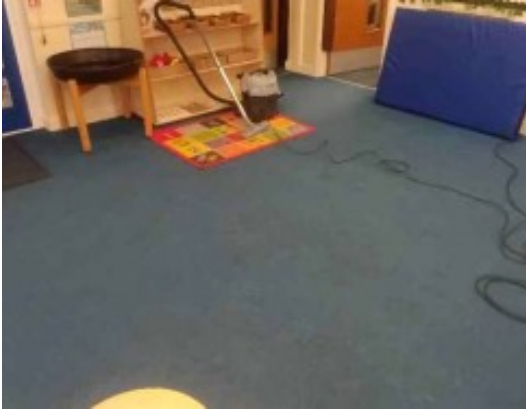
Item 202 Ref: As TL000302

The Floor – screed composite sample from opposite ends of room
Ground Floor, Rm G/002
Main Nursery Area – does not contain asbestos.

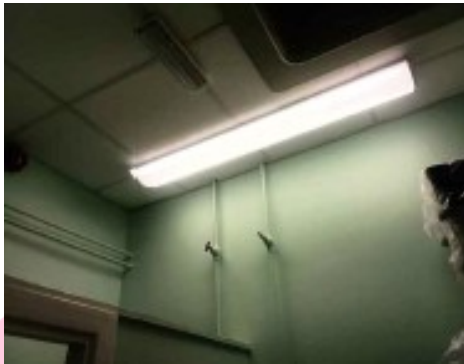
Item 206 Ref: Presumed

The Ceiling Void - Insulating Board, Ground Floor, Rm 109 Toilet(s) is presumed to contain asbestos.
