ASBESTOS SURVEY REPORT FOR, CARETAKERS HOUSE, CASTLETOWN PRIMARY, SUNDERLAND

Castletown Primary School – Caretakers House

CARETAKERS HOUSE, CASTLETOWN PRIMARY SUNDERLAND

Date: 15 April 2025

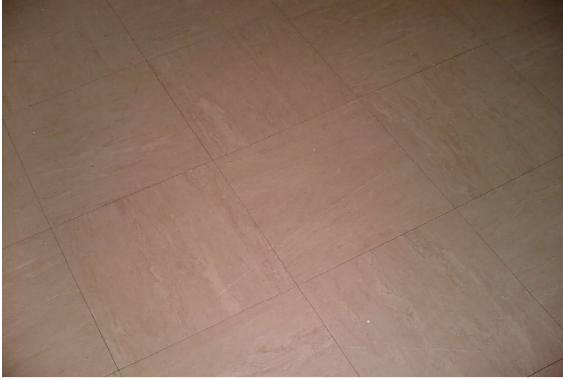
Item 1 Ref: ED19/2

ED19/2 – Vinyl floor tiles (Room 7) (Item 1) - Very Low Risk

The vinyl floor tiles in the storeroom (Room 7) contain asbestos.

Any change in its appearance should be recorded and passed to Property Services.

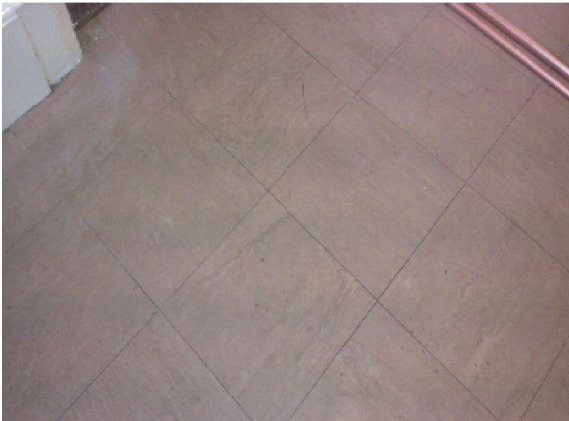
Item 2 Ref:48440-1

The vinyl floor tiles in the kitchen does not contain asbestos.

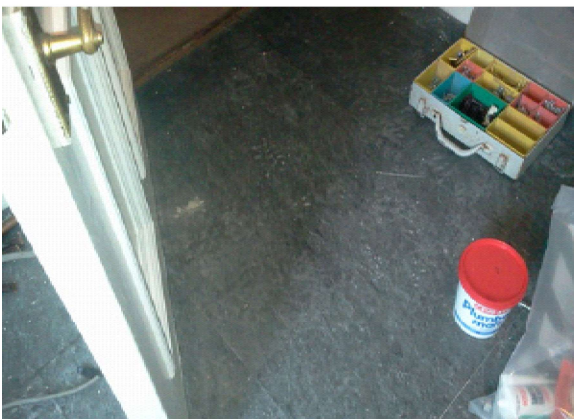
Item 3 Ref:48440-2

The black floor covering to the bathroom does not contain asbestos.

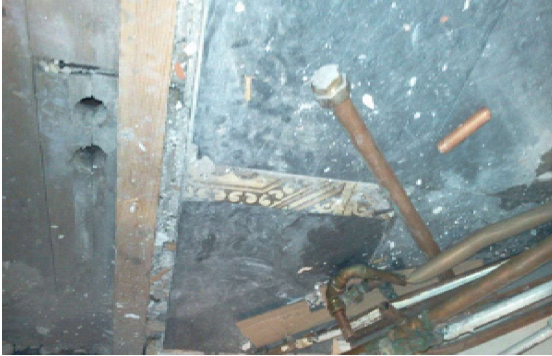
Item 4 Ref:48440-3

The sub floor tile in the bathroom does not contain asbestos.

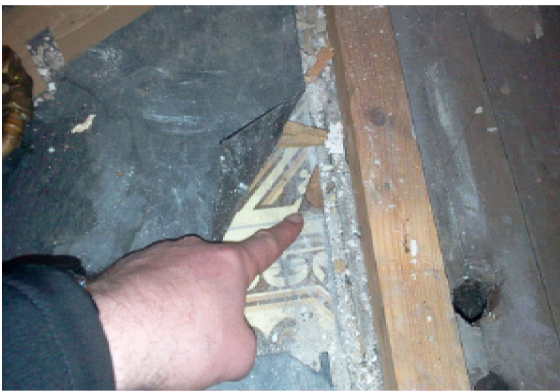
Item 5 Ref:48440-4

The packing to the sub floor in the bathroom does not contain asbestos.

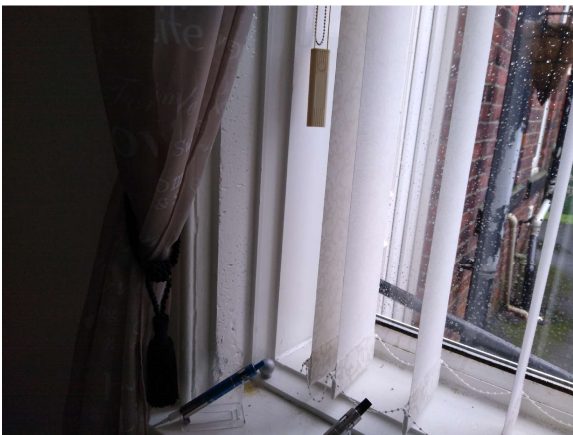
Item 6 Ref:378623-1

The insulation to the wall in the Dining Room (Rm 0/01) does not contain asbestos.

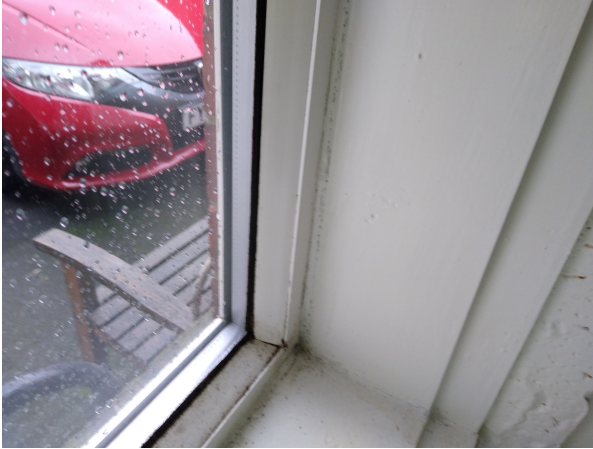
Item 7 Ref: 378623-2

The sealant to window frame in the Dining Room (Rm 0/01) does not contain asbestos.

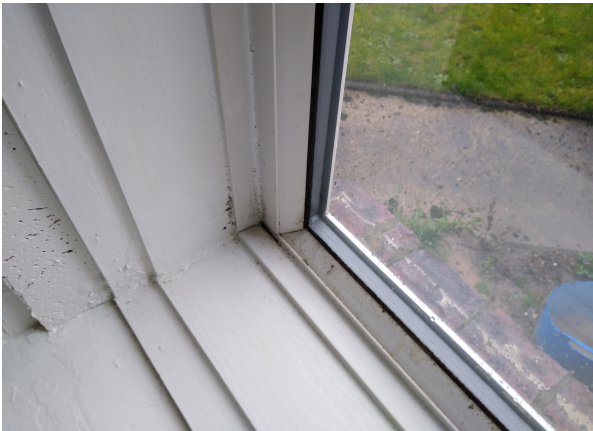
Item 9 Ref: As 378623-2

The sealant to the window frame in the Lounge (Rm 0/02) does not contain asbestos.

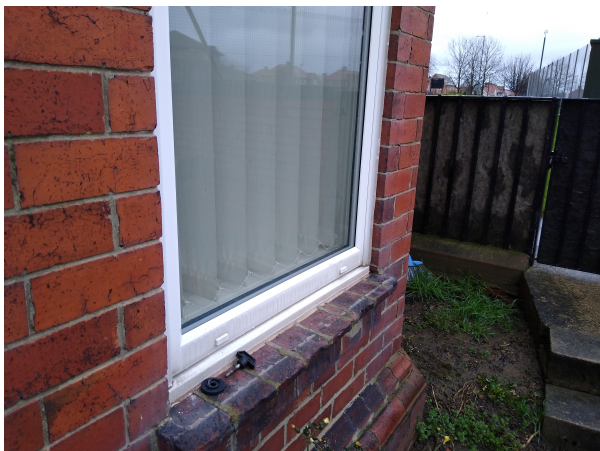
Item 10 Ref: 378623-3

The sealant to window frame (External) does not contain asbestos.
