ASBESTOS SURVEY REPORT FOR, CARETAKERS HOUSE, CASTLETOWN PRIMARY, SUNDERLAND

Castletown Primary School – Caretakers House

CARETAKERS HOUSE, CASTLETOWN PRIMARY SUNDERLAND

Date: 04 February 2025

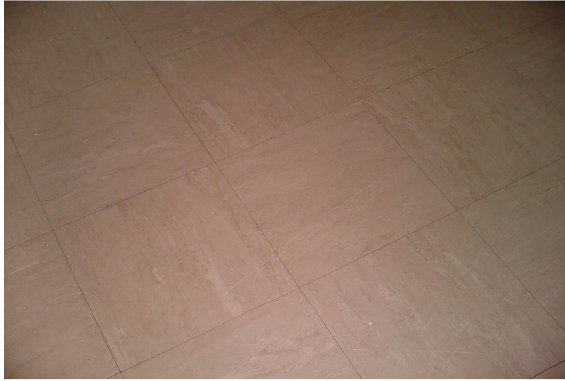
Item 1 Ref: ED19/2

ED19/2 – Vinyl floor tiles (Room 7) (Item 1) - Very Low Risk

The vinyl floor tiles in the store room (Room 7) contain asbestos. Any change in its appearance should be recorded, and passed to Property Services.

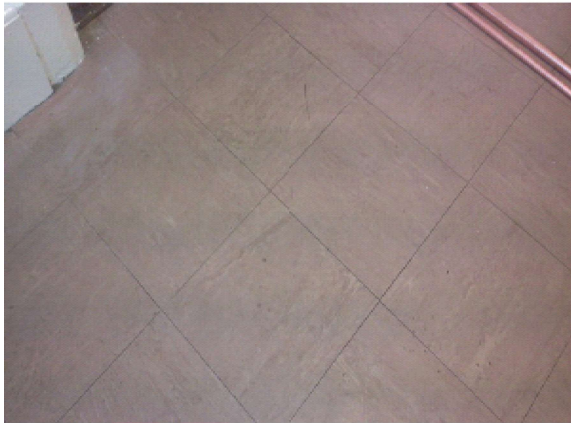
Item 2 Ref:48440-1

The vinyl floor tiles in the kitchen do not contain asbestos. Any change in its appearance should be recorded, and passed to Property Services.

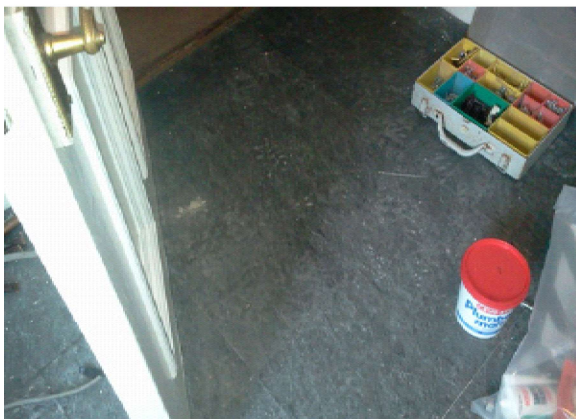
Item 3 Ref:48440-2

The black floor covering to the bathroom does not contain asbestos.

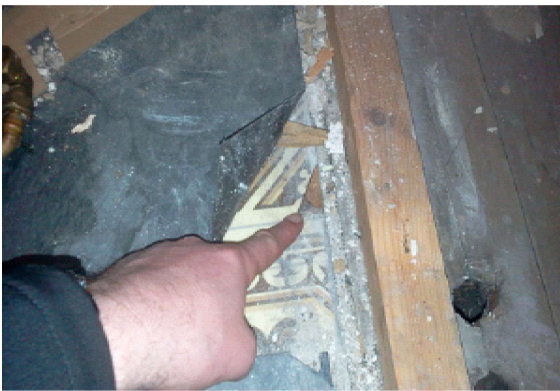
Item 5 Ref:48440-4

The packing to the sub floor in the bathroom does not contain asbestos.

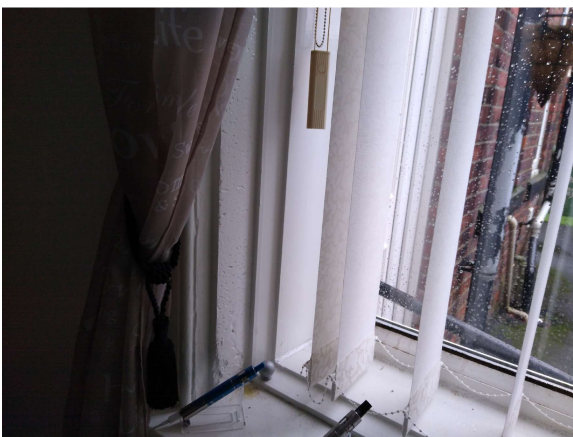
Item 6 Ref:378623-1

The insulation to the wall in the Dining Room (Rm 0/01) does not contain asbestos.

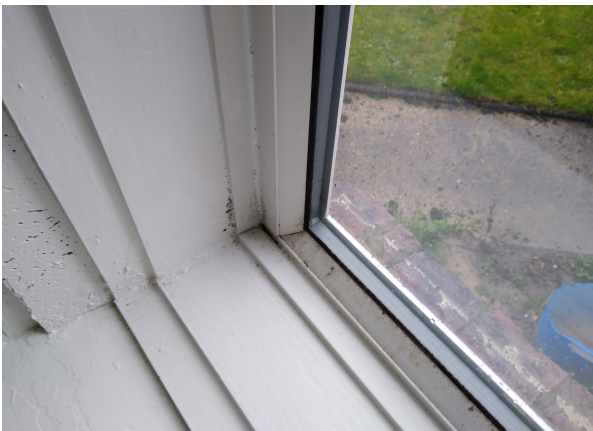
Item 9 Ref: As 378623-2

The sealant to the window frame in the Lounge (Rm 0/02) does not contain asbestos.
