### **ASBESTOS SURVEY REPORT FOR OXCLOSE ACADEMY CARETAKERS HOUSE No. 2, WASHINGTON**

### **OXCLOSE ACADEMY 2 CARETAKERS HOUSE, WASHINGTON**

**Date: 15 April 2025**

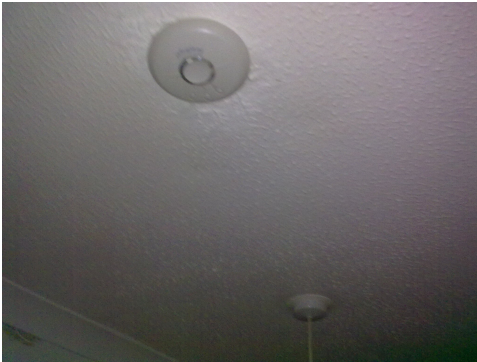
### **Item 1 Ref: DC2070/10**

The coating to the ceiling in the stairs/hall/landing (Rm 0/01) contains asbestos.

Removed February 2020.

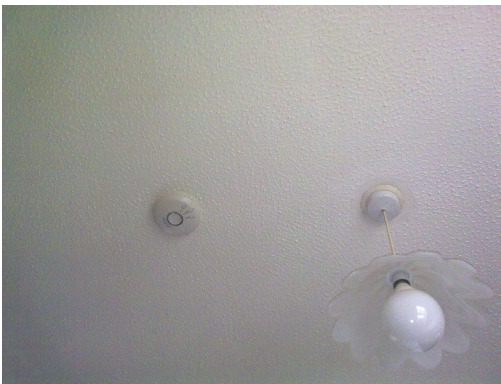
### **Item 2 – Ref: DC2071/10**

The coating to the ceiling in the toilet (Rm 0/02) contains asbestos.

Removed February 2020.

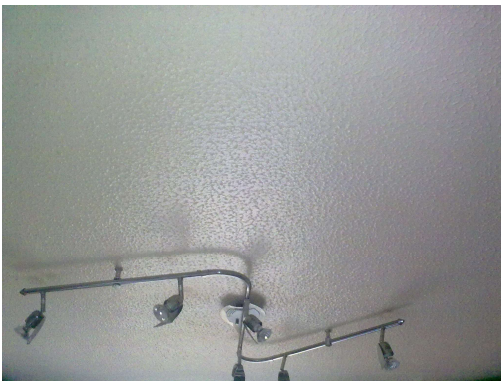
### **Item 3 – As DC2071/10**

The coating to the ceiling in the kitchen (Rm 0/03) contains asbestos.

Removed February 2020.

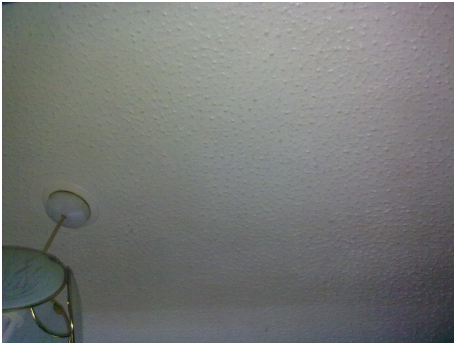
### **Item 4 - Ref: DC2072/10**

The ceiling coating to the lounge (Rm 0/04) contains asbestos.

Removed February 2020.

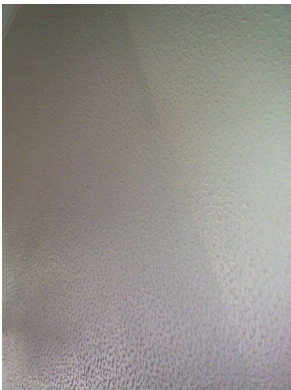
### **Item 5 – As DC2071/10**

The coating to the heating cupboard (Rm 0/06) contains asbestos.

Removed February 2020.

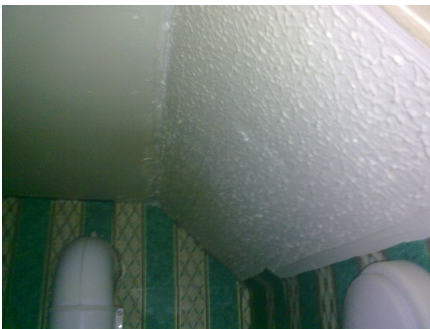
### **Item 6 – As DC2071/10**

The coating to the ceiling in the electrical cupboard (Rm 0/07) contains asbestos.

Removed February 2020.

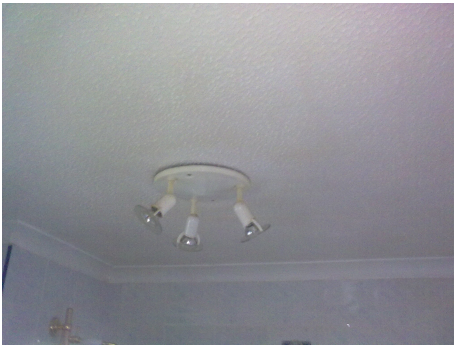
### **Item 7 - Ref: DC2073/10**

The coating to the ceiling in the bathroom (Rm 1/01) contains asbestos.

Removed February 2020.

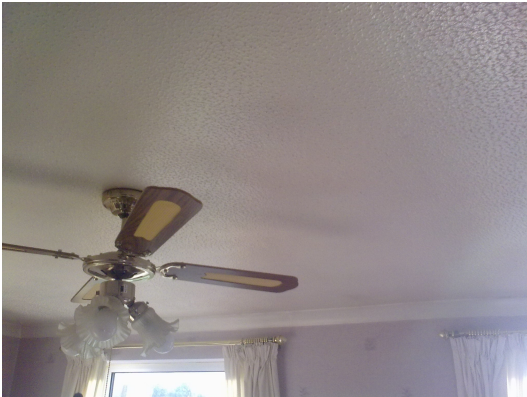
### **Item 8 – As DC2073/10**

The coating to the ceiling in bedroom 1 (Rm 1/02) contains asbestos.

Removed February 2020.

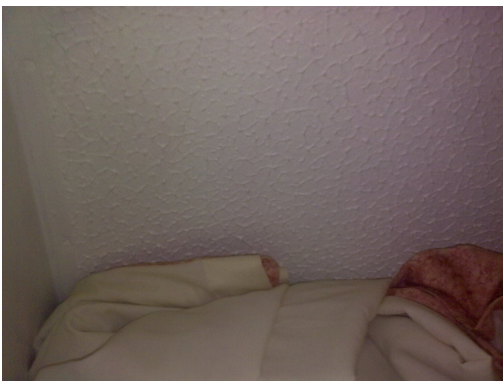
### **Item 9 – As DC2073/10**

The coating to the ceiling in the cupboard to the landing (Rm 1/03) contains asbestos.

Removed February 2020.

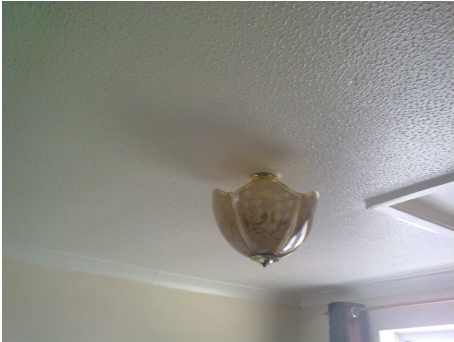
### **Item 10 – As DC2074/10**

The coating to the ceiling in bedroom 2 (Rm 1/04) contains asbestos.

Removed February 2020.

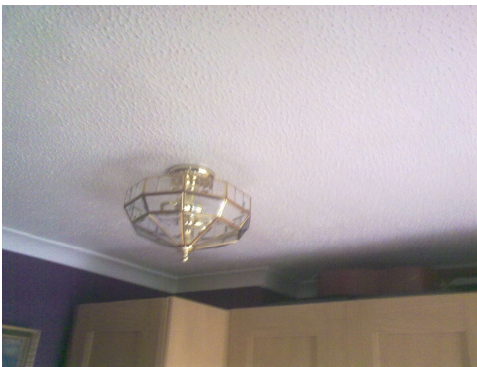
### **Item 11 – As DC2074/10**

The coating to the ceiling in bedroom 3 (Rm 1/05) contains asbestos.

Removed February 2020.

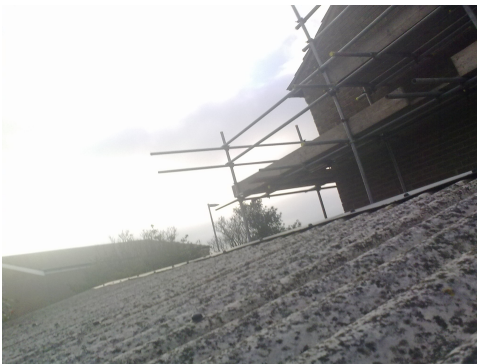
### **Item 12 – Ref: DC2077/10**

The roof to the garage (External) does not contain asbestos.

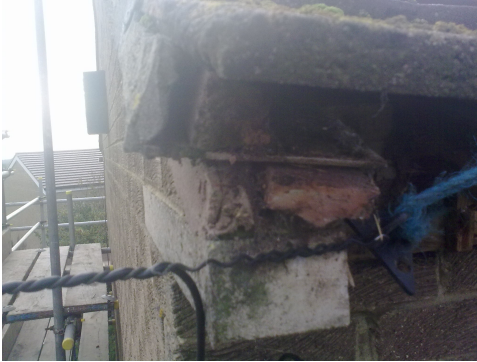
### **Item 13 – Ref: DC2078/10**

The undercloaking to the external of the house contains asbestos. Any change in its appearance should be recorded, and passed to Property Services.

| Picture | Location | Risk | Inspection Frequency | Date of return |
|---|---|---|---|---|
| <b>Item 13</b> | <b>Undercloaking – External</b> | <b>Very Low</b> | <b>12 Monthly</b> | <b>01.02.2026</b> |

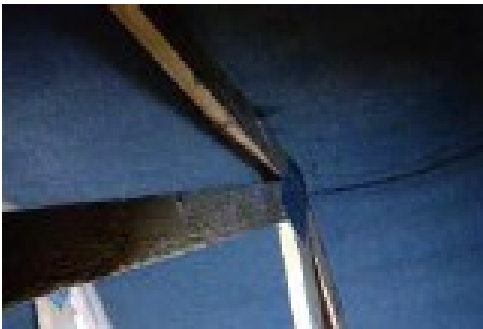
### **Item 14 – Ref: AN004138**

The roof felt in the roof void does not contain asbestos.

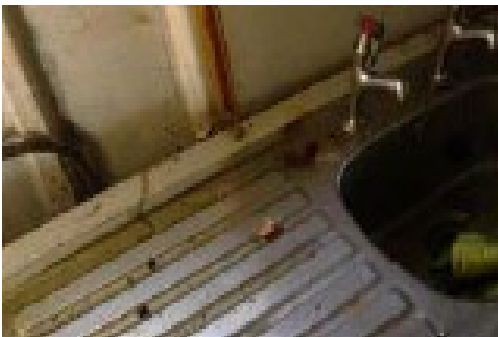
### **Item 15 – Ref: AN004140**

The sink pad in the garage does not contain asbestos.
