ASBESTOS SURVEY REPORT FOR LAMBTON VILLAGE CENTRE,  
HAMBLETON ROAD, WASHINGTON, NE38 0PL.

## *Control of Asbestos Regulations 2012*

**Lambton Village Centre, Hambleton Road, Washington,  
NE38 0PL**

**Date: 05 April 2024**

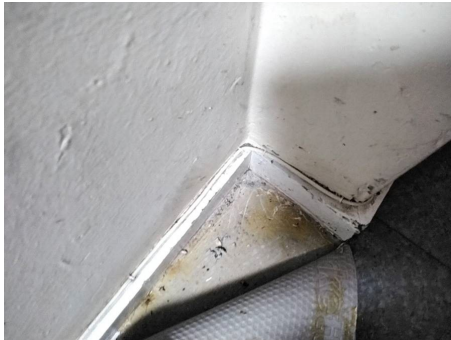
### **Item 1 Ref: SC004702**

Item No.	Sample Ref.	Area Sampled	Location Name	Inspection Frequency
1.	SC004702	Debris/Residue below floor screed	Community Hall, Ground Floor, Entrance Hall/Lobby (Room G/001)	Very low risk – To be checked on a 12 monthly basis

The Debris/Residue below floor screed, Community Hall, Ground Floor, Entrance Hall/Lobby (Room G/001) contains asbestos.

Any change in its appearance should be recorded and passed to Property Services.

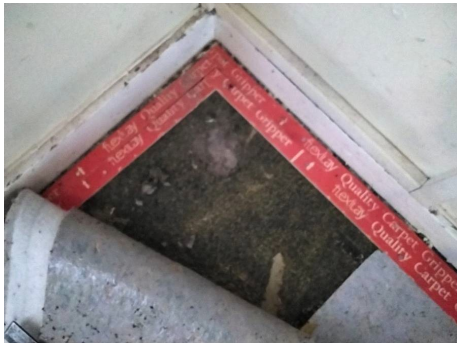
### **Item 2 Ref: As SC004702**

2.	As SC004702	Debris/Residue Limited inspection inline with job scope damage	Community Hall, Ground Floor, Living Room/Lounge (Room G/002)	Low risk – to be checked on a 6 monthly basis

The Debris/Residue Limited inspection inline with job scope damage, Community Hall, Ground Floor, Living Room/Lounge (Room G/002) contains asbestos.

Any change in its appearance should be recorded and passed to Property Services.

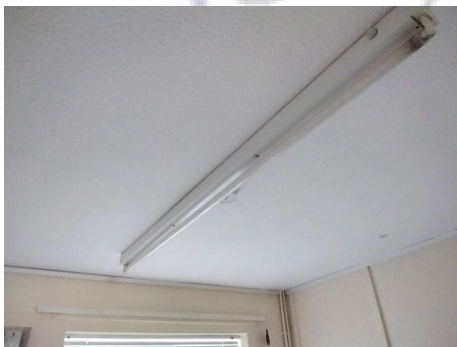
### **Item 3 Ref: SC004703**

The Ceiling Coating, Community Hall, Ground Floor, Office (Room G/003) contains asbestos.

Any change in its appearance should be recorded and passed to Property Services.

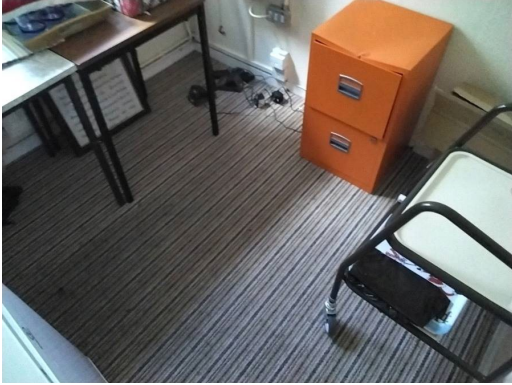
### **Item 4 Ref: SC004704**

The Floor tile with adhesive below carpet, Community Hall, Ground Floor, Office (Room G/003) does not contain asbestos.

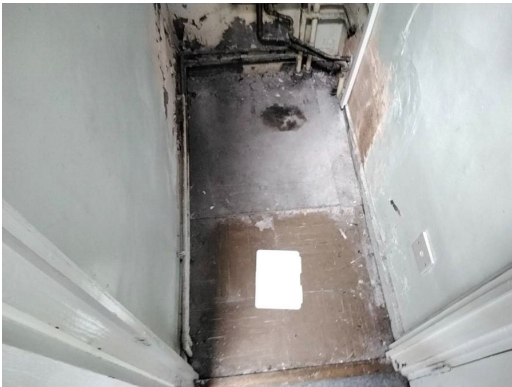
### **Item 5 Ref: SC004705**

The Floor tile with adhesive, Community Hall, Ground Floor, Cupboard Heating (Room G/004) contains asbestos.

Any change in its appearance should be recorded and passed to Property Services.

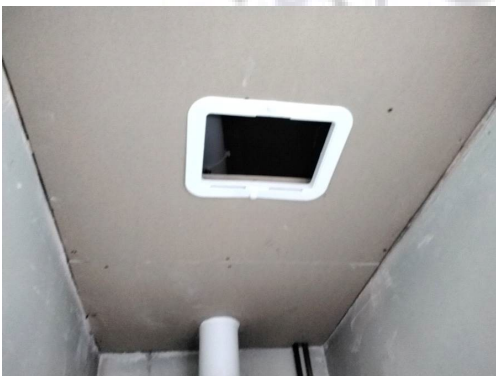
### **Item 6 Ref: As SC004711**

The Roof lining exposed at high level, Community Hall, Ground Floor, Cupboard Heating (Room G/004) does not contain asbestos.

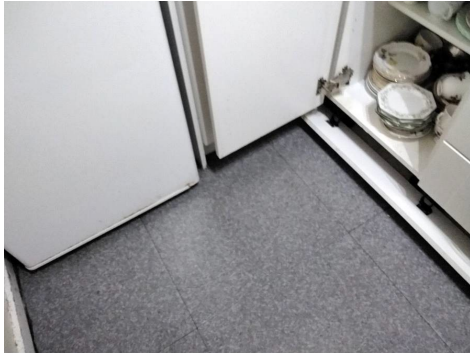
**Item 7 Ref: SC004706**

The Floor tiles below all floor covering and kitchen units, Community Hall, Ground Floor, Kitchen (Room G/005) do not contain asbestos.

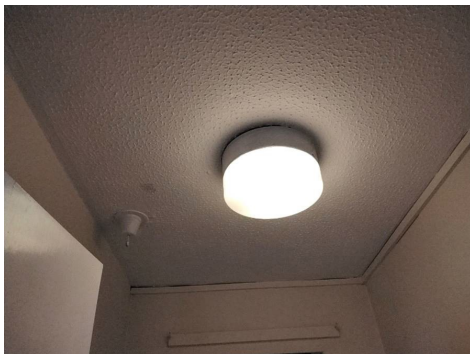
**Item 8 Ref: SC004707**

The Ceiling Coating, Community Hall, Ground Floor, Toilets (Room G/006) contains asbestos.

Any change in its appearance should be recorded and passed to Property Services.

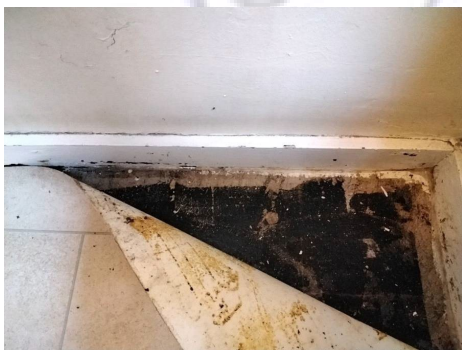
**Item 9 Ref: SC004708**

The Debris/Residue below floor lino, Community Hall, Ground Floor, Toilets (Room G/006) contains asbestos.

Any change in its appearance should be recorded and passed to Property Services.

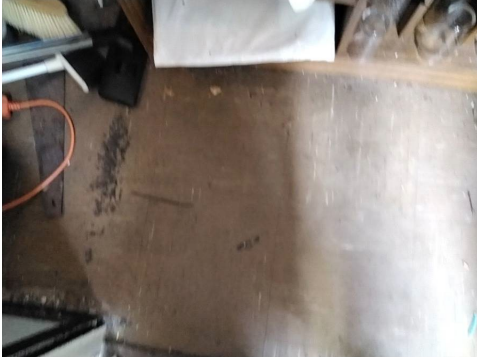
**Item 10 Ref: As SC004705**

The Floor tile with adhesive, Community Hall, Ground Floor, Cupboard Cleaners (Room G/007) contains asbestos.

Any change in its appearance should be recorded and passed to Property Services.

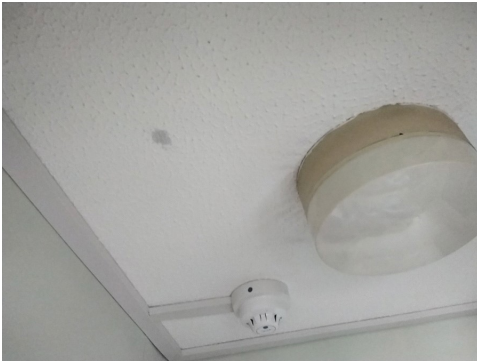
**Item 11 Ref: As SC004707**

The Ceiling Coating, Community Hall, Community Hall, Ground Floor, Cupboard Cleaners (Room G/007) contains asbestos.

Any change in its appearance should be recorded and passed to Property Services.

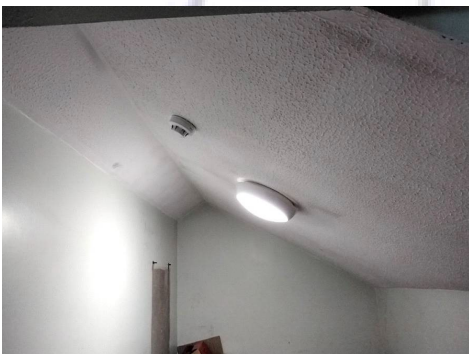
**Item 12 Ref: SC004700**

The Ceiling Coating, Community Hall, First Floor, Store Room (Room 1/001) contains asbestos.

Any change in its appearance should be recorded and passed to Property Services.

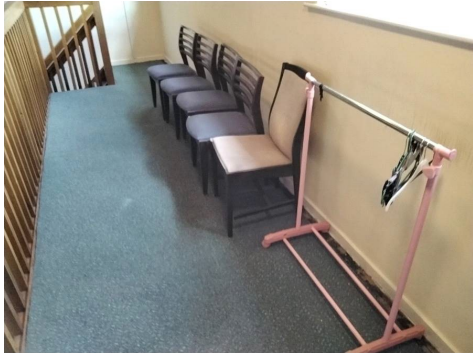
### **Item 13 Ref: SC004701**

The Floor tile with adhesive below carpet, Community Hall, First Floor, Landing (Room 1/002) contains asbestos.

Any change in its appearance should be recorded and passed to Property Services.

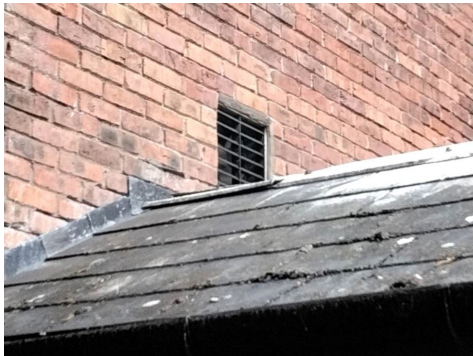
### **Item 14 Ref: SC004709**

The Roof tiles ridge tiles to canopy roof, Community Hall, External (E/001) contains asbestos.

Any change in its appearance should be recorded and passed to Property Services.

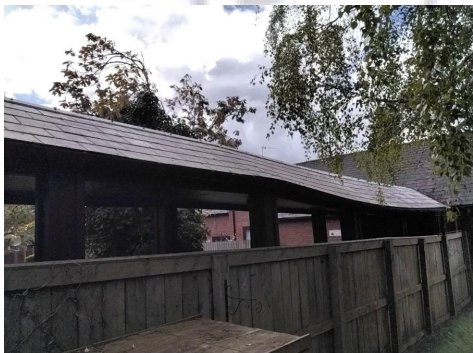
### **Item 15 Ref: SC004710**

The Roof tiles to canopy roof, Community Hall, External (E/001) contains asbestos.

Any change in its appearance should be recorded and passed to Property Services.

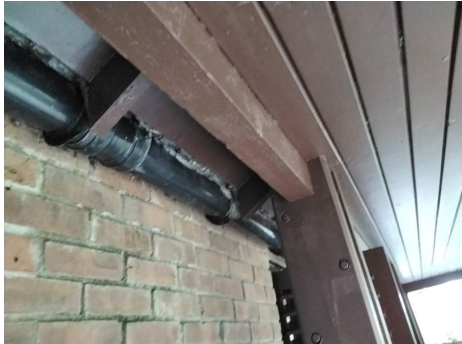
**Item 16 Ref: SC004711**

The Roof lining beyond all roof tiles, Community Hall, External (E/001) does not contain asbestos.

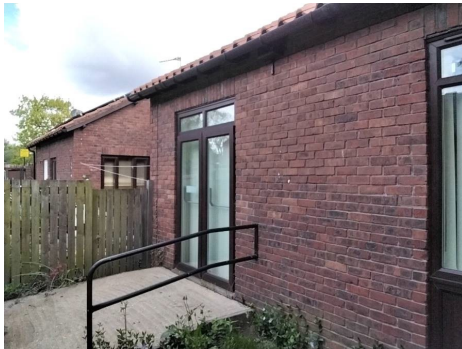
**Item 17 Ref: SC004712**

The Door seal/gasket including window. Residue from previous removal presumed to be below modern silicone seal, Community Hall, External (E/001) does not contain asbestos.

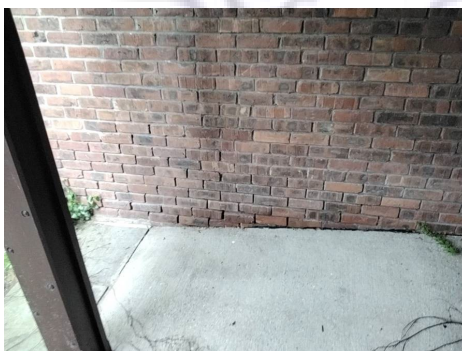
**Item 18 Ref: SC004713**

The Damp proof course, Community Hall, External (E/001) does not contain asbestos.

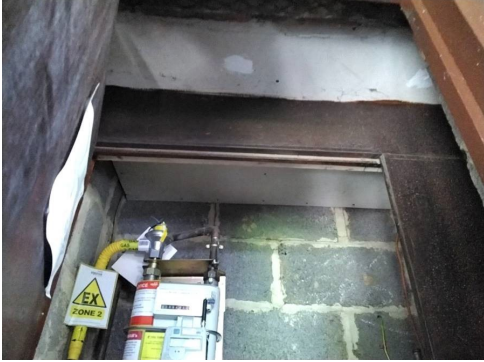
**Item 19 Ref: SC004714**

The Ceiling, Community Hall, Cupboard Services, External (E/002) does not contain asbestos.
