ASBESTOS SURVEY REPORT FOR SPRINGWELL SCHOOL, WILTSHIRE WAY, HARTLEPOOL, TS26 0TB.

Asbestos Register for Springwell School, Wiltshire Way, Hartlepool

Date: 16 July 2024

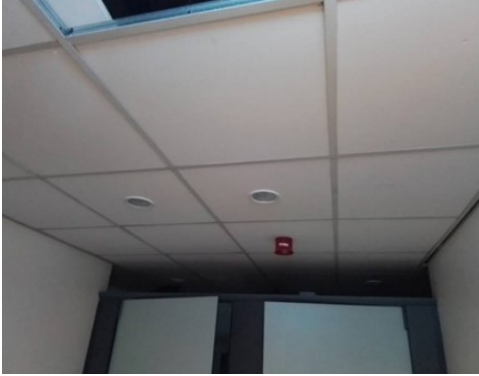
Item 1 Ref: As PZ000002

The old roof lining in the ground floor female toilets (Room 033) does not contain asbestos.

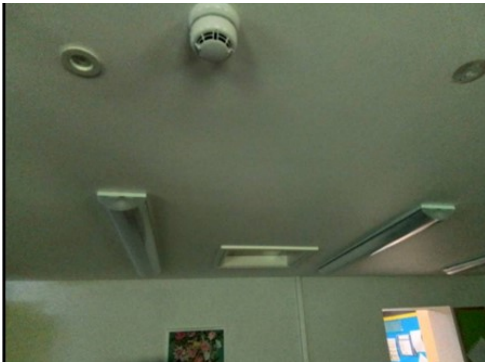
Item 2 Ref: PZ000002

The old roof lining in roof void in the loft space above the library (Room 032a) does not contain asbestos.

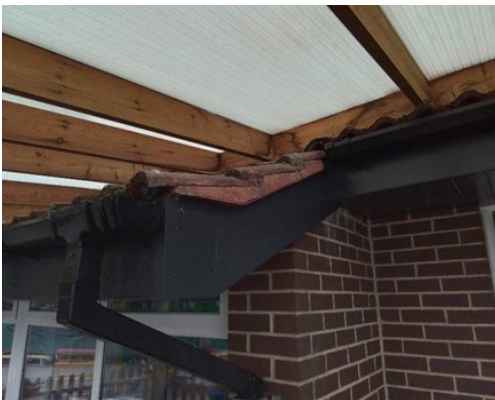
Item 3 Ref: PZ000003

The undercloak (External E1) does not contain asbestos.

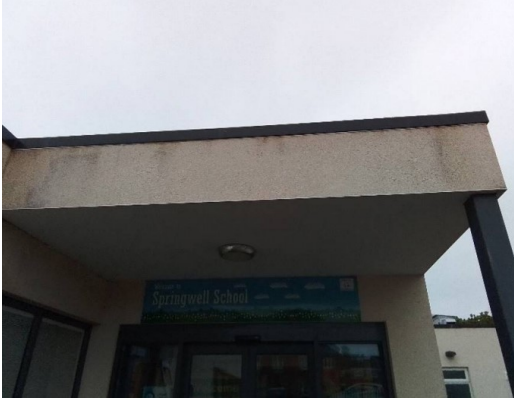
Item 4 Ref: PZ000004

The canopy ceiling (External E1) does not contain asbestos.

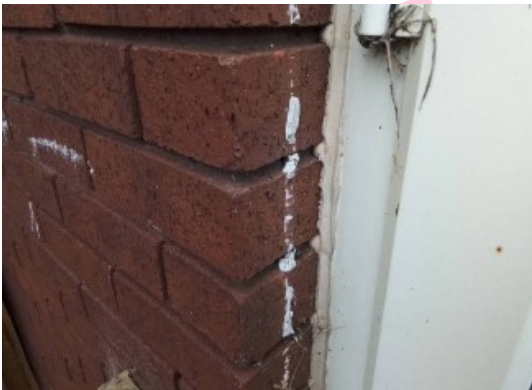
Item 5 Ref: PZ000005

3.	PZ000003	Undercloak	External E1	No Risk
4.	PZ000004	Canopy Ceiling	External E1	No Risk
5.	PZ000005	Window putty/seal old mastic around doors and windows outside rooms 058/059	External E1	Very Low Risk – To be checked on a 12 monthly basis

The window putty/seal old mastic around doors and windows and outside rooms (External E1) does contain asbestos.

Any change in its appearance should be recorded and passed to Property Services.

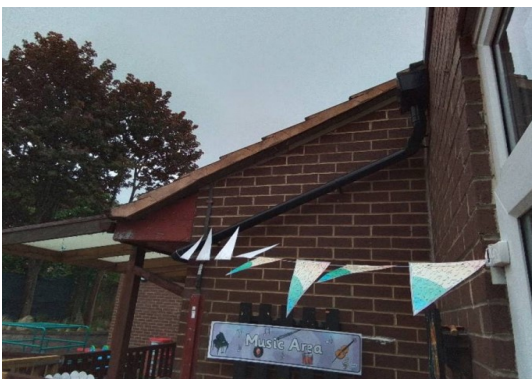
Item 6 Ref: PZ000006

The undercloak outside room 063 (External E1) does not contain asbestos.

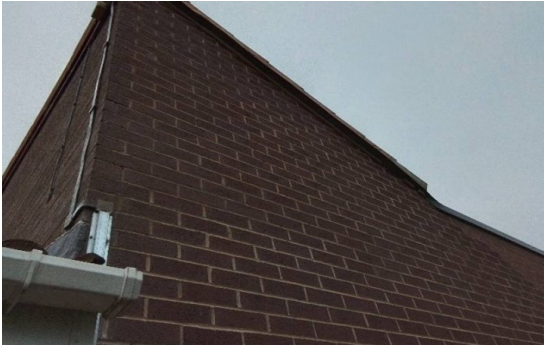
Item 7 Ref: As PZ000006

The undercloak outside room 070a (External E1) does not contain asbestos.

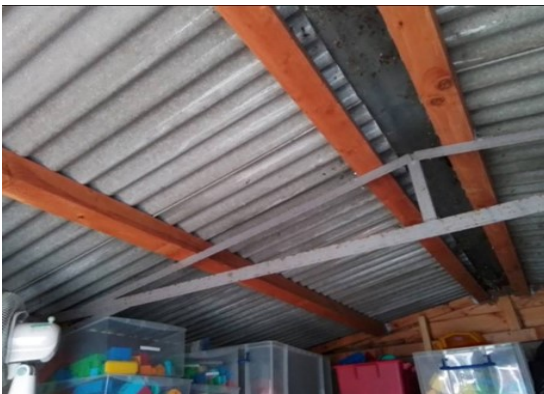
Item 8 Ref: PZ000007

The roof sheet cladding (External E2) does not contain asbestos.

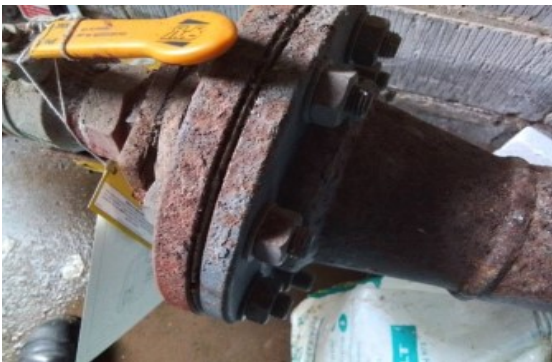
Item 9 Ref: PZ000008

9.	PZ000008	Pipework gaskets	External 089 – Meter Cupboard	Very Low Risk – To be checked on a 12 monthly basis
10.	PZ000009	Roof Lining	External 090 Garage block B	No Risk

The pipework gaskets in the meter cupboard (External 089) does contain asbestos.

Any change in its appearance should be recorded and passed to Property Services.

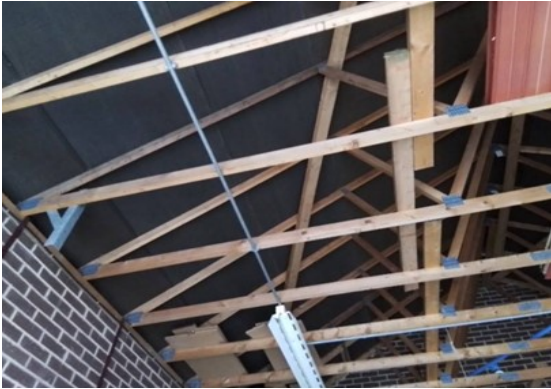
Item 10 Ref: PZ000009

The roof lining to Garage block B (external 090) does not contain asbestos.

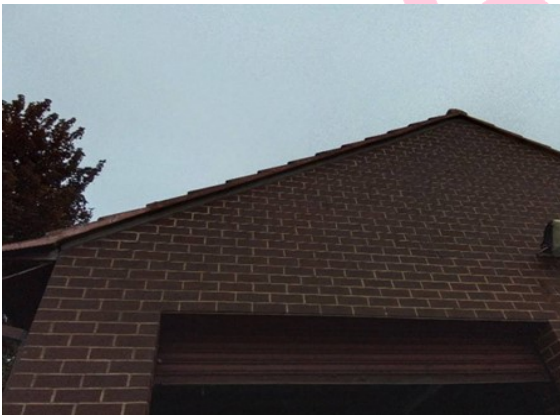
Item 11 Ref: PZ000010

The undercloak to Garage block B (external 090) does not contain asbestos.

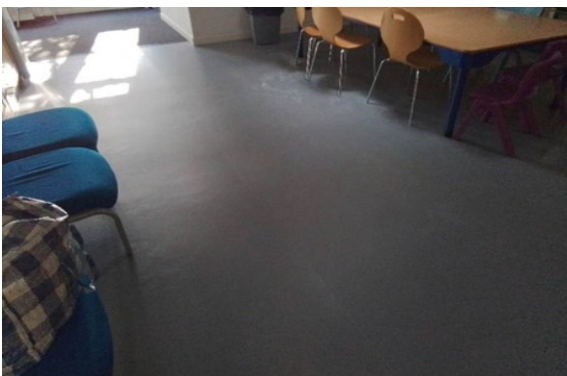
Item 12 Ref: RN000235

The floor adhesive in the Kitchen Cookery Room (G/002) does not contain asbestos.

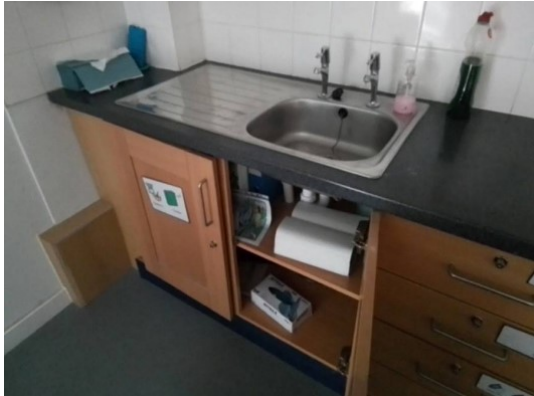
Item 13 Ref: RN000236

The under sink mat in the Kitchen Cookery Room (G/002) does not contain asbestos.

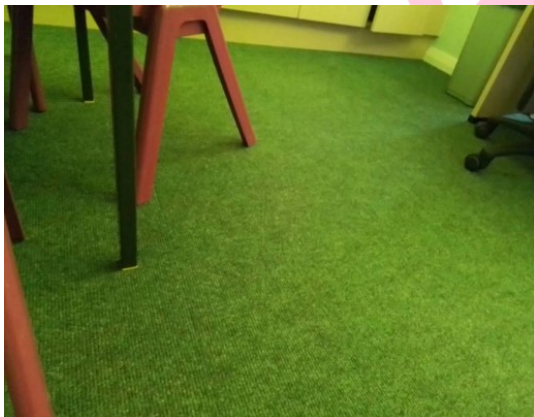
Item 14 Ref: RN000237

The floor adhesive in the Speech and language therapy room (G/003) does not contain asbestos.

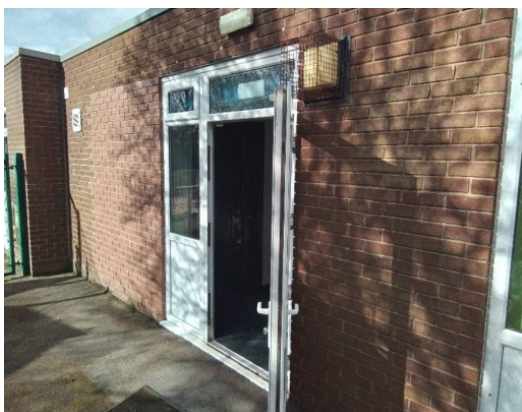
Item 15 Ref: RN000238

The door seal/gasket externally (E/001) does not contain asbestos.
