ASBESTOS SURVEY REPORT FOR SPRINGWELL SCHOOL, WILTSHIRE WAY, HARTLEPOOL, TS26 0TB.

## Asbestos Register for

**Springwell School, Wiltshire Way, Hartlepool**

**Date: 19 June 2025**

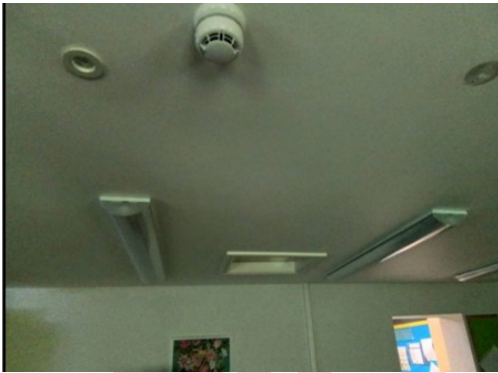
### **Item 2 Ref: PZ000002**

The old roof lining in roof void in the loft space above the library (Room 032a) does not contain asbestos.

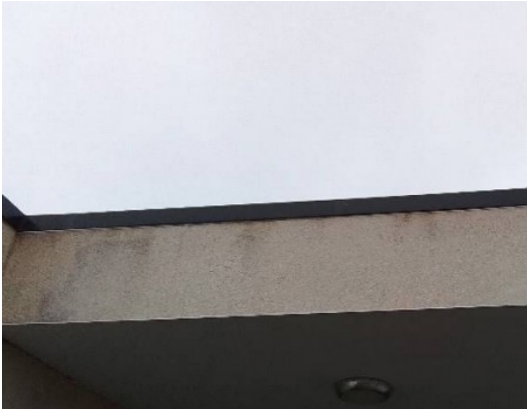
### **Item 4 Ref: PZ000004**

The canopy ceiling (External E1) does not contain asbestos.

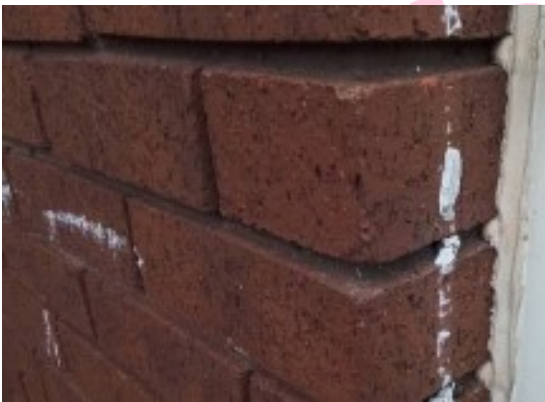
### **Item 5 Ref: PZ000005**

3.	PZ000003	Undercloak	External E1	No Risk
4.	PZ000004	Canopy Ceiling	External E1	No Risk
5.	PZ000005	Window putty/seal old mastic around doors and windows outside rooms 058/059	External E1	Very Low Risk – To be checked on a 12 monthly basis

The window putty/seal old mastic around doors and windows and outside rooms (External E1) does contain asbestos.

Any change in its appearance should be recorded and passed to Property Services.

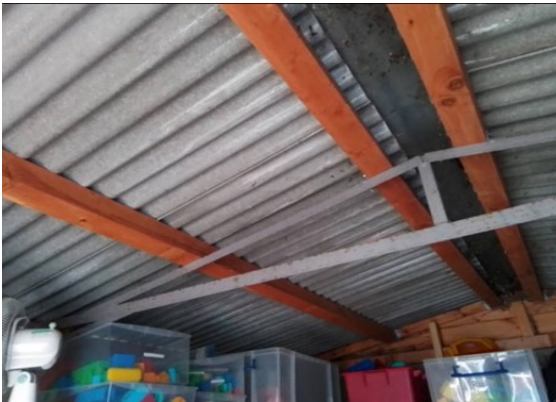
### **Item 8 Ref: PZ000007**

The roof sheet cladding (External E2) does not contain asbestos.

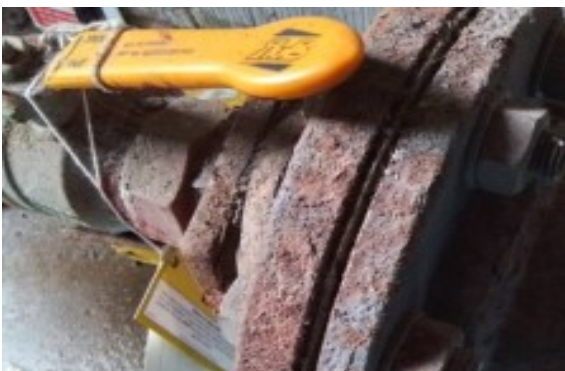
### **Item 9 Ref: PZ000008**

9.	PZ000008	Pipework gaskets	External 089 – Meter Cupboard	Very Low Risk – To be checked on a 12 monthly basis
10.	PZ000009	Roof Lining	External 090 Garage block B	No Risk

The pipework gaskets in the meter cupboard (External 089) does contain asbestos.

Any change in its appearance should be recorded and passed to Property Services.

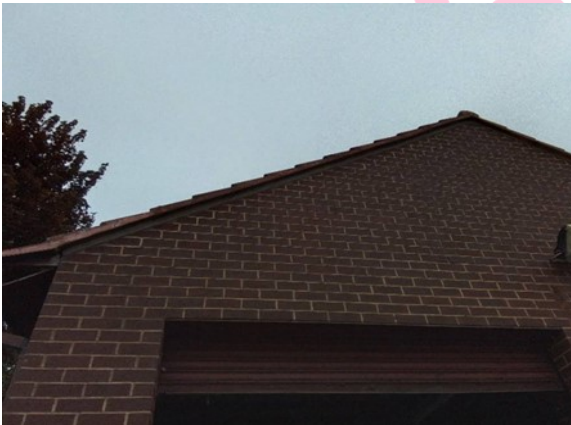
### **Item 11 Ref: PZ000010**

The undercloak to Garage block B (external 090) does not contain asbestos.

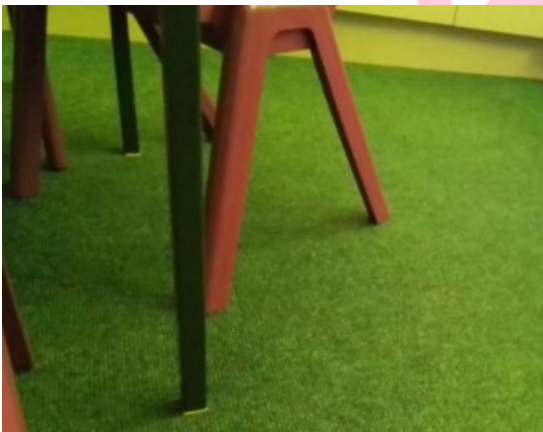
### **Item 14 Ref: RN000237**

The floor adhesive in the Speech and language therapy room (G/003) does not contain asbestos.

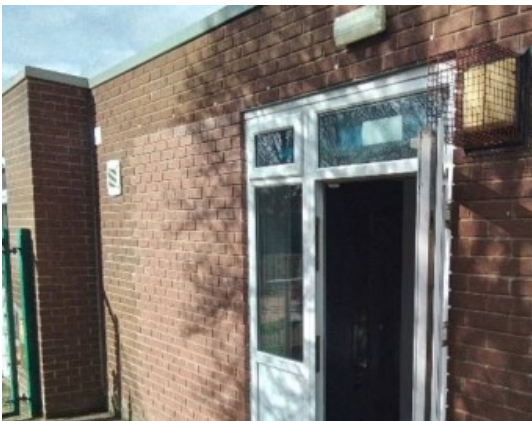
### **Item 15 Ref: RN000238**

The door seal/gasket externally (E/001) does not contain asbestos.

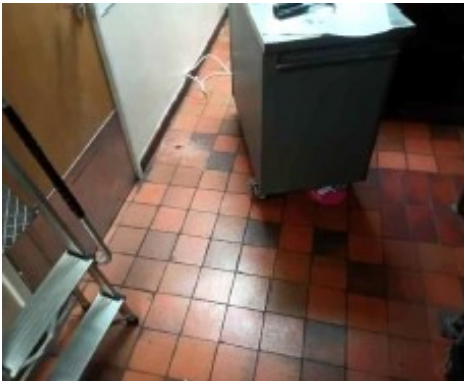
### **Item 17 Ref: TL001144**

The tile joining material to the floor in the Kitchen (G/021) does not contain asbestos.

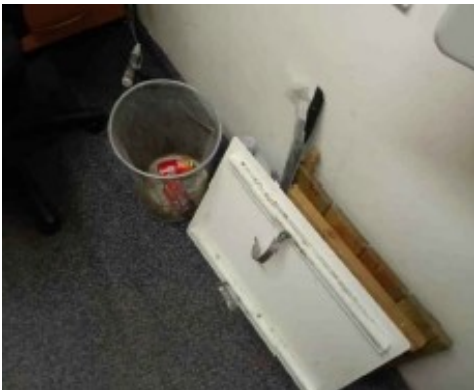
### **Item 18 Ref: TL001148**

The wall skirting in the Caretakers Room G/082) does not contain asbestos.

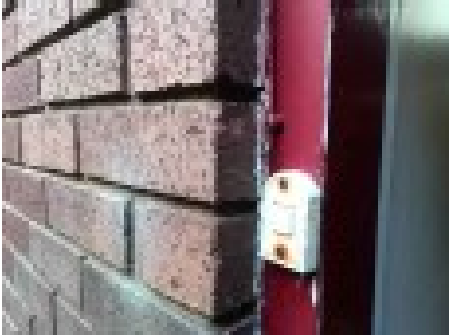
### **Item 19 Ref: TL001145**

17.	TL001144	Floor – tile joining material	Kitchen G/021	No Risk
18.	TL001148	Wall Skirting	Caretakers Room G/082	No Risk
19.	TL001145	Door - seal/Gasket door to kitchen	External E/01	Very Low Risk – To be checked on a 12 monthly basis

**The door seal/gasket door to kitchen (External E/01) does contain asbestos.**

**Any change in appearance should be reported to Property Services.**

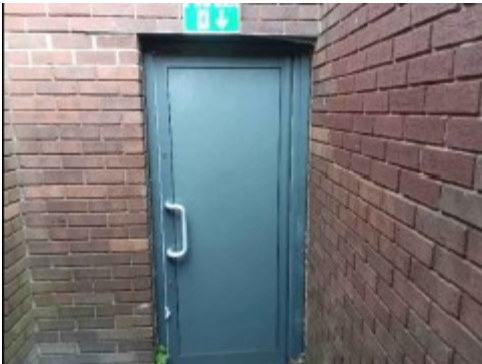
### **Item 20 Ref: TL001146**

**The wall remnants around metal door (external E/01) does not contain asbestos.**
