ASBESTOS SURVEY REPORT FOR JOPLING HOUSE, JOHN STREET,
SUNDERLAND, SR1 1DP.

Asbestos Register for Jopling House, John Street, Sunderland

UPRN: - J171340

Date: 13 February 2025

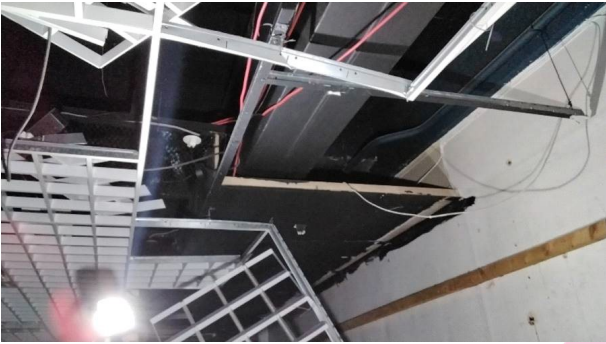
40.	As NO000267	Ductwork joints	Z-Sub level 1 Shop Floor (Room Z1/019)	Presumed to contain asbestos - Any change in its appearance should be recorded and passed to Property Services.

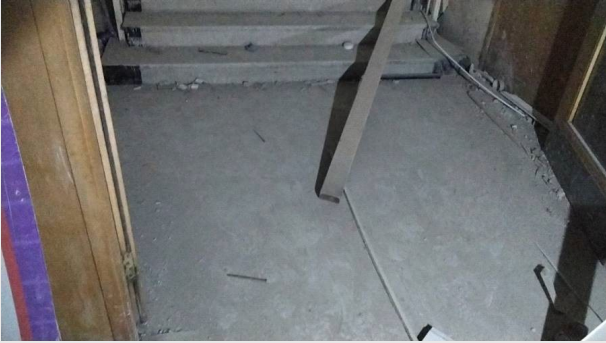
41.	As NO000251	Floor tile pink/grey	Z-Sub level 1 Staircase/Stairwell (Room Z1/020)	Does not contain asbestos.

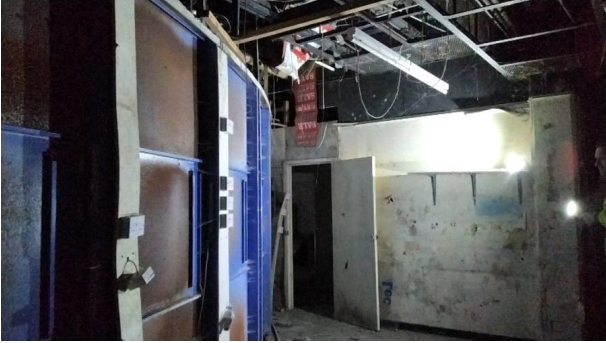
42.	As NO000273	<i>Debris/Residue to ceiling void and floor below</i>	Z-Sub level 1 Store Room (Room Z1/021)	<i>Removed Sept 2023</i>

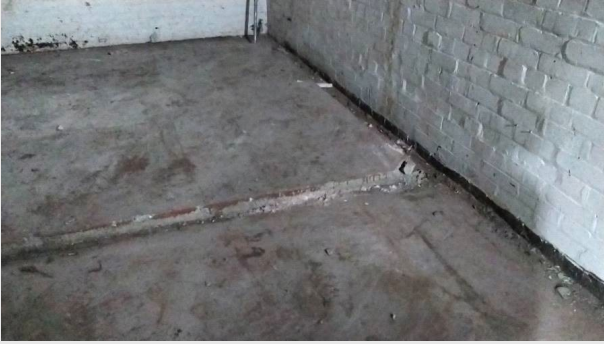
64.	NO000288	Debris/Residue to floor	Z-Sub level 1 Boiler Room (Room Z1/030)	Does not contain asbestos.

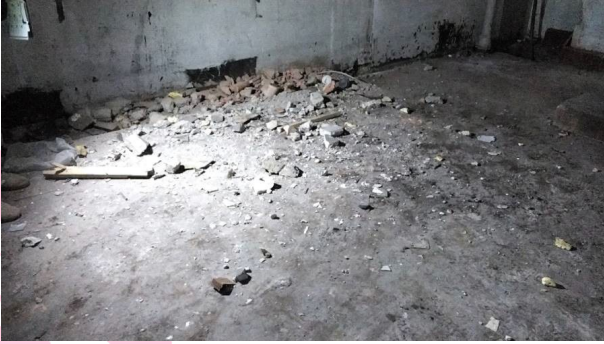
65.	NO000289	Floor tile	Z-Sub level 1 Boiler Room (Room Z1/030)	Contains asbestos - Any change in its appearance should be recorded and passed to Property Services.

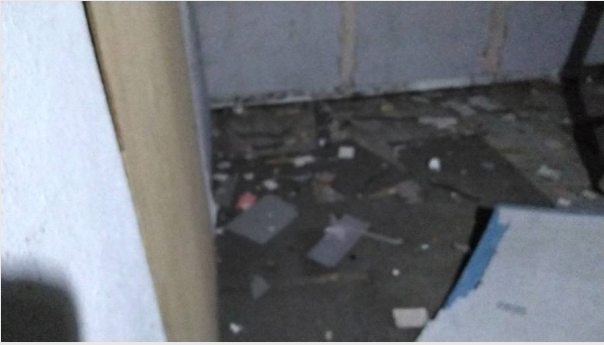
66.	As NO000268	Floor tile	Z-Sub level 1 Store Room (Room Z1/032)	Does not contain asbestos.

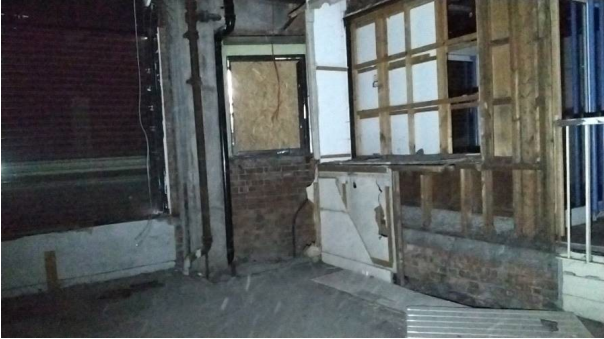
73.	NO000294	Window putty/seal adjacent main entrance damaged and in-situ	Ground Floor Shop Floor Unit 1 (Room G/001)	This item is classed as very low risk and should be inspected every 12 months

73.	NO000294	Window putty/seal adjacent main entrance damaged and in-situ	Ground Floor Shop Floor Unit 1 (Room G/001)	Contains asbestos - Any change in its appearance should be recorded and passed to Property Services.

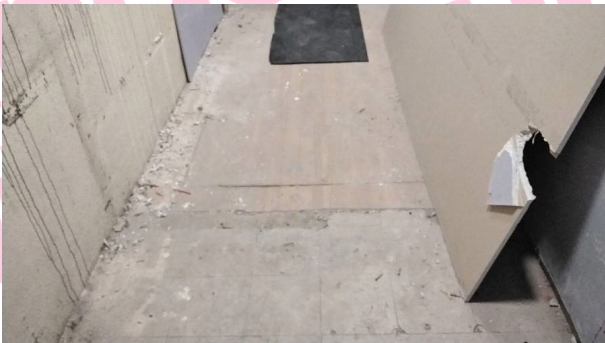
89.	As NO000303	Tile grey/beige beneath modern lino	Ground Floor Hallway/passageway Switch Room (Room G/008)	Presumed to contain asbestos - Any change in its appearance should be recorded and passed to Property Services.

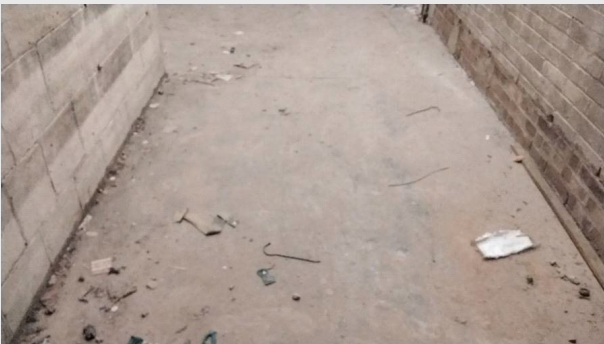
92.	NO000306	Floor jointing compound	Ground Floor Switch Room behind lifts (Room G/009)	Does not contain asbestos.

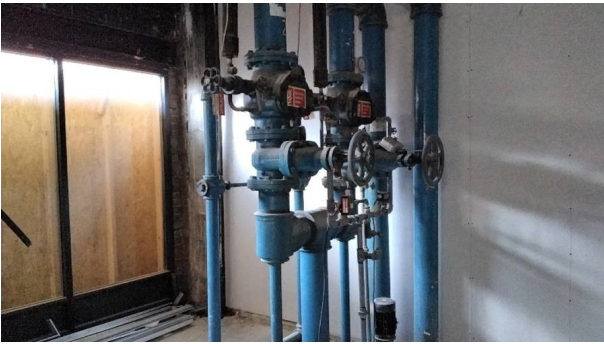
111.	Presumed	Pipework gasket too deeply recessed to sample	Ground Floor Unit 3 (café) limited inspection to ceiling (Room G/022)	Presumed to contain asbestos - Any change in its appearance should be recorded and passed to Property Services.

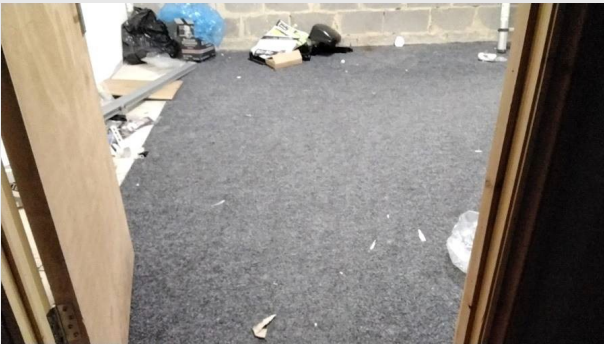
119.	As NO000307	Floor adhesive remnants	Ground Floor Hallway/passageway (Room G/027)	Does not contain asbestos.

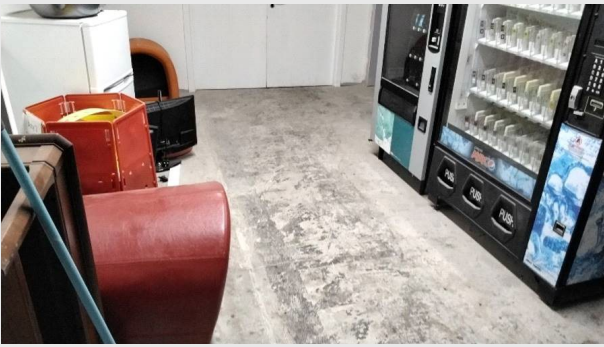
122.	As NO000307	Floor adhesive remnants	Ground Floor Bin store (Room G/031)	Does not contain asbestos.

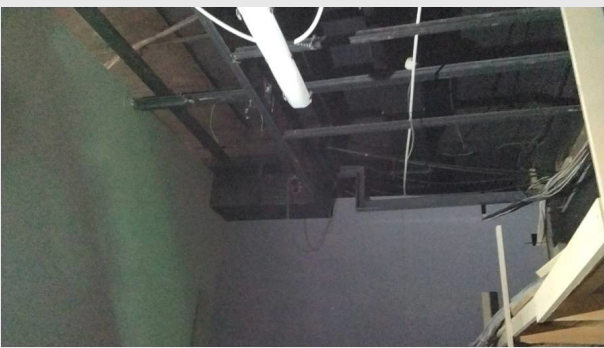
123.	As NO000315	Ceiling tiles	Ground Floor Store Room (Room G/032)	Does not contain asbestos.

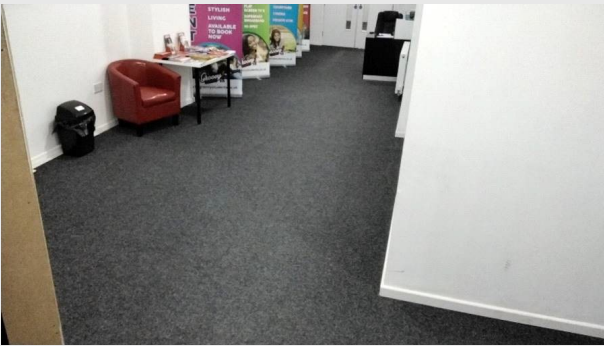
127.	As NO000307	Floor adhesive remnants	Ground Floor Entrance Hall/Foyer/Lobby (Room G/037)	Does not contain asbestos.

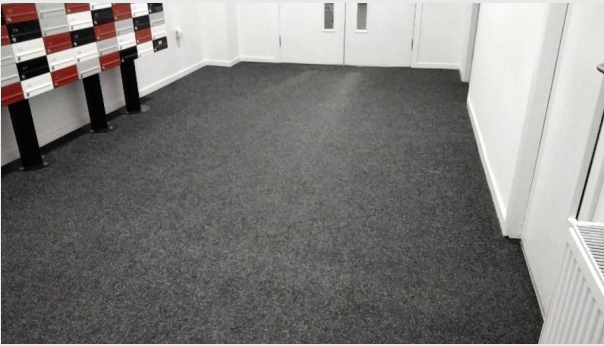
128.	As NO000307	Floor adhesive remnants	Ground Floor Hallway/Passageway (Room G/038)	Does not contain asbestos.

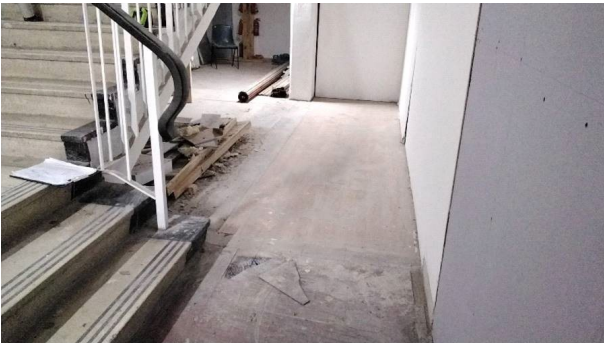
129.	NO000317	Floor tile to former shop floor and understairs area	Ground Floor Staircase/Stairwell (Room G/039)	Contains asbestos - Any change in its appearance should be recorded and passed to Property Services.

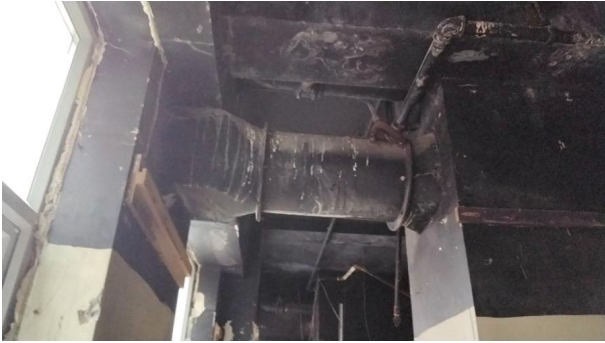
150.	NO000329	Ductwork	Second Floor Store Room Former toilets (Room 2/019)	Contains asbestos - Any change in its appearance should be recorded and passed to Property Services.

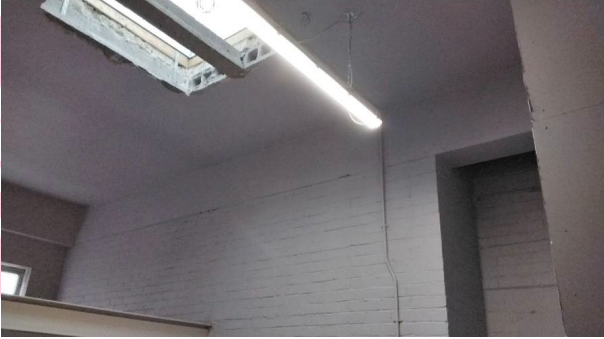
158.	As NO000335	Beam cladding suspected continuation from electric cupboard	Fourth Floor Landing (Room 4/001)	Presumed to contain asbestos - Any change in its appearance should be recorded and passed to Property Services.

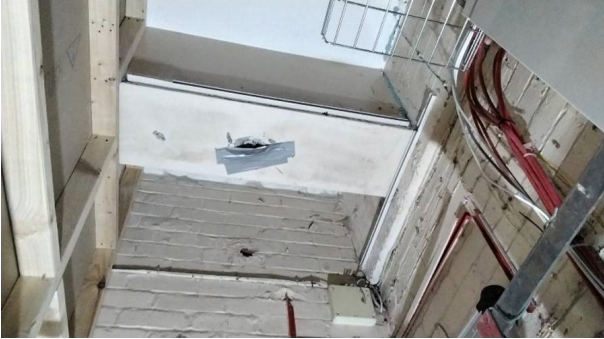
159.	As NO000335	Beam cladding beneath skim, sampled via pre-existing damage to skim	Fourth Floor Electric cupboard (Room 4/002)	Presumed to contain asbestos - Any change in its appearance should be recorded and passed to Property Services.

159.	As NO000335	Beam cladding beneath skim, sampled via pre- existing damage to skim	Fourth Floor Electric cupboard (Room 4/002)	This item should be removed by a licensed contractor asap

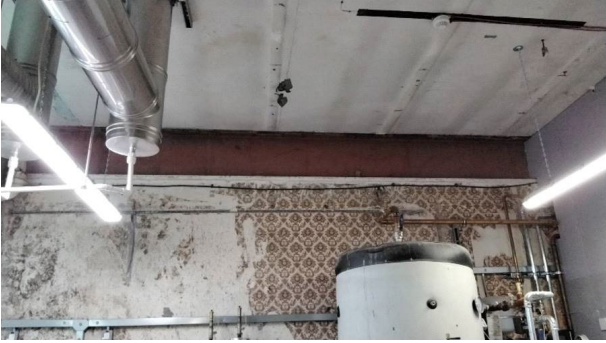
163.	As NO000336	<i>Beam cladding remnants beneath girder</i>	<i>Fourth Floor Plant Room (Room 4/007)</i>	<i>Removed Sept 2023</i>

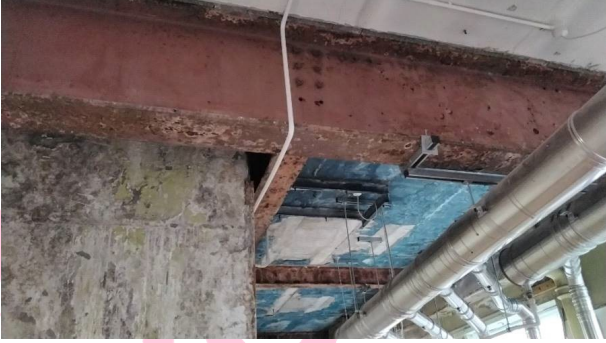
164.	As NO000337	<i>Debris/Residue to steel girder</i>	<i>Fourth Floor Plant Room (Room 4/007)</i>	<i>Removed Sept 2023</i>

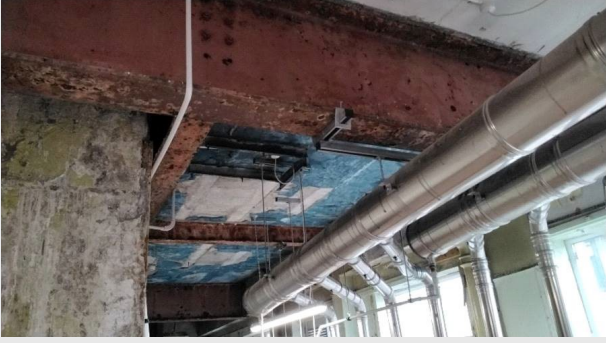
165.	As NO000338	Debris/Residue	Fourth Floor Plant Room (Room 4/007)	Does not contain asbestos.

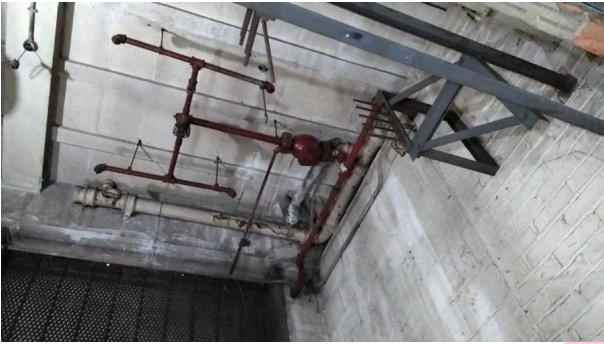
172.	Presumed	Pipework gaskets to sprinkler system	Mezzanine Switch Room midway between basement and ground floor	Presumed to contain asbestos - Any change in its appearance should be recorded and passed to Property Services.

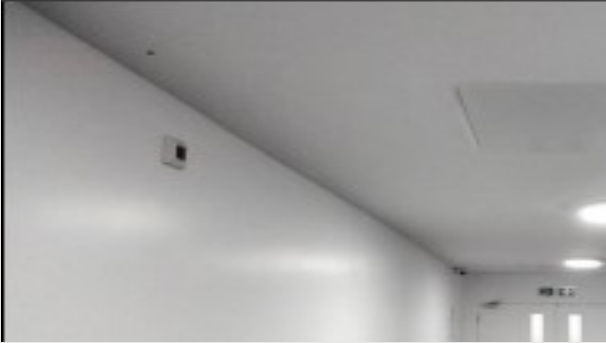
178.	As NG001616	Ceiling	First Floor, Entrance Hall/Foyer/Lobby Main lift lobby (Room 1/001)	Does not contain asbestos.

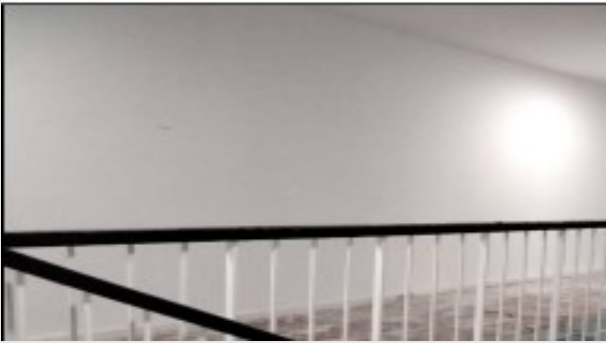
180.	As NG001602	Wall panel	Staircase/Stairwell (Room 1/003)	Does not contain asbestos.

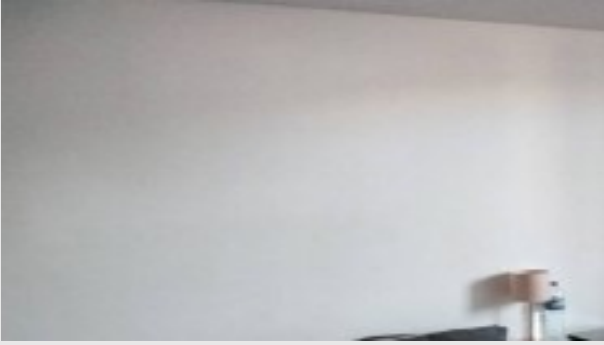
187.	As NG001596	Wall panel	Bedroom 214 (Room 1/007)	Does not contain asbestos.

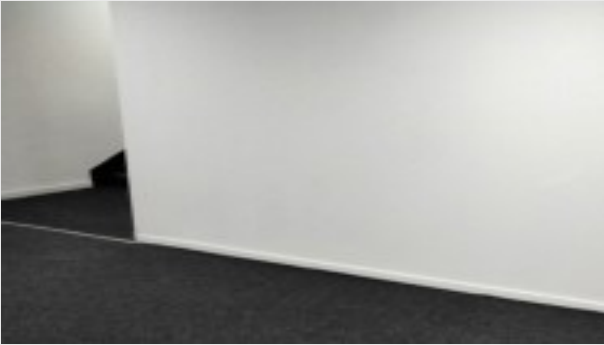
188.	NG001600	Wall panel	Entrance Hall/Foyer/Lobby Lift lobby east (Room 2/001)	Does not contain asbestos.

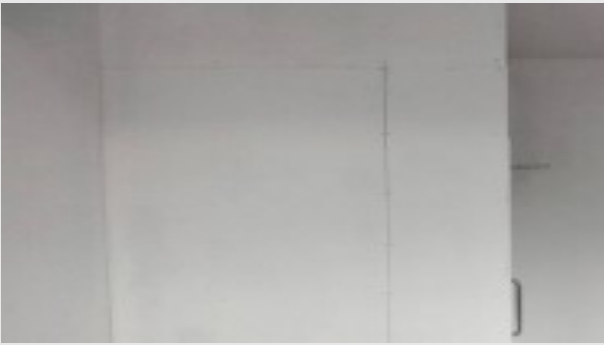
189.	NG001602	Wall panel	Staircase/Stairwell North fire exit (Room 2/002)	Does not contain asbestos.

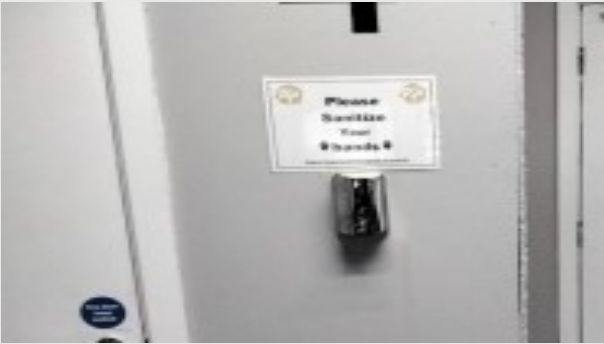
216.	NG001589	Wall panel	Entrance Hall/Foyer/Lobby (Room 4/001)	Does not contain asbestos.

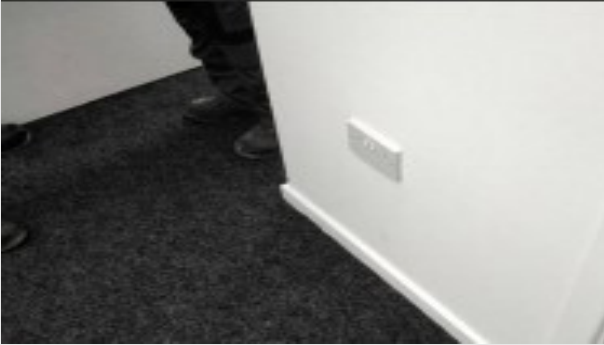
218.	NG001591	Wall panel	Bedroom 405 (Room 4/003)	Does not contain asbestos.

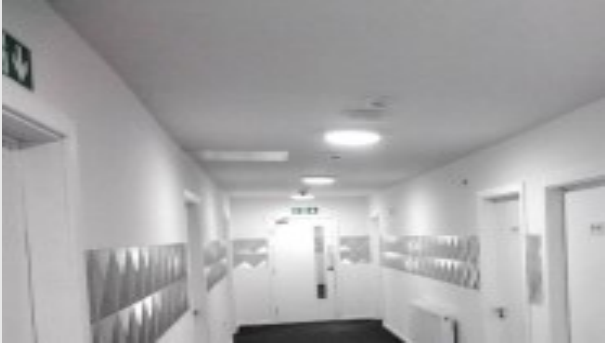
221.	NG001615	Ceiling	Corridor (Room 4/006)	Does not contain asbestos.

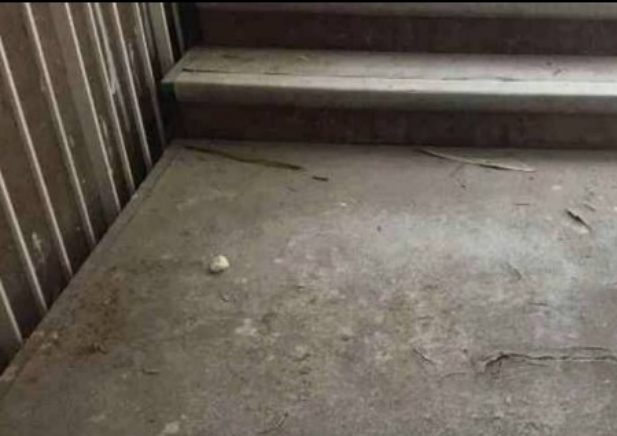
222.	AW005669	Floor covering	Rear Stairwell adjacent Room 301 (Room 2/001)	Does not contain asbestos.

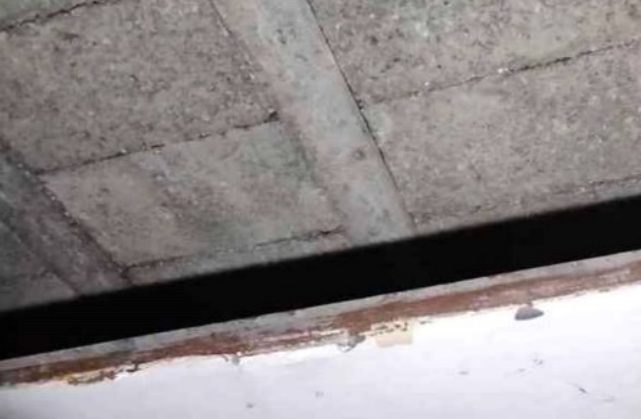
223.	AW005670	Ceiling void residue to redundant radiator	Corridor adjacent Room 214 (Room 2/002)	Does not contain asbestos.

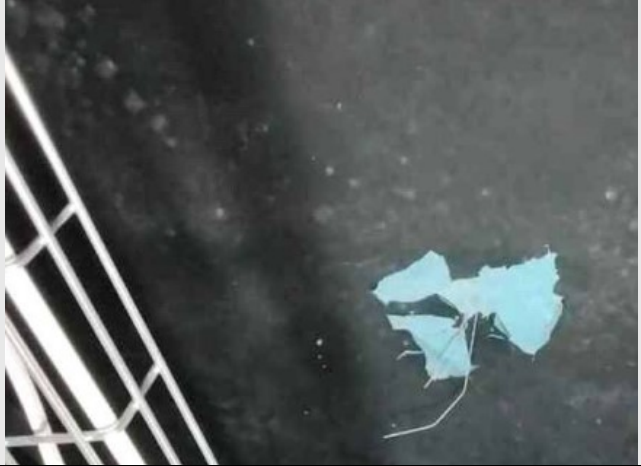
224.	AW005671	Ceiling void paint coating to ceiling	Corridor adjacent room 316 (Room 3/001)	Does not contain asbestos.

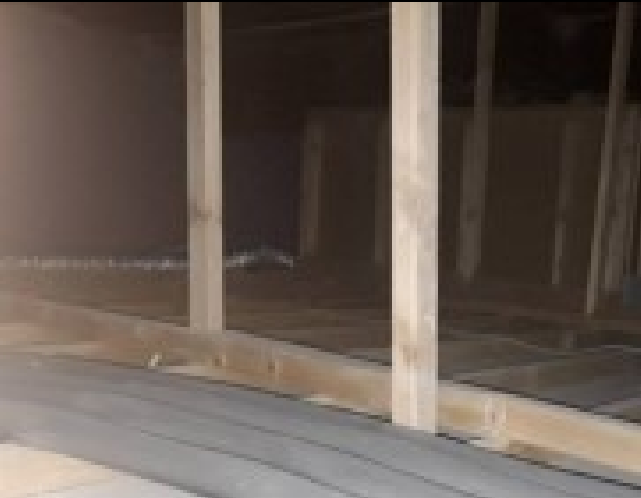
225.	NZ001414	Debris/Residue to ceiling floor below	Loft space within lift lobby (Room 1/001)	Does not contain asbestos.

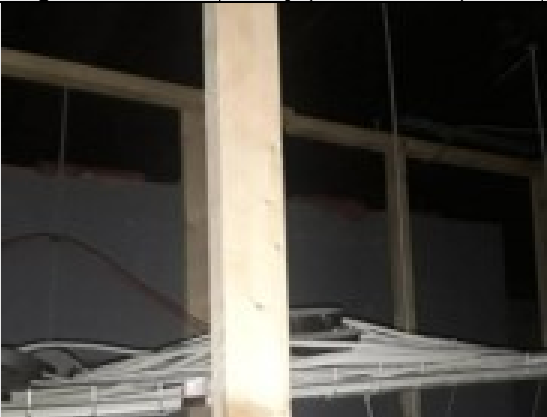
226.	As NZ001414	Debris/Residue to ceiling floor below	Loft space within crazy lobby (Room 1/002)	Does not contain asbestos.

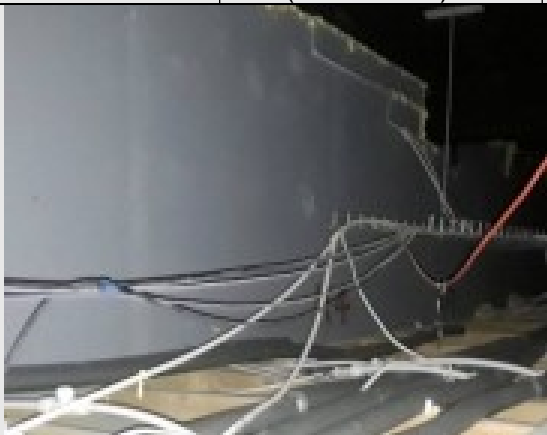
229.	NZ001416	Debris/Residue to ceiling floor below	Loft space within corridors to flats 112-119 (Room 1/005)	Does not contain asbestos.

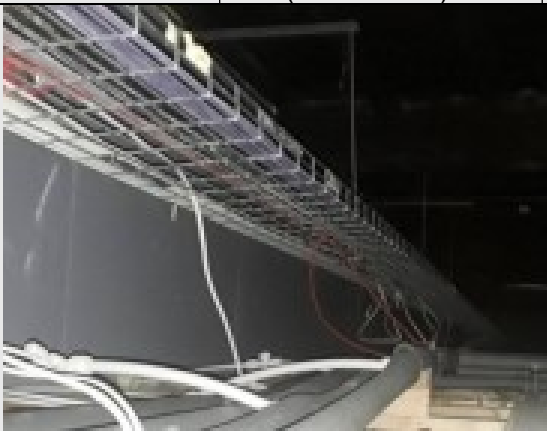
230.	As NZ001416	Debris/Residue to ceiling floor below	Loft space within corridors to flats 120-125 (Room 1/006)	Does not contain asbestos.

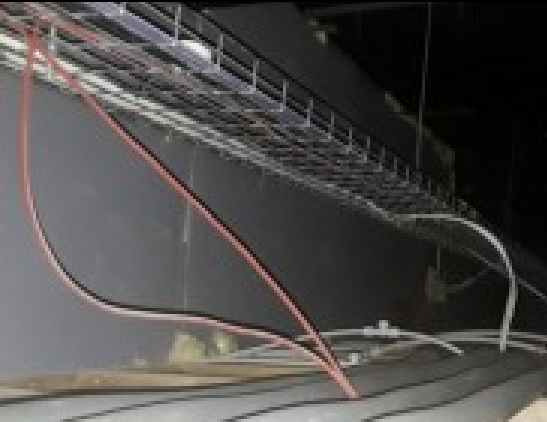
231.	NZ001417	Debris/Residue to ceiling floor below	Loft space within corridors to flats 126-130 (Room 1/007)	Does not contain asbestos.

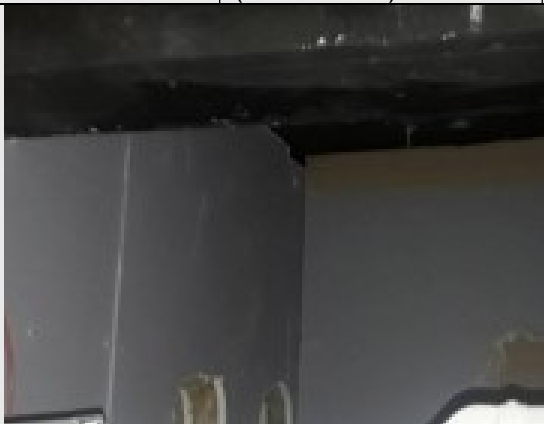
232.	As NZ001417	Debris/Residue to ceiling floor below	Loft space within corridor adjacent flat 130 (Room 1/008)	Does not contain asbestos.

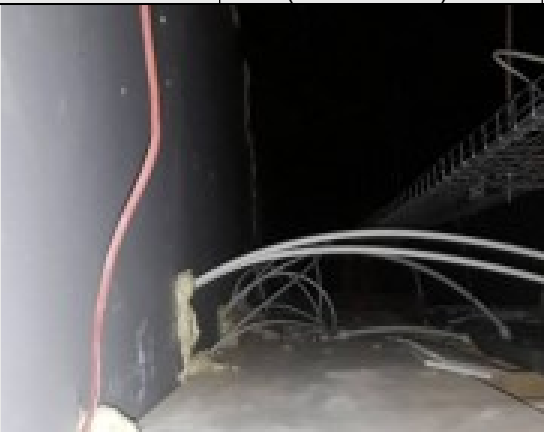
233.	NZ001418	Debris/Residue to ceiling floor below	Loft space within corridors to flats 101- 103 (Room 1/009)	Does not contain asbestos.

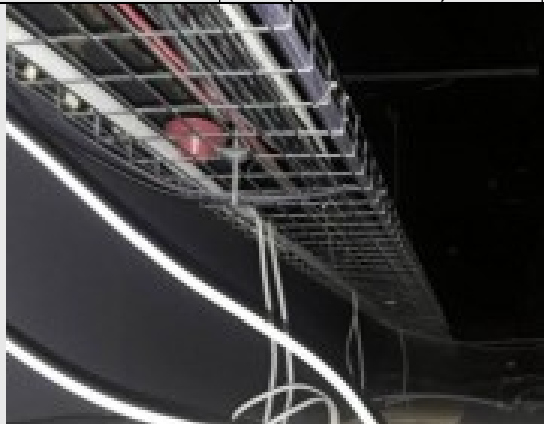
234.	As NZ001418	Debris/Residue to ceiling floor below	Loft space within corridors to flats 104- 105 (Room 1/010)	Does not contain asbestos.

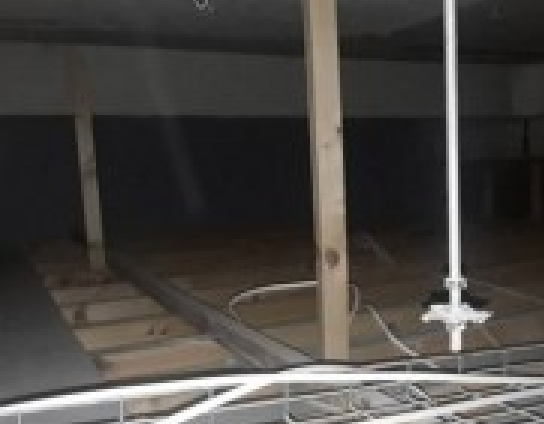
235.	NZ001408	Debris/Residue to ceiling floor below	Loft space within lift lobby (Room 2/001)	Does not contain asbestos.

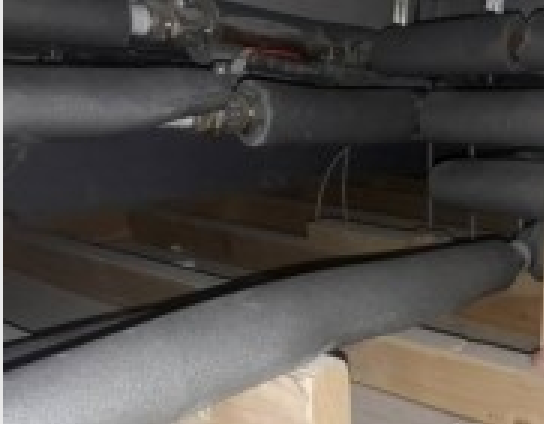
236.	As NZ001408	Debris/Residue to ceiling floor below	Loft space within gaming room lobby (Room 2/002)	Does not contain asbestos.

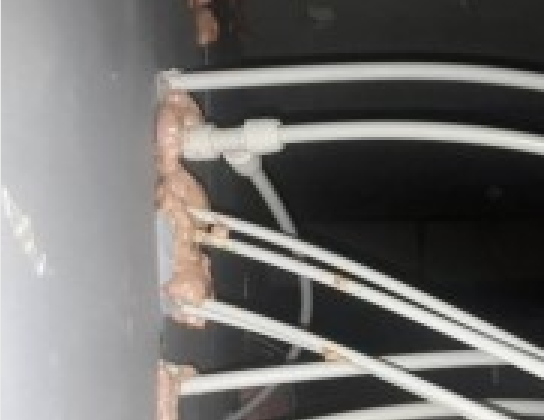
237.	NZ001409	Debris/Residue to ceiling floor below	Loft space within corridor to flats 207-208 (Room 2/003)	Does not contain asbestos.

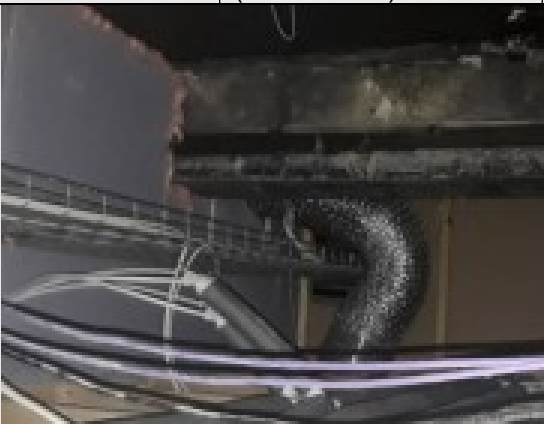
238.	As NZ001409	Debris/Residue to ceiling floor below	Loft space within corridor to flats 209-211 (Room 2/004)	Does not contain asbestos.

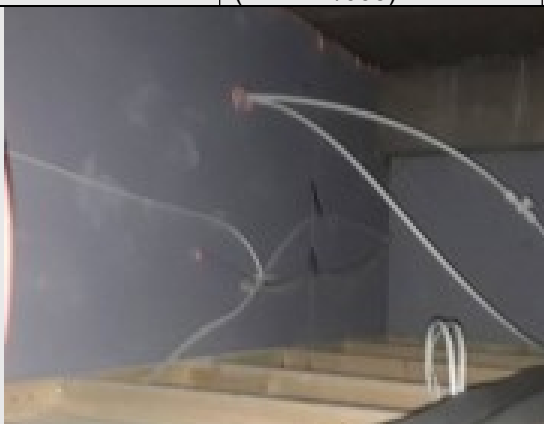
239.	NZ001410	Debris/Residue to ceiling floor below	Loft space within corridor adjacent flat 210 (Room 2/005)	Does not contain asbestos.

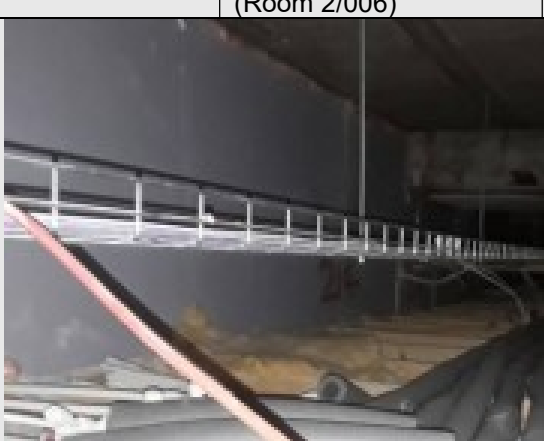
240.	As NZ001410	Debris/Residue to ceiling floor below	Loft space within corridor to flats 212-219 (Room 2/006)	Does not contain asbestos.

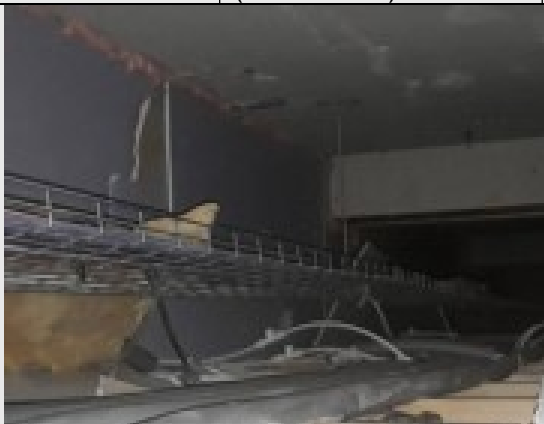
241.	NZ001411	Debris/Residue to ceiling floor below	Loft space within corridor to flats 220-225 (Room 2/007)	Does not contain asbestos.

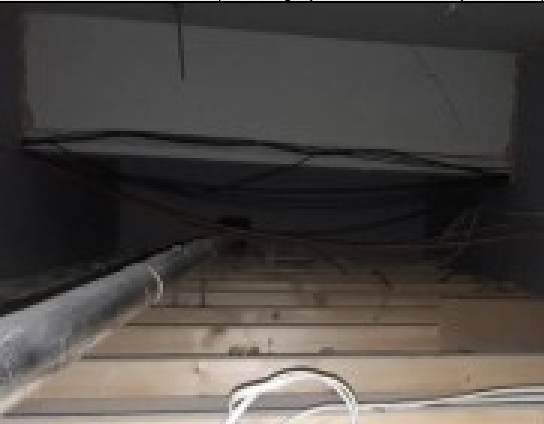
242.	As NZ001411	Debris/Residue to ceiling floor below	Loft space within corridor adjacent lift lobby (Room 2/008)	Does not contain asbestos.

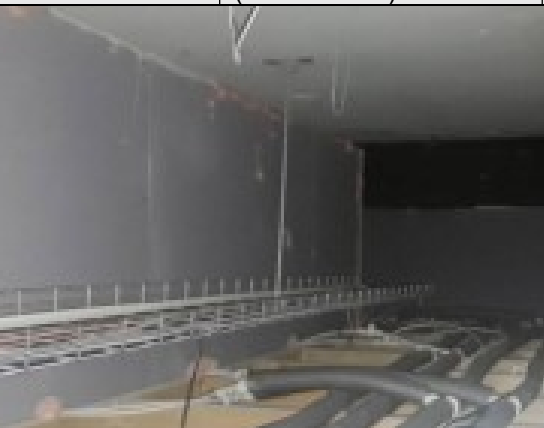
243.	NZ001412	Debris/Residue to ceiling floor below	Loft space within corridor to flats 226-230 (Room 2/009)	Does not contain asbestos.

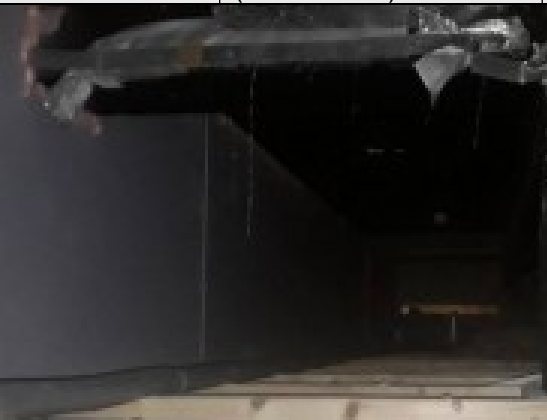
244.	As NZ001412	Debris/Residue to ceiling floor below	Loft space within corridor adjacent flat 230 (Room 2/010)	Does not contain asbestos.

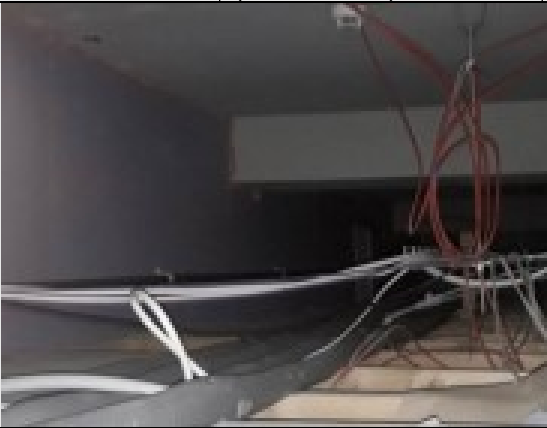
245.	NZ001413	Debris/Residue to ceiling floor below	Loft space within corridor to flats 201-203 (Room 2/011)	Does not contain asbestos.

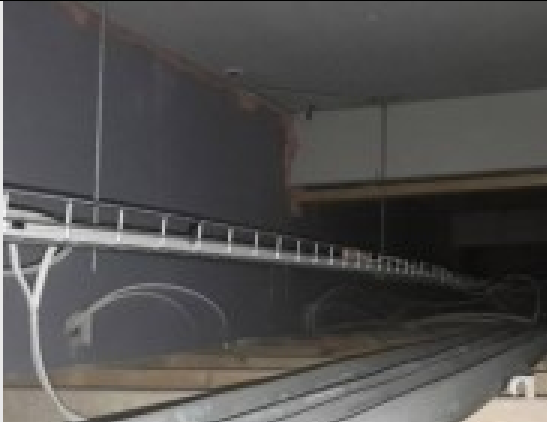
246.	As NZ001413	Debris/Residue to ceiling floor below	Loft space within corridor to flats 204-205 (Room 2/012)	Does not contain asbestos.

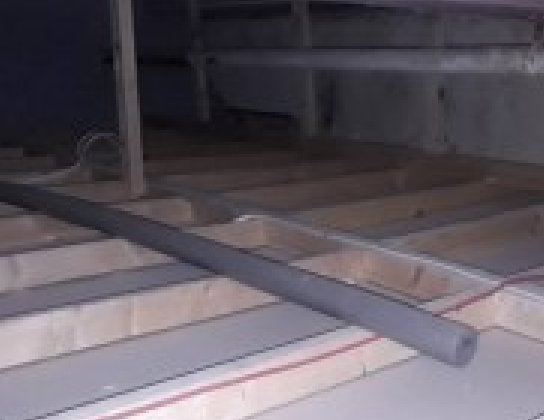
247.	NZ001403	Debris/Residue to ceiling floor below	Loft space within lobby (Room 3/001)	Does not contain asbestos.

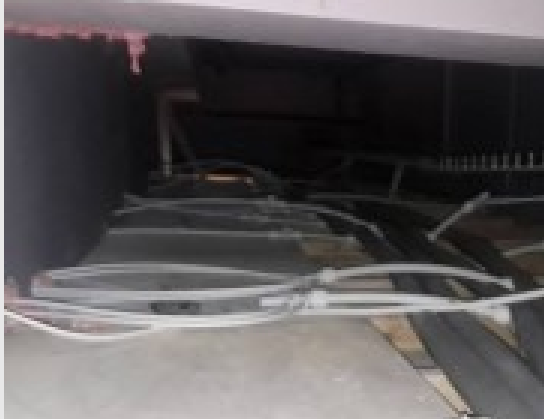
249.	NZ001404	Debris/Residue to ceiling floor below	Loft space within corridor to flats 306-311 (Room 3/003)	Does not contain asbestos.

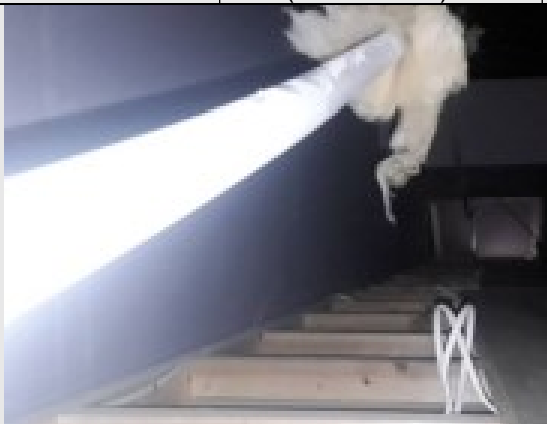
250.	As NZ001404	Debris/Residue to ceiling floor below	Loft space within corridor adjacent Flat 311 (Room 3/004)	Does not contain asbestos.

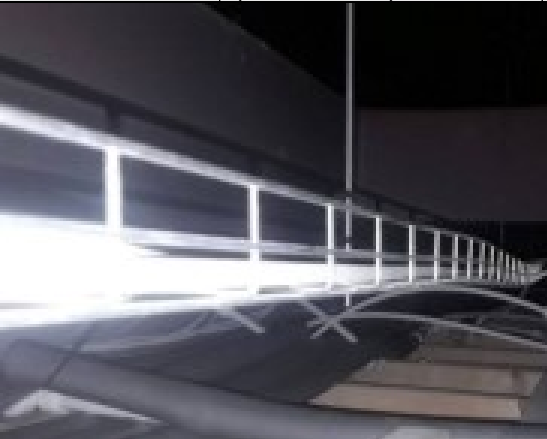
251.	NZ001405	Debris/Residue to ceiling floor below	Loft space within corridor to flats 312-319 (Room 3/005)	Does not contain asbestos.

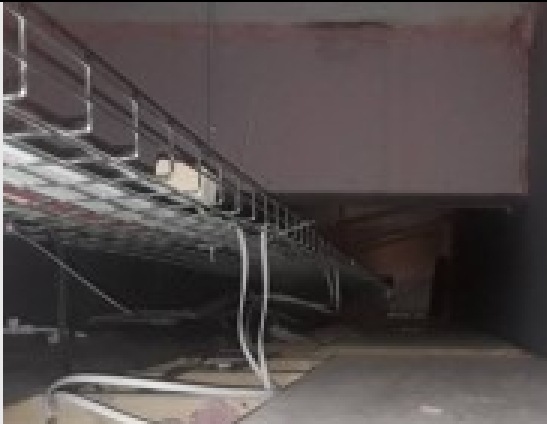
252.	As NZ001405	Debris/Residue to ceiling floor below	Loft space within corridor to flats 320-325 (Room 3/006)	Does not contain asbestos.

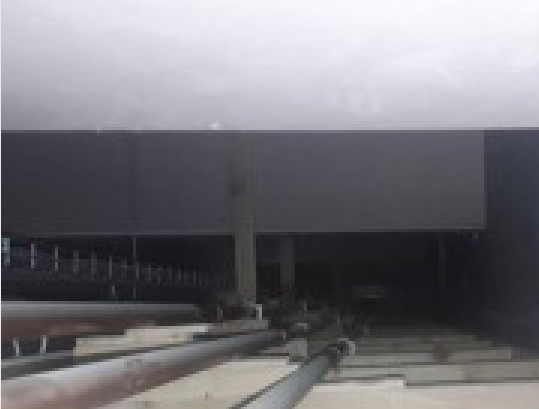
253.	As NZ001404	Debris/Residue to ceiling floor below	Loft space within corridor adjacent Flat 321 (Room 3/007)	Does not contain asbestos.

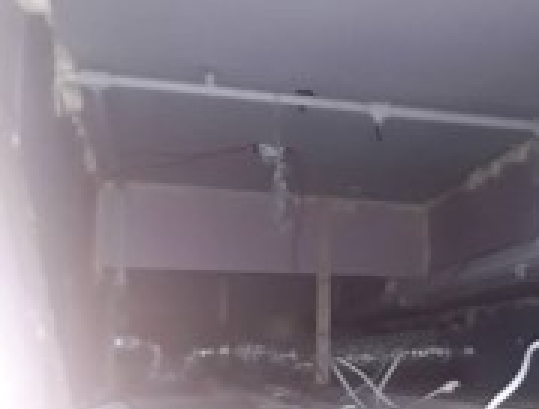
254.	NZ001406	Debris/Residue to ceiling floor below	Loft space within corridor to flats 326-330 (Room 3/008)	Does not contain asbestos.

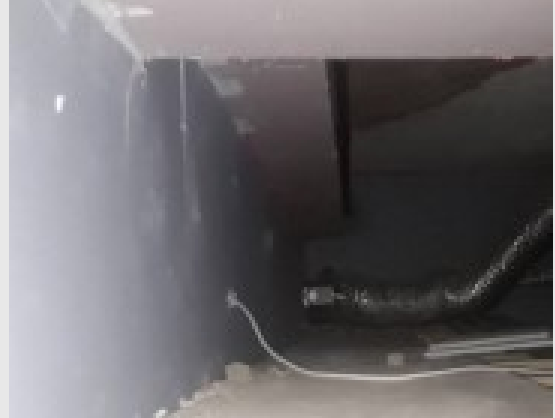
257.	As NZ001407	Debris/Residue to ceiling floor below	Loft space within corridor to flats 301-304 (Room 3/011)	Does not contain asbestos.

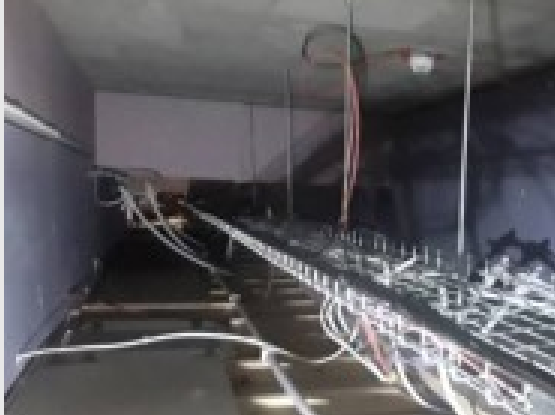
258.	NZ001401	Debris/Residue to ceiling floor below	Loft space within corridor to flats 413-414 (Room 4/001)	Does not contain asbestos.

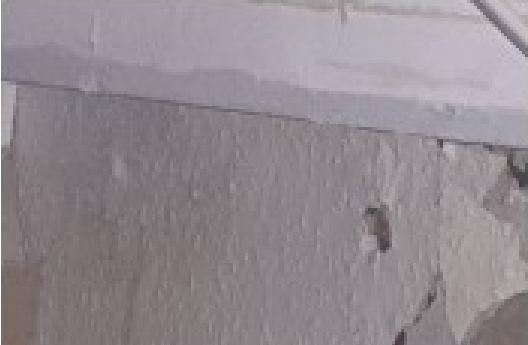
262.	EV005969	Textured coated wall & debris to ceiling loft space where the wall had been damaged to ducting installation	Loft space/Ceiling void (R/01)	Does not contain asbestos.
