ASBESTOS SURVEY REPORT FOR 24 CHISWICK SQUARE, SUNDERLAND

Asbestos Register for

24 CHISWICK SQUARE, SUNDERLAND

Date: 17 September 2024

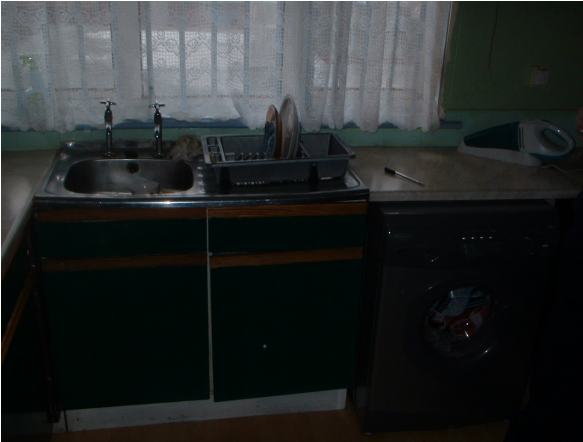
Item 2 - Ref: Sample 02

The sink pad to the kitchen does not contain asbestos.

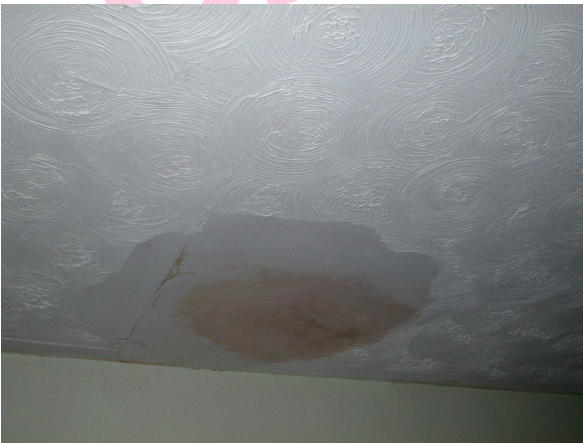
Item 3 - Ref: Sample 03

The textured coating to the ceiling in the kitchen does not contain asbestos.

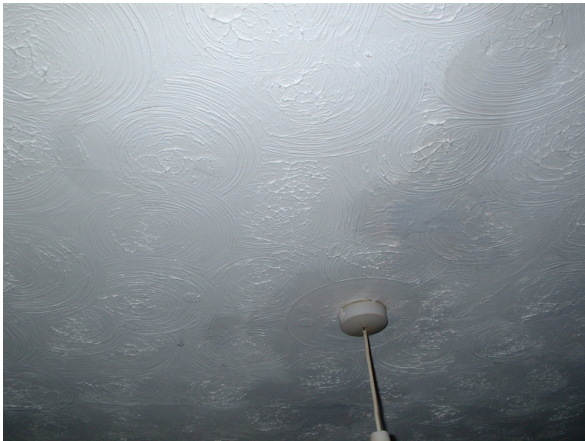
Item 5 - Ref: Sample 05

The textured coating to the ceiling in the bedroom does not contain asbestos.

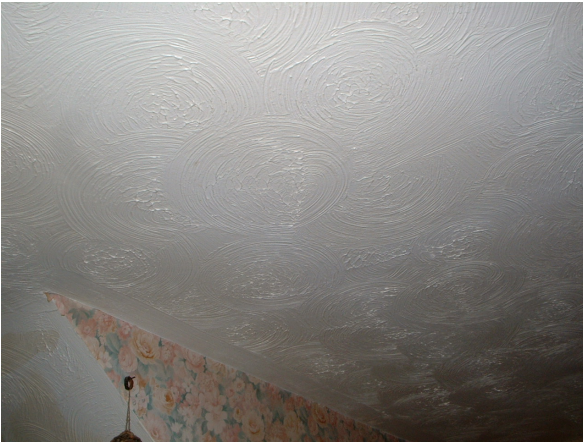
Item 7 - Ref: Sample 07

The textured coating to the ceiling in the bedroom does not contain asbestos.

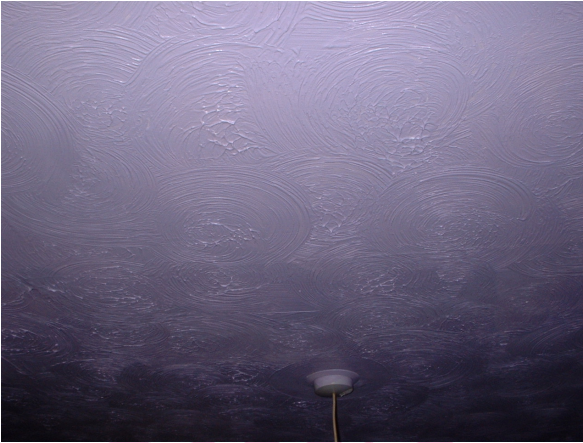
Item 8 - Ref: Sample 08

The textured coating to the ceiling in the bedroom does not contain asbestos.

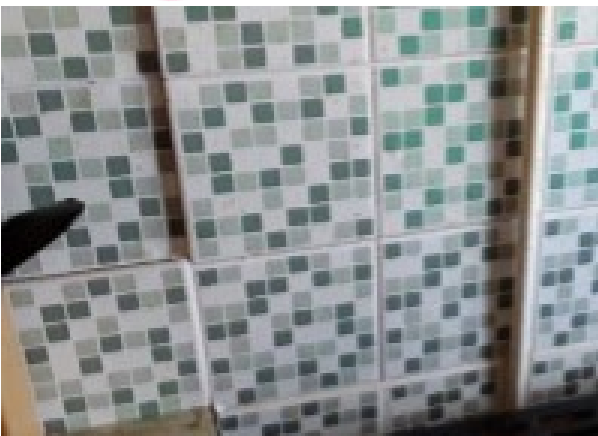
Item 9 - Ref: 20-27625-2

The ceramic tile adhesive in the kitchen does not contain asbestos.

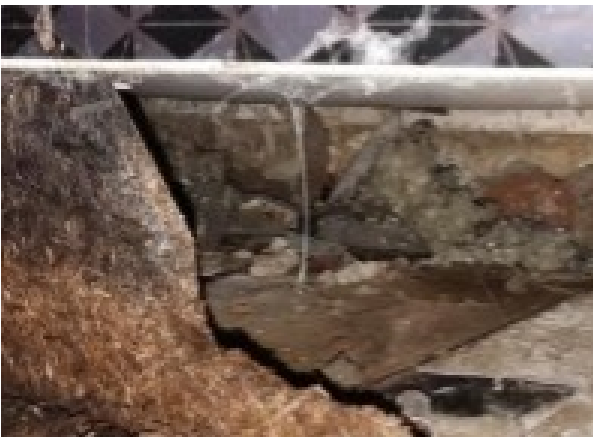
Item 11 - Ref: 20-27625-4

The debris under the sink unit does contain asbestos.

Noted as removed on reinspection survey 2024

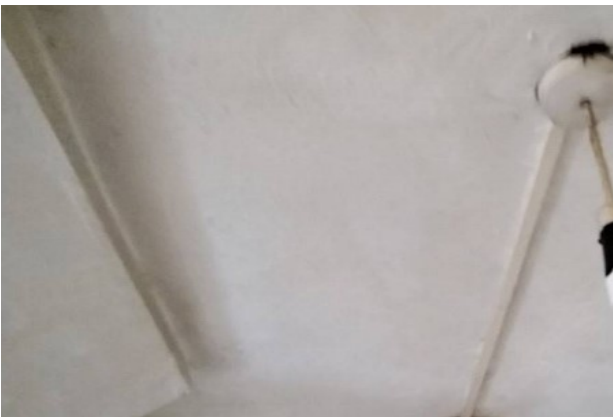
Item 12 - Ref: SC004898

The Textured coating to ceiling (Landing Rm 2/001) does not contain asbestos.

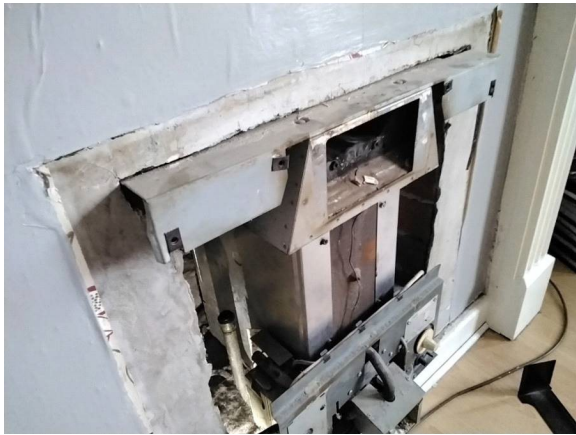
Item 16 - Ref: SC004976

The paper/card product debris (Living Rm/Lounge Rm 1/001) does not contain asbestos.

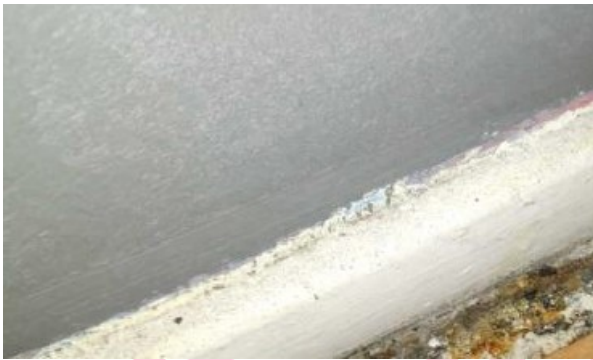
Item 17 - Ref: 23-62130-1

The floor adhesive below modern vinyl tiles in the Entrance Hall (Area 1) does contain asbestos.

Item 17	Floor adhesive below modern vinyl tiles (Entrance Hall Area 1)	Low Risk	6 monthly	21/12/2025
Item 18	Floor adhesive below modern vinyl flooring (Hall and Stairs Area 2)	Low Risk	6 monthly	21/12/2025

Any change in appearance should be reported to Property Services.

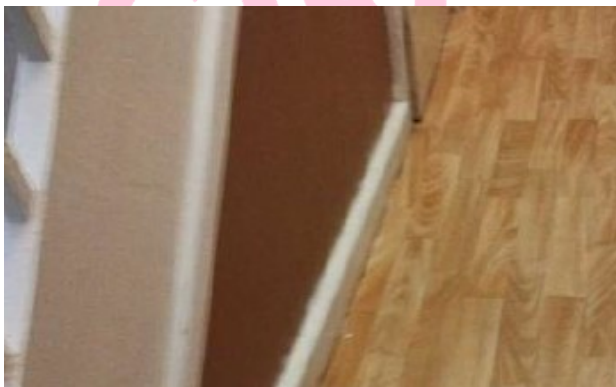
Item 18 - Ref: 23-62130-1

The floor adhesive below modern vinyl flooring in the Hall and Stairs (Area 2) does contain asbestos.

Any change in appearance should be reported to Property Services.

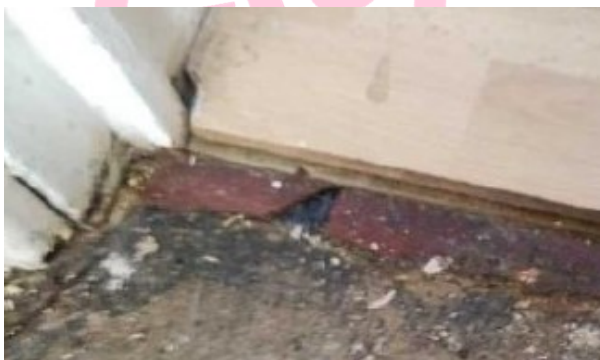
Item 21 - Ref: 23-62130-3

The tile and adhesive remnants at doorway in Bedroom 1 (Area 010) does contain asbestos.

Any change in appearance should be reported to Property Services.

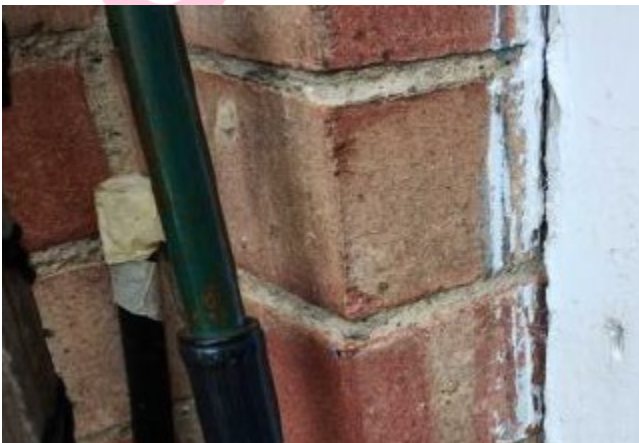
Item 24 - Ref: 23-62130-9

The sealant to the door frame External (Area 019) does contain asbestos.

Any change in appearance should be reported to Property Services.

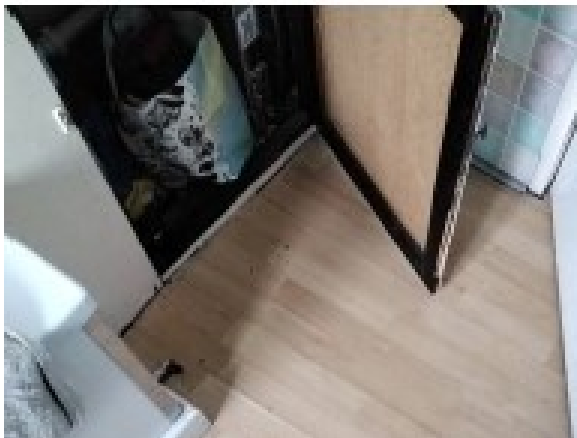
Item 26 - Ref: SC005472

The floor tile with adhesive (Bathroom Rm 1/001) does contain asbestos.

Removed February 2024.
