ASBESTOS SURVEY REPORT FOR SIZZLERS, 1 STOBART STREET,
MONKWEARMOUTH SR5 1BW

Asbestos Register for Sizzlers, 1 Stobart Street, Monkwearmouth, SR5 1BW

Date: 20 July 2023

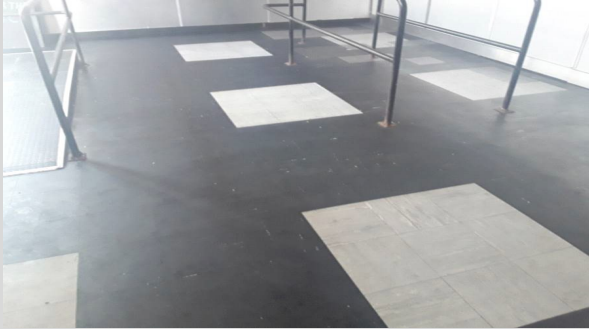
1.	NZ000496	Floor tile with adhesive - various	Shop Floor G/001	No Risk

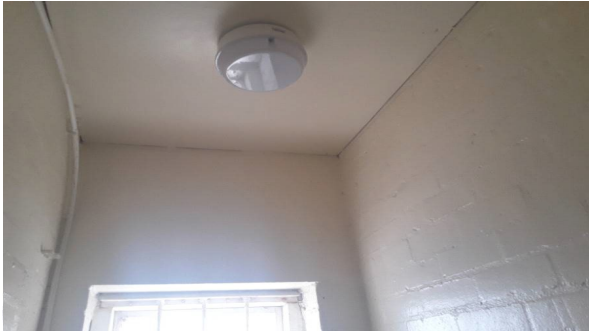
2.	NZ000497	Ceiling	Toilets G/006	This item is classed as very low risk and should be inspected every 12 months

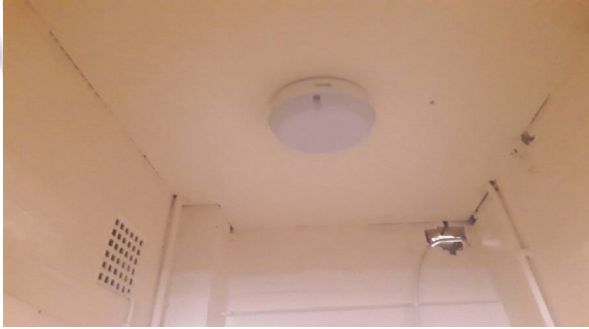
3.	As NZ000497	Ceiling	Wash Room Toilet G/007	This item is classed as very low risk and should be inspected every 12 months

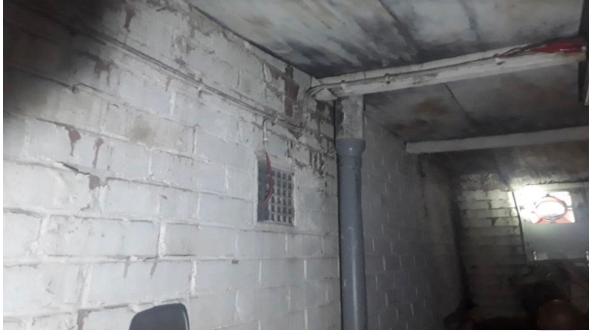
4.	NZ000498	Rainwater Goods top section to plastic rainwater goods	Store Room G/009	This item is classed as very low risk and should be inspected every 12 months

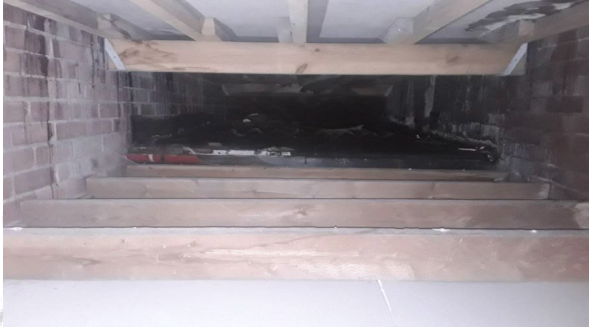
5.	Presumed	Roof Sheet Cladding above timber ceiling viewed from office unable to gain access	Store Room G/009	This item is classed as very low risk and should be inspected every 12 months

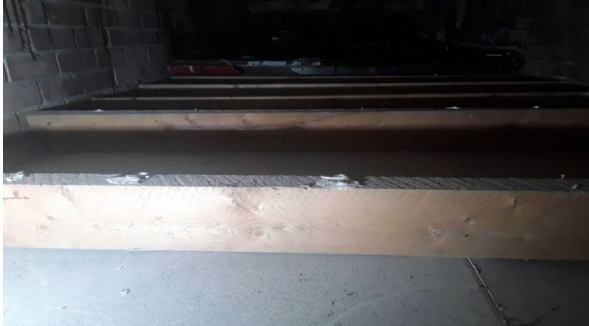
6.	NZ000499	Ceiling to nail heads from removed ceiling above plasterboard ceiling viewed from office	Store Room G/010	This item is classed as low risk and should be inspected every 6 months
