ASBESTOS SURVEY REPORT FOR ELDON GROVE ACADEMY, ELDON GROVE, HARTLEPOOL, TS26 9LY

Asbestos Register for Eldon Grove Academy

Date: 27 June 2025

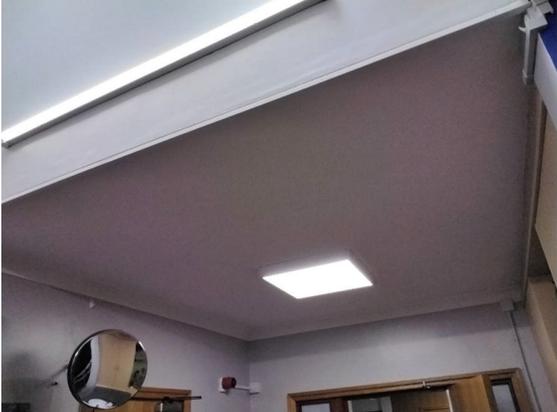
1	SC004854	Ceiling Coating	Main building Ground Floor, Corridor (Room G/002)	Does not contain asbestos.

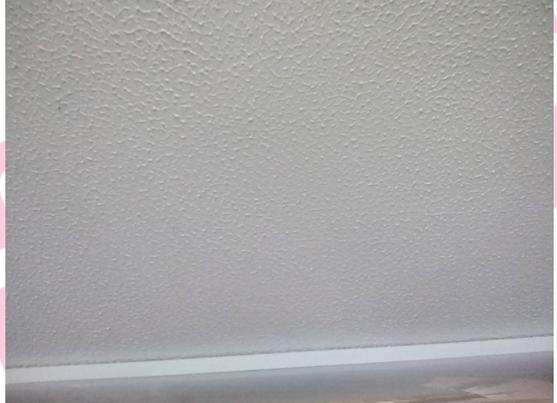
2	SC004856	Ceiling Coating	Main building Ground Floor, Corridor (Room G/004)	Does not contain asbestos.

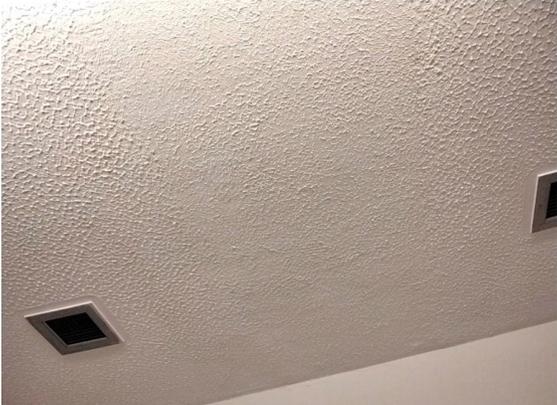
3	As SC004854	Ceiling Coating	Main building Ground Floor, Toilets Disabled (Room G/005)	Does not contain asbestos.

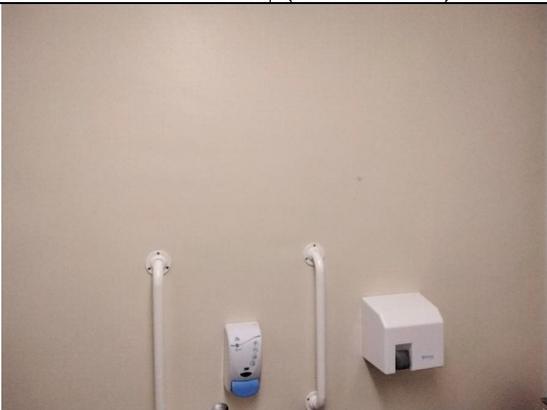
4	SC004855	Wall Coating	Main building Ground Floor, Toilets Disabled (Room G/005)	Does not contain asbestos.

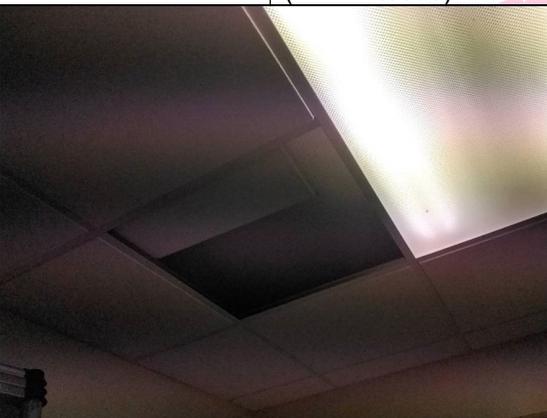
5	As SC004854	Ceiling Coating	Main building Ground Floor, Social Inclusion (Room G/006)	Does not contain asbestos.

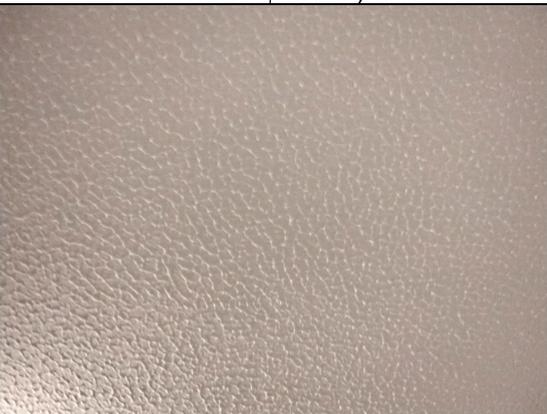
6	As SC004854	Ceiling Coating	Main building Ground Floor, Electrical Cupboard (Room G/009)	Does not contain asbestos.

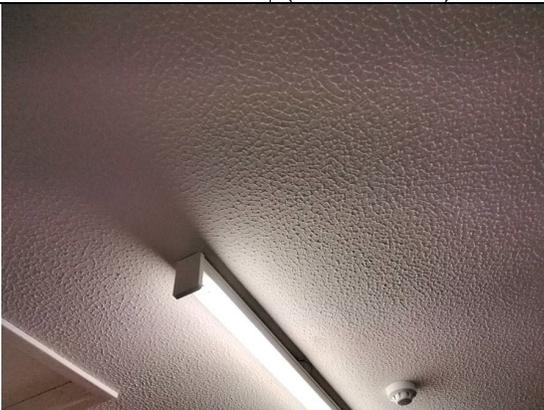
7	As SC004854	Ceiling Coating	Main building Ground Floor, Store Room (Room G/010)	Does not contain asbestos.

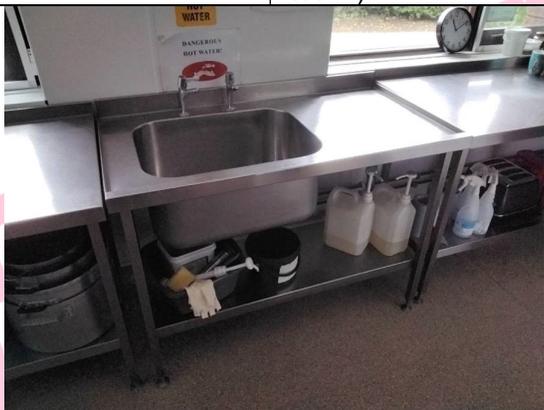
8	SC004857	Under sink mat	Main building Ground Floor, Kitchen (Room G/011)	Does not contain asbestos.

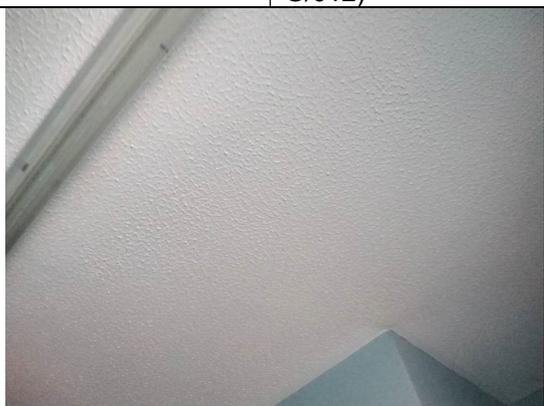
9	SC004858	Ceiling Coating	Main building Ground Floor, Staff Room (Kitchen) (Room G/012)	Does not contain asbestos.

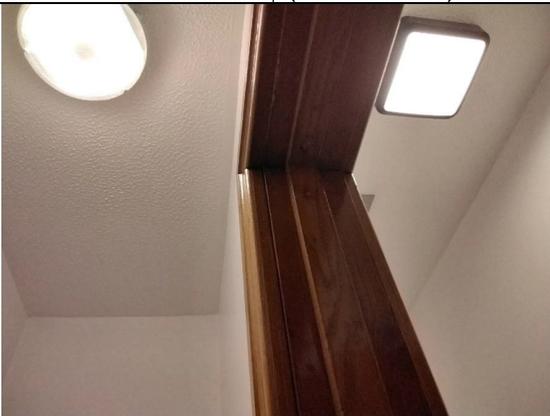
10	As SC004858	Ceiling Coating	Main building Ground Floor, Toilets Staff (Room G/013)	Does not contain asbestos.

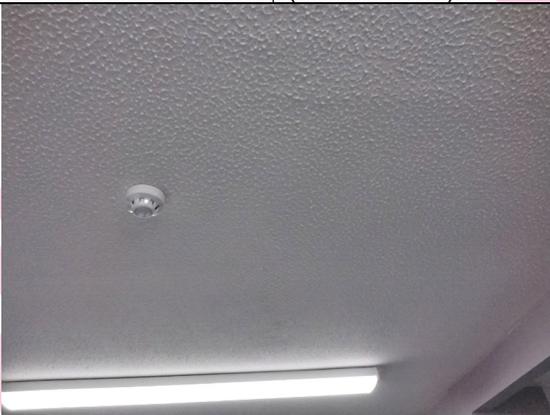
11	SC004859	Ceiling Coating	Main building Ground Floor, Classroom 1 (Room G/016)	Does not contain asbestos.

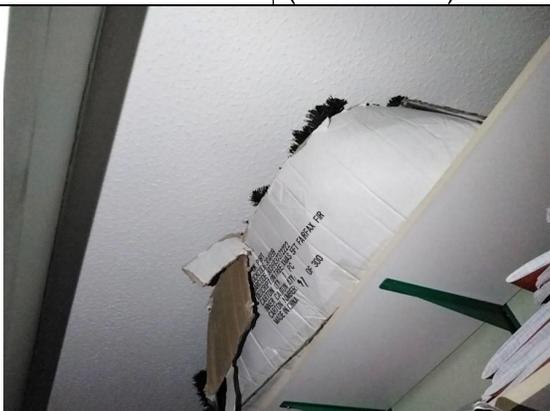
12	As SC004859	Ceiling Coating	Main building Ground Floor, Cupboard (Room G/017)	Does not contain asbestos.

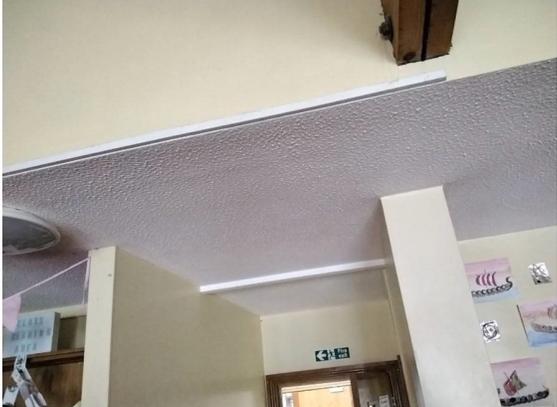
13	As SC004859	Ceiling Coating	Main building Ground Floor, Classroom 2 (Room G/018)	Does not contain asbestos.

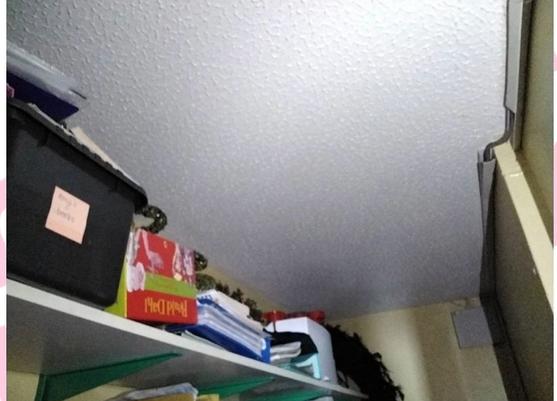
14	As SC004859	Ceiling Coating	Main building Ground Floor, Cupboard (Room G/019)	Does not contain asbestos.

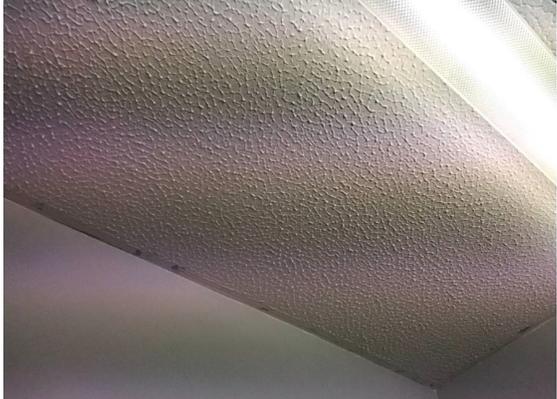
15	As SC004859	Ceiling Coating	Main building Ground Floor, AHT Office (Room G/021)	Does not contain asbestos.

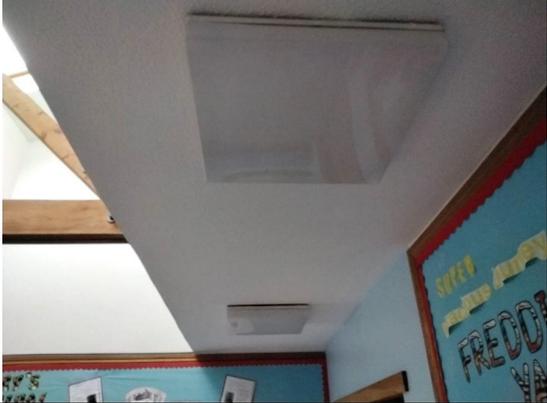
16	As SC004859	Ceiling Coating	Main building Ground Floor, Upper Cloakroom (Room G/022)	Does not contain asbestos.

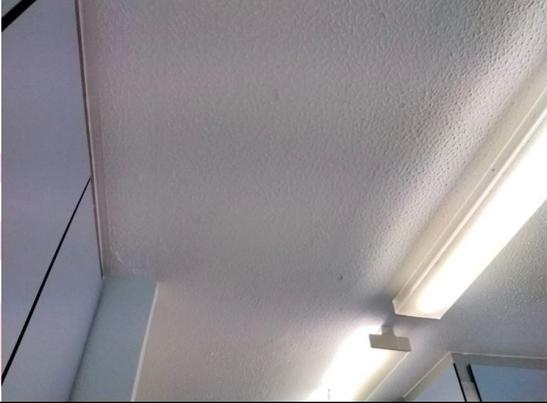
17	SC004860	Ceiling Coating	Main building Ground Floor, Toilets Male (Room G/023)	Does not contain asbestos.

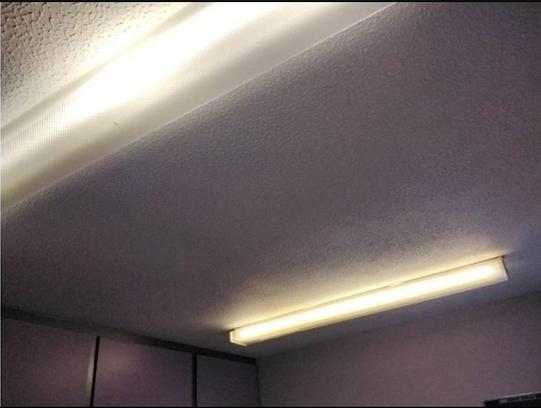
19	As SC004860	Ceiling Coating	Main building Ground Floor, Female Toilets (Room G/025)	Does not contain asbestos.

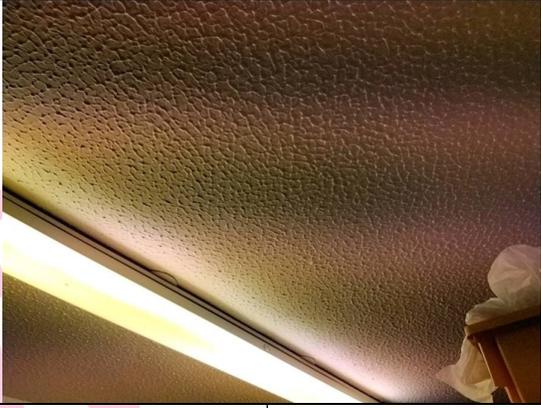
20	As SC004860	Ceiling Coating	Main building Ground Floor, Store Cupboard (Room G/026)	Does not contain asbestos.

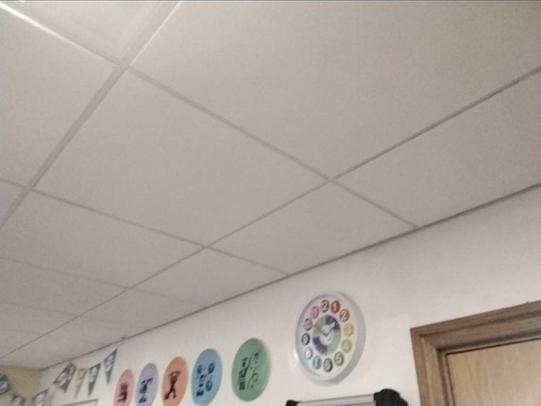
23	As SC004861	Ceiling Coating	Main building Ground Floor, Classroom 8 (Room G/041)	Does not contain asbestos.

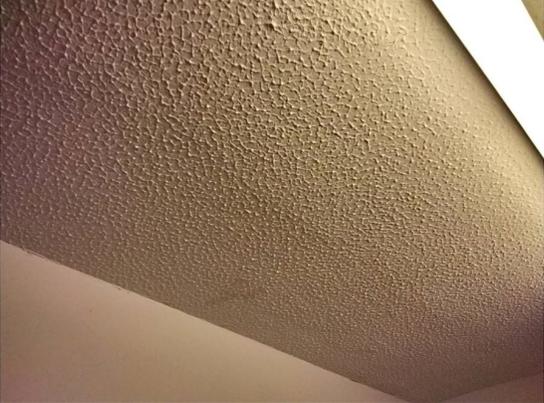
25	SC004862	Ceiling Coating	Main building Ground Floor, Photo copy room (Room G/043)	Does not contain asbestos.

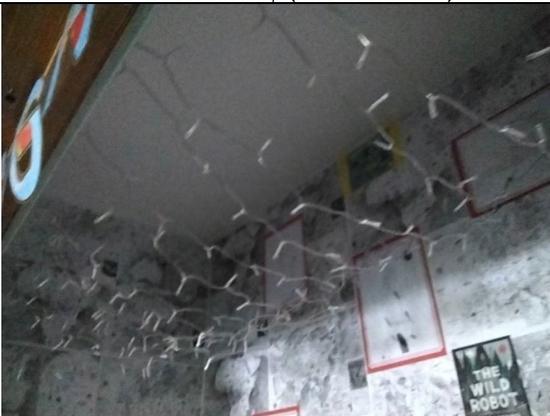
28	As SC004862	Ceiling Coating	Main building Ground Floor, Cupboard (Room G/046)	Does not contain asbestos.

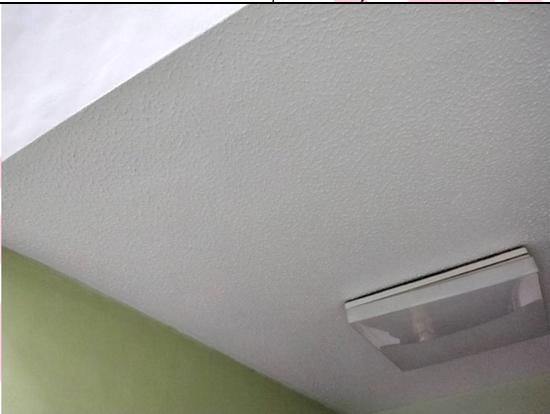
29	SC004863	Ceiling Coating	Main building Ground Floor, Middle Cloakroom (Room G/047)	Does not contain asbestos.

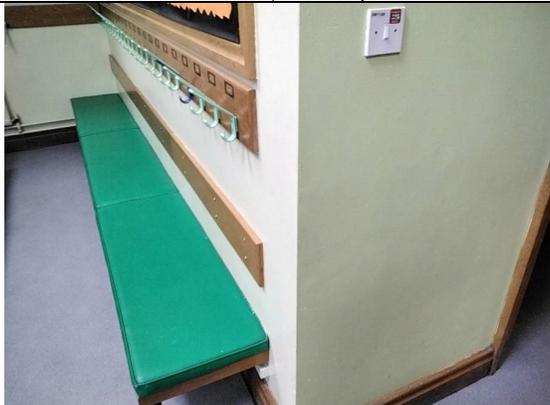
30	SC004864	Wall Coating	Main building Ground Floor, Middle Cloakroom (Room G/047)	Does not contain asbestos.

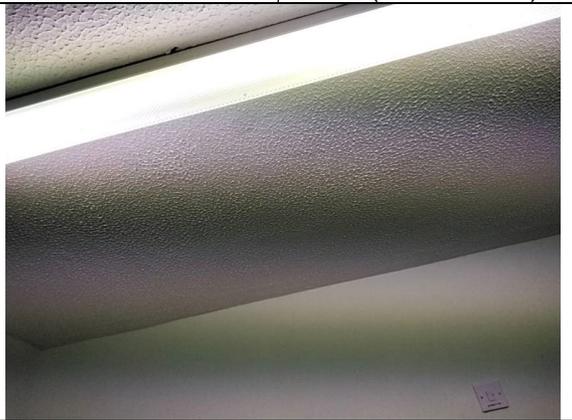
31	As SC004863	Ceiling Coating	Main building Ground Floor, Changing Room (Room G/048)	Does not contain asbestos.

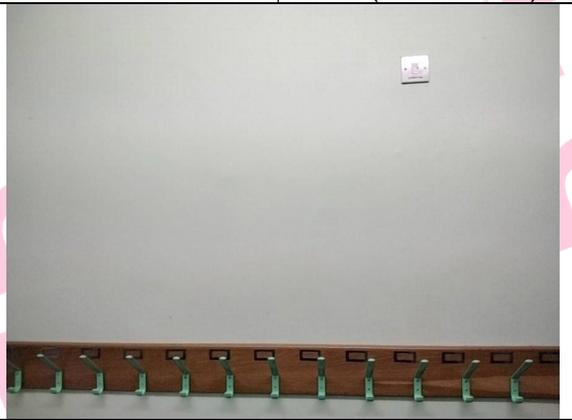
32	As SC004864	Wall Coating	Main building Ground Floor, Changing Room (Room G/048)	Does not contain asbestos.

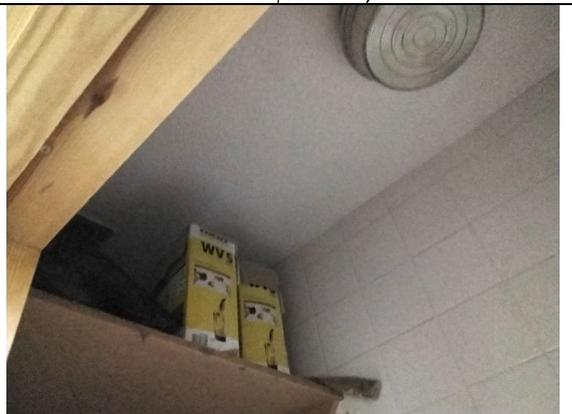
33	As SC004863	Ceiling Coating	Main building Ground Floor, Cleaners Cupboard (Room G/049)	Does not contain asbestos.

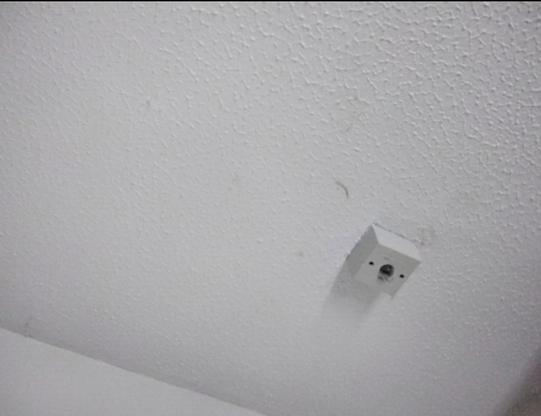
36	As SC004863	Ceiling Coating	Main building Ground Floor, Male Toilets (Room G/051)	Does not contain asbestos.

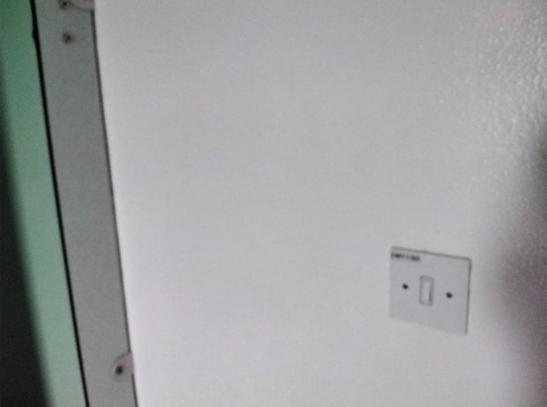
37	As SC004864	Wall Coating	Main building Ground Floor, Male Toilets (Room G/051)	Does not contain asbestos.

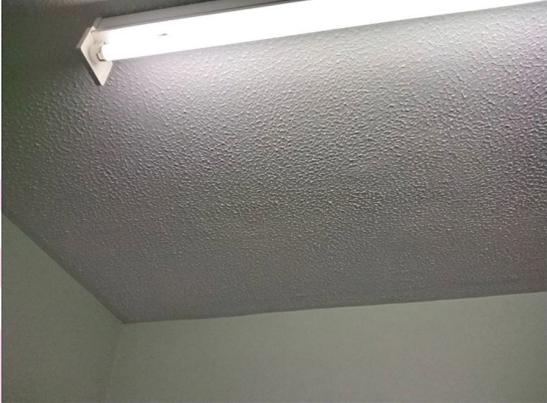
38	As SC004863	Ceiling Coating	Main building Ground Floor, Changing Room (Room G/052)	Does not contain asbestos.

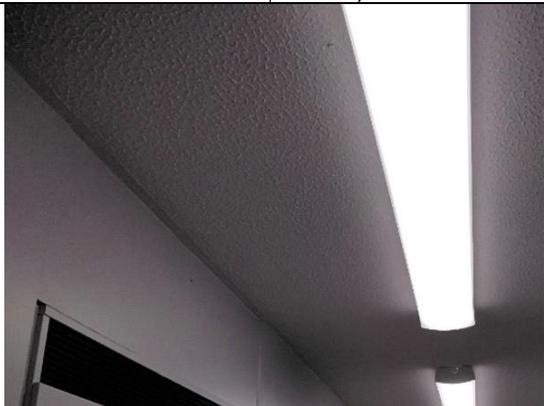
43	SC004865	Ceiling Coating	Main building Ground Floor, Corridor (Room G/057)	Does not contain asbestos.

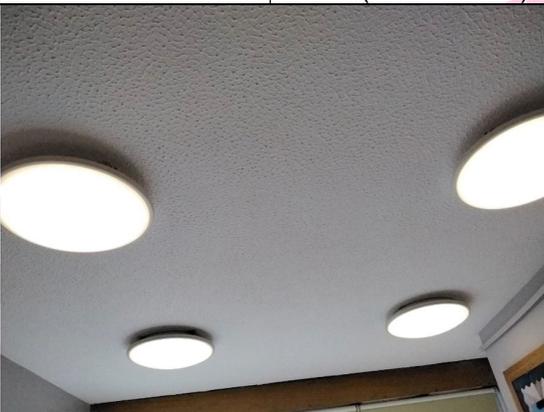
44	As SC004865	Ceiling Coating	Main building Ground Floor, Headteachers Office (Room G/059)	Does not contain asbestos.

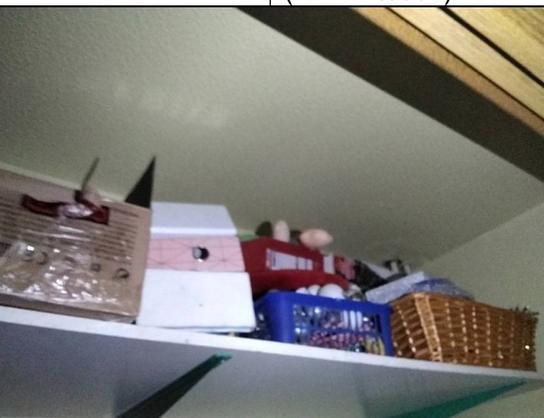
45	As SC004865	Ceiling Coating	Main building Ground Floor, Cupboard (Room G/061)	Does not contain asbestos.

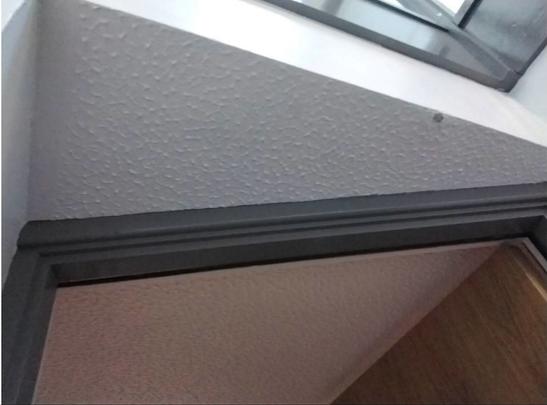
46	As SC004865	Ceiling Coating	Main building Ground Floor, Stairwell (Room G/062)	Does not contain asbestos.

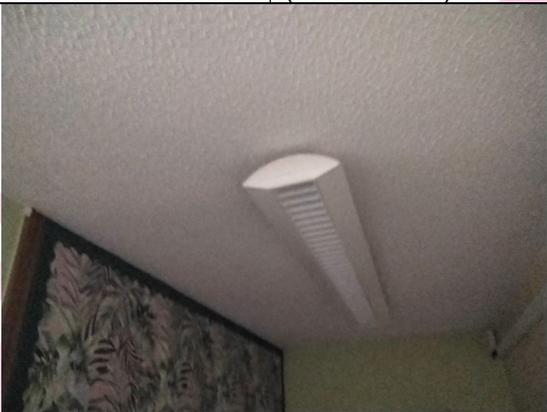
47	As SC004865	Ceiling Coating	Main building Ground Floor, Classroom 12 (Room G/063)	Does not contain asbestos.

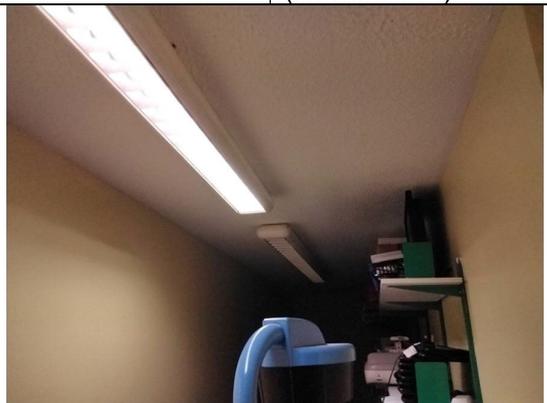
48	As SC004865	Ceiling Coating	Main building Ground Floor, Store Cupboard (Room G/064)	Does not contain asbestos.

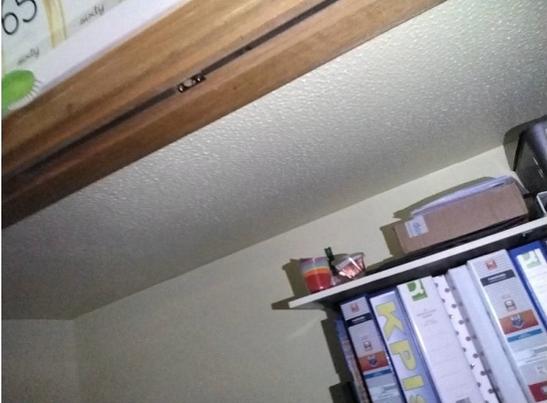
49	As SC004865	Ceiling Coating	Main building Ground Floor, Cupboard (Room G/065)	Does not contain asbestos.

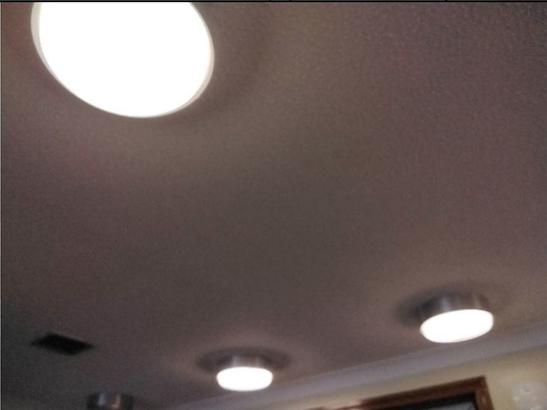
50	SC004866	Ceiling Coating	Main building Ground Floor, Classroom 13 (Room G/066)	Does not contain asbestos.

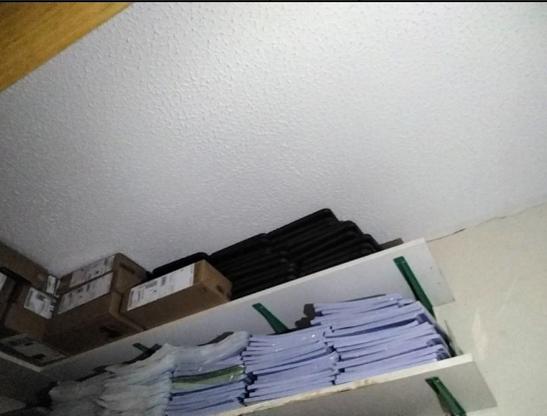
51	As SC004866	Ceiling Coating	Main building Ground Floor, Server Cupboard (Room G/067)	Does not contain asbestos.

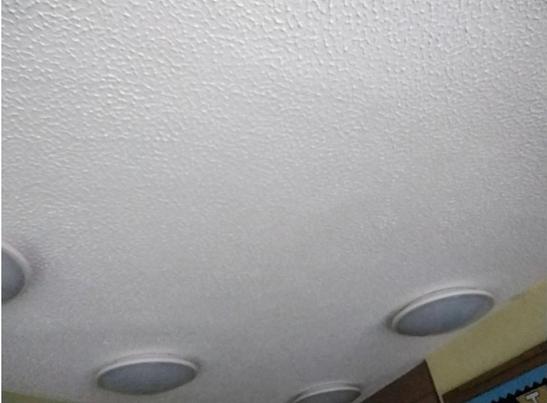
52	As SC004866	Ceiling Coating	Main building Ground Floor, Classroom 14 (Room G/070)	Does not contain asbestos.

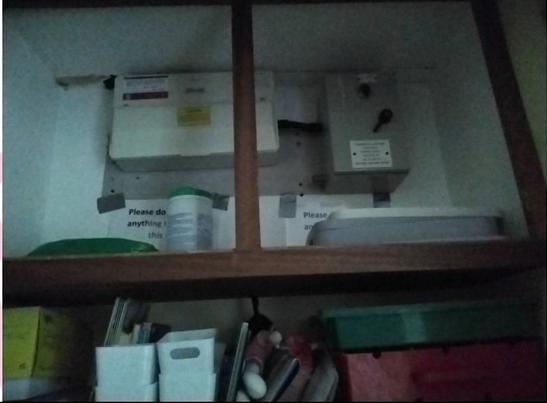
53	As SC004866	Ceiling Coating	Main building Ground Floor, Electrical Cupboard (Room G/071)	Does not contain asbestos.

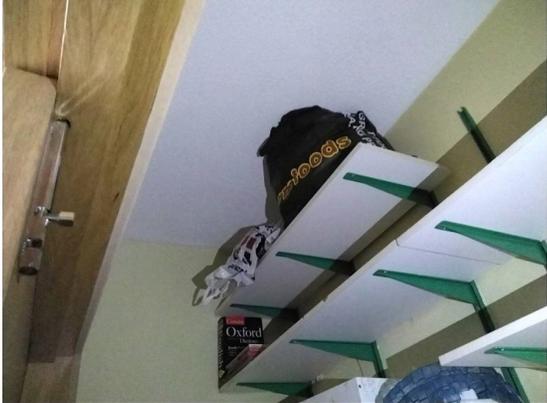
55	As SC004867	Ceiling Coating	Main building Ground Floor, Cupboard (Room G/073)	Does not contain asbestos.

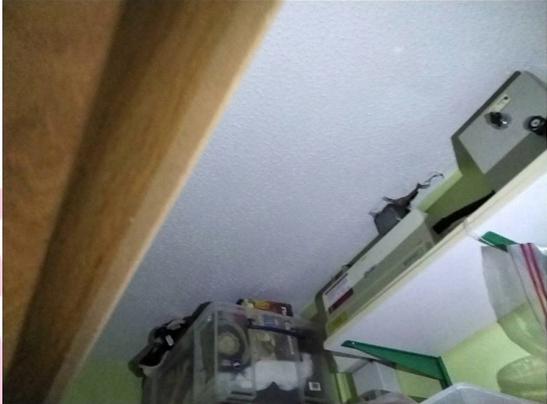
56	As SC004867	Ceiling Coating	Main building Ground Floor, Cupboard (Room G/074)	Does not contain asbestos.

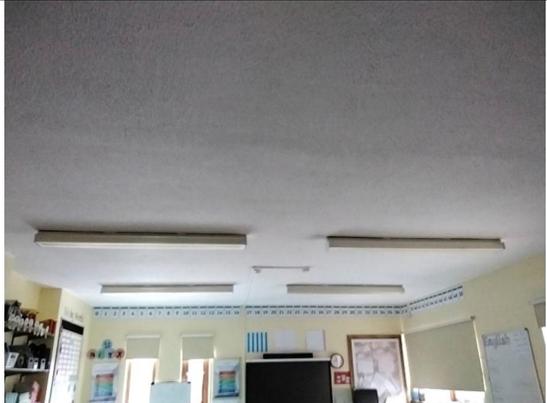
57	SC004868	Ceiling Coating	Main building Ground Floor, Classroom 15 (Room G/076)	Does not contain asbestos.

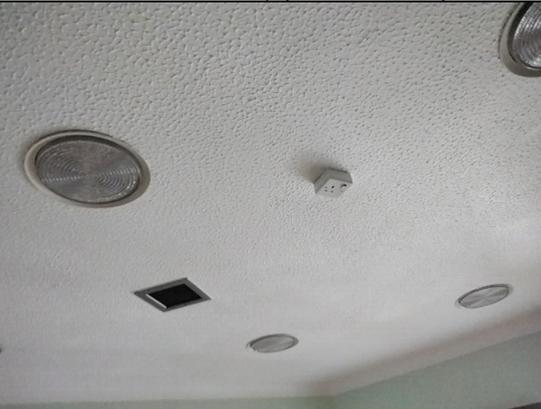
63	SC004869	Ceiling Coating	Main building Ground Floor, Classroom 18 (Room G/083)	Does not contain asbestos.

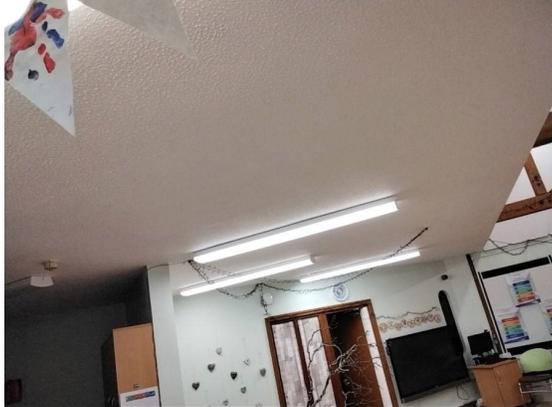
64	As SC004869	Ceiling Coating	Main building Ground Floor, Nursery (Room G/084)	Does not contain asbestos.

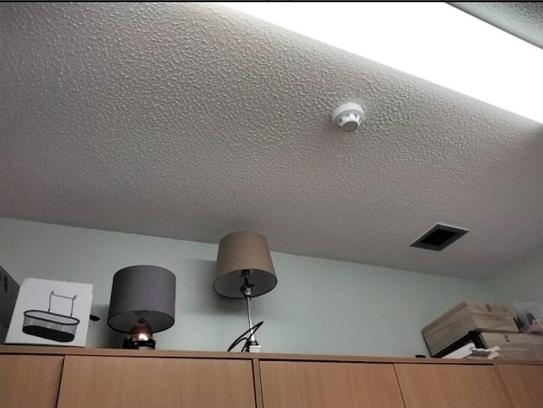
68	As SC004870	Ceiling Coating	Main building Ground Floor, Utility Room (Room G/088)	Does not contain asbestos.

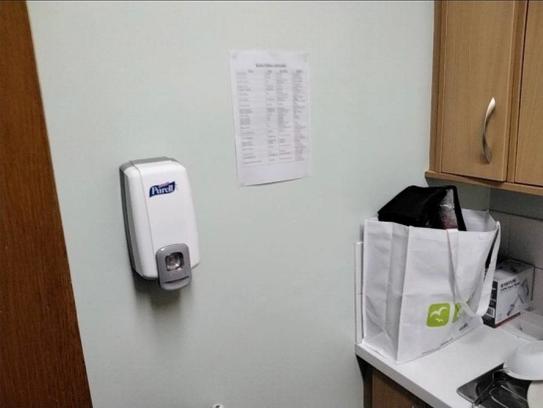
69	As SC004871	Wall Coating	Main building Ground Floor, Utility Room (Room G/088)	Does not contain asbestos.

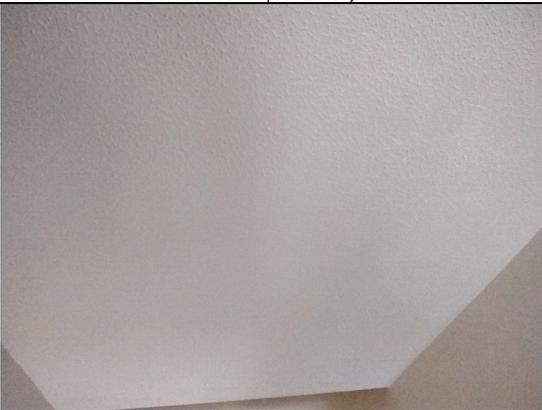
73	SC004873	Ceiling Coating	Main building First Floor Landing (Room 1/006)	Does not contain asbestos.

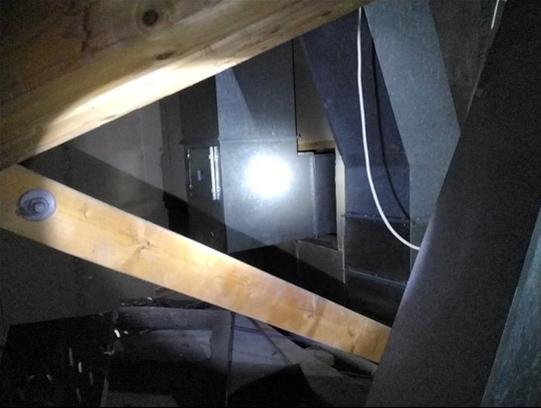
77	As SC004888	Ductwork joints	Main building Roof void Loft space (Room R/002)	Does not contain asbestos.

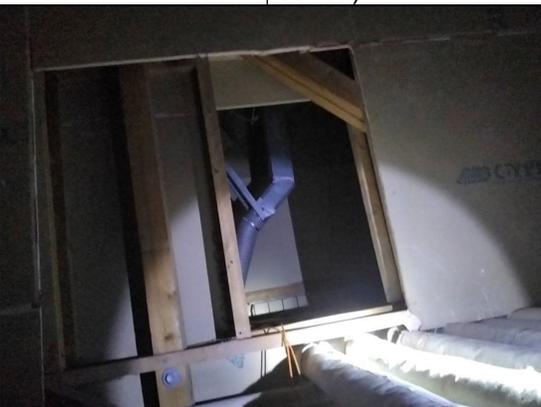
81	As SC004888	Ductwork joints	Main building Roof void Loft space (Room R/010)	Does not contain asbestos.

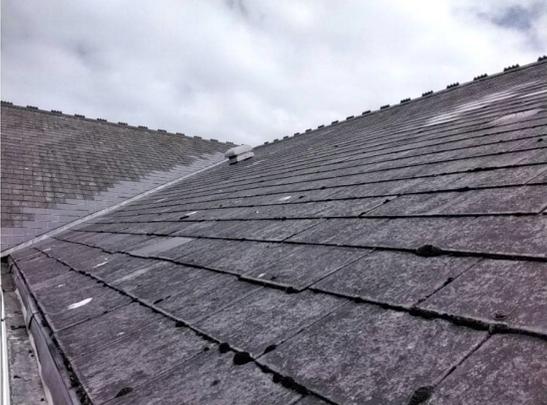
85	SC004876	Roof Tiles	Main building External Courtyard 1 (Room E/001)	Does not contain asbestos.

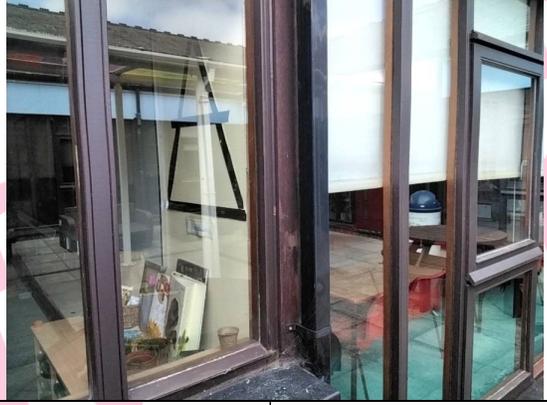
86	SC004877	Window putty/seal	Main building External Courtyard 1 (Room E/001)	Does not contain asbestos.

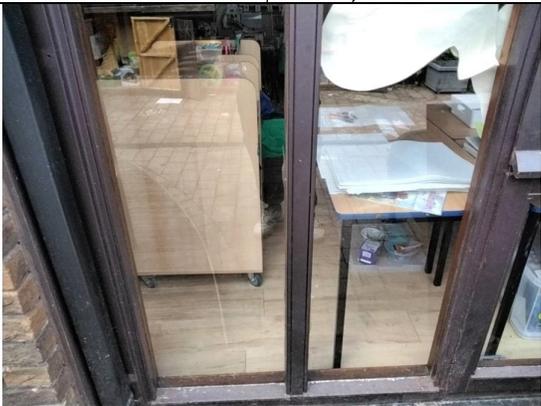
88	As SC004875	Window beading putty/seal	Main building External Courtyard 2 (Room E/002)	Does not contain asbestos.

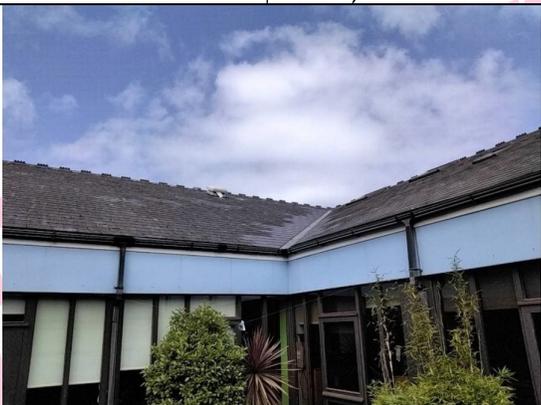
89	As SC004876	Roof Tiles	Main building External Courtyard 2 (Room E/002)	Does not contain asbestos.

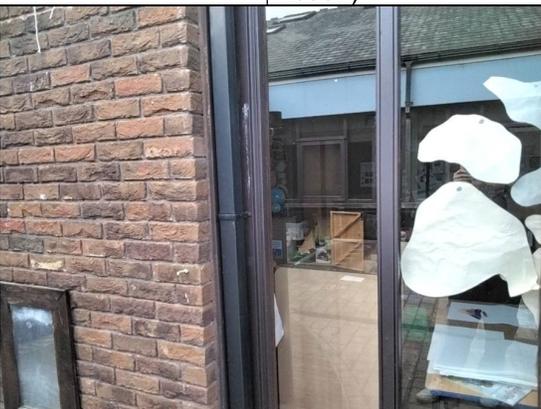
90	As SC004877	Window putty/seal	Main building External Courtyard 2 (Room E/002)	Does not contain asbestos.

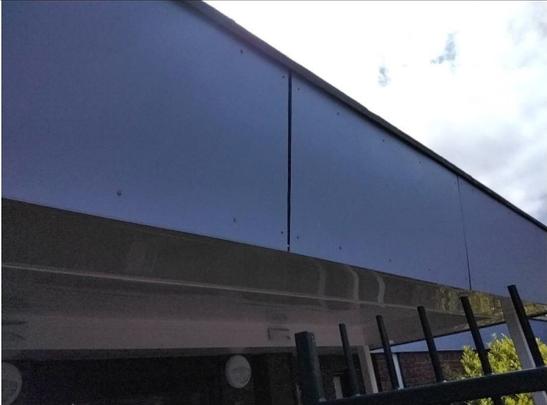
91	As SC004874	Wall sheet cladding	Main building External (Room E/003)	Does not contain asbestos.

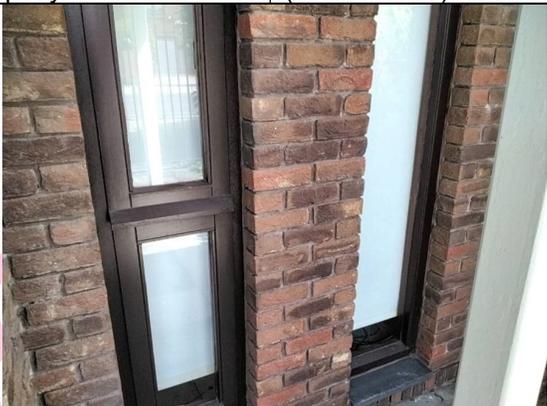
92	As SC004875	Window beading putty/seal	Main building External (Room E/003)	Does not contain asbestos.

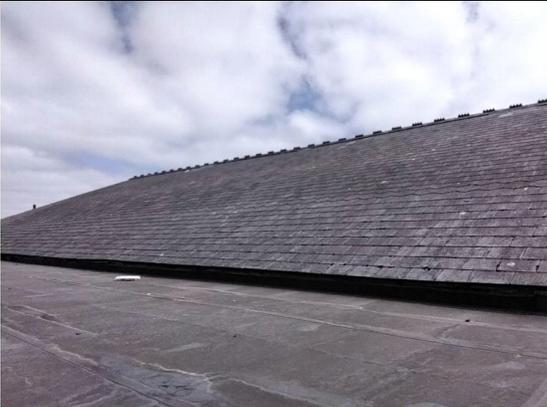
93	As SC004876	Roof Tiles	Main building External (Room E/003)	Does not contain asbestos.

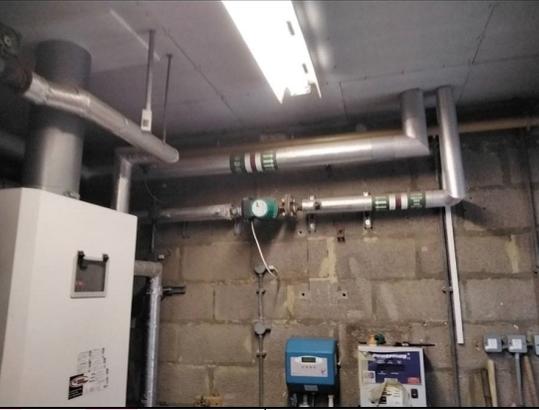
101	SC004883	Pipework Gaskets	Main building External Plant Room (Room E/006)	Does not contain asbestos.

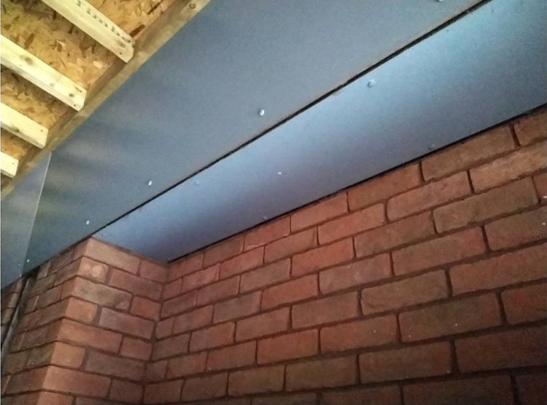
106	As SC004879	Soffits to building perimeter	Main building External PE Cupboard (Room E/007)	Does not contain asbestos.

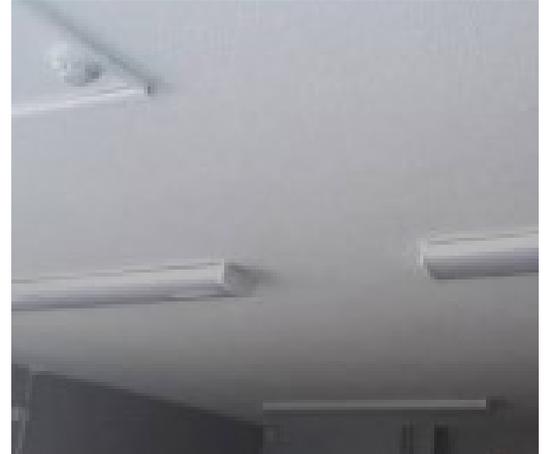
108	As NZ001421	Ceiling coating	Main building Ground Floor Classroom B (Room G/002)	Does not contain asbestos.

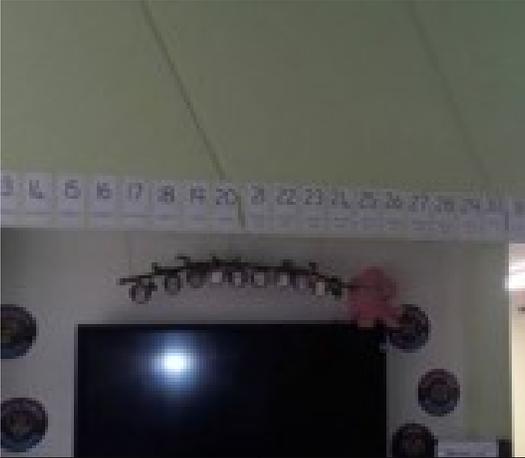
109	NZ001422	Ceiling – coating to lower ceiling above entrance and television wall	Main building Ground Floor Classroom C (Room G/003)	Does not contain asbestos.

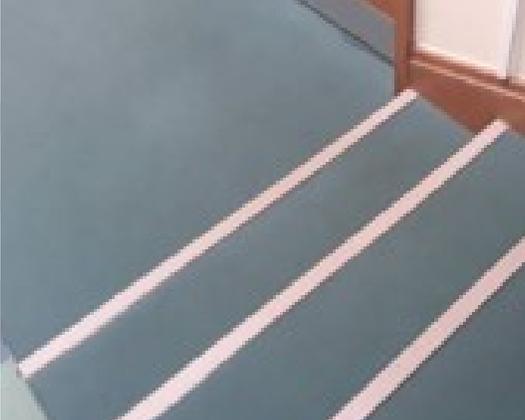
110	NZ001423	Floor nosing to stairs	Main building Ground Floor Classroom C (Room G/003)	Does not contain asbestos.

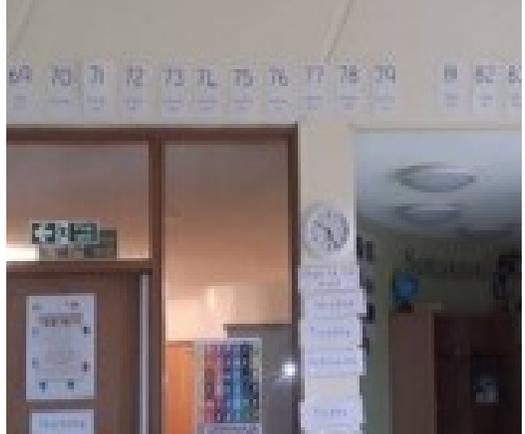
111	As NZ001422	Ceiling – coating to lower ceiling above entrance's and within alcove's	Main building Ground Floor Classroom D (Room G/004)	Does not contain asbestos.

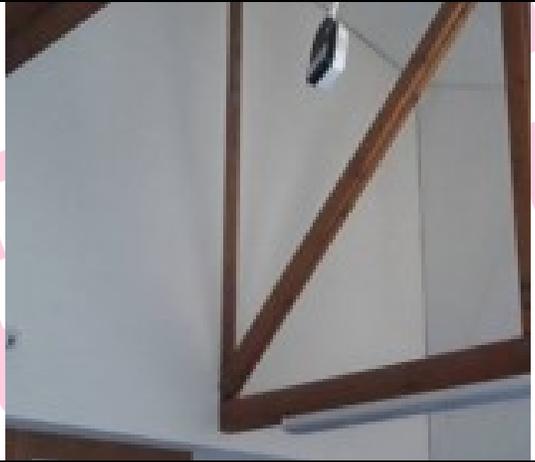
113	As NZ001422	Ceiling – coating to lower ceiling above entrance and within alcove	Main building Ground Floor Classroom E (Room G/005)	Does not contain asbestos.

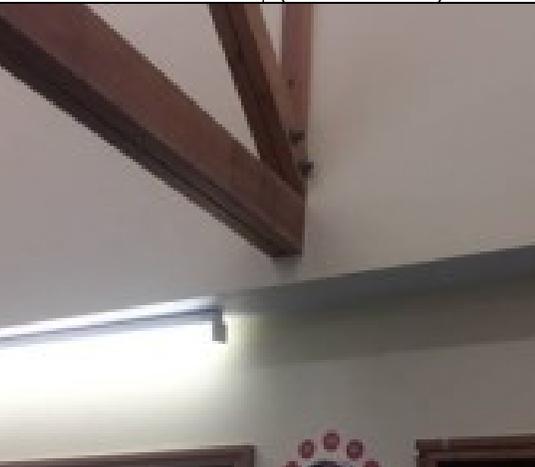
114	As NZ001422	Ceiling – coating to lower ceiling above entrance	Main building Ground Floor Classroom G (Room G/007)	Does not contain asbestos.
