ASBESTOS SURVEY REPORT FOR FULWELL CA, SUNDERLAND

Asbestos Register for FULWELL CA, SUNDERLAND

Date: 12 March 2025

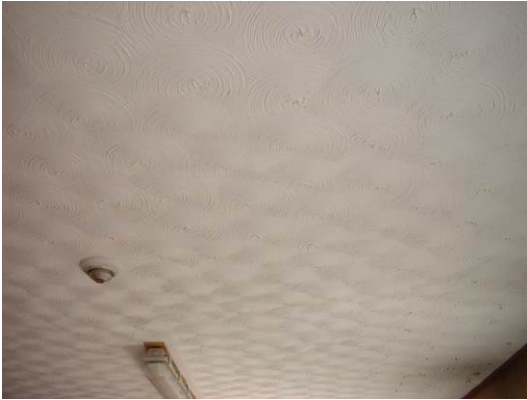
Item 1 Ref: CA02/1

CA02/1 – Ceiling (Room 1) (Item 1) Low Risk

The ceiling to the kitchen (Room 1) contains asbestos.

Any change in its appearance should be recorded and passed to Property Services.

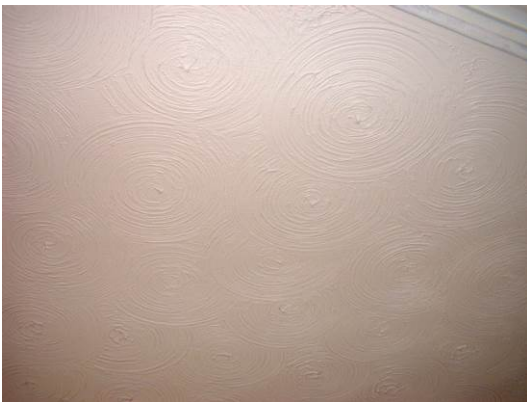
Item 2 - Ref: as CA02/1

As CA02/1 - Ceiling (Room 3) (Item 2) Low Risk

The ceiling to Room 3 contains asbestos.

Any change in its appearance should be recorded and passed to Property Services.

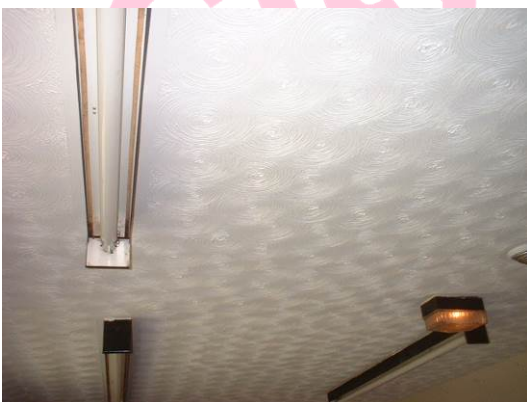
Item 3 - Ref: As CA02/1

As CA02/1 – Ceiling (Room 11) (Item 3) Low Risk

The ceiling to Room 11 contains asbestos.

Any change in its appearance should be recorded, and passed to Property Services

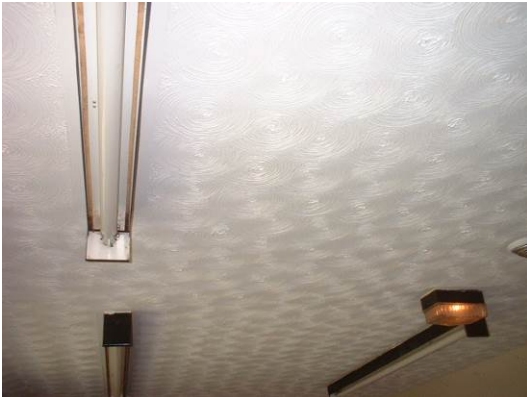
Item 4 - Ref: as CA02/1

As CA02/1 – Ceiling (Room 12) (Item 4) Low Risk

The ceiling to Room 12 contains asbestos.

Any change in its appearance should be recorded, and passed to Property Services

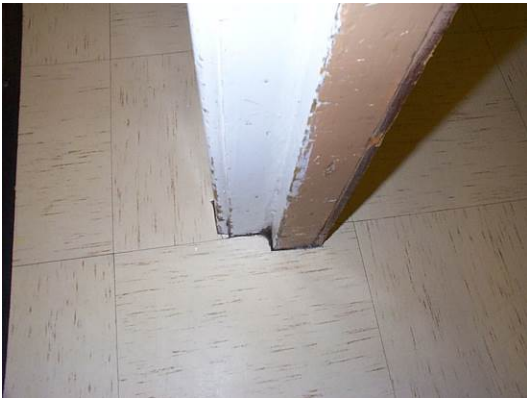
Item 5 - Ref: CA02/2

The flooring to Room 1 does not contain asbestos.

Similar flooring is also located in Room 3 (Item 6).

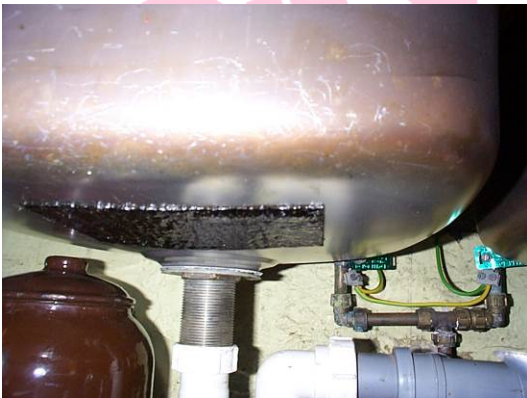
Item 7 - Ref: CA02/3

The sink pad in Room 1 does not contain asbestos.

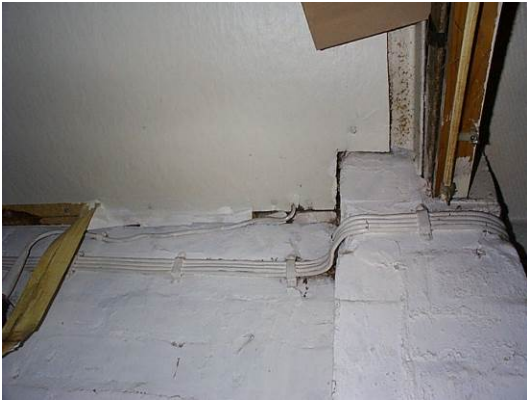
Item 8- Ref: CA02/4

The ceiling in room 8 does not contain asbestos.

A similar ceiling is located in rooms 9 (Item 9) and 10 (Item 10).

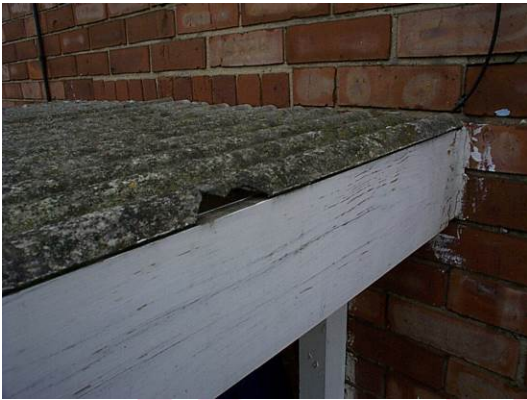
Item 11 Ref: CA02/5

CA02/5 – Canopy (Ex 13) (Item 11) Low Risk

The external canopy (Area 13) contains asbestos.

A similar canopy is also located in area 14 (Item 12).

Any change in its appearance should be recorded, and passed to Property Services

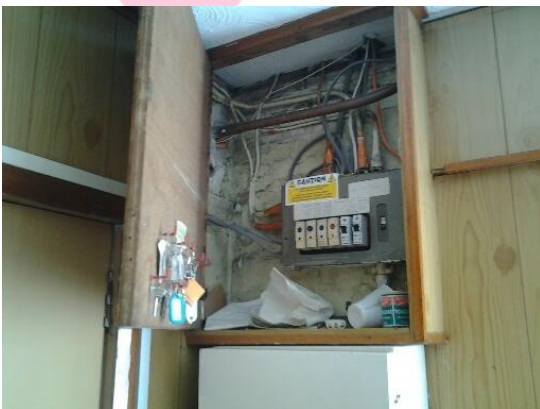
Item 13 Ref: 16-23632-2

The walls behind the wood panels in Room 1 (Kitchen) does not contain asbestos.

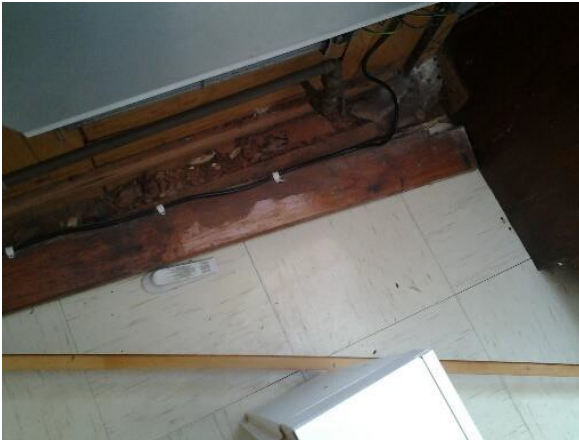
Item 14 - Ref: 16-24632-4

16-24632-4 – Floor behind kickboards (Room 1) (Item 14) Very Low Risk

The floor behind the kickboards in Room 1 (Kitchen) does contain asbestos.

Any change in its appearance should be recorded and passed to Property Services.

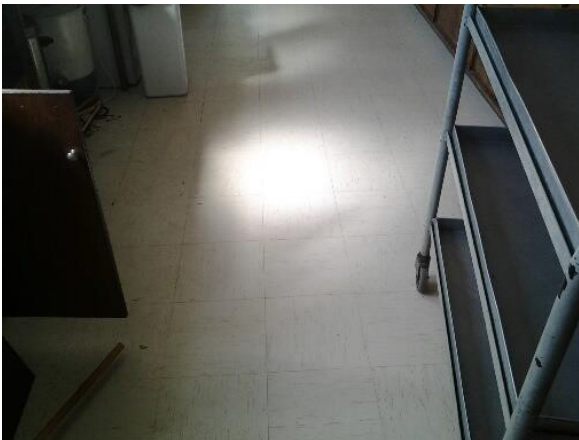
Item 15 Ref: 16-24632-5

16-24632-5 - Floor under vinyl tiles and screed (Room 1) (Item 15) Low Risk

The floor under vinyl tiles and screed in Room 1 (Kitchen) does contain asbestos.

Any change in its appearance should be recorded and passed to Property Services.

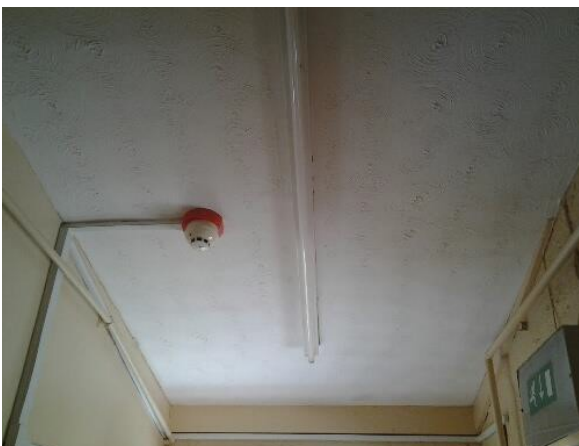
Item 16 Ref: 16-23632-1

16-24632-1- Ceiling (Entrance Lobby) (Item 16) Very Low Risk

The ceiling in the Entrance lobby does contain asbestos.

Any change in its appearance should be recorded and passed to Property Services.

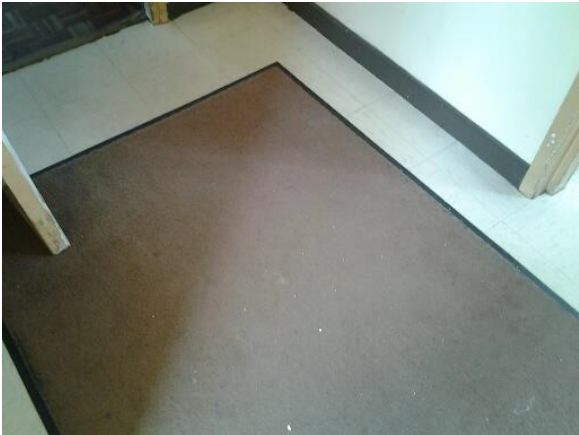
Item 17 - Ref: 16-24632-3

The flooring in the Entrance lobby does not contain asbestos.

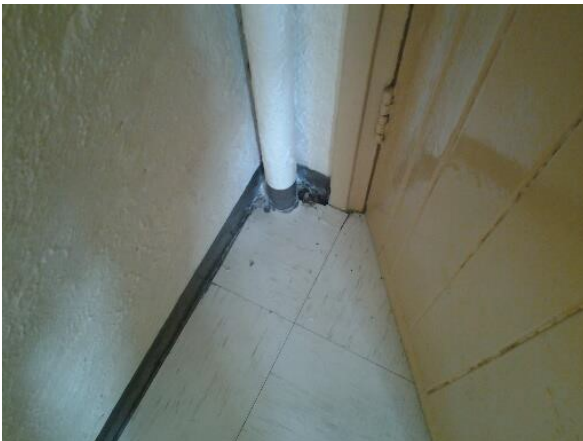
Item 18 Ref: As 16-24632-4

As 16-24632-4 – Floor around pipe penetration (Entrance Lobby) (Item 18) Very Low Risk

The floor around pipe penetration in the Entrance lobby does contain asbestos.

Any change in its appearance should be recorded and passed to Property Services.

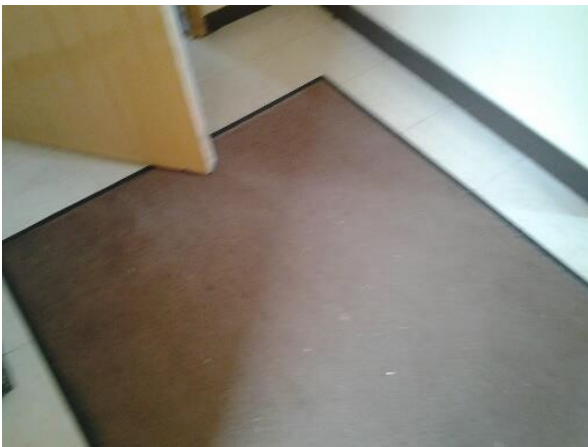
Item 19 Ref: As 16-23632-5

As 16-24632-5 - Floor under vinyl tiles and screed (Entrance Lobby) (Item 19) Low Risk

The floor under the vinyl tiles and screed in the Entrance lobby does contain asbestos.

Any change in its appearance should be recorded and passed to Property Services.

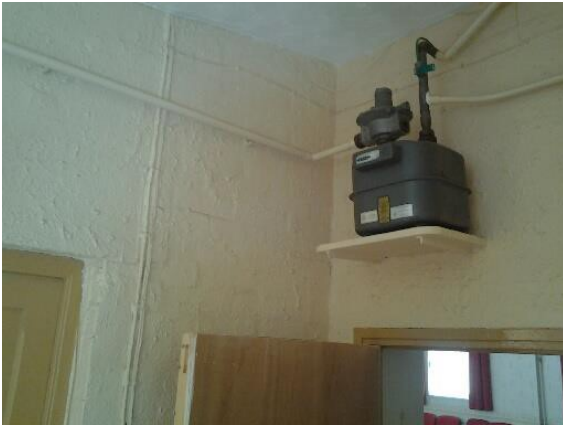
Item 20 - Ref: 16-24632-6

The textured coating in the Entrance lobby does not contain asbestos.

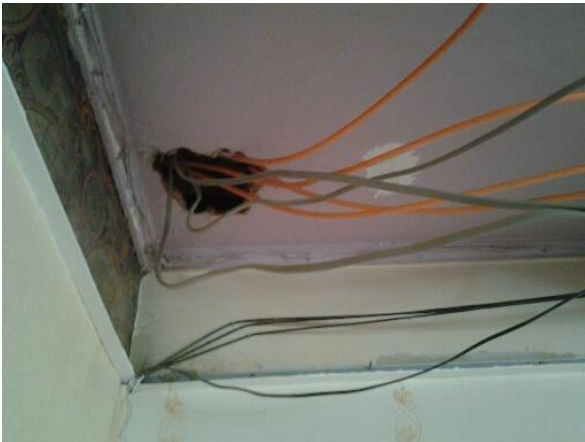
Item 21 Ref: 16-24632-7

The ceiling above the suspended ceiling in the Hall does not contain asbestos.

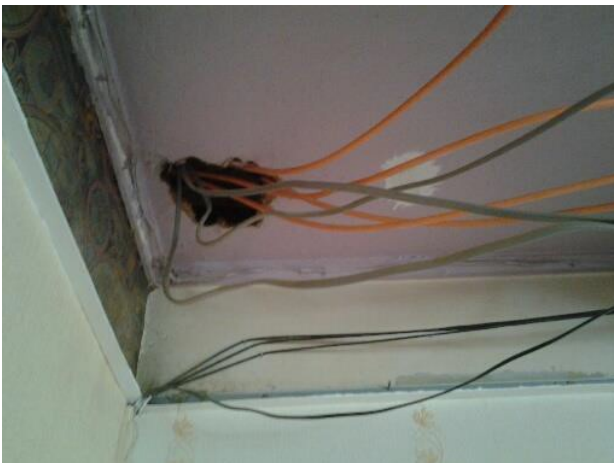
Item 22 Ref: 16-23632-8

The ceiling above the suspended ceiling in the Hall does not contain asbestos.

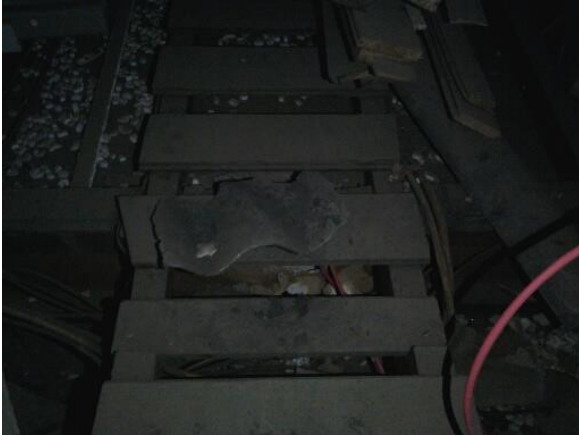
Item 23 - Ref: 16-24632-9

16-24632-9 – Debris to ceiling void (Hall) (Item 23) Low Risk

The debris to the ceiling void in the Hall does contain asbestos.

Any change in its appearance should be recorded and passed to Property Services.

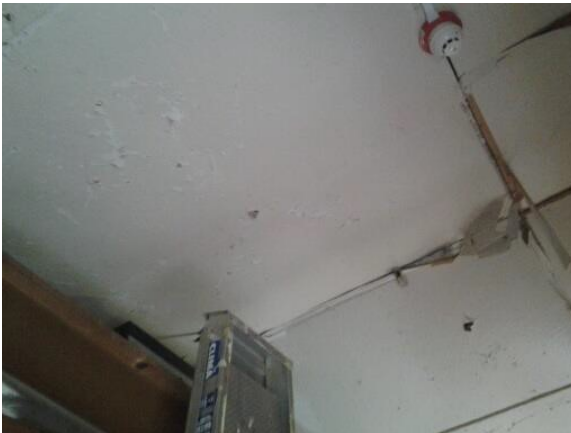
Item 24 Ref: 16-24632-10

The ceiling, soffit and fascia in the Stage does not contain asbestos.

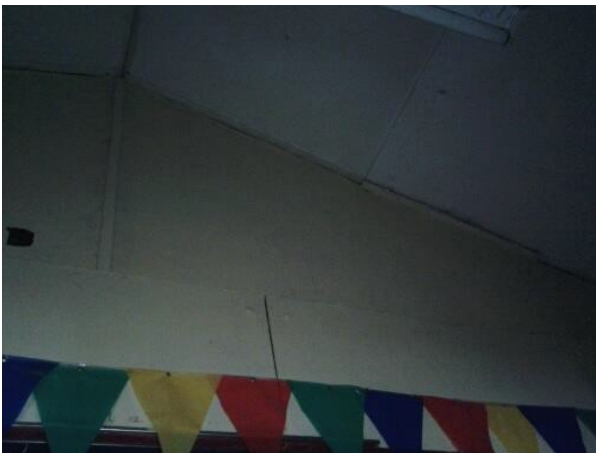
Item 25 Ref: 16-23632-11

The fascia in the Stage does not contain asbestos.

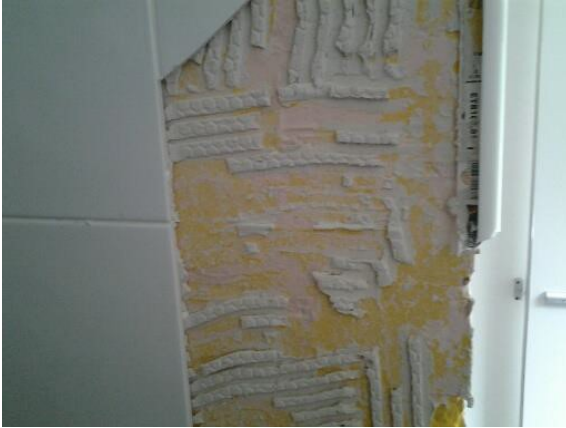
Item 26 - Ref: 16-24632-13

The walls in the Female WC does not contain asbestos.

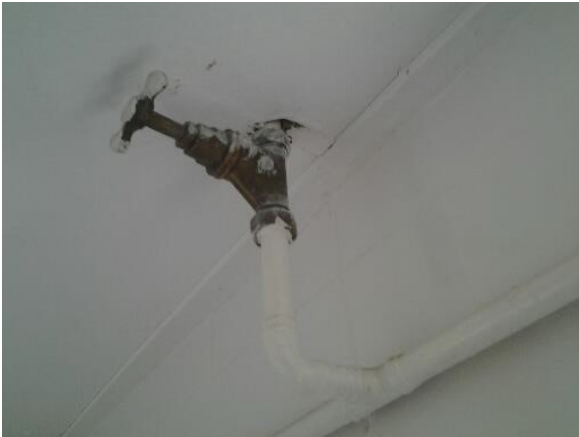
Item 27 Ref: 16-24632-15

The gaskets in the Female WC does not contain asbestos.

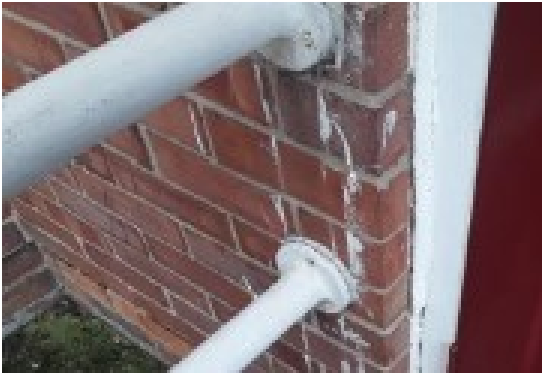
Item 29 - Ref: 21-39178-1

The frame sealant to the door in the Entrance to the Community Centre (Area 1) does not contain asbestos.

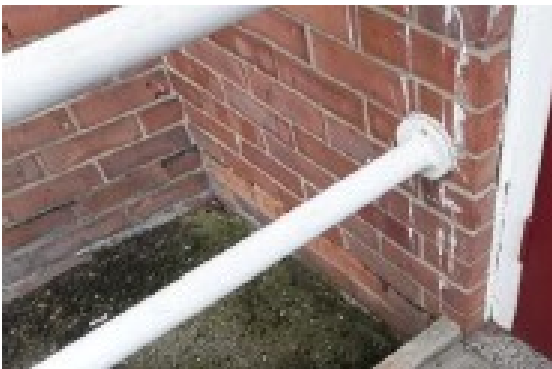
Item 30 Ref: 21-39178-2

The damp proof course to the Entrance door to the Community Centre (Area 1) does not contain asbestos.

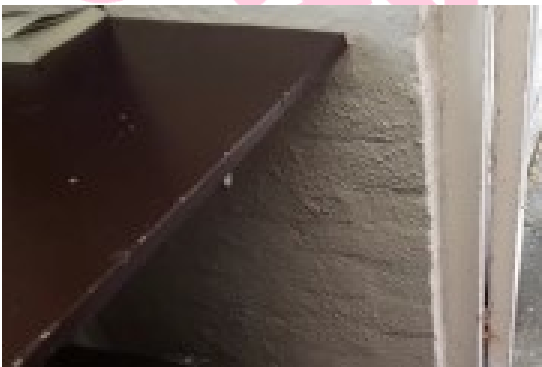
Item 31 Ref: 21-39178-3

The walls to the Entrance door to the Community Centre (Area 1) does not contain asbestos.

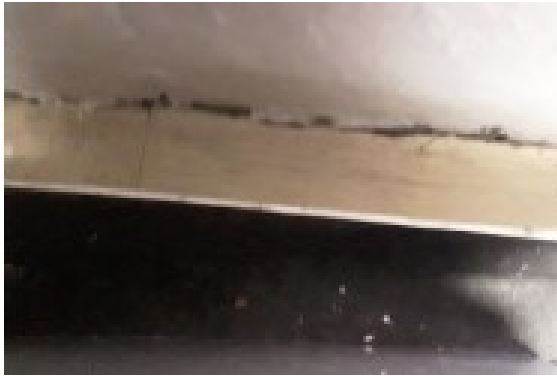
Item 32 - Ref: 21-39178-3

The floor tiles and adhesive to the Entrance door to the Community Centre (Area 1) does not contain asbestos.
