ASBESTOS SURVEY REPORT FOR THORNTREE ACADEMY, BIRKHALL ROAD, MIDDLESBOROUGH, TS3 9JW.

## **Asbestos Register for Thorntree Academy, Middlesbrough**

**Date: 13 February 2025**

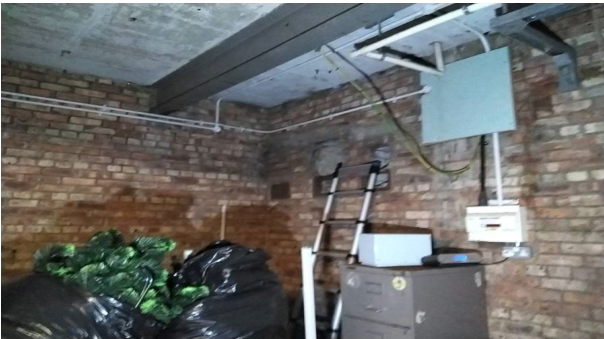
4	KX001656	Debris/residue to walls adjacent to flue openings	Main Building Boiler Room (Room 098)	6 monthly

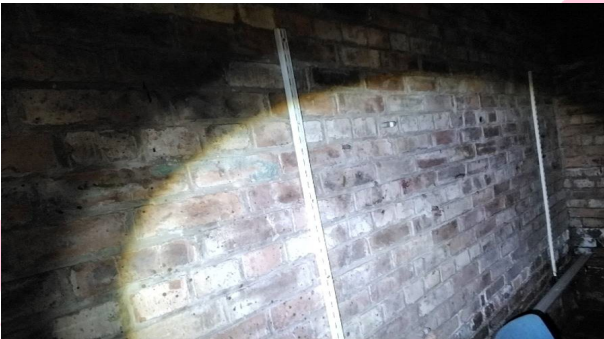
5	KX001657	Debris/residue to walls in paint	Main Building Boiler Room (Room 098)	6 monthly

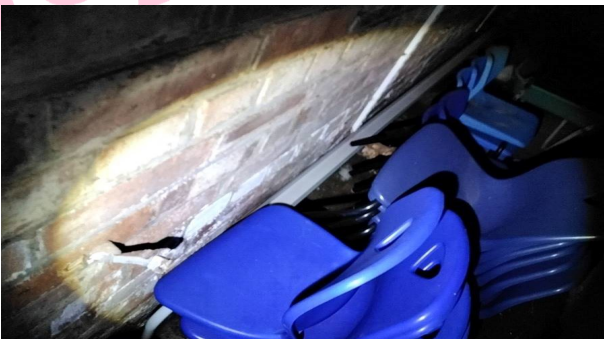
6	KX001658	Debris/residue to walls and old pipe hangars	Main Building Boiler Room (Room 098)	6 monthly

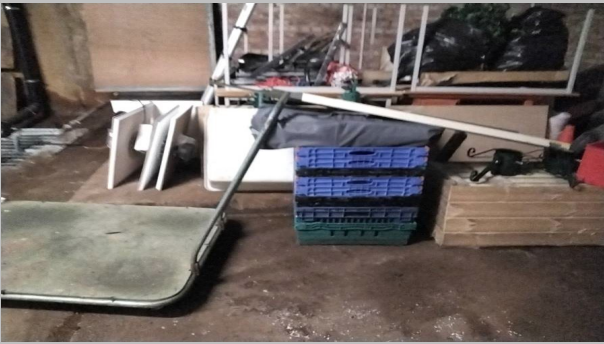
7	KX001659	Debris/residue to floor off plinths	Main Building Boiler Room (Room 098)	No Risk

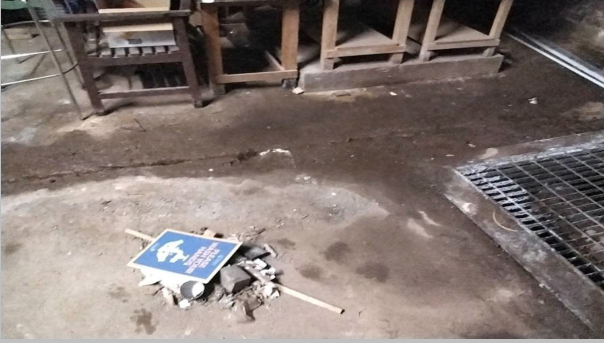
8	KX001660	Debris/residue to floor, drainage gulleys	Main Building Boiler Room (Room 098)	No Risk

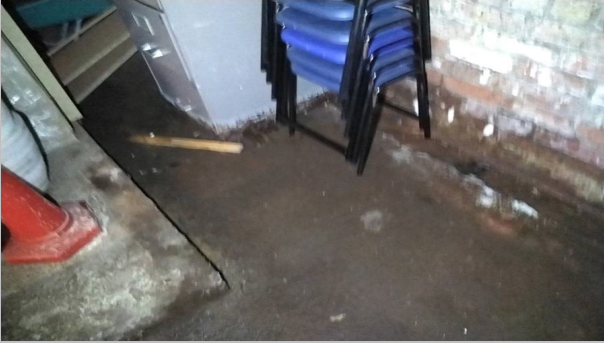
9	KX001661	Debris/residue to floor, at walls behind boiler plinths	Main Building Boiler Room (Room 098)	No Risk

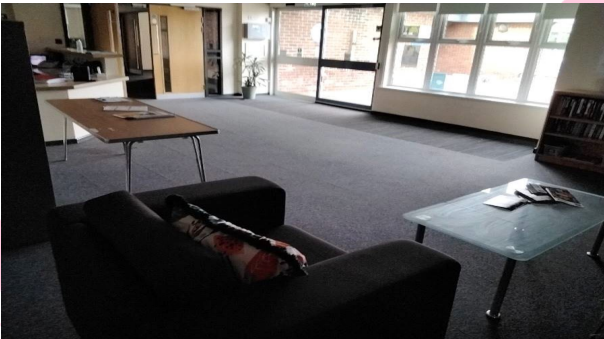
11	KX001636	Floor adhesive residue under carpet and screed	Main Building Reception/Entrance (Room 001)	6 monthly

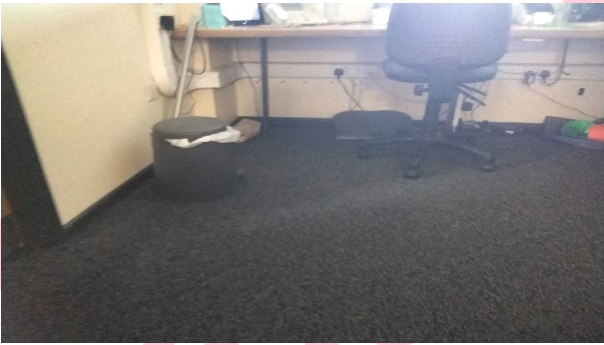
14	As KX001636	Floor adhesive residue under carpet and screed	Main Building Reception (Room 007)	6 monthly

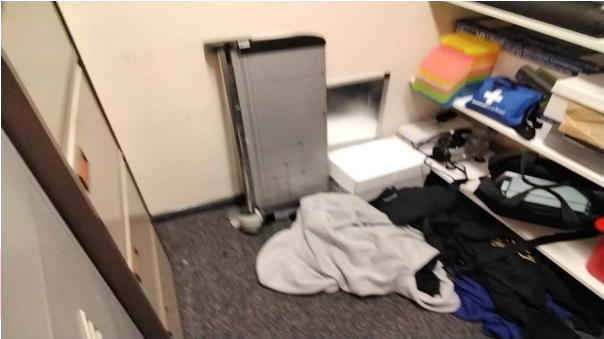
23	As KX001636	Floor adhesive residue under carpet and screed	Main Building Office (Room 009)	12 monthly

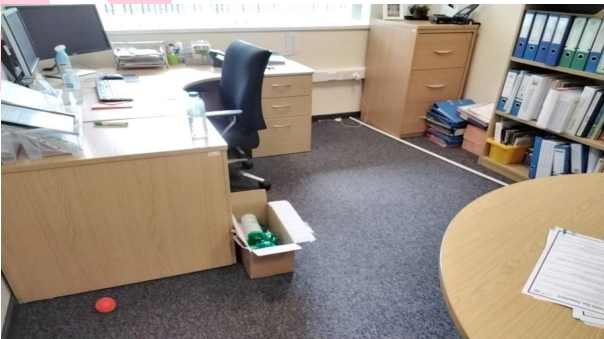
24	KX001638	Floor adhesive residue under carpet	Main Building Office (Room 011)	6 monthly

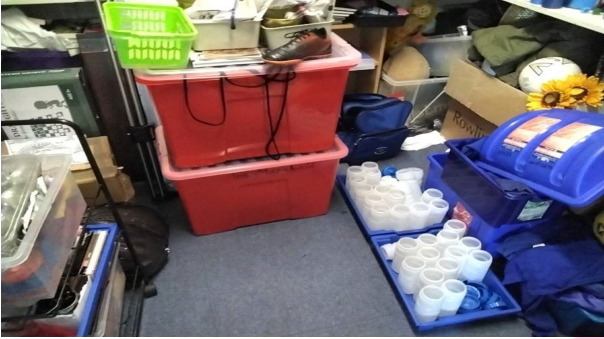
43	Presumed	Floor duct pipe insulation binding to fibreglass pipe insulation within floor duct under concrete slab (identified in previous report)	Main Building Storeroom (Room 024)	12 monthly

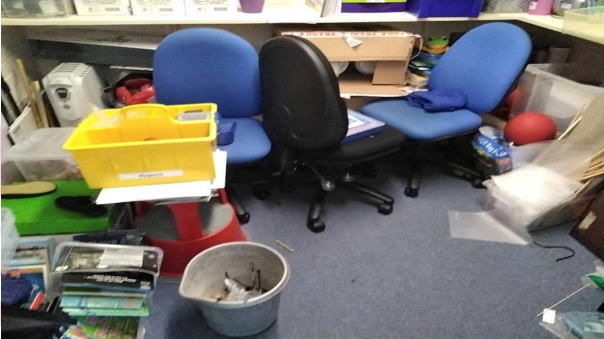
50	Presumed	Floor void/duct string binding to pipework within floor duct under concrete slab (identified in previous report)	Main Building Storeroom (Room 029)	12 monthly

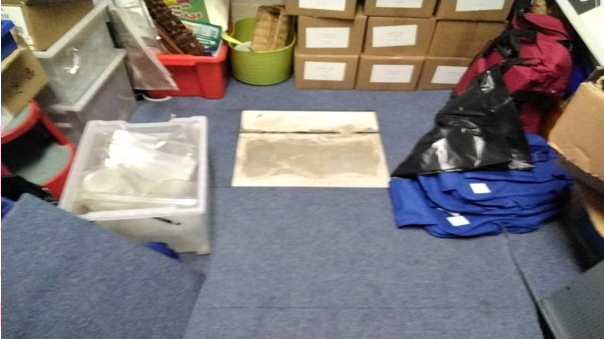
56	Presumed	Floor void/duct string binding to pipework within floor duct under concrete slab (identified in previous report)	Main Building Storeroom (Room 033)	12 monthly

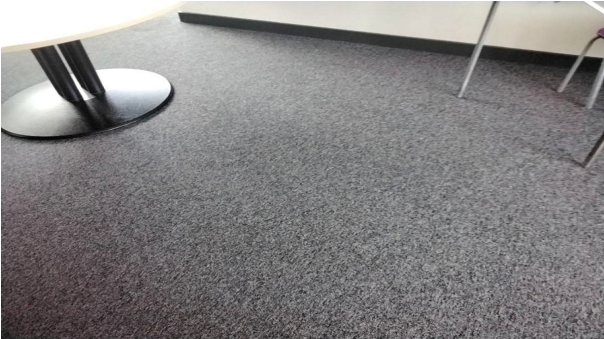
64	As KX001639	Floor adhesive residue under carpet	Main Building Library (Room 051)	6 monthly

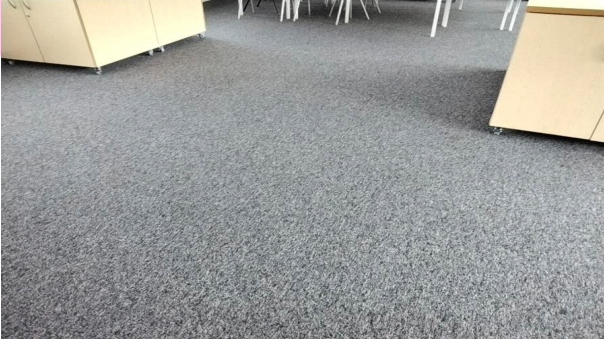
66	As KX001639	Floor adhesive residue under carpet	Main Building Hallway/Passageway (Room 052)	6 monthly

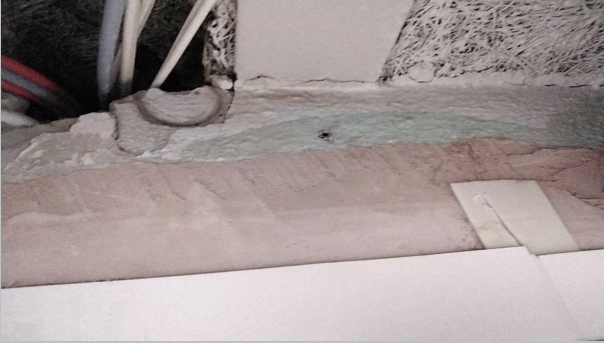
72	KX001641	Wall coating skimmed cladding visible in ceiling void	Main Building Toilets (Room 056)	No Risk

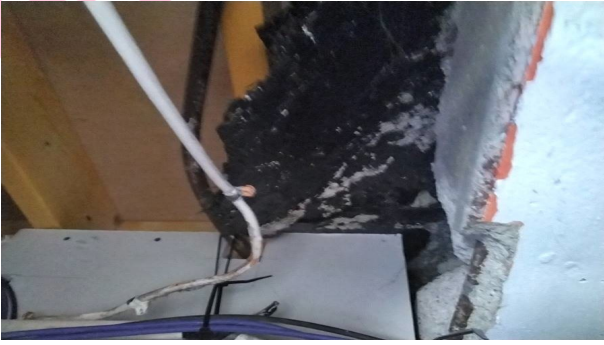
75	KX001643	Ceiling void roof felt debris	Main Building Corridor (Room 037a)	6 monthly

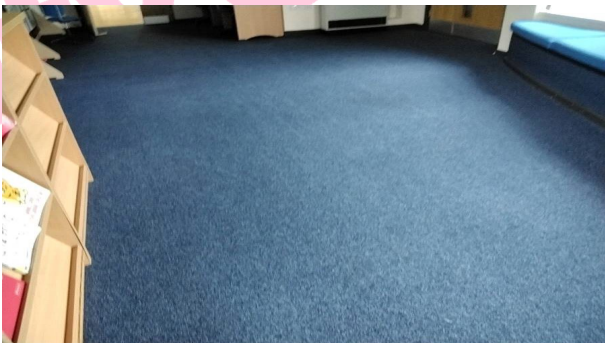
99	As KX001644	Floor adhesive residue	Main Building Corridor (Room 070)	6 monthly

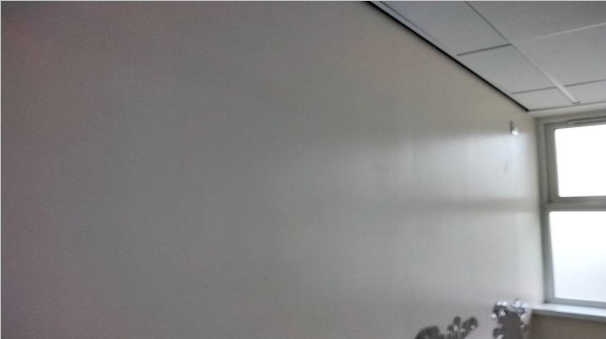
115	As KX001667	Wall Coating	Main Building Toilets (Room 080)	No Risk
