ASBESTOS SURVEY REPORT FOR 1 MARLOW DRIVE, MOORSIDE,
DOXFORD PARK, SR3 2RW

Asbestos Register for

1 Marlow Drive, Moorside, SR3 2RW

Date: 09 September 2024

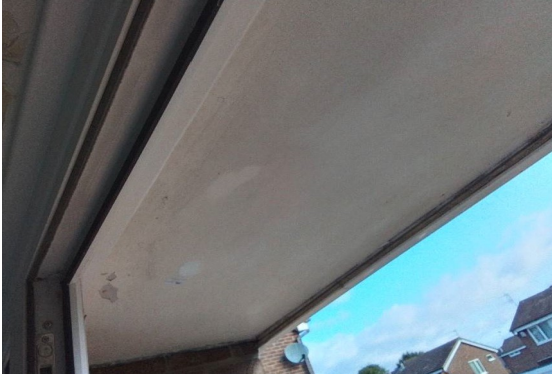
Item 1 Ref: Presumed

The canopy ceiling externally (E/001) contains asbestos.

Any change in its appearance should be recorded and passed to Property Services.

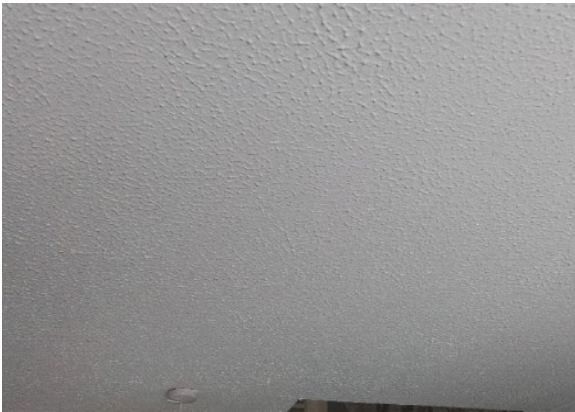
Item 2 Ref: PZ000414

The ceiling coating in the Entrance Hall/Foyer/Lobby G/001 does not contain asbestos.

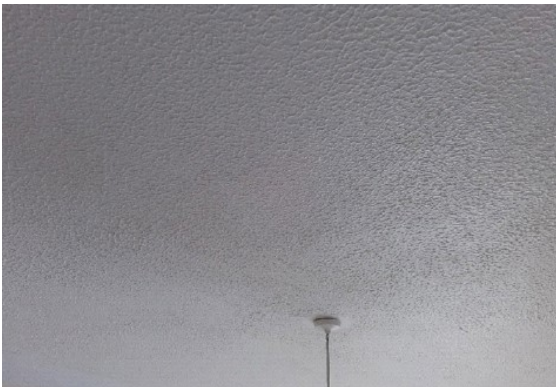
Item 3 Ref: As PZ000414

The ceiling coating in the Dining Room G/003 does not contain asbestos.

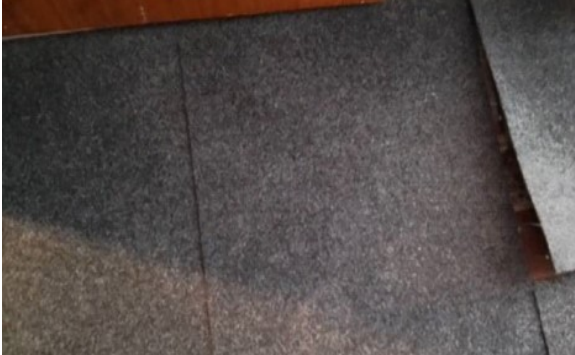
Item 4 Ref: PZ000415

The floor adhesive in the Hallway/Passageway rear of property does not contain asbestos.

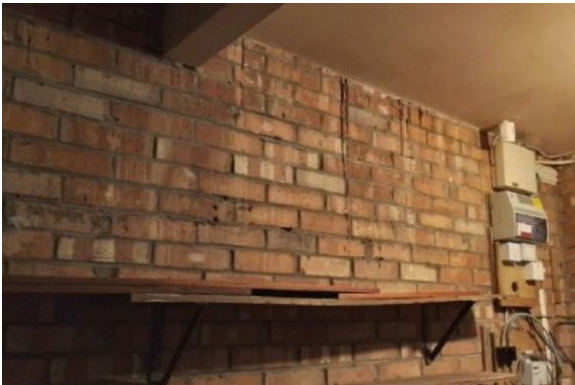
Item 5 Ref: PZ000416

The roof felt adhesive in the Garage G/007 does not contain asbestos.

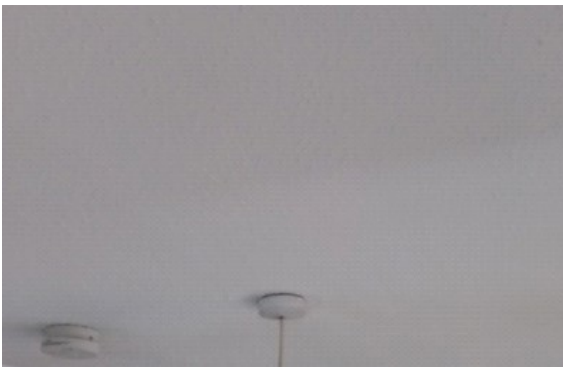
Item 6 Ref: PZ000417

The ceiling coating in the landing 1/001 does not contain asbestos.

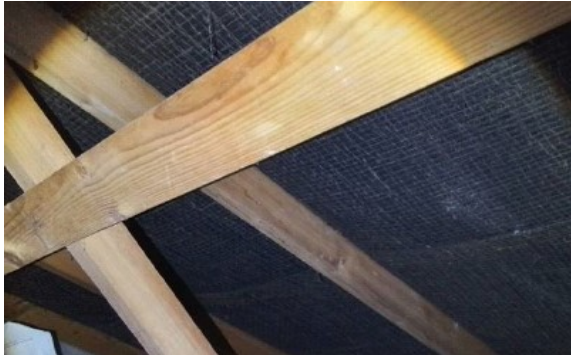
Item 7 Ref: PZ000418

The roof lining limited access low roof wire across hatch area in the loft space R/001 does not contain asbestos.

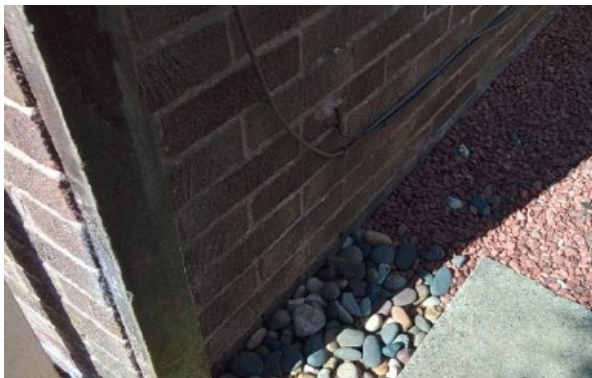
Item 8 Ref: PZ000419

The damp proof course externally E/001 does not contain asbestos.

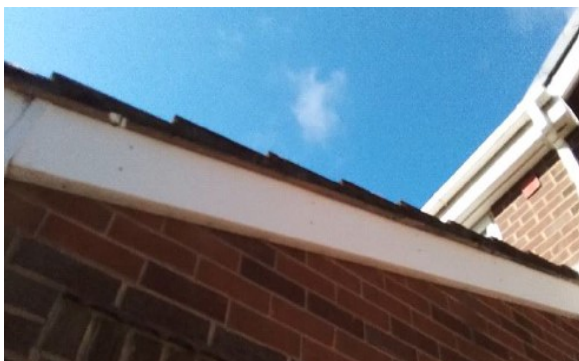
Item 9 Ref: PZ000420

The undercloak lower level front and rear externally E/001 does not contain asbestos.

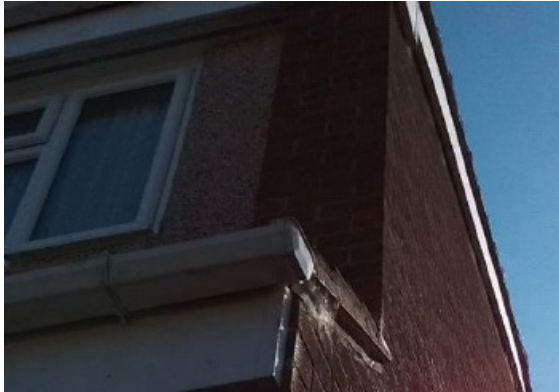
Item 10 Ref: As PZ000420

The undercloak to the main roof externally E/001 does not contain asbestos.

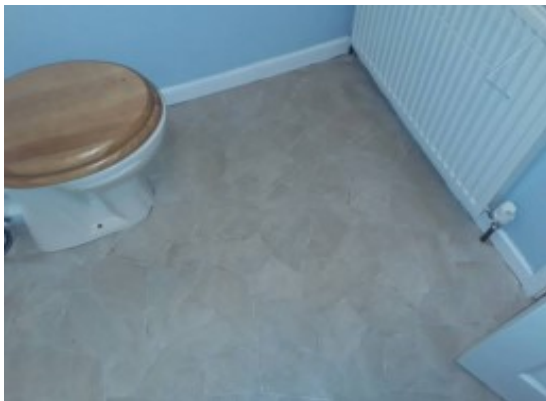
Item 11 Ref: NZ000699

The floor covering bottom layer in Bathroom 1/001 does not contain asbestos.

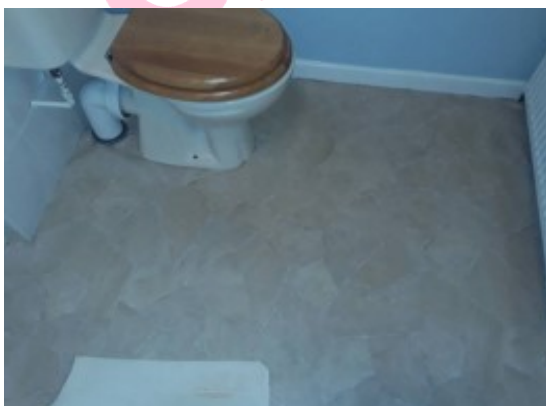
Item 12 Ref: NZ000700

The floor covering top layer in Bathroom 1/001 does not contain asbestos.

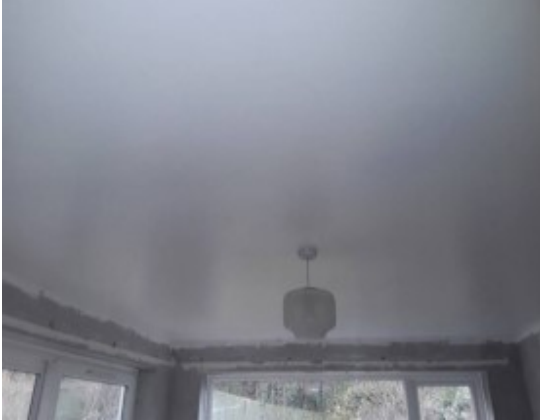
Item 13 Ref: NZ000830

The Composite decorative finish in Dining Room G/001 does not contain asbestos.

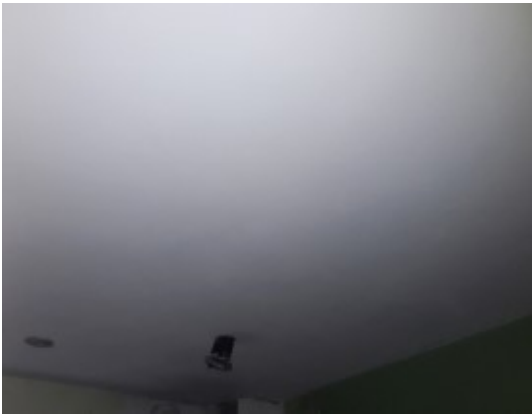
Item 14 Ref: NZ000831

The ceiling single boarded no textured coating including sloping ceiling in Kitchen G/002 does not contain asbestos.
