ASBESTOS SURVEY REPORT FOR 1 MARLOW DRIVE, MOORSIDE,
DOXFORD PARK, SR3 2RW

Asbestos Register for

1 Marlow Drive, Moorside, SR3 2RW

Date: 21 August 2025

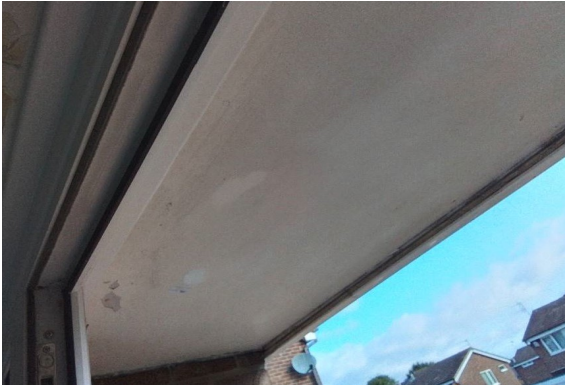
Item 1 Ref: Presumed

The canopy ceiling externally (E/001) contains asbestos.

Any change in its appearance should be recorded and passed to Property Services.

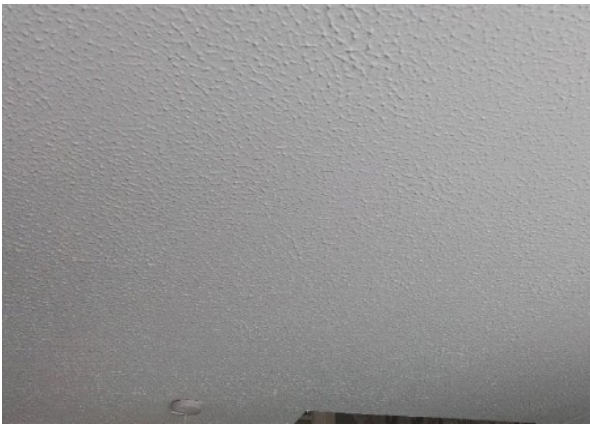
Item 2 Ref: PZ000414

The ceiling coating in the Entrance Hall/Foyer/Lobby G/001 does not contain asbestos.

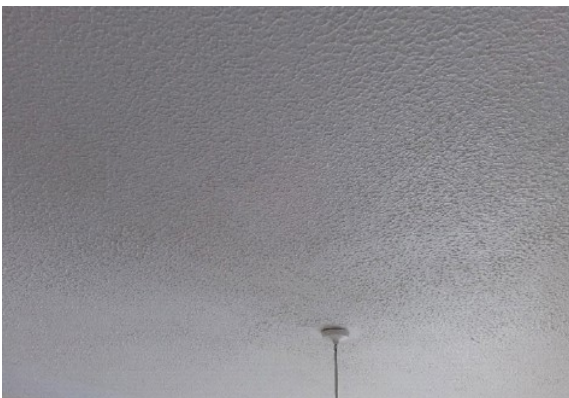
Item 3 Ref: As PZ000414

The ceiling coating in the Dining Room G/003 does not contain asbestos.

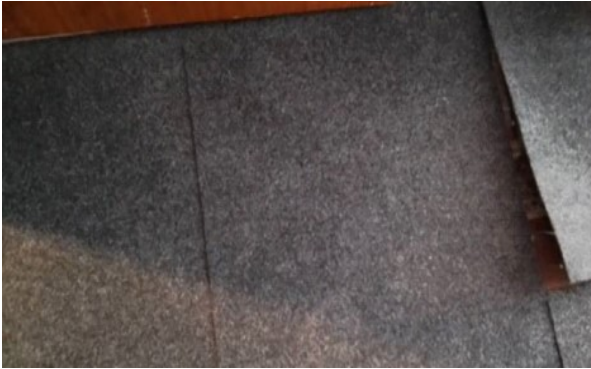
Item 4 Ref: PZ000415

The floor adhesive in the Hallway/Passageway rear of property does not contain asbestos.

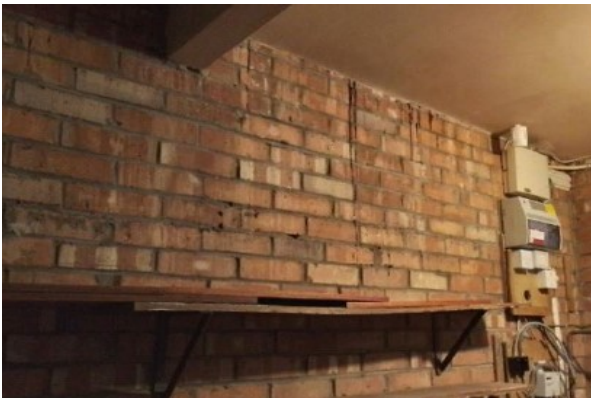
Item 5 Ref: PZ000416

The roof felt adhesive in the Garage G/007 does not contain asbestos.

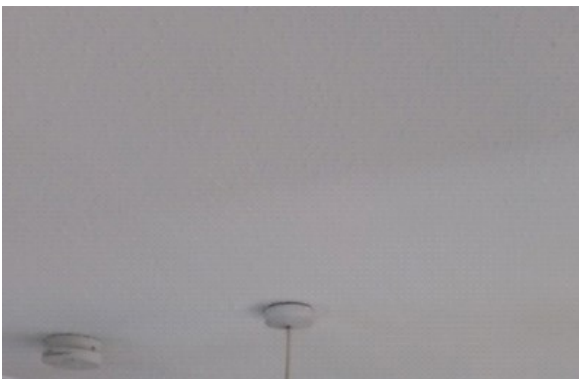
Item 6 Ref: PZ000417

The ceiling coating in the landing 1/001 does not contain asbestos.

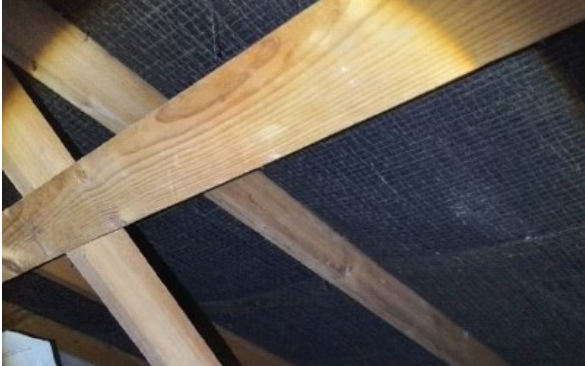
Item 7 Ref: PZ000418

The roof lining limited access low roof wire across hatch area in the loft space R/001 does not contain asbestos.

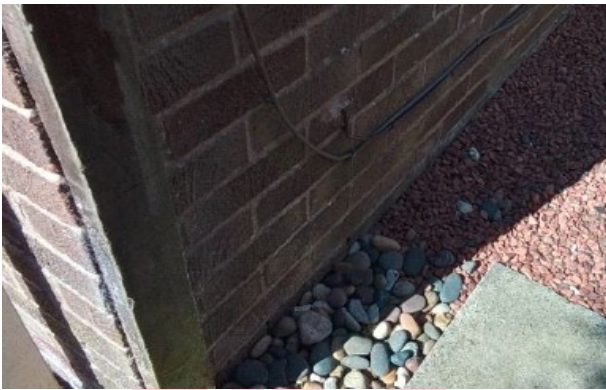
Item 8 Ref: PZ000419

The damp proof course externally E/001 does not contain asbestos.

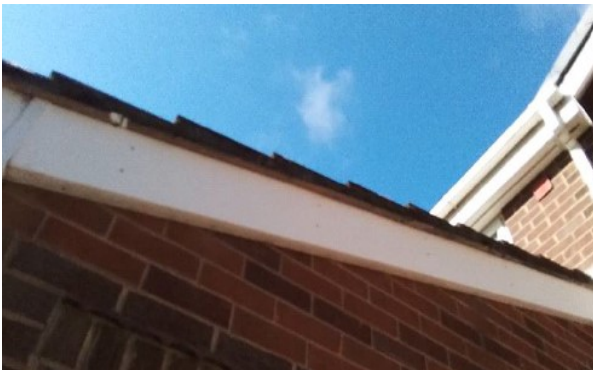
Item 9 Ref: PZ000420

The undercloak lower level front and rear externally E/001 does not contain asbestos.

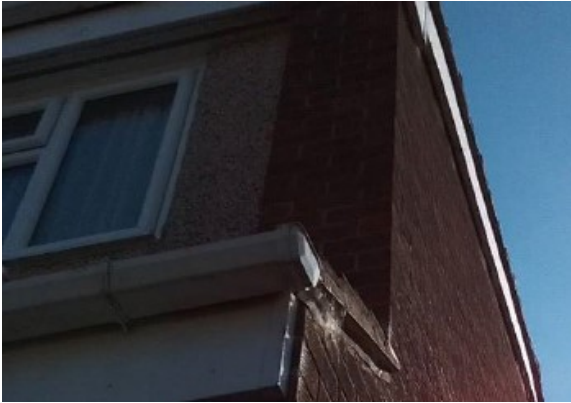
Item 10 Ref: As PZ000420

The undercloak to the main roof externally E/001 does not contain asbestos.

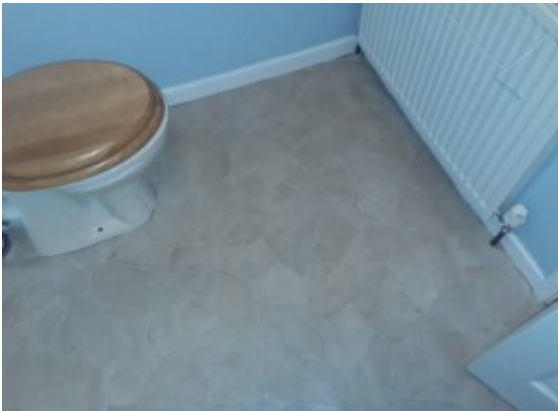
Item 11 Ref: NZ000699

The floor covering bottom layer in Bathroom 1/001 does not contain asbestos.

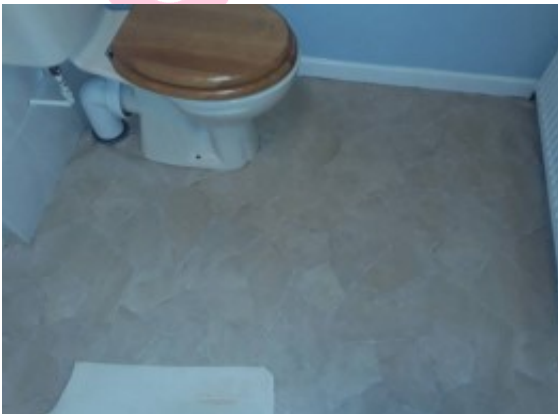
Item 12 Ref: NZ000700

The floor covering top layer in Bathroom 1/001 does not contain asbestos.

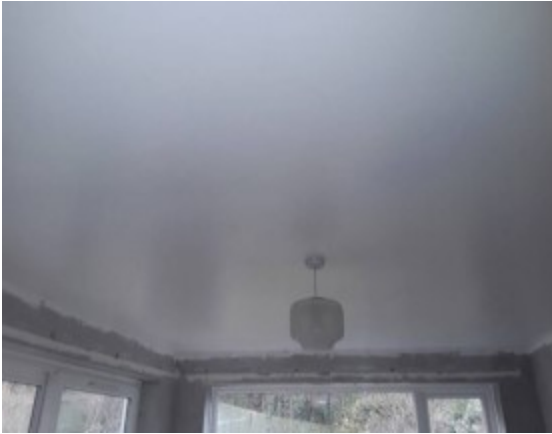
Item 13 Ref: NZ000830

The Composite decorative finish in Dining Room G/001 does not contain asbestos.

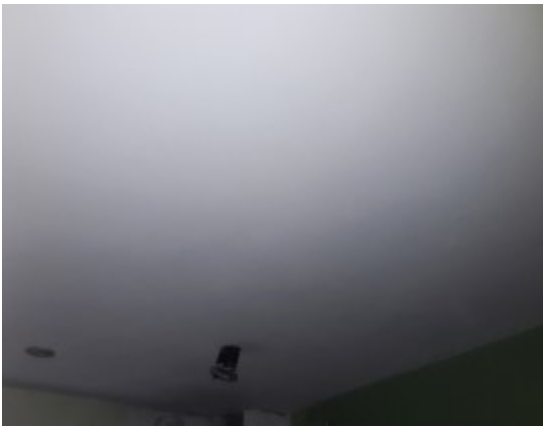
Item 14 Ref: NZ000831

The ceiling single boarded no textured coating including sloping ceiling in Kitchen G/002 does not contain asbestos.
