ASBESTOS SURVEY REPORT FOR FULWELL JUNIOR SCHOOL CT HOUSE, SUNDERLAND

Fulwell Juniors Caretakers House

**Asbestos Register for
FULWELL JUNIORS CARETAKERS HOUSE**

Date: 20 September 2023

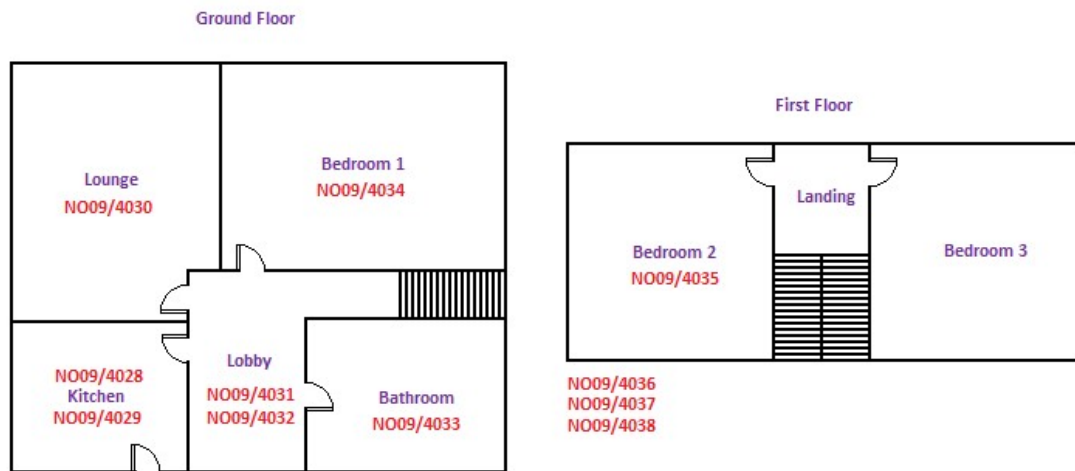
Plan of Building and Samples Location – Caretakers House

- NO09/4028 – Coating to ceiling (Kitchen) (Item 1) - No Risk
 - NO09/4029 – Sink pad (Kitchen) (Item 2) - No Risk
 - NO09/4030 – Coating to ceiling (Lounge) (Item 3) – No Risk

- NO09/4031 – Coating to walls (Lobby) (Item 4) - No Risk
 - NO09/4032 – Coating to ceiling (Lobby) (Item 5) – No Risk
 - NO09/4033 – Coating to ceiling (Bathroom) (Item 6) - No Risk

- NO09/4034 – Coating to ceiling (Grnd Flr Bedrm) (Item 7) - No Risk
 - As NO09/4031 – Coating to walls (Stairs) (Item 8) - No Risk
 - As NO09/4032 – Coating to ceiling (Stairs) (Item 9) - No Risk

- NO09/4035 – Coating to ceiling (1st Flr Bedrm 2) (Item 10) - No Risk
 - As NO09/4035 – Coating to ceiling (1st Flr bedrm 3) (Item 11) – No Risk
- *No access to loft gained***

- NO09/4036 – Fillet boards (Externals) - Removed March 2011
 - NO09/4037 – Soffit boards (Externals) (Item 12) – No Risk
 - NO09/4038 – Damp proof course (External) (Item 13) - No Risk

- IC11/246 – Sarking Felt (Loft) (Item 14) - No Risk

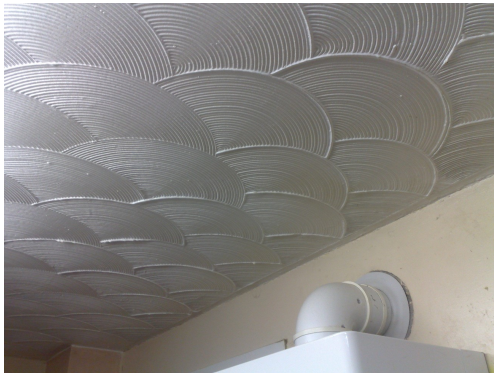
Item 1 Ref: NO09/4028

The textured coating to the ceiling in the kitchen does not contain asbestos.

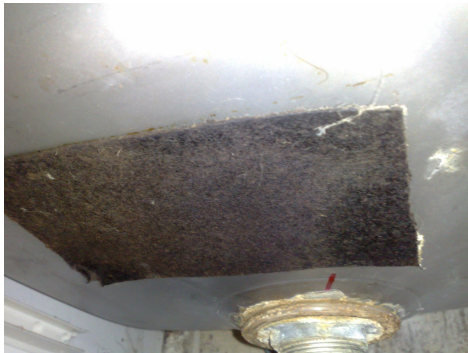
Item 2 - Ref: NO09/4028

The sink pad to the kitchen does not contain asbestos.

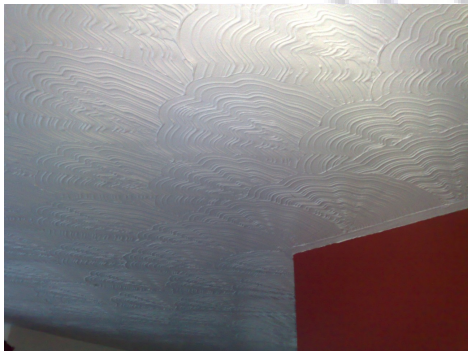
Item 3 - Ref: NO09/4030

The textured coating to the ceiling in the lounge does not contain asbestos.

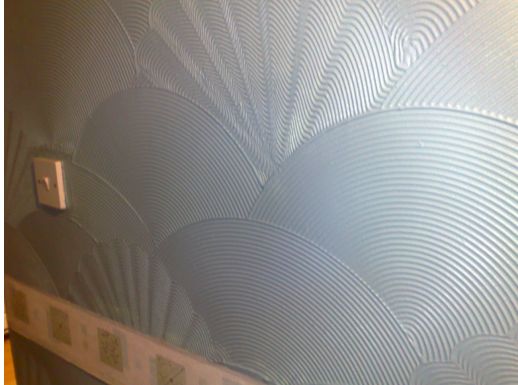
Various - Ref: NO09/4031

The textured coating to the walls in the lobby does not contain asbestos.

Similar textured coating is located on the stairs.

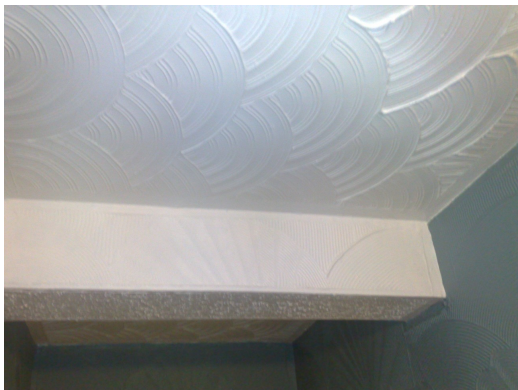
Various - Ref: NO09/4032

The textured coating to the ceiling in the living room does not contain asbestos.

Similar textured coating is located on the stairs and landing.

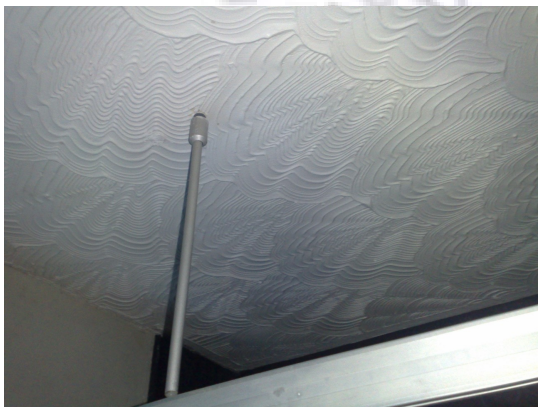
Item 6 - Ref: NO09/4033

The textured coating to the ceiling in the bathroom does not contain asbestos.

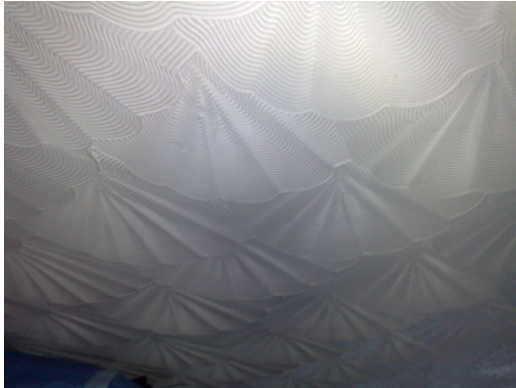
Item 7 - Ref: NO09/4034

The textured coating to the ceiling in the ground floor bedroom does not contain asbestos.

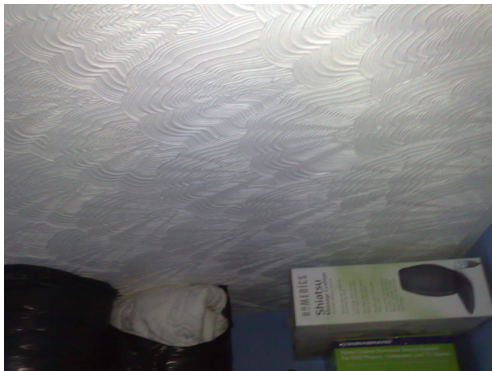
Various - Ref: NO09/4035

The textured coating to the ceiling in the first floor bedroom does not contain asbestos.

Similar textured coating is located on the ceiling to first floor bedroom 3.

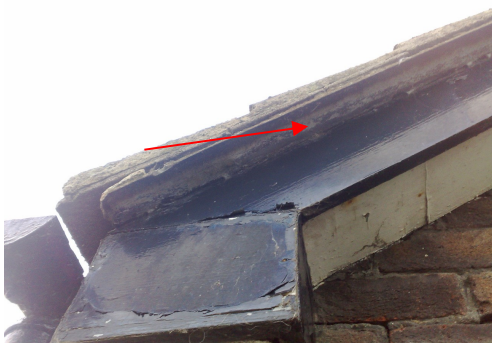
Ref: NO09/4036

The fillet boards to the external of the house contained asbestos. They were removed in March 2011.

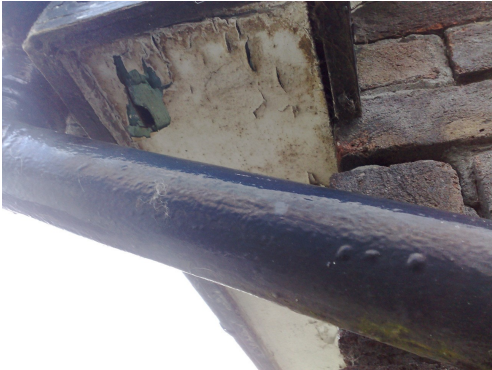
Item 12 - Ref: NO09/4037

The soffit boards to the external do not contain asbestos.

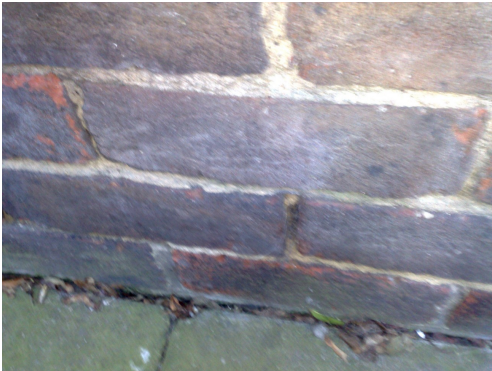
Item 13 - Ref: NO09/4037

The damp proof course to the external does not contain asbestos.
