ASBESTOS SURVEY REPORT FOR DOXFORD PARK LIBRARY AND COMMUNITY BUILDING

Asbestos Register for Doxford Park Library and Community Building

UPRN: - J200958

Date: 04 October 2023

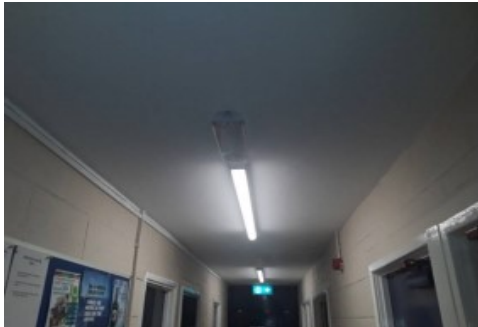
Item 1 Ref: NZ000592

The ceiling in the Hallway/Passageway (Rm G/014) does not contain asbestos.

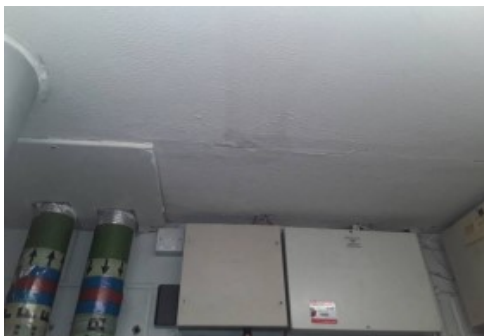
Item 2 Ref: As NZ000592

The ceiling in the Boiler Room (Rm G/018) does not contain asbestos.

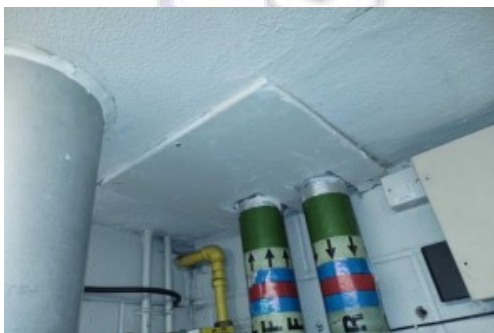
Item 3 Ref: 23-63903-2

The ceiling panel to flue penetration in the Boiler Room (Area 001) does not contain asbestos.
