ASBESTOS SURVEY REPORT FOR CASTLETOWN PRIMARY SCHOOL

Asbestos Register for CASTLETOWN PRIMARY SCHOOL

Date: 21 January 2025

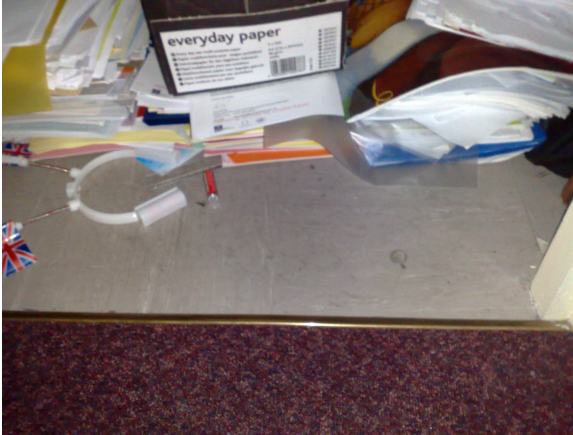
Various Ref: CS09/237

The vinyl flooring to the Heads room does not contain asbestos.

Similar vinyl flooring is located in:

Staff Rm, Repro Rm, Base 11/12, Base 13/14, CT Office, Base 7/8, Base 9/10, Base 3/4, Base 3/4 Stores, Base 5/6 Stores, Toy Store, Library Store, Cleaners Cupbd, Servery Staff Wc, Dep Ht Stores, Cleaners Store, Equipment Store, Reception Store, Base 2 Store, Secure Store 1 and Cleaners Equip Store.

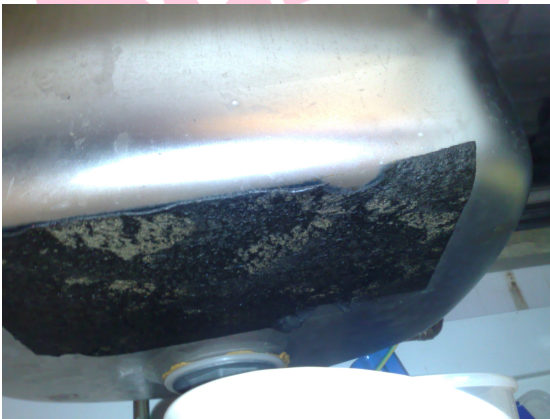
Various - Ref: CS09/238

The sink pad in the staff room does not contain asbestos.

Similar sink pads are located in;

Repro Rm, Base 11/12, Base 13/14, Base 7/8, Base 9/10, Base 5/6, Base 1/2 Prac, Nursery Playroom, Kitchen and Tea Room.

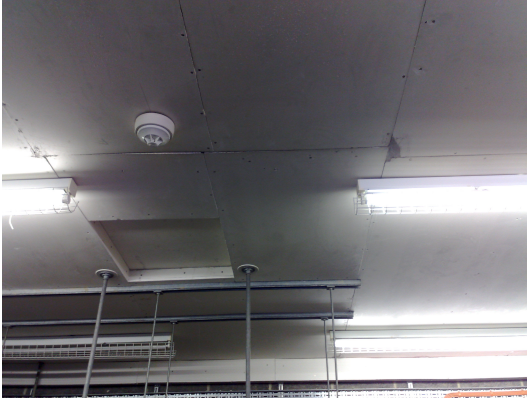
Various - Ref: CS09/239

The ceiling panels in the boiler room do not contain asbestos.

Similar ceilings are located in the electric room and Gas Room.

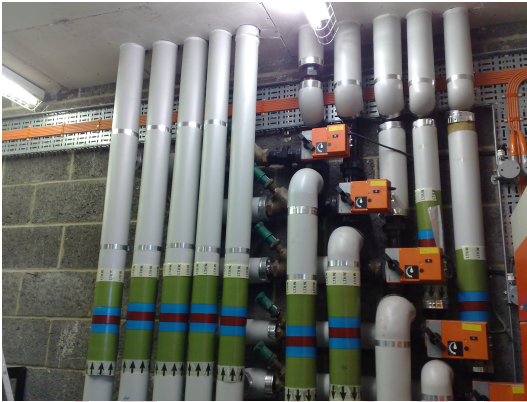
Item 29 - Ref: CS09/240

The pipe insulation to the boiler room does not contain asbestos.

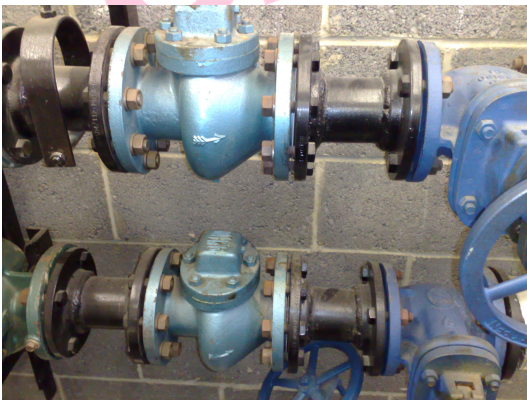
Item 30 - Ref: CS09/241

The gaskets throughout the Boiler Room contained asbestos.

These were removed in August 2015.

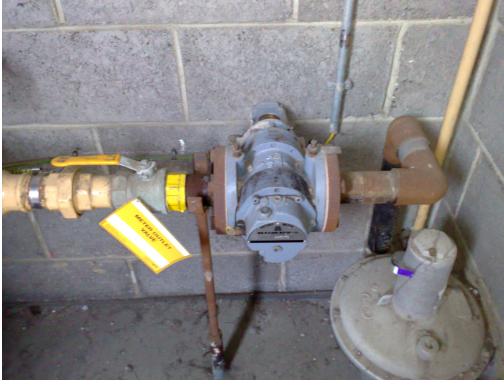
Item 33- Ref: CS09/242

The gaskets throughout the Gas Room contain asbestos.

Any change in their appearance should be recorded and passed to Property Services.

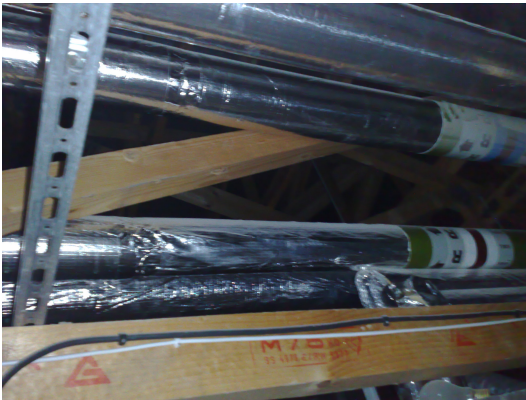
Item 36- Ref: CS09/243

The pipe insulation to the loft space does not contain asbestos.

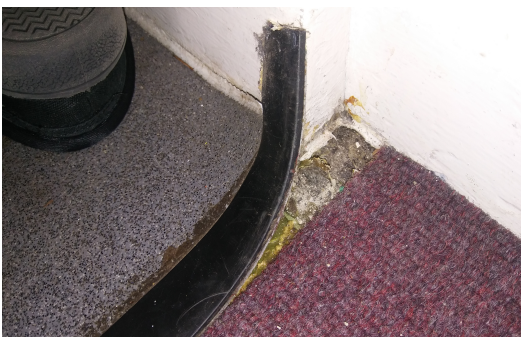
Item 41- Ref: As 343959-1

The screed to the floor in Year 5 Classroom does not contain asbestos.

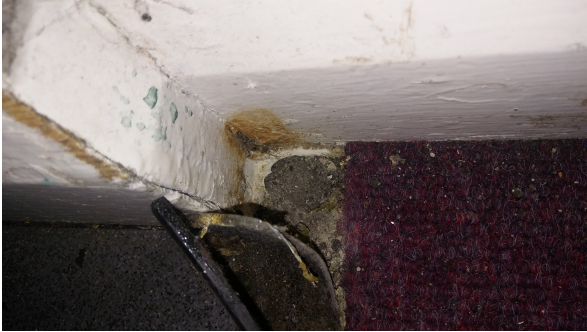
Item 42- Ref: 343959-1

The screed to the floor in Year 6 Classroom does not contain asbestos.

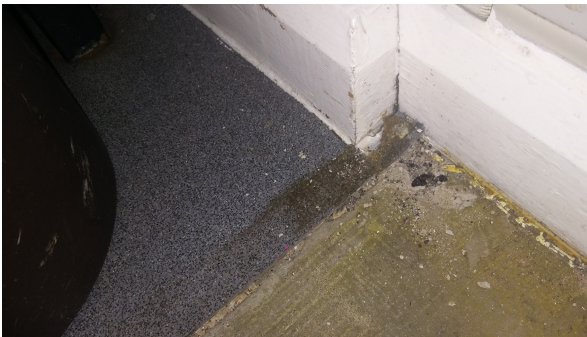
Item 43- Ref: 343959-1

The screed to the floor in Year 3 Classroom does not contain asbestos.

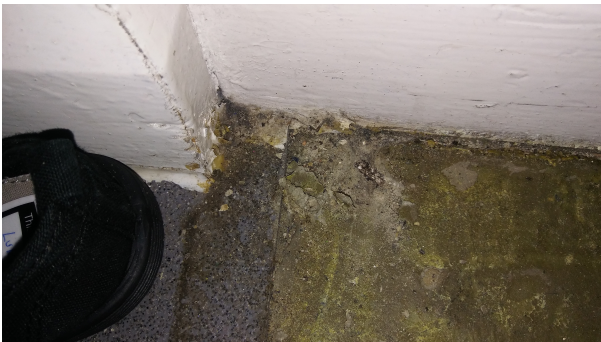
Item 44- Ref: 343959-1

The screed to the floor in Year 4 Classroom does not contain asbestos.

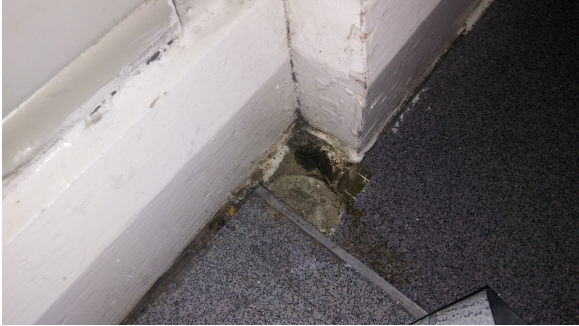
Item 45- Ref: 343959-1

The screed to the floor in Year 1 Classroom does not contain asbestos.

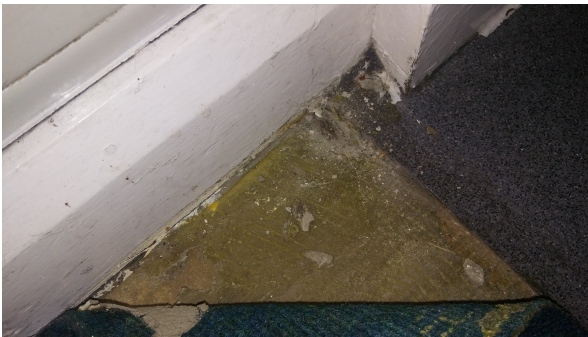
Item 46- Ref: 343959-1

The screed to the floor in Year 2 Classroom does not contain asbestos.

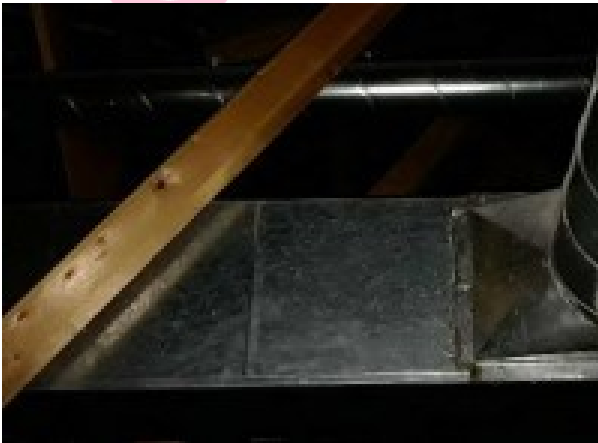
Item 47- Ref: 21-33433-1

The vessels – ducting inside ceiling void (Mastic) in the ceiling void above Boys Changing Rooms and Classroom does not contain asbestos.

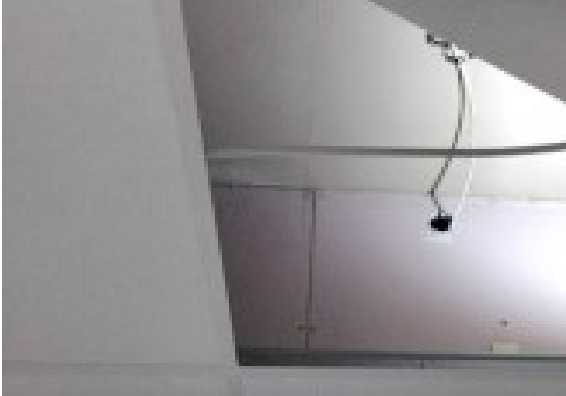
Item 48- Ref: NO000679

The fire breaks in the ceiling void in the Kitchen (G/001) does not contain asbestos.

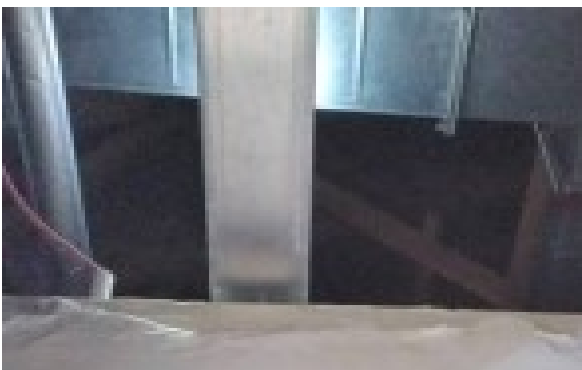
Item 50- Ref: NO000681

The fire breaks in the ceiling void in the Corridor (G/002) does not contain asbestos.
