ASBESTOS SURVEY REPORT FOR WINCHESTER HOUSE, SUNDERLAND,
TYNE AND WEAR, SR5 4LW

Asbestos Register for

Winchester House, Sunderland, SR5 4LW

Date: 22 April 2024

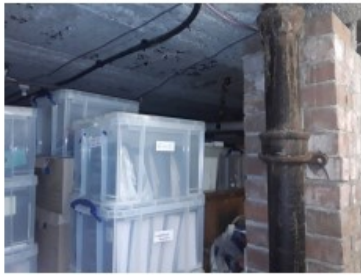
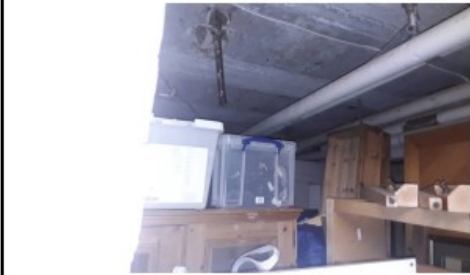
1	Presumed	Electrical services cable braiding/insulation	Store room restricted access due to stored items Z1/002	Very Low Risk – 12 monthly
Photo 1: Wide Angle			Photo 2: Close-up

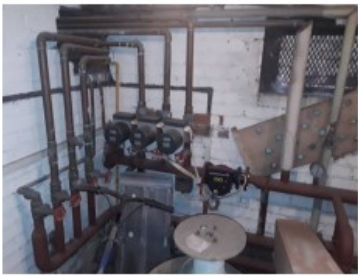
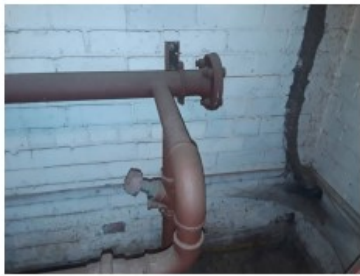
2	NZ001192	Pipework Gasket	Boiler Room Z1/003	Very Low Risk – 12 monthly
Photo 1: Wide Angle			Photo 2: Close-up

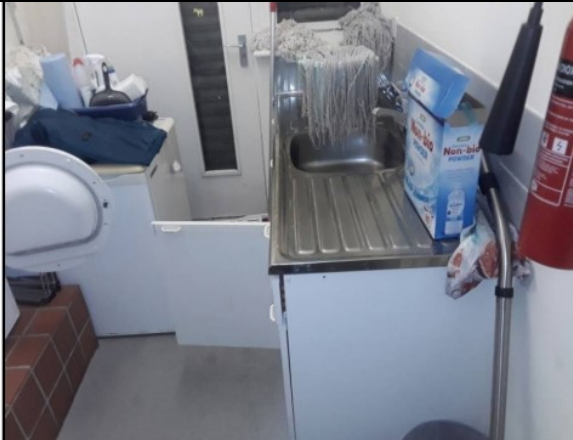
3	NZ001184	Under Sink Mat	Laundry G/008	No Risk

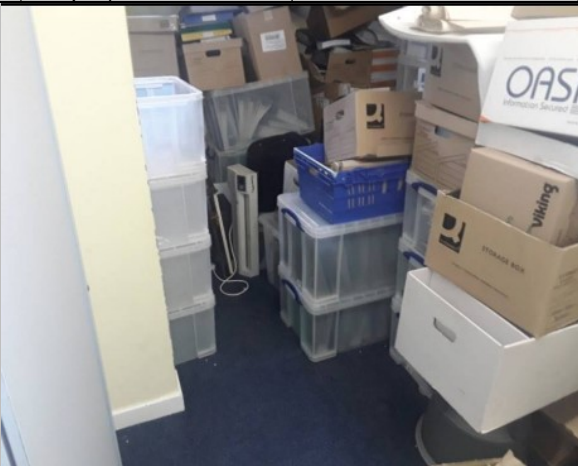
4	NZ001185	Floor tile with adhesive (under carpet)	Store Room G/021	No Risk

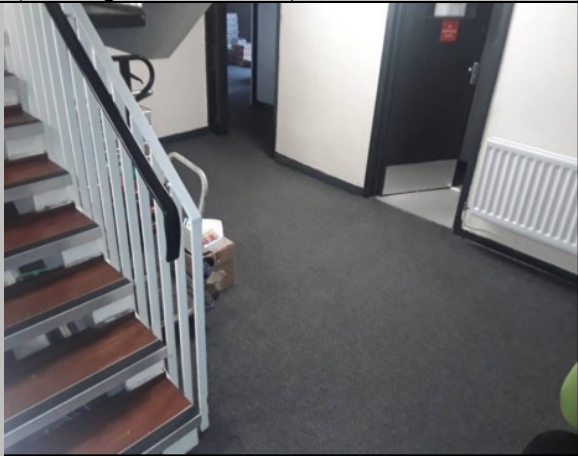
5	NZ001186	Floor covering under carpet running up skirting	Stairwell/Staircase G/026	No Risk

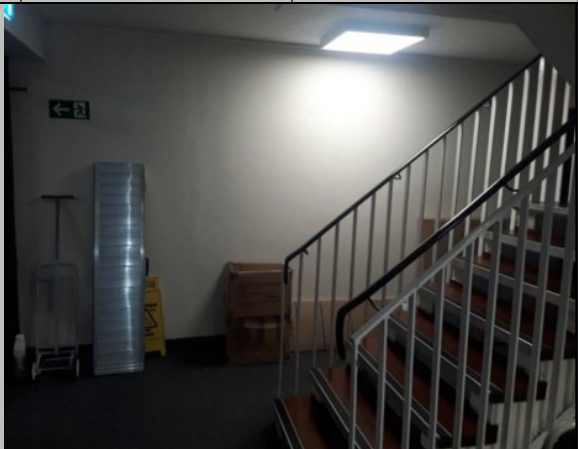
6	NZ001187	Wall coating	Stairwell/Staircase G/026	No Risk

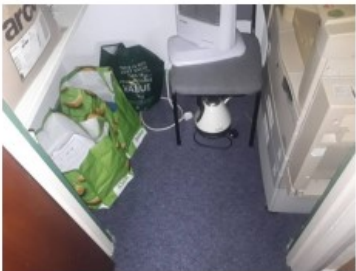
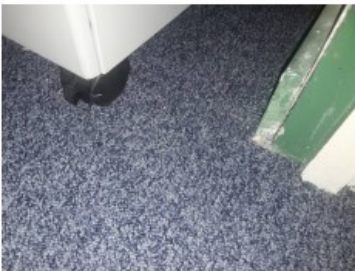
22	As NZ001191	Floor adhesive under carpet and modern screed	Cupboard 2 Office 1/022	Very Low Risk – 12 monthly
Photo 1: Wide Angle		Photo 2: Close-up

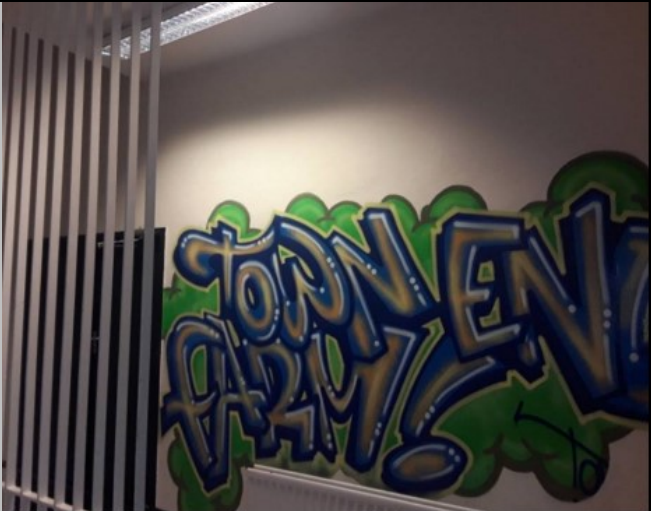
23	As NZ001190	Wall coating	Landing 2/001	No Risk

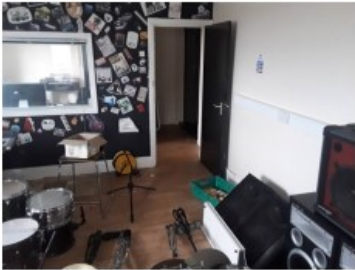
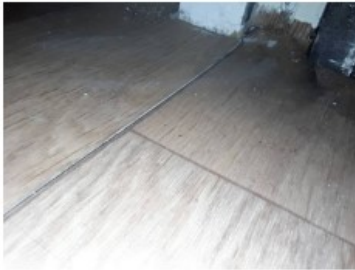
24	NZ001195	Floor adhesive under modern flooring	Corridor 2/002	Very Low Risk – 12 monthly
Photo 1: Wide Angle		Photo 2: Close-up

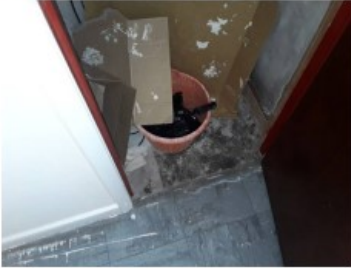
28	As NZ001195	Floor adhesive	Cupboard Store Ladies Toilet 2/010	Very Low Risk – 12 monthly
Photo 1: Wide Angle		Photo 2: Close-up

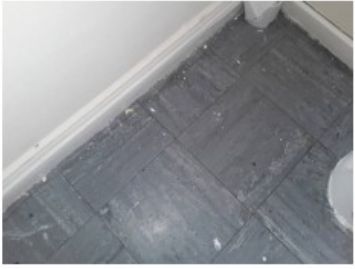
29	As NZ001196	Floor tile (with adhesive) with old adhesive on rear	Toilets Female 2/011	Very Low Risk – 12 monthly
Photo 1: Wide Angle		Photo 2: Close-up

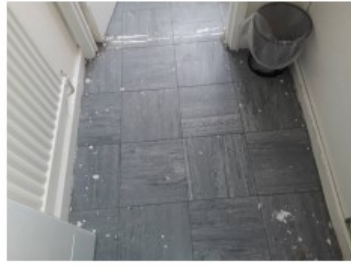
30	As NZ001196	Floor tile (with adhesive) with old adhesive on rear	Toilets Female washroom 2/012	Very Low Risk – 12 monthly
Photo 1: Wide Angle		Photo 2: Close-up

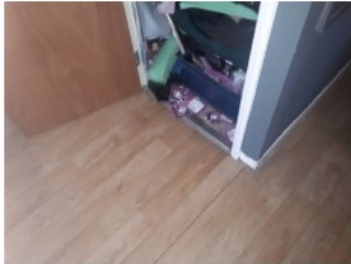
38	As NZ001196	Floor tile (with adhesive) with old adhesive on rear to the threshold only	Cupboard 2/021	Very Low Risk – 12 monthly
Photo 1: Wide Angle		Photo 2: Close-up

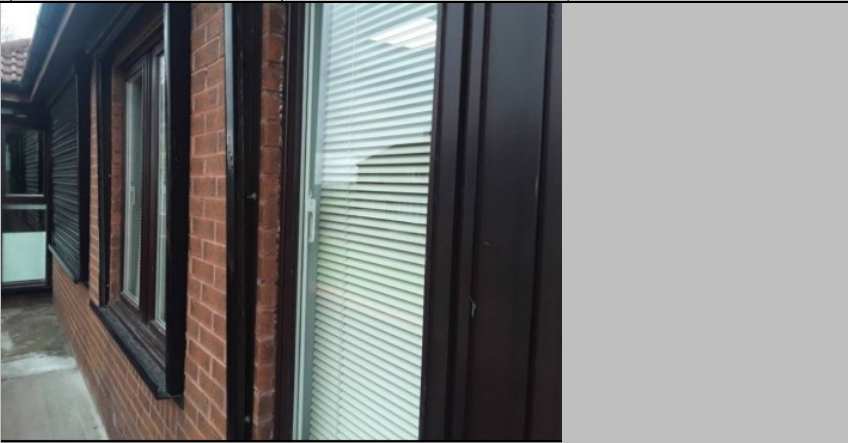
40	NZ001194	Window putty seal to frame wall door and windows. Timber frame to nursery extension	External E/001	No Risk

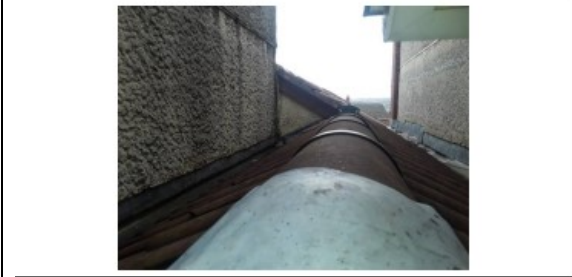
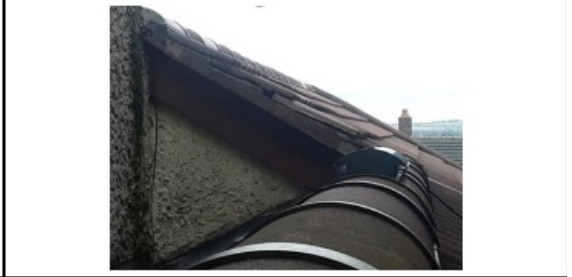
41	Presumed	Undercloak to small section of roof above reception corridor	External E/001	Very Low Risk – 12 monthly
Photo 1: Wide Angle			Photo 2: Close-up
