ASBESTOS SURVEY REPORT FOR PRUDHOE WEST ACADEMY, WEST ROAD, PRUDHOE, NORTHUMBERLAND, NE42 6HR

## **Asbestos Register for Prudhoe West Academy**

**Date: 17 January 2025**

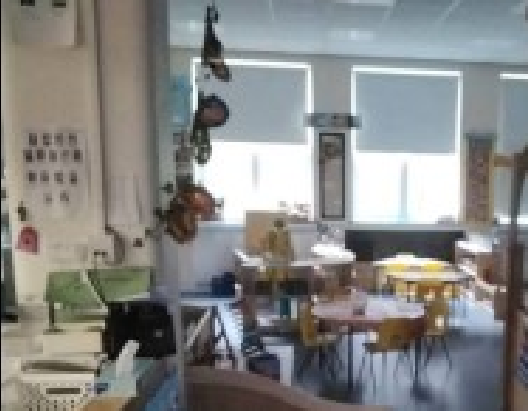
16	As NG002180	Floor covering	Classroom G/040	No Risk

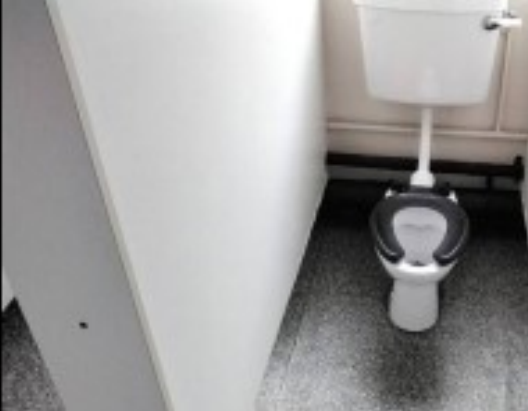
17	NG002179	Pipework	Toilets G/041	No Risk
