ASBESTOS SURVEY REPORT FOR PRUDHOE WEST ACADEMY, WEST ROAD, PRUDHOE, NORTHUMBERLAND, NE42 6HR

Asbestos Register for Prudhoe West Academy

Date: 03 April 2025

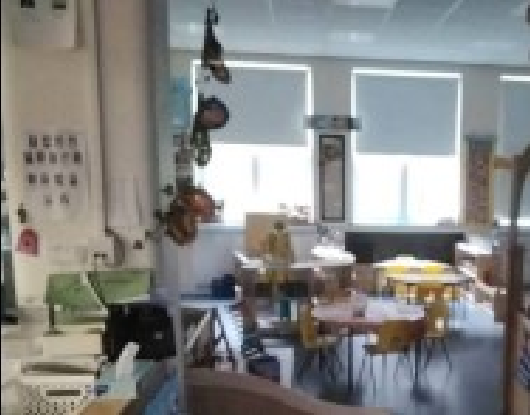
16	As NG002180	Floor covering	Classroom G/040	No Risk

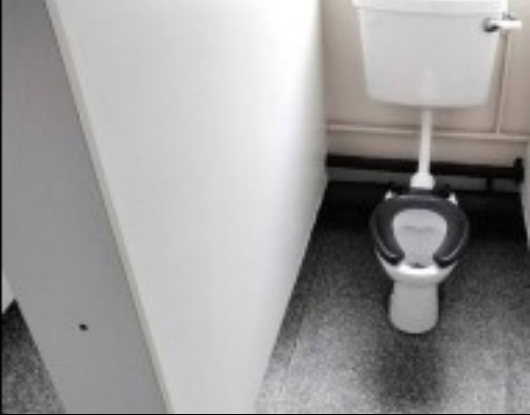
17	NG002179	Pipework	Toilets G/041	No Risk
