ASBESTOS SURVEY REPORT FOR CHAPELGARTH REMEDIATION,
WEYMOUTH ROAD, SUNDERLAND, SR3 2NQ.

Asbestos Register for

Chapelgarth Remediation, Weymouth Road, Sunderland

Date: 09 April 2024

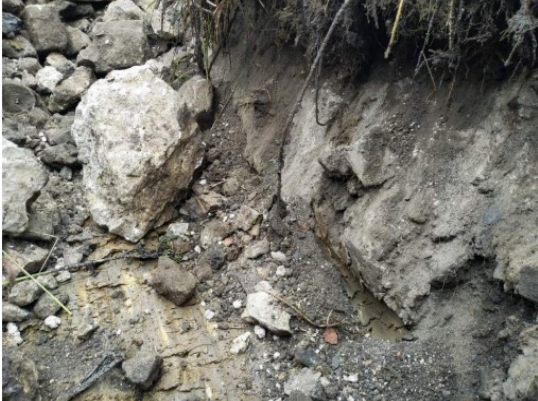
4	060722DP-04	Debris to Trail Pit 3 Clay 800 mm	External	Very Low Risk - 12 monthly

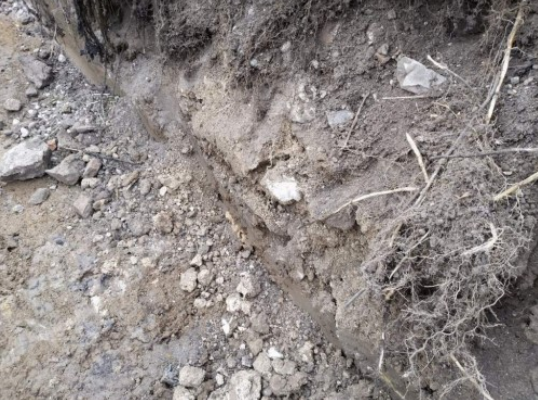
5	060722DP-05	Debris to Trail Pit 4 Clay 250mm	External	Very Low Risk - 12 monthly

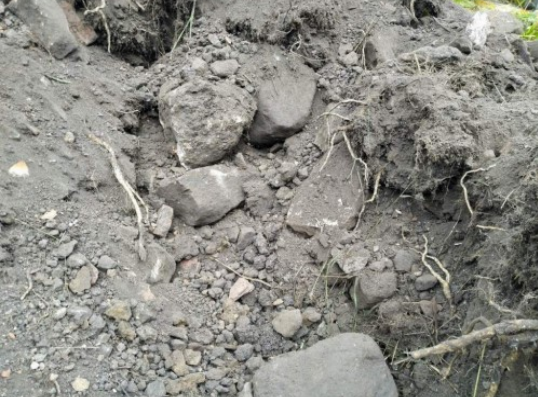
6	060722DP-06	Debris to Trail Pit 5 Clay 250 mm	External	No Risk

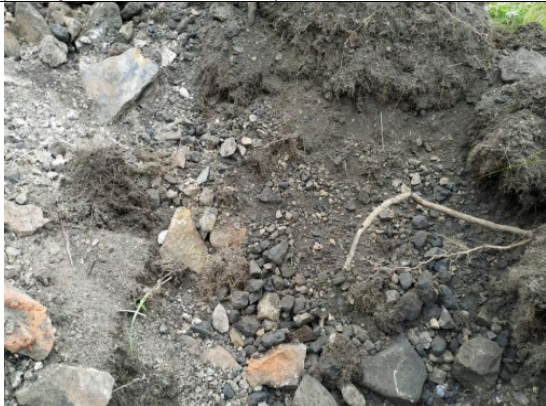
13	060722DP-013	Debris to Trail Pit 13 Clay 200 mm	External	Very Low Risk - 12 monthly

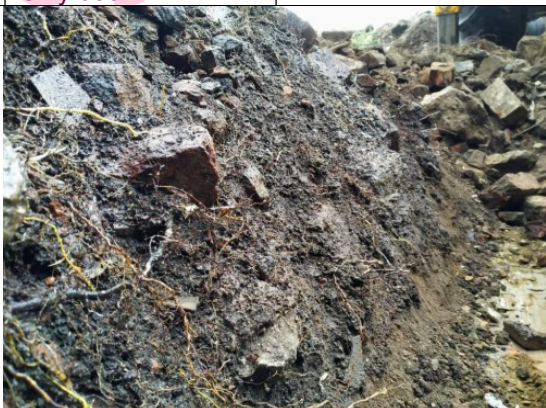
15	070722DP-02	Debris to Trail Pit 18 Clay 600 mm	External	Very Low Risk - 12 monthly
