### ASBESTOS SURVEY REPORT FOR PETER SMITH ANTIQUES, 12 – 14 BOROUGH ROAD

# Sunderland City Council

## Asbestos Register for

**12 – 14 Borough Road, Sunderland**

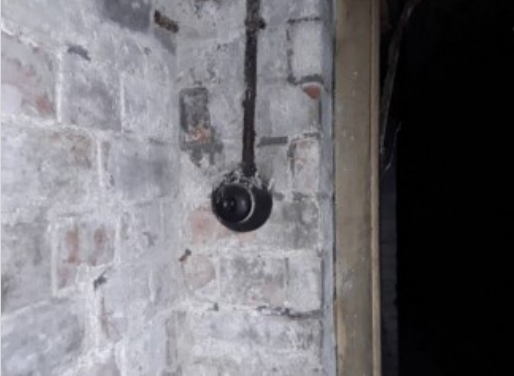
4	As NZ001333	Electrical Services Light switch (Composite Resinous/Reinforced Plastics)	Storage Z1/002	No Risk – N/A

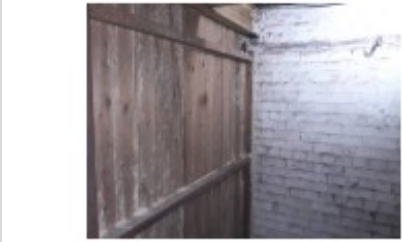
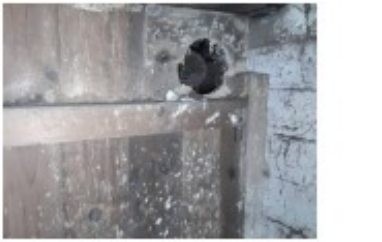
7	NZ001351	<i>Debris/Residue To Timber wall adjacent stairwell (Thermal Insulation Lagging)</i>	Storage Area Z1/004	<i>Removed Aug/Sept 24</i>
<b>Photo 1: Wide Angle</b>		<b>Photo 2: Close-up</b>

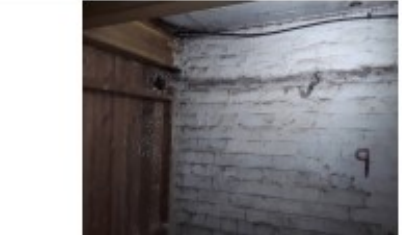
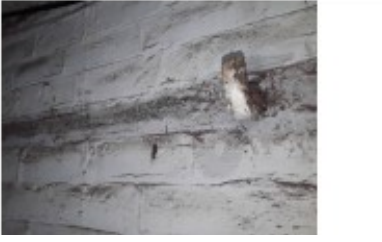
8	NZ001352	<i>Debris/Residue To brick wall and pipework hangers adjacent stairwell (Thermal Insulation Lagging)</i>	Storage Area Z1/004	Low Risk – every 6 months
<b>Photo 1: Wide Angle</b>		<b>Photo 2: Close-up</b>

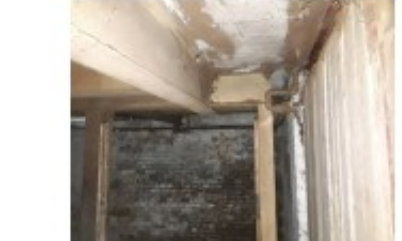
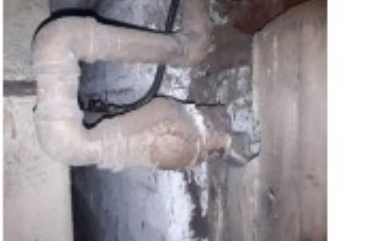
9	NZ001353	<i>Debris/Residue To pipework adjacent Timber wall (Thermal Insulation Lagging)</i>	Storage Area Z1/004	<i>Removed Aug/Sept 24</i>
<b>Photo 1: Wide Angle</b>		<b>Photo 2: Close-up</b>

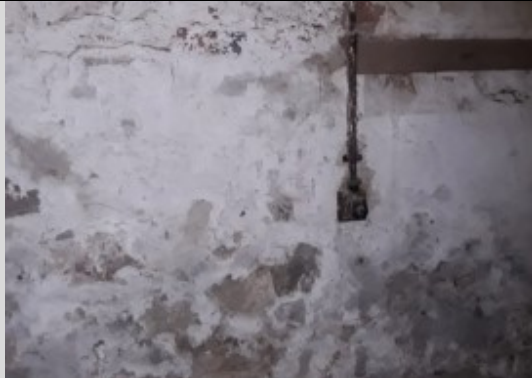
10	As NZ001333	Electrical Services Light switch (Composite Resinous/Reinforced Plastics)	Storage Area Z1/004	No Risk – N/A

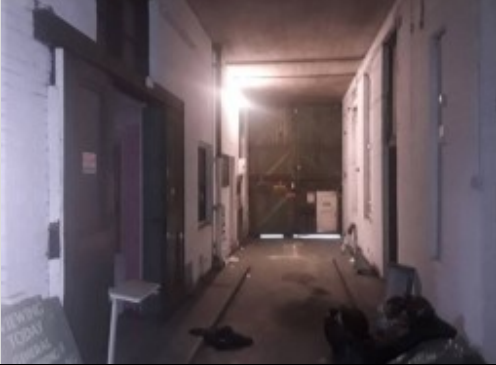
20	NZ001320	Window Putty/seal to glass windows and doors	Entrance Hall/Foyer/Lobby G/001	No Risk – N/A

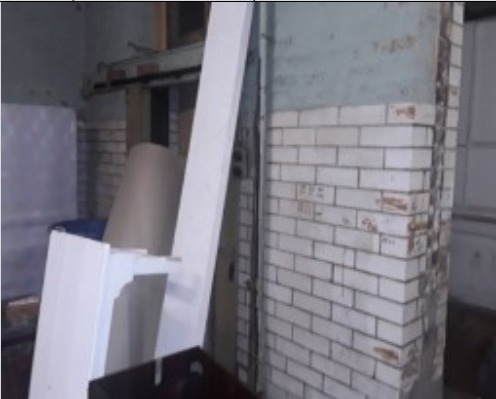
21	As NZ001333	Electrical Services Light switch (Composite Resinous/Reinforced Plastics)	Room G/006	No Risk – N/A

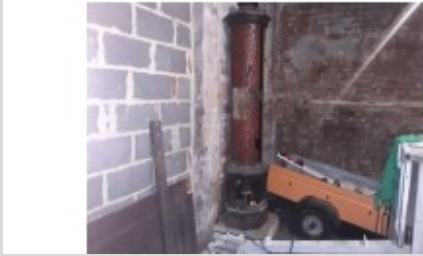
22	<i>Presumed</i>	<i>Pipework Gasket(s) (Too deeply recessed to sample)</i>	<i>Room G/009</i>	<i>Removed Aug/Sept 24</i>
<b>Photo 1: Wide Angle</b>		<b>Photo 2: Close-up</b>

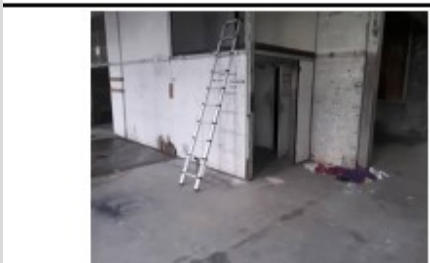
24	NZ001322	Debris/Residue To floor adjacent lift shaft and lift lobby from damaged panels (Insulating Board)	Room – Large G/010	Removed Aug/Sept 24
<b>Photo 1: Wide Angle</b>		<b>Photo 2: Close-up</b>

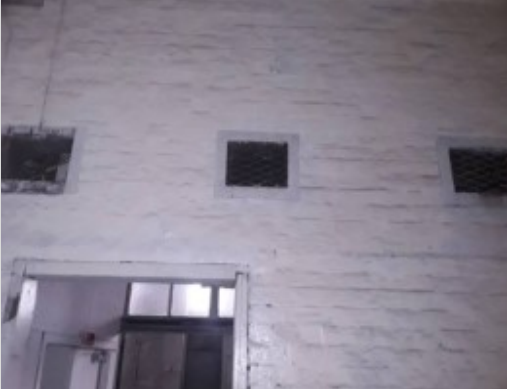
33	NZ001326	Wall - Vent Lining Panels to mesh (Cement)	Plant Room G/014	No Risk – N/A

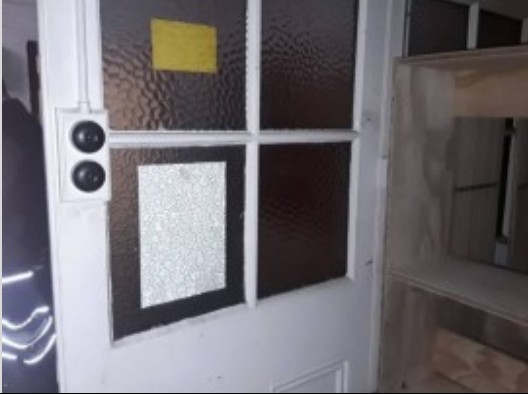
40	NZ001333	Electrical Services Light switch (Composite Resinous/Reinforced Plastics)	Office G/016	No Risk – N/A

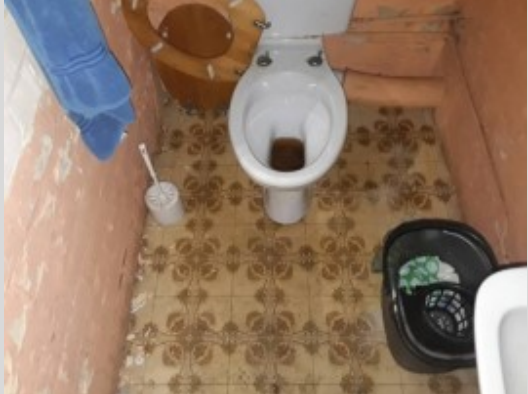
41	NZ001334	Floor – Covering (Paper/Card Products)	Toilets G/020	No Risk – N/A

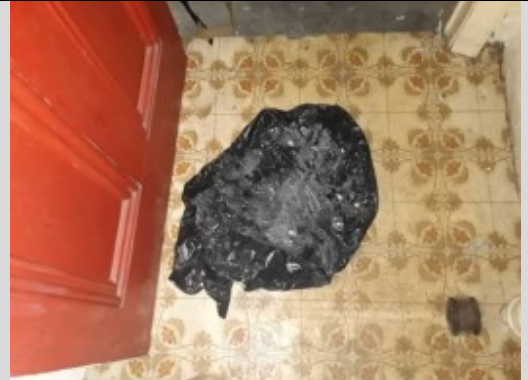
42	As NZ001334	Floor – Covering (Paper/Card Products)	Toilets Entrance G/021	No Risk – N/A

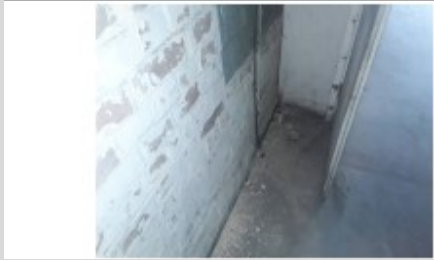
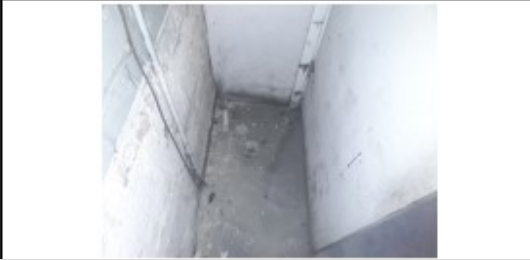
64	As NZ001336	Debris/Residue To floor next to door (Insulating Board)	Hallway/passageway Including staircase to roof 1/006	Removed Aug/Sept 24
<b>Photo 1: Wide Angle</b>		<b>Photo 2: Close-up</b>

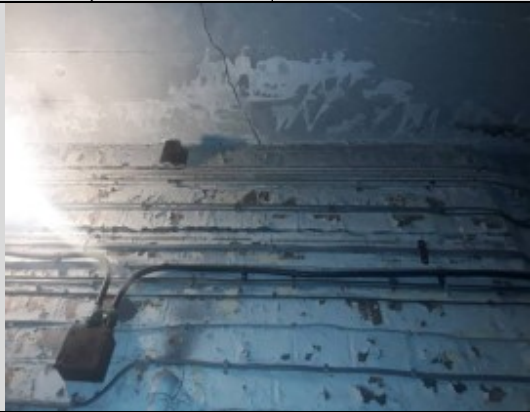
65	As NZ001333	Electrical Services Socket (Composite Resinous/Reinforced Plastics)	Hallway/passageway Including staircase to roof 1/006	No Risk – N/A

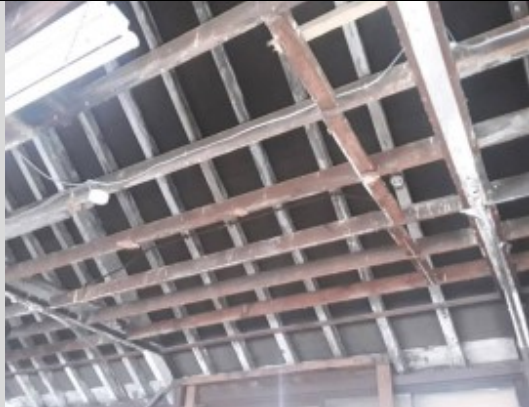
79	NZ001346	Roof – Lining (Composite Bitumen)	Workshop 2/005	No Risk – N/A

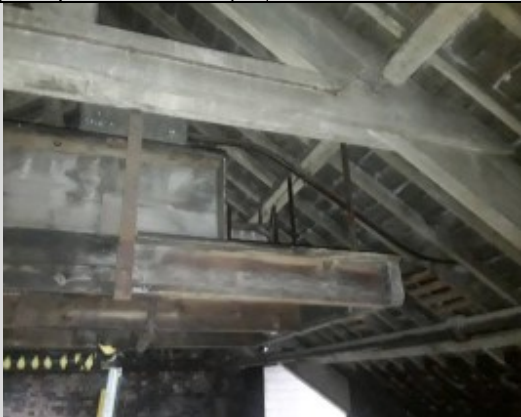
82	NZ001347	Roof – Lining (Composite Bitumen)	Room - Large Attic 3/001	No Risk – N/A

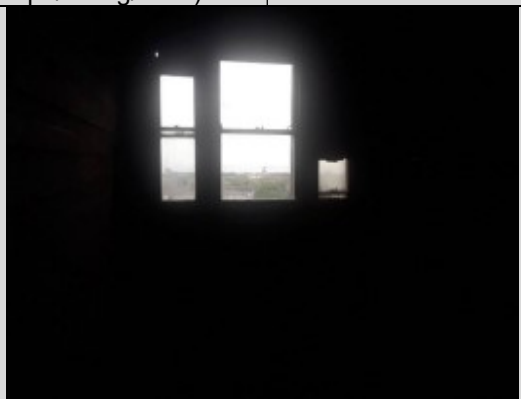
83	As NZ001340	Window Sash cords (Textile Rope/String/Yarn)	Room - Large Attic 3/001	No Risk – N/A

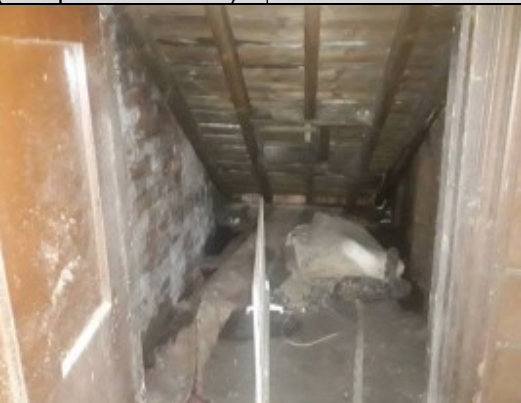
84	As NZ001347	Roof – Lining (Composite Bitumen)	Cupboard - Store Attic 3/003	No Risk – N/A

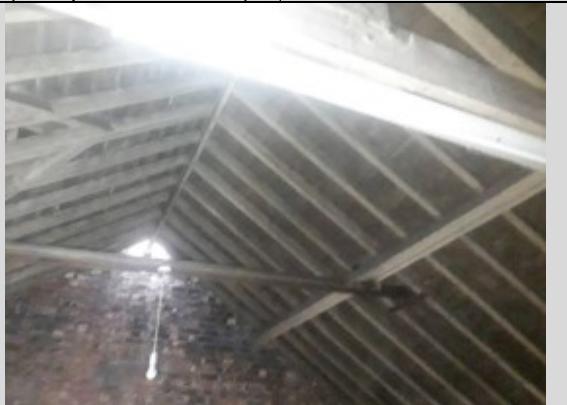
85	As NZ001347	Roof – Lining (Composite Bitumen)	Room - Large Attic 3/004	No Risk – N/A

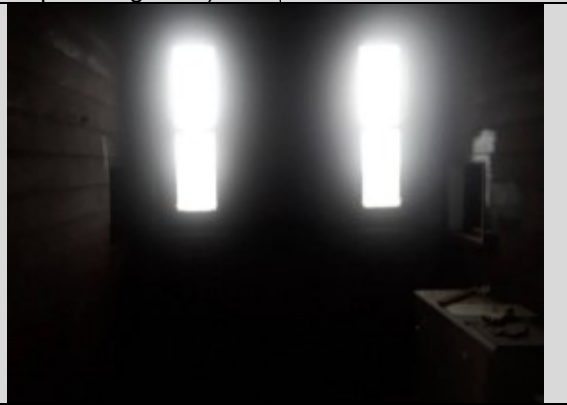
86	As NZ001340	Window Sash cords (Textile Rope/String/Yarn)	Room - Large Attic 3/004	No Risk – N/A

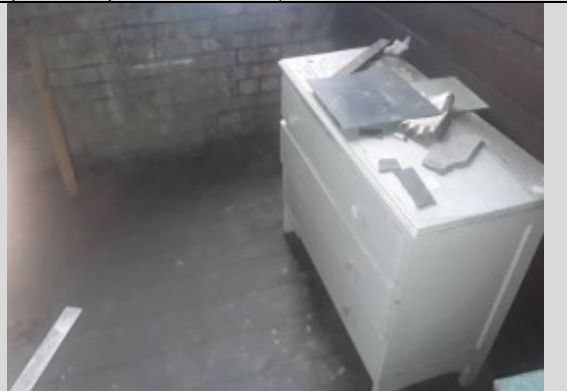
87	NZ001348	Debris To table (Cement)	Room - Large Attic 3/004	No Risk – N/A

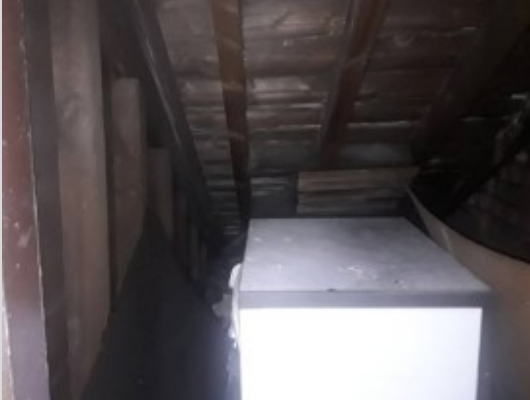
88	As NZ001347	Roof – Lining (Composite Bitumen)	Cupboard - Store Attic 3/005	No Risk – N/A

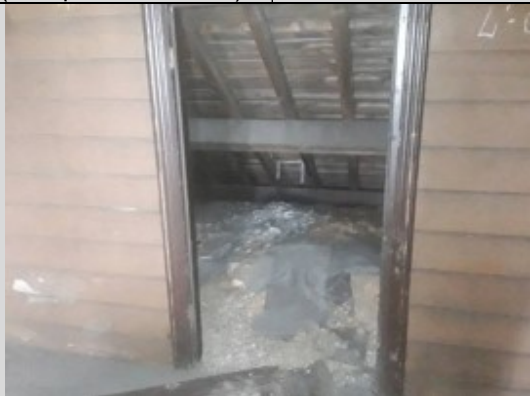
89	As NZ001347	Roof – Lining (Composite Bitumen)	Cupboard - Store Attic 3/006	No Risk – N/A

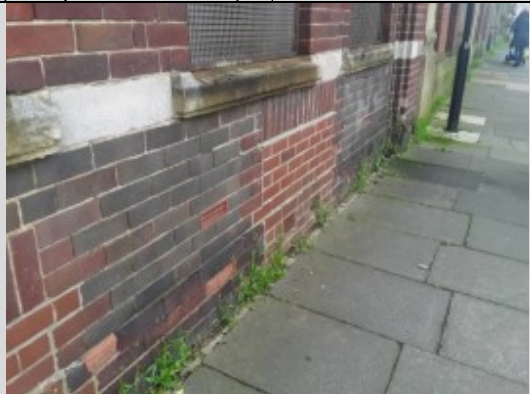
90	NZ001364	Damp Proof Course (Composite Bitumen)	External E/001	No Risk – N/A
