ASBESTOS SURVEY REPORT FOR THE WHITE HOUSE, WEST BOLDON,  
EAST BOLDON, NE36 OBB

**The White House, West Boldon, East Boldon**

**Date: 07 July 2025**

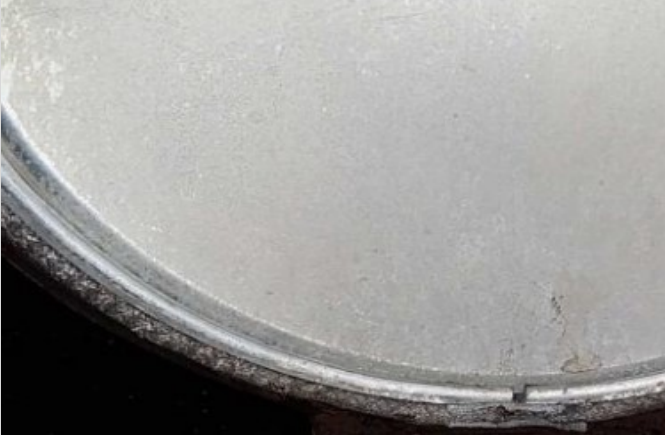
2	21-41287-2	Sealant around cooker doors and top lids (Rope)	Kitchen 1 (Area 4)	No Risk

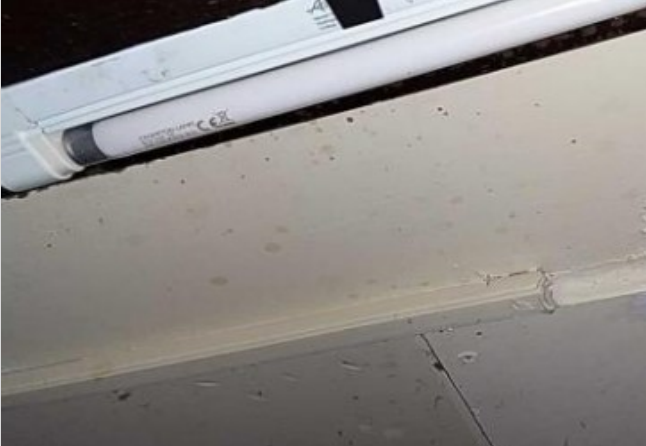
3	21-41287-3	Soffits Panels around cooker flue (insulation board)	Kitchen 1 (Area 4)	No Risk

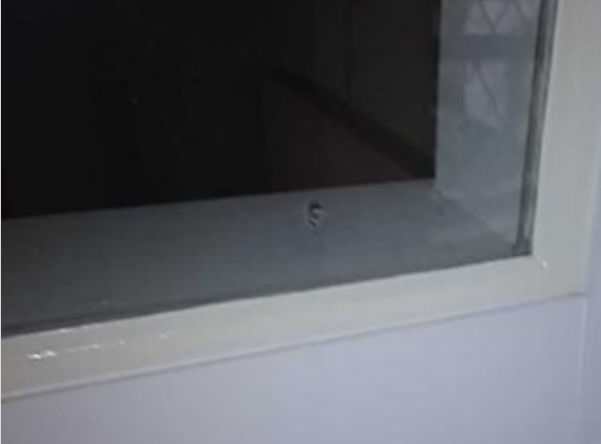
5	21-41287-5	Window putty around window frame	Lounge 8 (Area 3)	No Risk

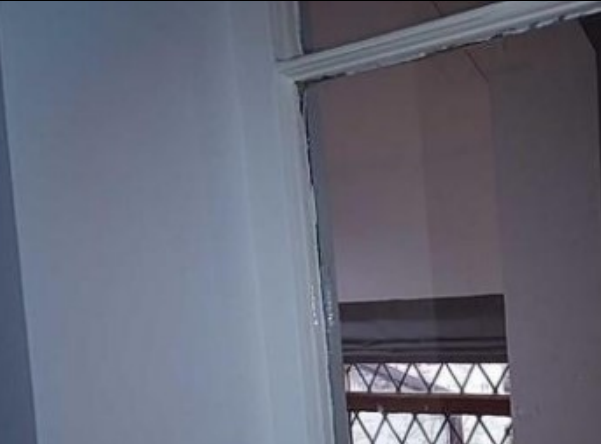
6	As 21-41287-5	Window putty around window frame	Office (Area 9)	No Risk

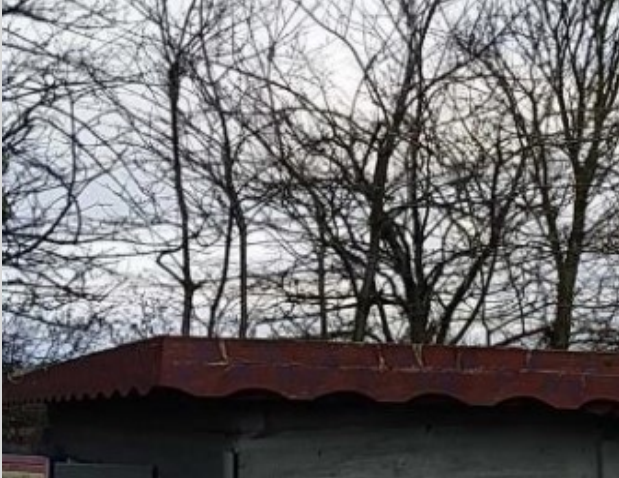
10	21-41287-8	Roof	Summer House (Area 27)	No Risk

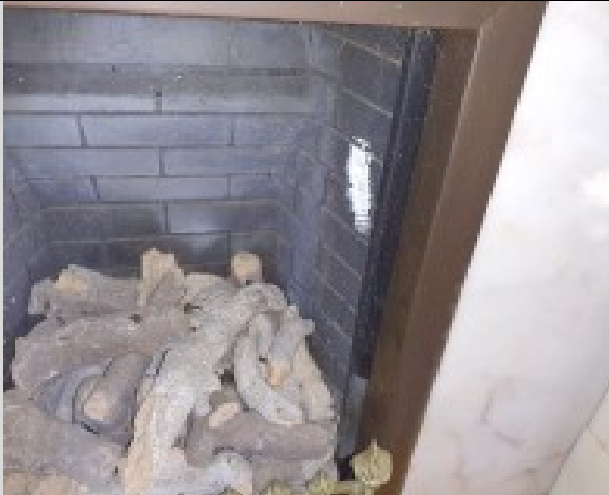
11	OU003003	Fireplace insulation	Lounge G/02	No Risk

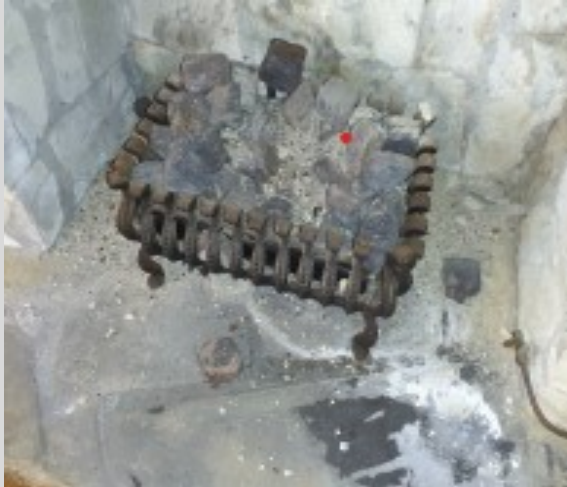
12	OU003004	Debris Fireplace	Dining Room G/03	No Risk

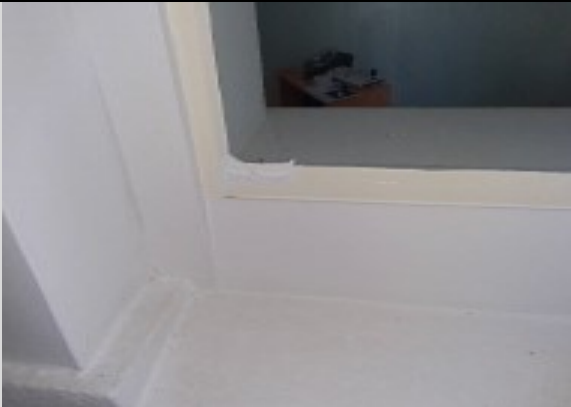
13	OU003007	Putty around glass on timber window	Communal Room G/09	No Risk

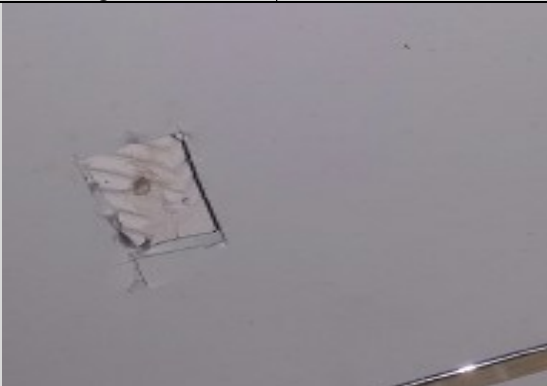
14	OU003008	Textured coating – ceiling above pvc cladding	Bathroom 1/06	No Risk

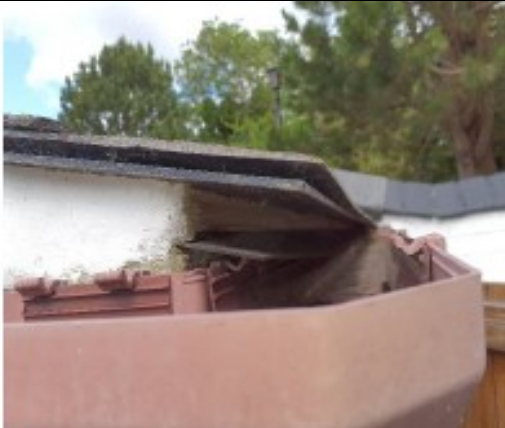
15	OU003009	Cement tiles – Roof	External E/01	No Risk
