ASBESTOS SURVEY REPORT FOR HART PRIMARY SCHOOL, HART VILLAGE, HARTLEPOOL, TS27 3AP

## **Asbestos Register for Hart Primary School**

**Date: 02 September 2024**

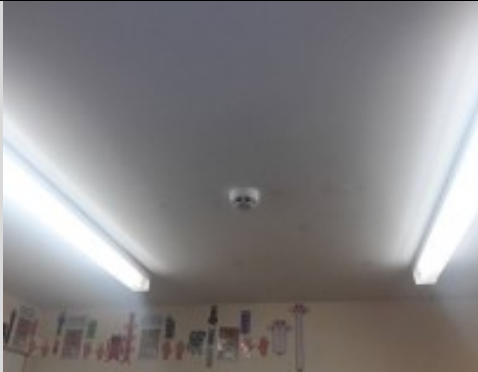
5	As NZ001840	Ceiling coating above plaster skim	Kitchen G/014	No Risk

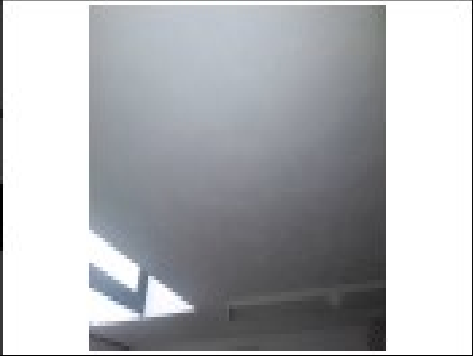
19	As NZ001843	Ceiling coating	Classroom G/030	Very Low Risk – 12 monthly
Photo 1: Wide Angle		Photo 2: Close-up

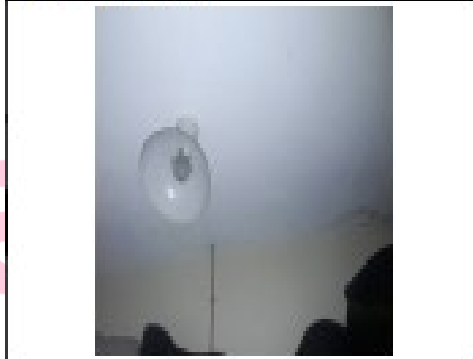
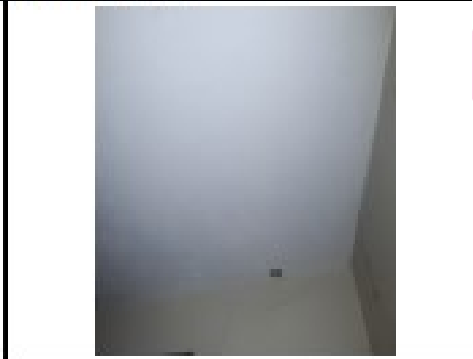
20	As NZ001843	Ceiling coating	Meeting Room G/036	Very Low Risk – 12 monthly
Photo 1: Wide Angle		Photo 2: Close-up

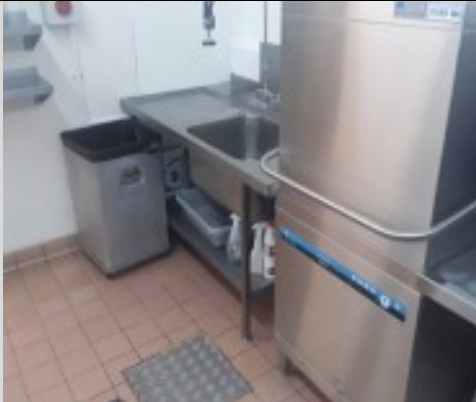
21	NZ001844	Under sink mat	Kitchen G/037	No Risk

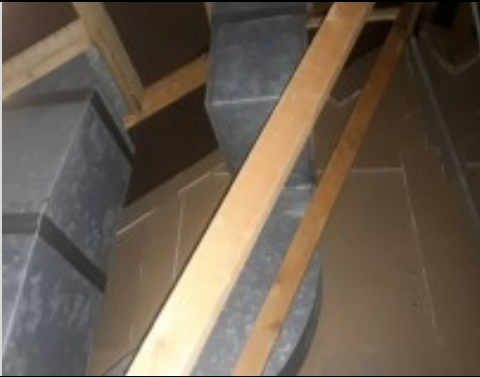
25	NZ001845	Ductwork joints red	Roof void R/004 (Loft space access above toilet G/026)	No Risk

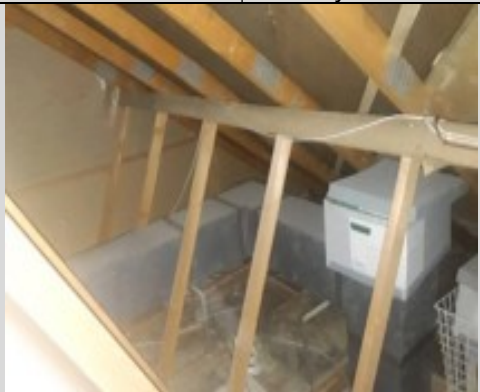
26	As NZ001845	Ductwork joints red	Roof void R/005 (Loft space access above sensory room G/012)	No Risk

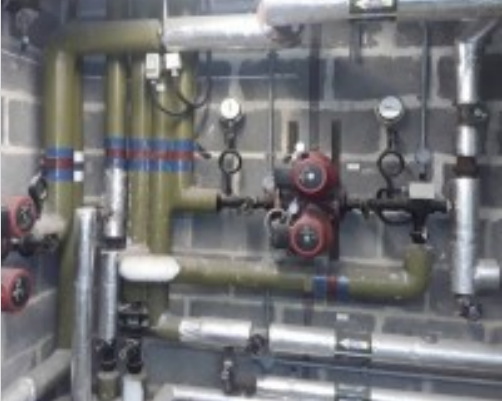
31	NZ001850	Pipework insulation to rear wall painted green	External Boiler Room E/004	No Risk

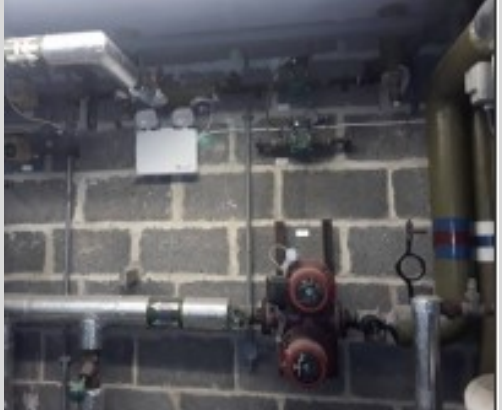
32	NZ001851	Pipework insulation to left hand wall painted green	External Boiler Room E/004	No Risk

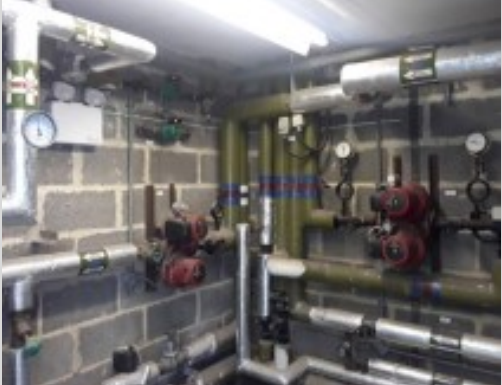
33	NZ001852	Debris/residue to left and rear walls	External Boiler Room E/004	No Risk

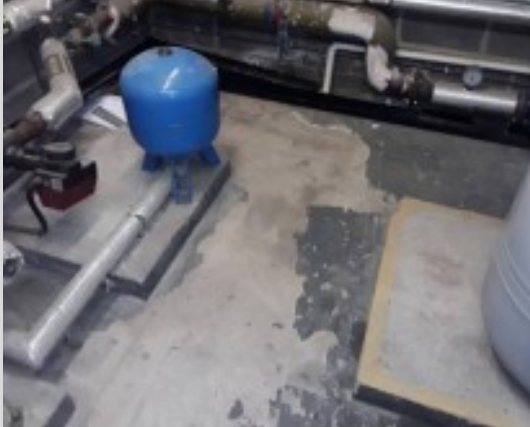
34	NZ001853	Debris/residue to floor	External Boiler Room E/004	No Risk

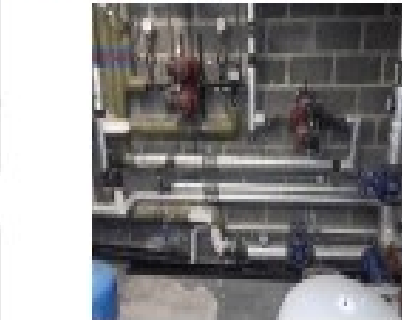
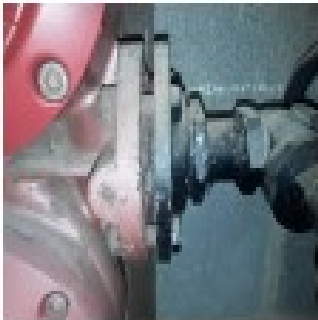
35	NZ001854	Pipework Gasket	External Boiler Room E/004	Very Low Risk – 12 monthly
<p><b>Photo 1: Wide Angle</b></p>		<p><b>Photo 2: Close-up</b></p>

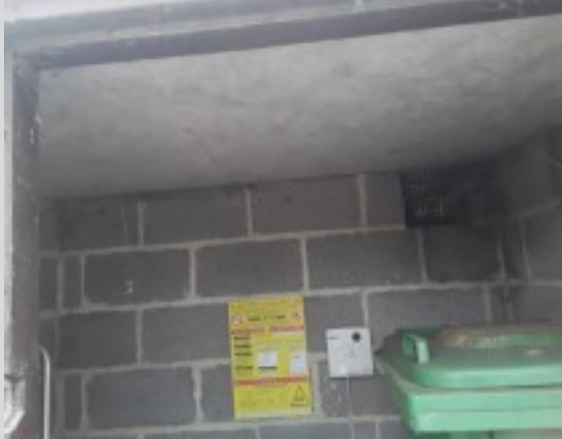
36	NZ001855	Ceiling	External Gas Inlet Room E/005	No Risk
