ASBESTOS SURVEY REPORT FOR HART PRIMARY SCHOOL, HART VILLAGE, HARTLEPOOL, TS27 3AP

Asbestos Register for Hart Primary School

Date: 07 August 2025

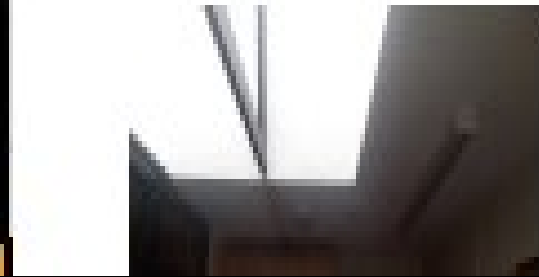
| 10 | As NZ001842 | Ceiling coating within hallway between classroom and store rooms | Library G/017 | Very Low Risk – 12 monthly |

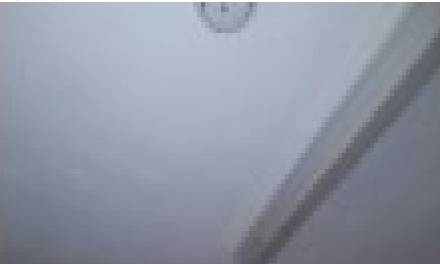
| 13 | As NZ001842 | Ceiling coating | Office G/023 | Very Low Risk – 12 monthly |

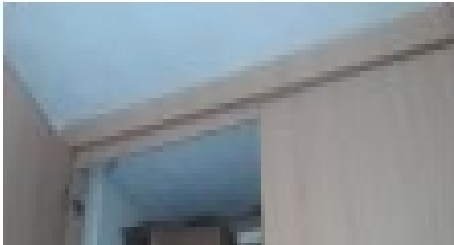
| 14 | NZ001843 | Ceiling coating | Cupboard Store G/024 | Very Low Risk – 12 monthly |

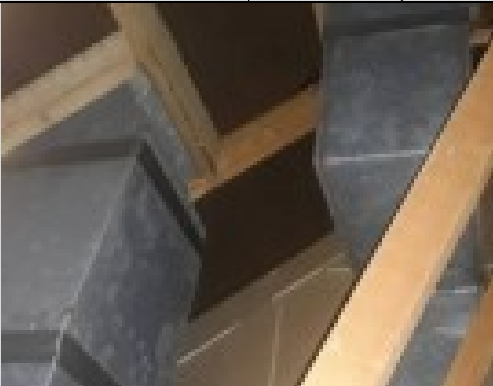
| 25 | NZ001845 | Ductwork joints red | Roof void R/004 (Loft space access above toilet G/026) | No Risk |

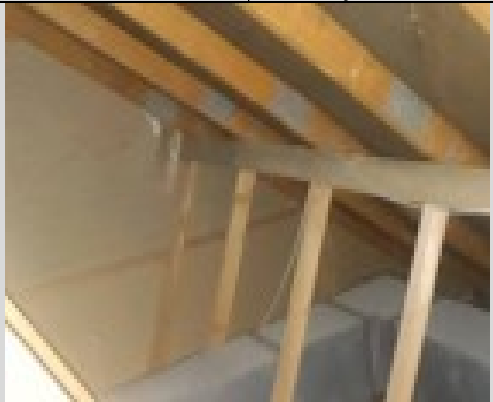
| 26 | As NZ001845 | Ductwork joints red | Roof void R/005 (Loft space access above sensory room G/012) | No Risk |

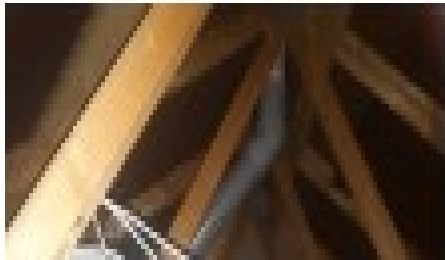
| 27 | NZ001846 | Flue pipe top section of flue from sensory room | Roof void R/005 (Loft space access above sensory room G/012) | Very Low Risk – 12 monthly |

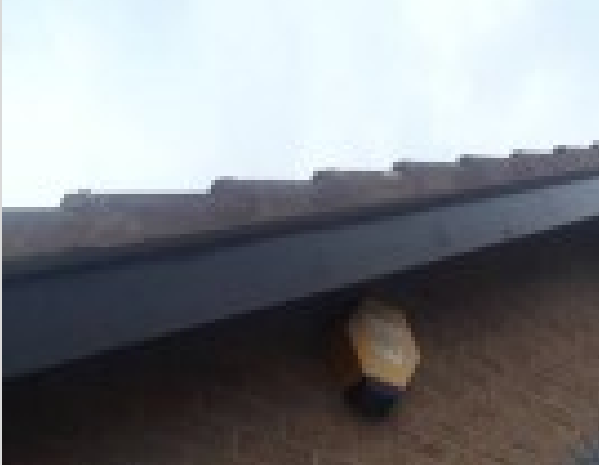
| 28 | NZ001847 | Undercloak to entrance and entrance canopy | External E/001 | No Risk |

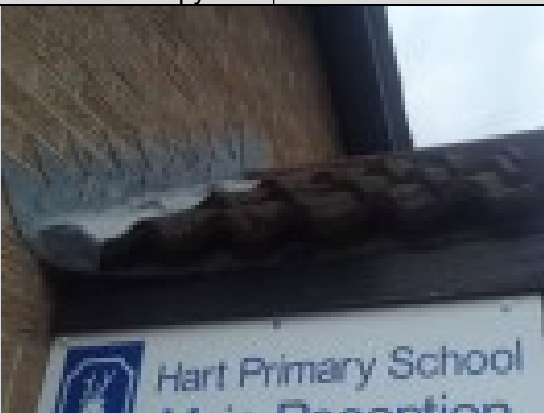
| 29 | NZ001848 | Roof lining to entrance canopy | External E/001 | No Risk |

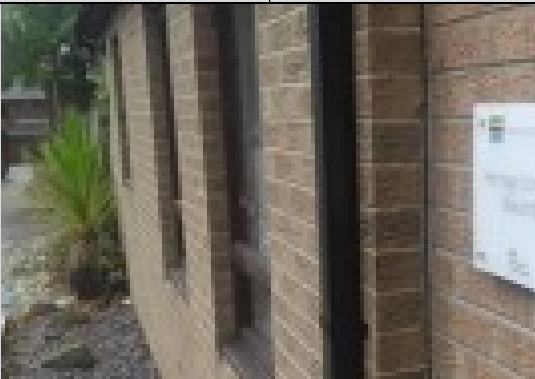
| 30 | NZ001849 | Window putty/seal to frame wall door and windows | External E/001 | No Risk |

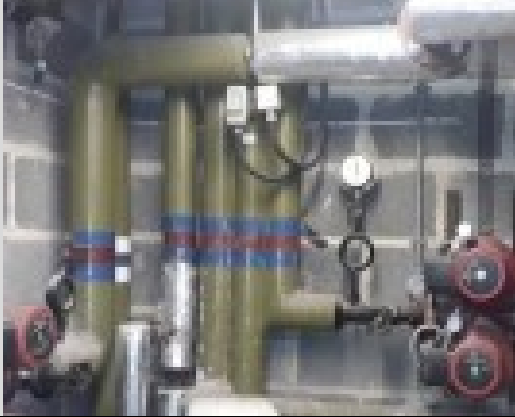
| 31 | NZ001850 | Pipework insulation to rear wall painted green | External Boiler Room E/004 | No Risk |

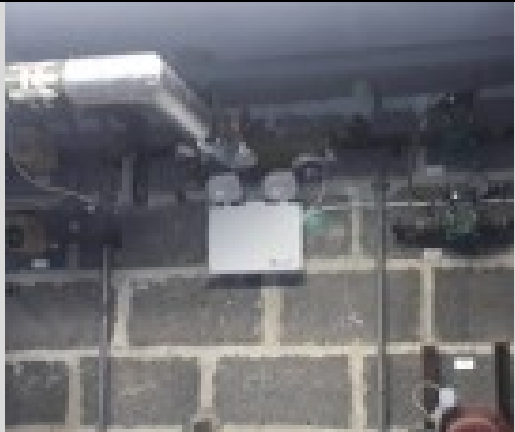
| 32 | NZ001851 | Pipework insulation to left hand wall painted green | External Boiler Room E/004 | No Risk |

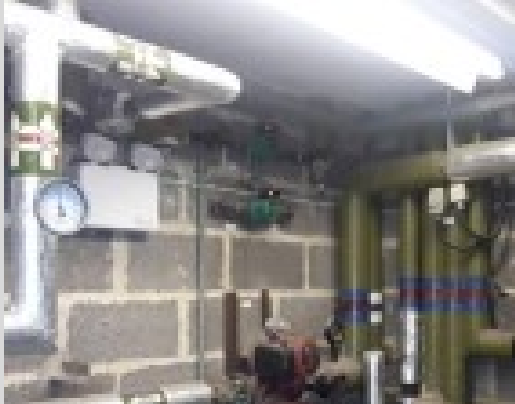
| 33 | NZ001852 | Debris/residue to left and rear walls | External Boiler Room E/004 | No Risk |

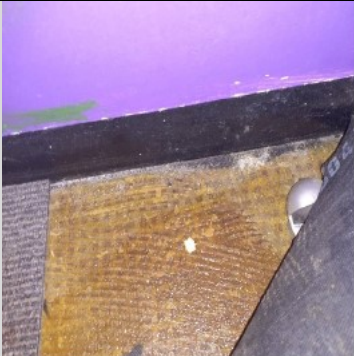
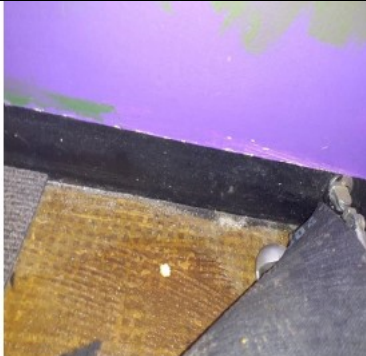
| 40 | KG000901 | Adhesive - Under carpet to edges | Library G/17 | No Risk |

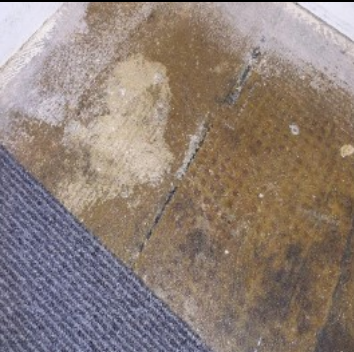
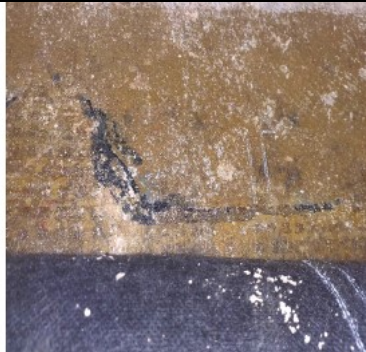
| 41 | As KG000901 | Adhesive - Under carpet | Staff room G/18 | No Risk |

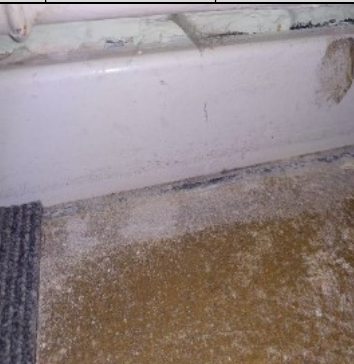
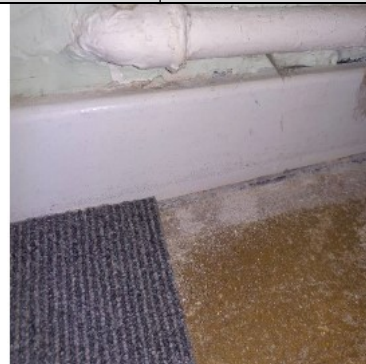
| 42 | As KG000901 | Adhesive - Under carpet at edges of room | Admin office G/20 | No Risk |

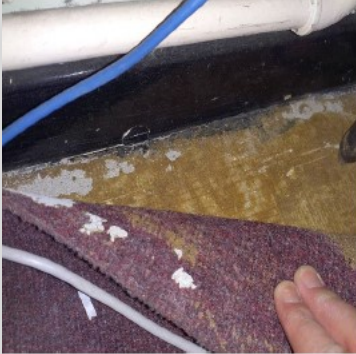
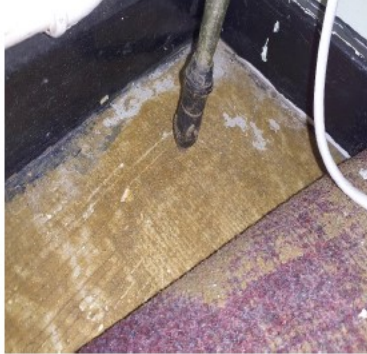
| 43 | As KG000901 | Adhesive - Under carpet at edges of room | Secretary G/21 | No Risk |

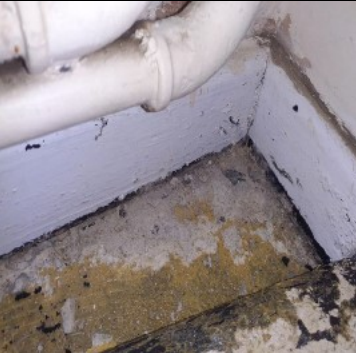
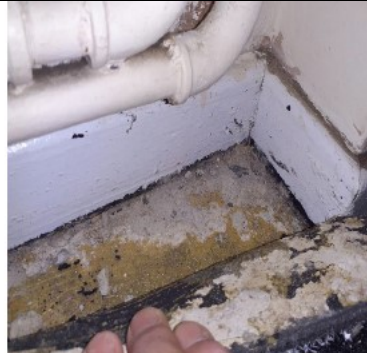
| 44 | As KG000901 | Adhesive - Under carpet at edges of room | Reception lobby G/22 | No Risk |

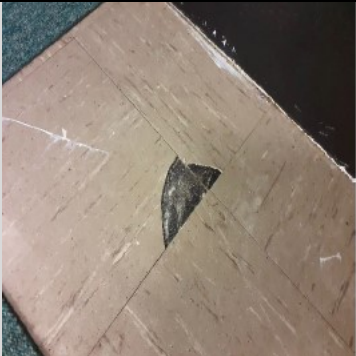
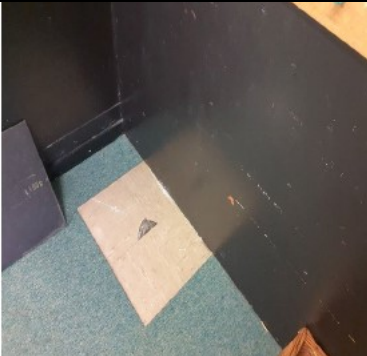
| 45 | KG000899 | Adhesive - Floor under tiles | EYSF G/03 (aka Classroom G/009) | No Risk |

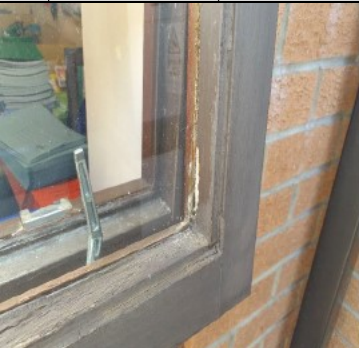
| 51 | KG000903 | Mastic - Window putty single glazed windows only | External E/01 | No Risk |
