ASBESTOS SURVEY REPORT FOR CARETAKERS BUNGALOW, KEPIER SCHOOL, HOUGHTON

Asbestos Register for CARETAKERS BUNGALOW, KEPIER

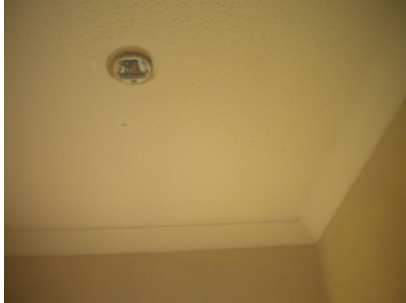
Item 1 Ref: BS/01

BS/01 – Textured coating to ceiling (Entrance Hall) (Item 1) No Risk

The textured coating to the ceiling in the entrance hall does not contain asbestos.

Similar textured coating is also located on the ceiling in the hall, WC and hall cupboard 2

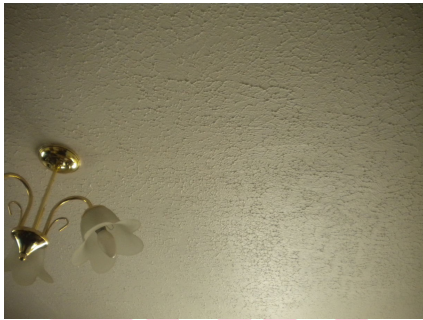
Item 3 - Ref: BS/02

BS/02 – Textured coating (Living Room) (Item 3) No Risk

The textured coating to the ceiling in the living room does not contain asbestos.

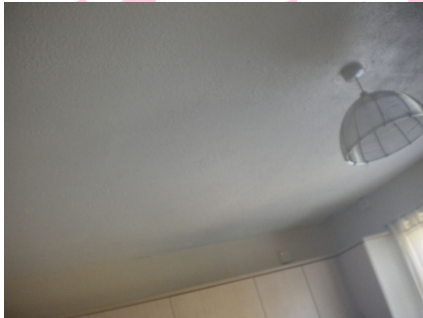
Item 4 - Ref: BS/03

BS/03 - Textured coating (Kitchen) (Item 4) No Risk

The textured coating to the ceiling in the kitchen does not contain asbestos.

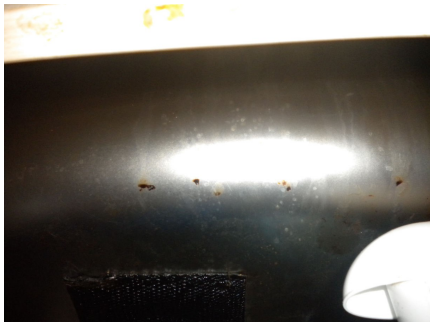
Item 5 - Ref: BS/04

BS/04 – Sink pad (Kitchen) (Item 5) No Risk

The sink pad to the sink in the kitchen does not contain asbestos.

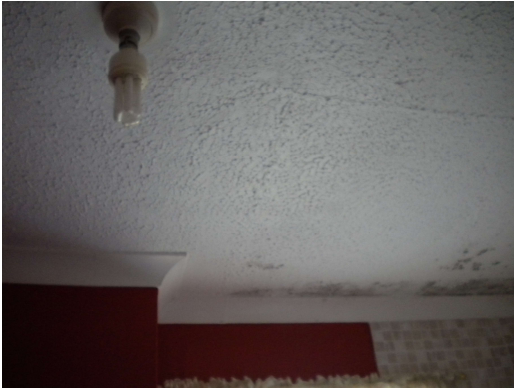
Item 7 - Ref: BS/05

BS/05 – Textured coating (Bathroom) (Item 7) No Risk

The textured coating to the ceiling in the bathroom does not contain asbestos.

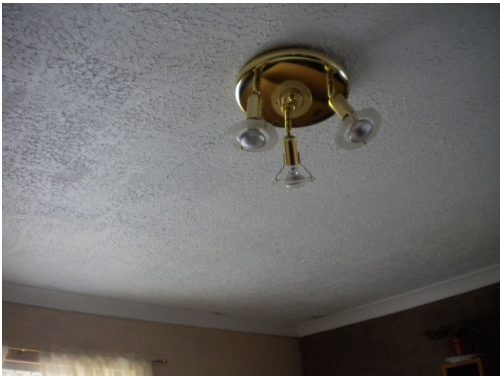
Item 9 - Ref: BS/06

BS/06 – Textured coating (Bedroom1) (Item 9) No Risk

The textured coating to the ceiling in bedroom 1 does not contain asbestos.

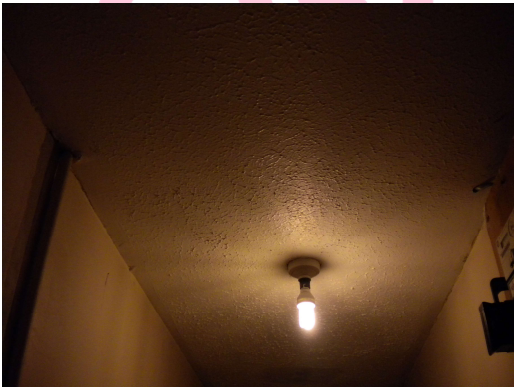
Item 10 - Ref: BS/07

BS/07 – Textured coating (Boiler Cupboard) (Item 10) No Risk

The textured coating to the ceiling in the boiler cupboard does not contain asbestos.

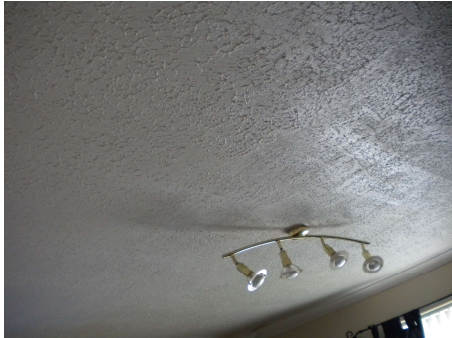
Item 11 - Ref: BS/08

BS/08 – Textured coating (Bedroom 2) (Item 11) No Risk

The textured coating to the ceiling in bedroom 2 does not contain asbestos.

Similar textured coating is located on the ceiling of bedroom 3.

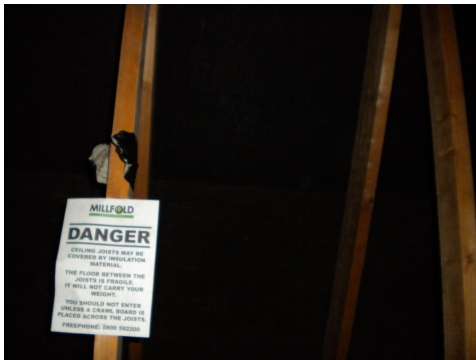
Item 12 - Ref: BS/09

BS/09 – Roof (External) (Item 12) No Risk

The roof felt to the loft does not contain asbestos.

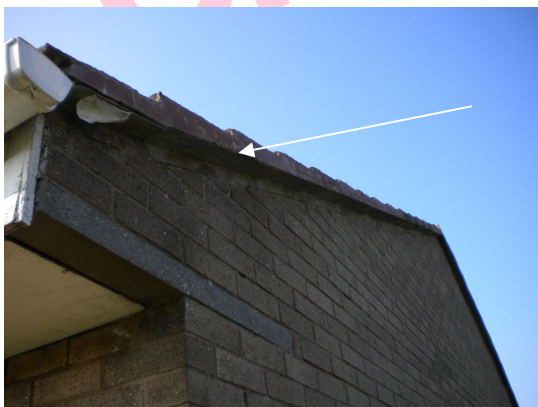
Item 13 - Ref: BS/10

BS/10 – Verge (External) (Item 13) Very Low Risk

The cement verge board to the external of the property contains asbestos.

Any change in its appearance should be noted and passed to Property Services.
