ASBESTOS SURVEY REPORT FOR SHAFTOE ACADEMY PRIMARY SCHOOL, HAYDON BRIDGE, HEXHAM, NE47 6BN.

Asbestos Register for Shaftoe Academy Primary School

Date: 13 June 2025

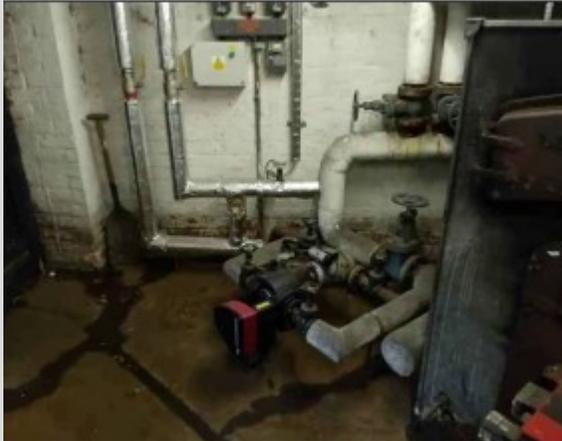
2	TL000318	Debris/Residue walls, composite sample from walls	Boiler Room Shaftoe Academy Z1/001	No Risk

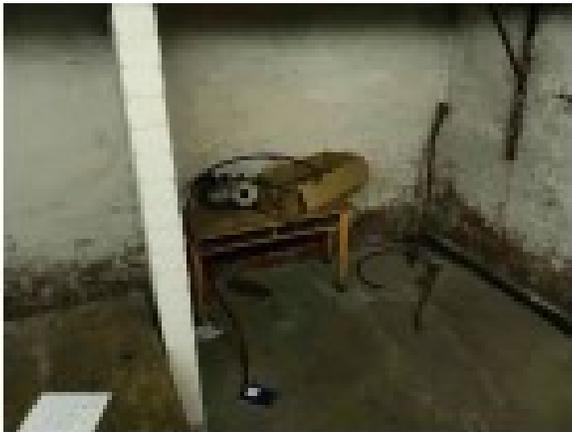
3	TL000319	Pipe Joints exposed flange on loose pipe	Boiler Room Shaftoe Academy Z1/001	Medium Risk – 3 monthly

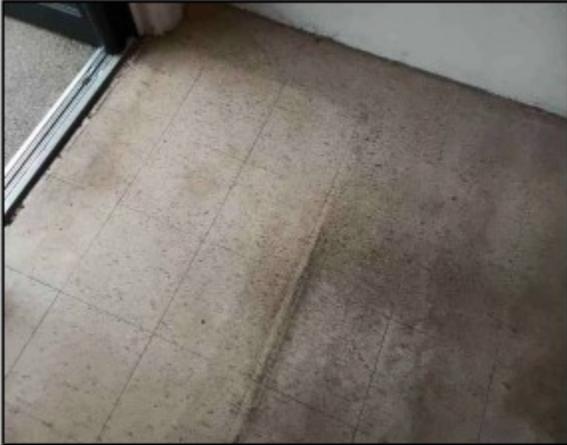
4	TL000310	Floor tile (with adhesive) Grey by main entrance	Entrance Hall/Foyer/Lobby Shaftoe Academy G/001	No Risk

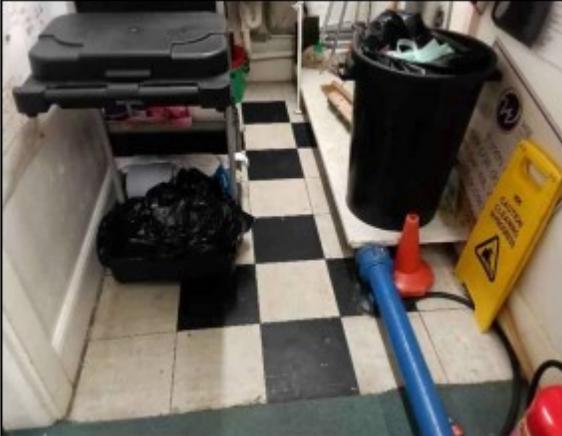
7	TL000311	Floor tile with adhesive Black and white	Store Room Shaftoe Academy G/009	No Risk

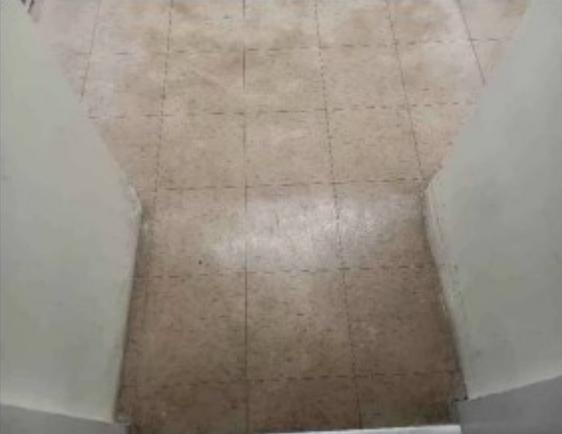
8	As TL000310	Floor tile (with adhesive) Grey beneath	Entrance Hall/Foyer/Lobby to stores Shaftoe Academy G/010	No Risk

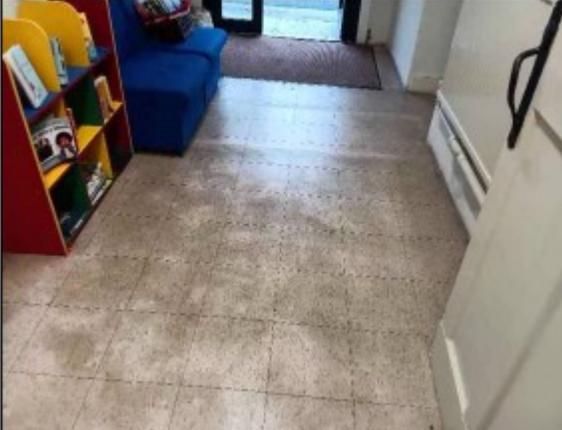
9	As TL000310	Floor tile (with adhesive) Grey	Entrance Hall/Foyer/Lobby to boys toilets Shaftoe Academy G/011	No Risk

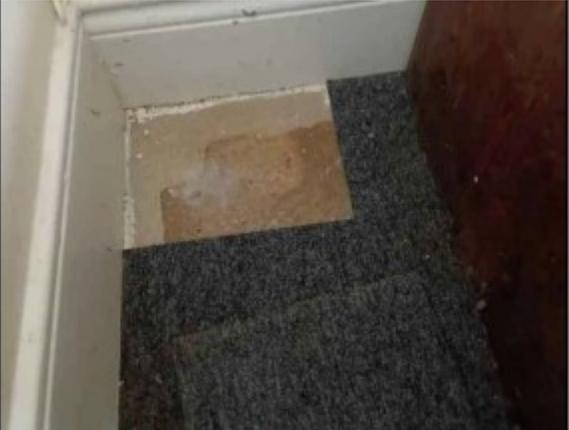
11	TL000313	Floor screed	Office Shaftoe Academy G/018	No Risk

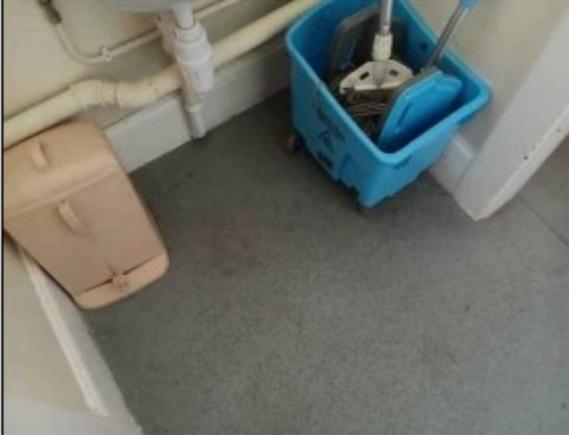
12	As TL000313	Floor screed	Entrance Hall/Foyer/Lobby Shaftoe Academy G/019	No Risk

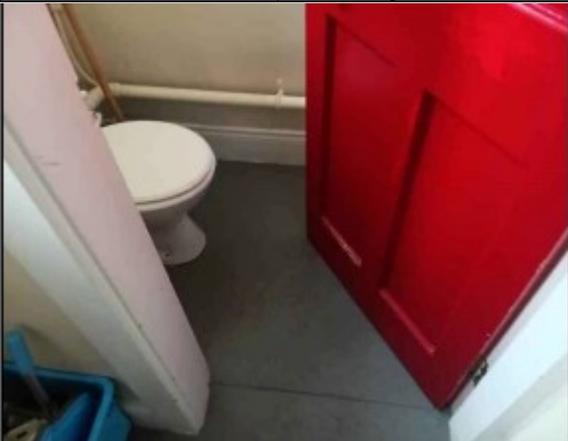
13	As TL000313	Floor screed	Toilet Shaftoe Academy G/20	No Risk

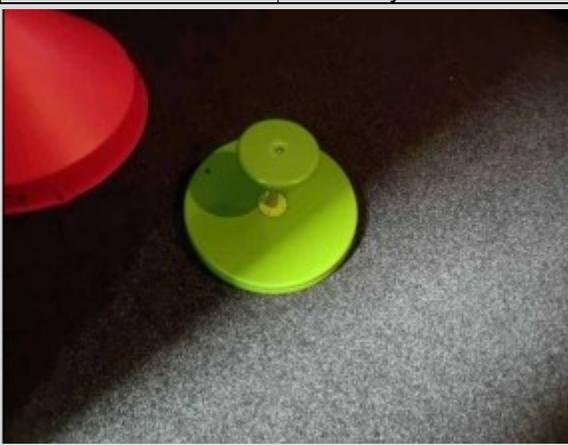
14	TL000314	Floor screed beneath carpet	Classroom The Newton Room Shaftoe Academy G/024	No Risk

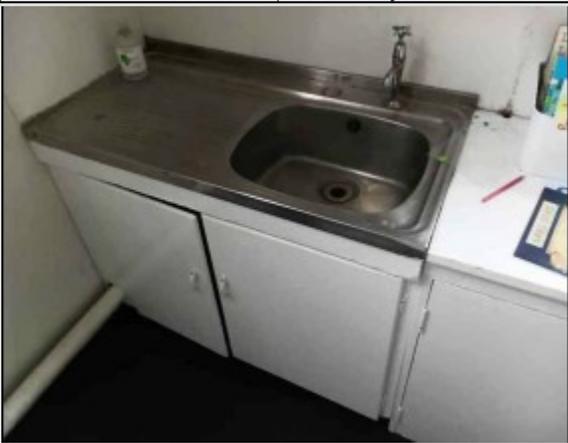
15	TL000315	Under sink mat	Classroom Shaftoe Academy G/025	No Risk

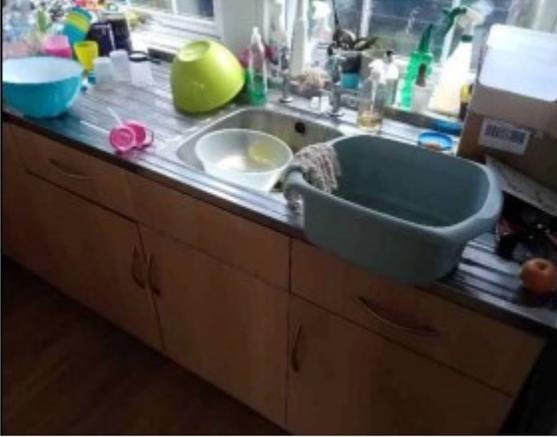
17	As TL000315	Under sink mat	Classroom Early Years Block G/010	No Risk

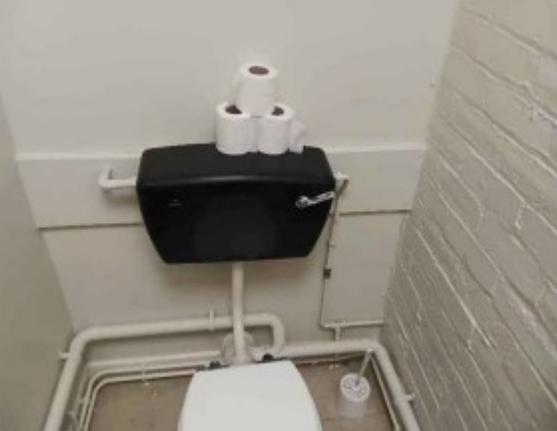
18	TL000321	Toilet cistern	Toilets Bamburgh Building G/003	No Risk

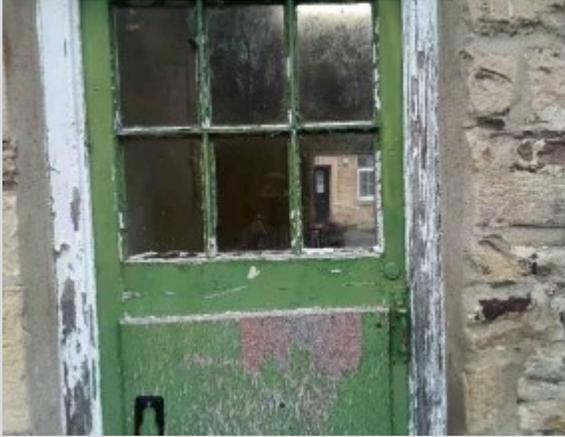
20	TL000323	Window putty seal to rear door	External Stores E/001	No Risk
