ASBESTOS SURVEY REPORT FOR SHAFTOE ACADEMY PRIMARY SCHOOL, HAYDON BRIDGE, HEXHAM, NE47 6BN.

Asbestos Register for Shaftoe Academy Primary School

Date: 16 January 2025

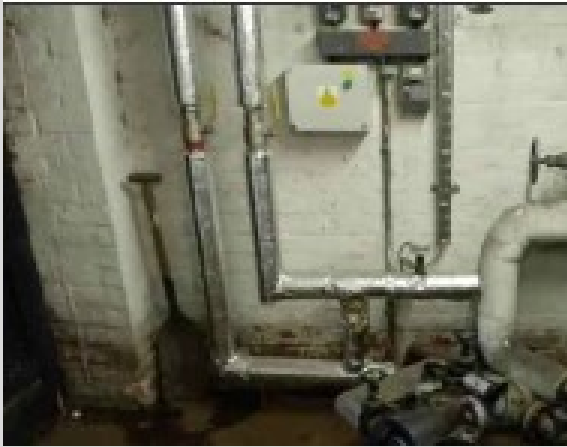
2	TL000318	Debris/Residue walls, composite sample from walls	Boiler Room Shaftoe Academy Z1/001	No Risk

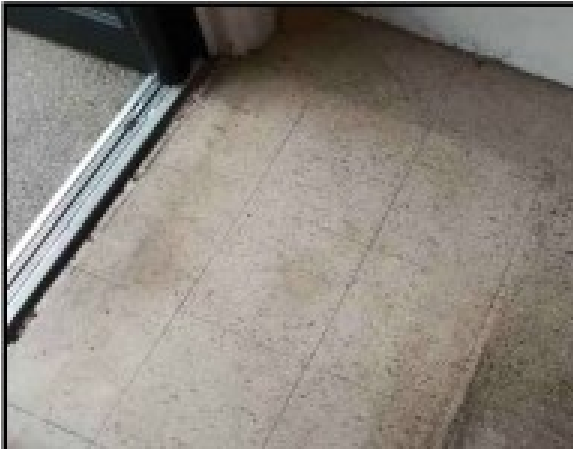
4	TL000310	Floor tile (with adhesive) Grey by main entrance	Entrance Hall/Foyer/Lobby Shaftoe Academy G/001	No Risk

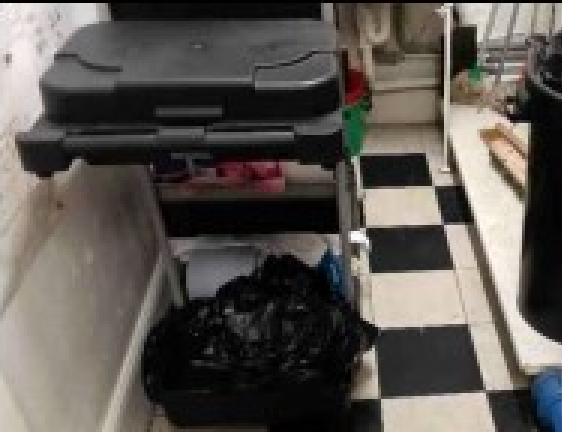
7	TL000311	Floor tile with adhesive Black and white	Store Room Shaftoe Academy G/009	No Risk

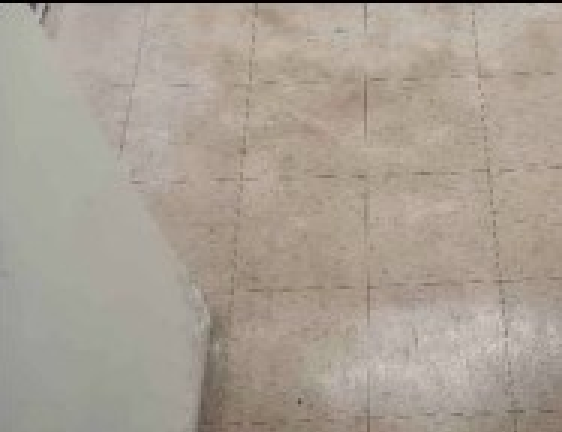
8	As TL000310	Floor tile (with adhesive) Grey beneath	Entrance Hall/Foyer/Lobby to stores Shaftoe Academy G/010	No Risk

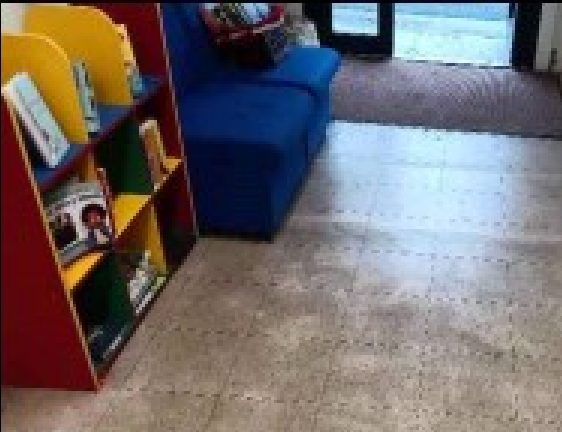
9	As TL000310	Floor tile (with adhesive) Grey	Entrance Hall/Foyer/Lobby to boys toilets Shaftoe Academy G/011	No Risk

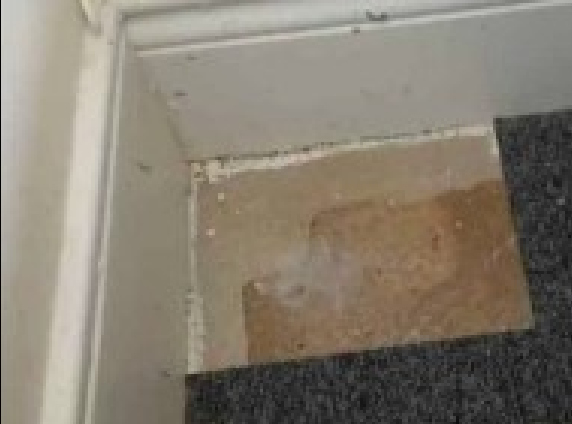
11	TL000313	Floor screed	Office Shaftoe Academy G/018	No Risk

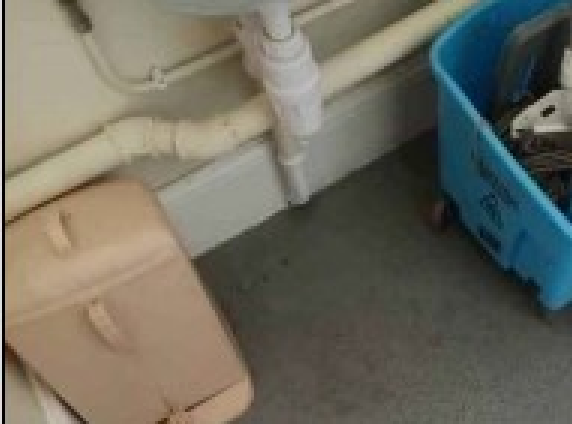
12	As TL000313	Floor screed	Entrance Hall/Foyer/Lobby Shaftoe Academy G/019	No Risk

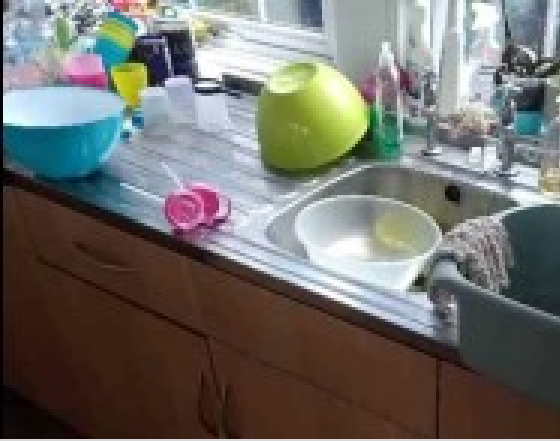
17	As TL000315	Under sink mat	Classroom Early Years Block G/010	No Risk

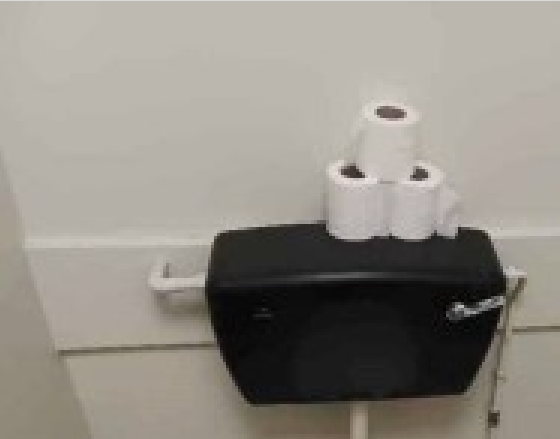
18	TL000321	Toilet cistern	Toilets Bamburgh Building G/003	No Risk
