ASBESTOS SURVEY REPORT FOR WHITBURN VILLAGE PRIMARY SCHOOL, CLEADON LANE, WHITBURN, SUNDERLAND, TYNE AND WEAR, SR6 7NS

Asbestos Register for

**Whitburn Village Primary School, Cleadon Lane, Whitburn,
Sunderland, Tyne and Wear, SR6 7NS**

Date: 24 June 2025

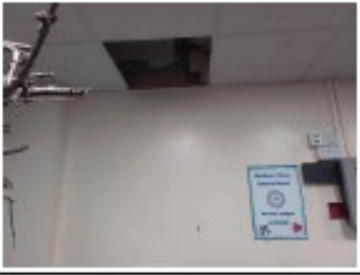
2	As OQ002218	Column Cladding - suspected behind wooden cladding	Ground Floor G/003 Hallway/passageway	Low Risk – Check every 6 months
Photo 1: Wide Angle		Photo 2: Close-up

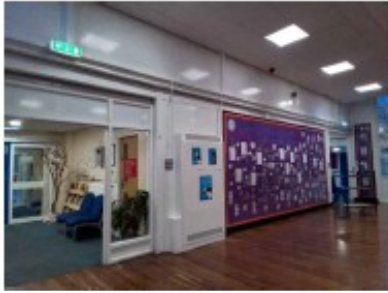
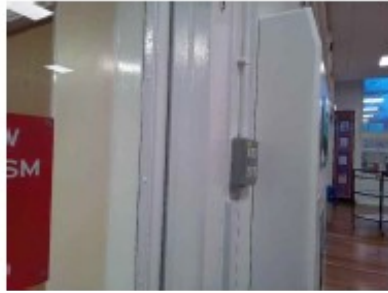
10	OQ002222	Wall - beneath plastic cladding	Ground Floor G/010 Dining Hall/area	Low Risk – Check every 6 months
Photo 1: Wide Angle		Photo 2: Close-up

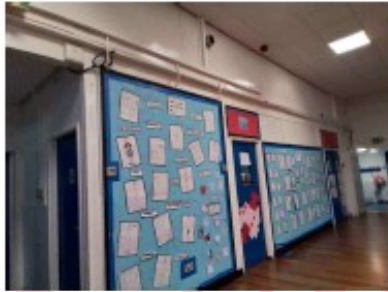
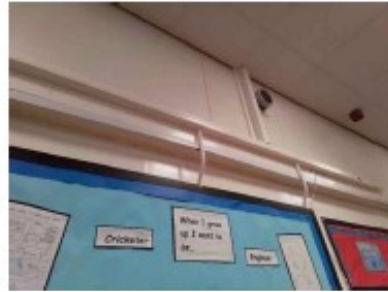
11	As OQ002222	Wall - beneath plastic cladding	Ground Floor G/011 Main Hall	Low Risk – Check every 6 months
Photo 1: Wide Angle		Photo 2: Close-up

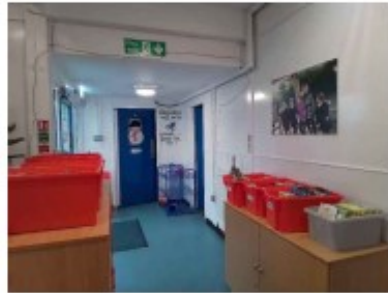
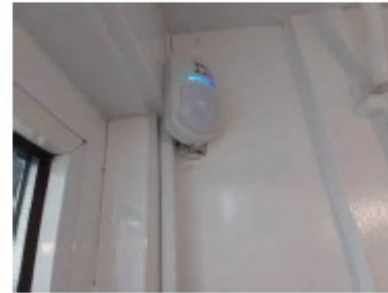
12	OQ002223	Wall - behind plastic cladding, visible at alarm sensor	Ground Floor G/012 Hallway/passageway	Low Risk – Check every 6 months
Photo 1: Wide Angle		Photo 2: Close-up

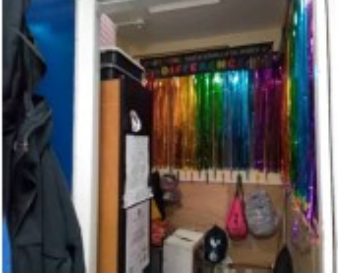
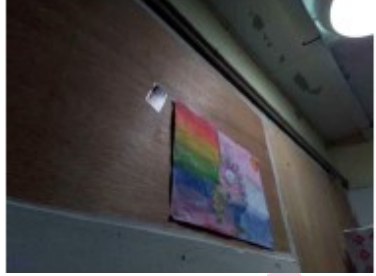
16	As OQ002223	Wall - all walls, protected by plywood	Ground Floor G/014 Cupboard - Store	Very Low Risk – Check every 12 months
Photo 1: Wide Angle			Photo 2: Close-up

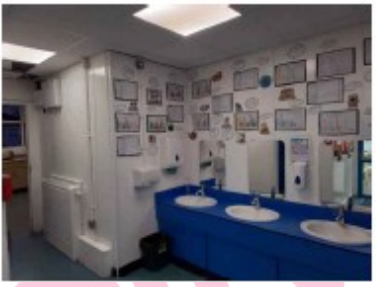
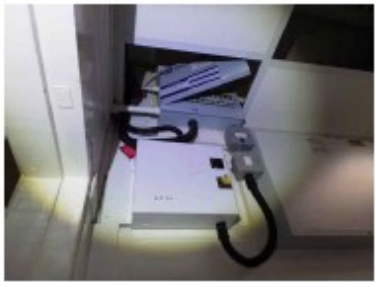
17	As OQ002223	Wall - all walls, beneath plastic cladding	Ground Floor G/015 Hallway/passageway /cloakroom	Low Risk – Check every 6 months
Photo 1: Wide Angle			Photo 2: Close-up

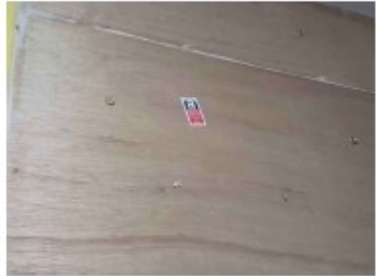
18	As OQ002223	Wall - all walls, protected by plywood	Ground Floor G/016 Cupboard - Store - Year 5 Classroom	Very Low Risk – Check every 12 months
Photo 1: Wide Angle			Photo 2: Close-up

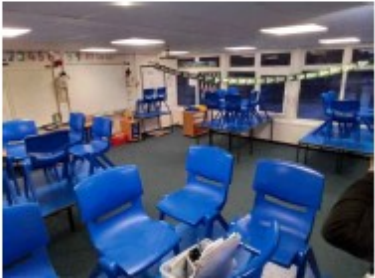
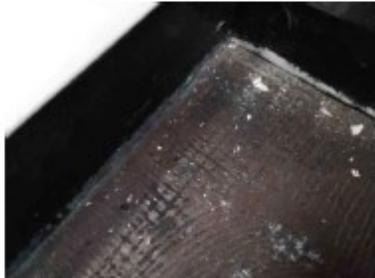
19	As OQ002220	Floor - former tile adhesive, beneath carpet	Ground Floor G/017 Classroom - Year 4	Very Low Risk – Check every 12 months
Photo 1: Wide Angle		Photo 2: Close-up

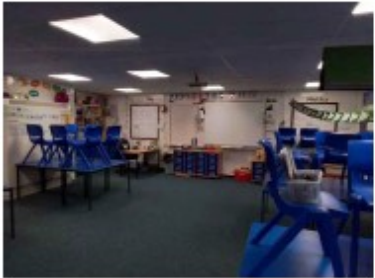
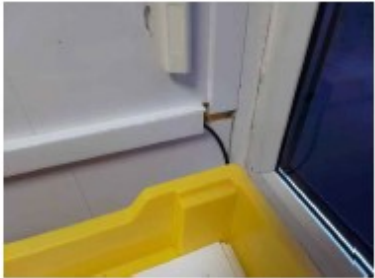
20	As OQ002223	Wall - behind plastic cladding and suspected behind window infill panels	Ground Floor G/017 Classroom - Year 4	Low Risk – Check every 6 months
Photo 1: Wide Angle		Photo 2: Close-up

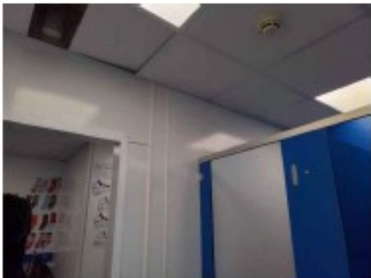
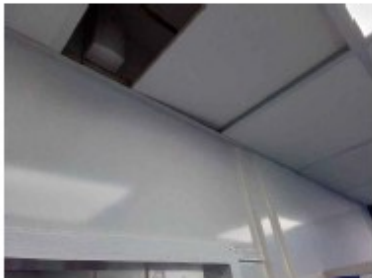
21	As OQ002223	Wall - all walls, beneath plastic cladding	Ground Floor G/018 Toilet(s)	Low Risk – Check every 6 months
Photo 1: Wide Angle		Photo 2: Close-up

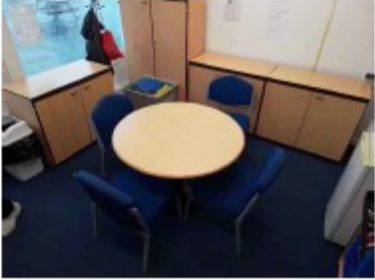
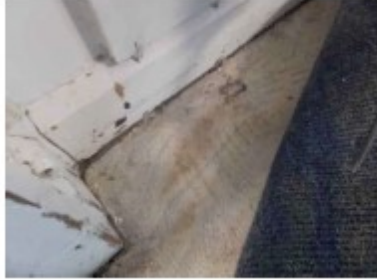
25	OQ002225	Floor - former tile adhesive, beneath carpet	Ground Floor G/023 Classroom - Breakfast	Very Low Risk – Check every 12 months
Photo 1: Wide Angle		Photo 2: Close-up

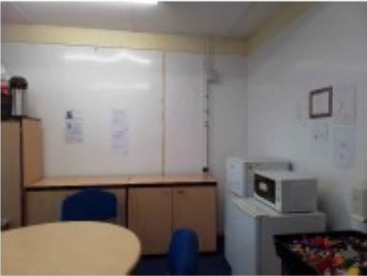
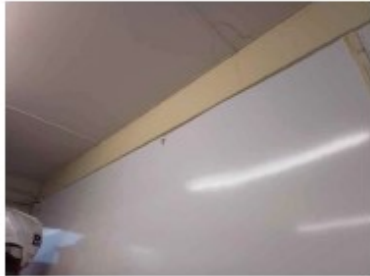
26	As OQ002223	Wall - behind plastic cladding and suspected behind window infill panels	Ground Floor G/023 Classroom - Breakfast	Low Risk – Check every 6 months
Photo 1: Wide Angle		Photo 2: Close-up

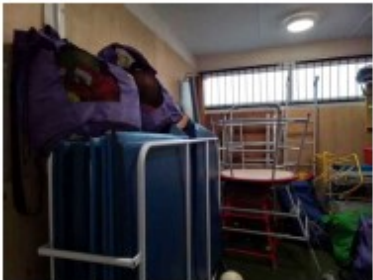
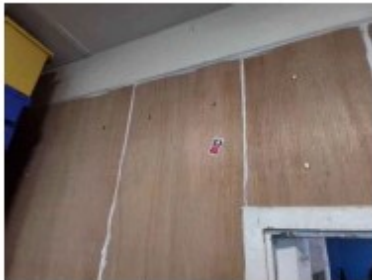
27	As OQ002219	Wall - all walls, protected by plywood	Ground Floor G/024 Cupboard - Store	Very Low Risk – Check every 12 months
Photo 1: Wide Angle		Photo 2: Close-up

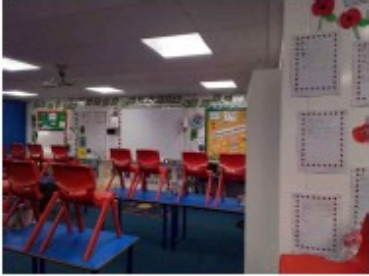
31	As OQ002226	Wall - behind plastic cladding and suspected behind window infill panels	Ground Floor G/027 Classroom - Year 3	Low Risk – Check every 6 months
Photo 1: Wide Angle		Photo 2: Close-up

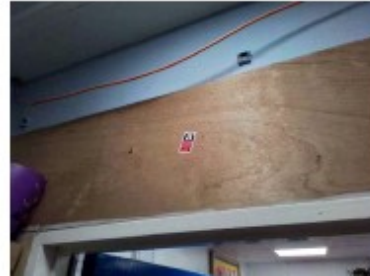
32	As OQ002226	Wall - all walls, protected by plywood	Ground Floor G/028 Cupboard - Store - Year 3 Classroom	Very Low Risk – Check every 12 months
Photo 1: Wide Angle		Photo 2: Close-up

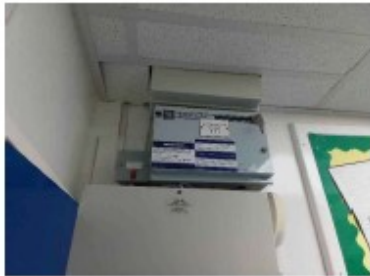
33	As OQ002226	Wall - all walls, beneath plastic and wood cladding	Ground Floor G/029 Hallway/passageway /cloakroom	Low Risk – Check every 6 months
Photo 1: Wide Angle		Photo 2: Close-up

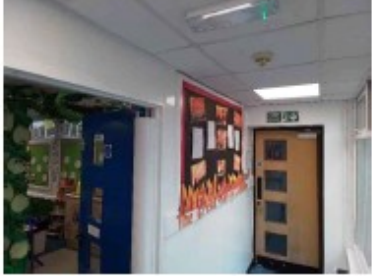
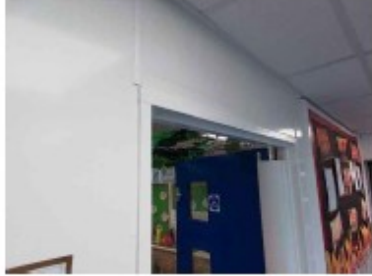
34	As OQ002226	Wall - all walls, beneath plastic cladding	Ground Floor G/030 Hallway/passageway	Low Risk – Check every 6 months
Photo 1: Wide Angle			Photo 2: Close-up

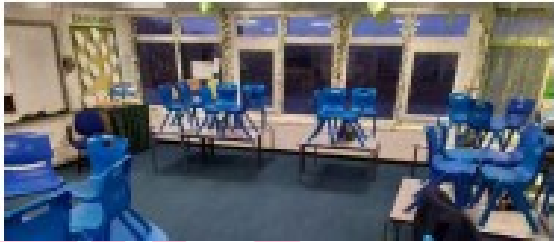
35	As OQ002225	Floor - former tile adhesive, beneath carpet	Ground Floor G/031 Classroom - Year 2	Very Low Risk – Check every 12 months
Photo 1: Wide Angle			Photo 2: Close

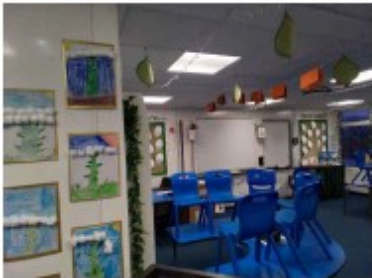
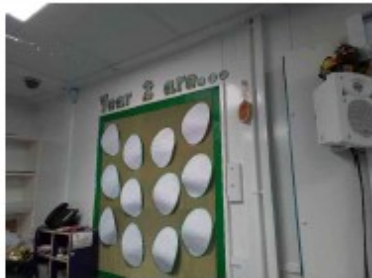
No Photog	
36	As OQ002226	Wall - behind plastic cladding and suspected behind window infill panels	Ground Floor G/031 Classroom - Year 2	Low Risk – Check every 6 months
Photo 1: Wide Angle			Photo 2: Close-up

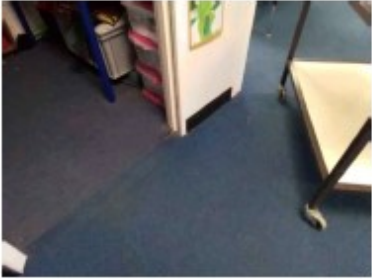
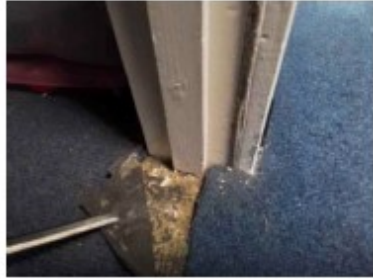
37	OQ002229	Floor - Tile - remnants to door frame	Ground Floor G/031 Classroom - Year 2	Very Low Risk – Check every 12 months
Photo 1: Wide Angle		Photo 2: Close-up

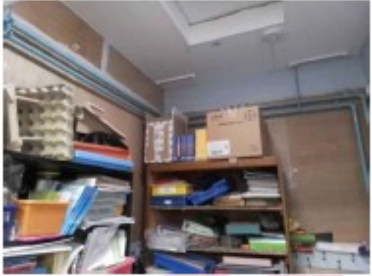
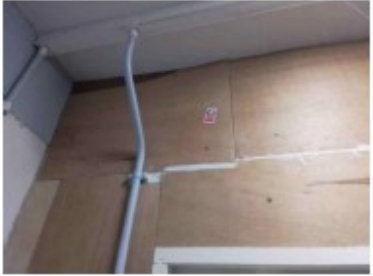
38	As OQ002226	Wall - all walls, protected by plywood	Ground Floor G/032 Cupboard - Store - Year 2 Classroom	Very Low Risk – Check every 12 months
Photo 1: Wide Angle		Photo 2: Close-up

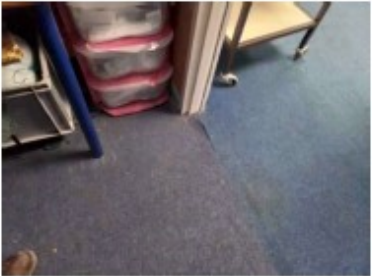
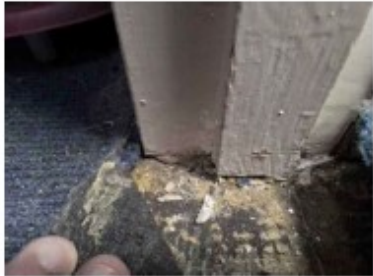
39	As OQ002229	Floor - Tile - remnants to door frame	Ground Floor G/032 Cupboard - Store - Year 2 Classroom	Very Low Risk – Check every 12 months
Photo 1: Wide Angle		Photo 2: Close-up

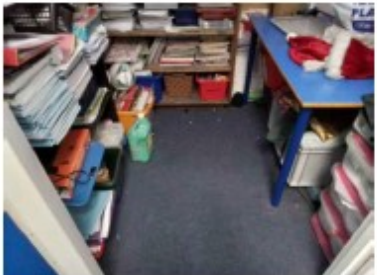
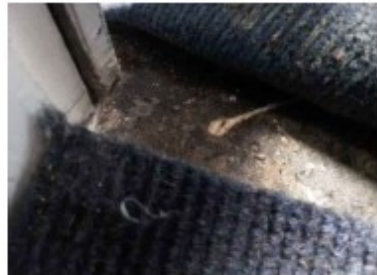
40	As OQ002225	Floor - former tile adhesive, beneath carpet	Ground Floor G/032 Cupboard - Store - Year 2 Classroom	Very Low Risk – Check every 12 months
Photo 1: Wide Angle			Photo 2: Close-up

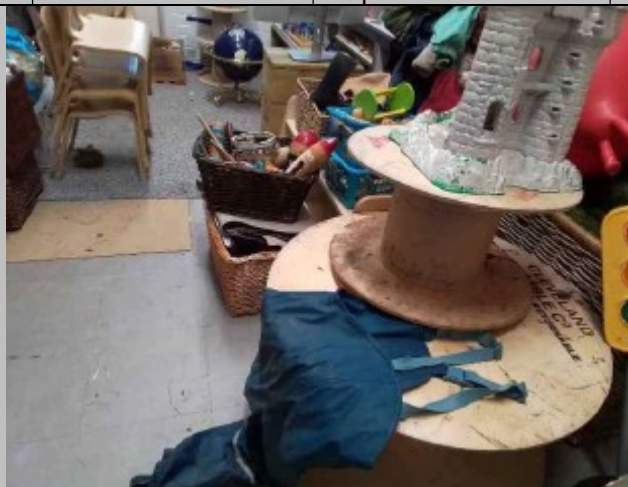
41	OQ002230	Floor - Tile - grey	Ground Floor G/038 Cupboard - Store	No Risk

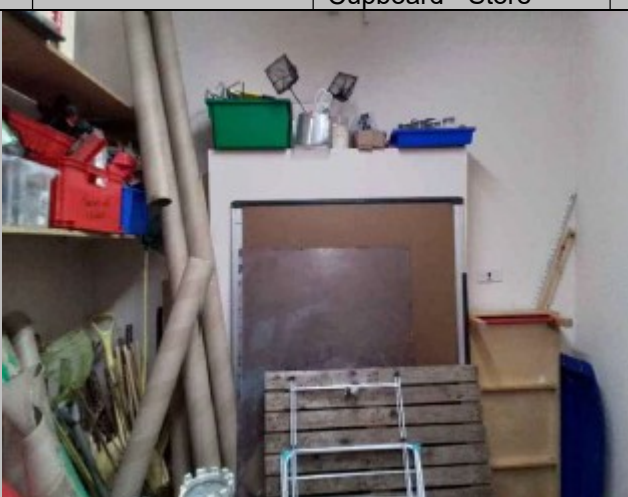
42	OQ002231	Heater - Casing	Ground Floor G/038 Cupboard - Store	No Risk

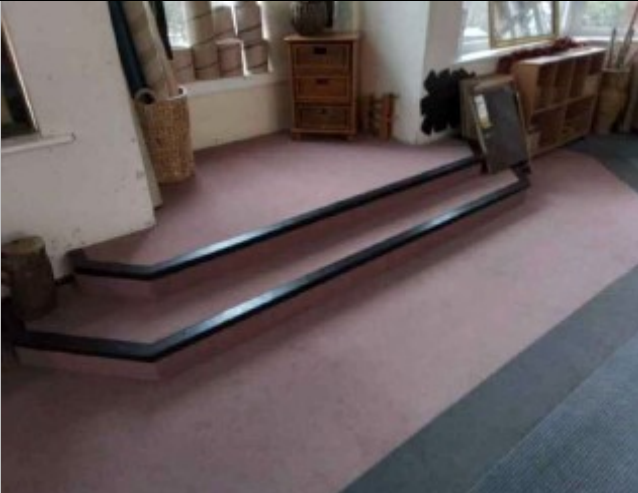
43	OQ002232	Floor - Nosing to stairs	Ground Floor G/040 Classroom - Nursery	No Risk

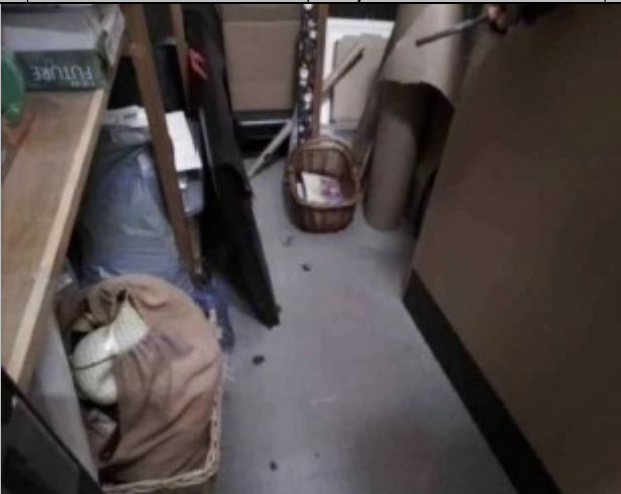
44	As OQ002230	Floor - Tile - grey	Ground Floor G/043 Cupboard - Store	No Risk

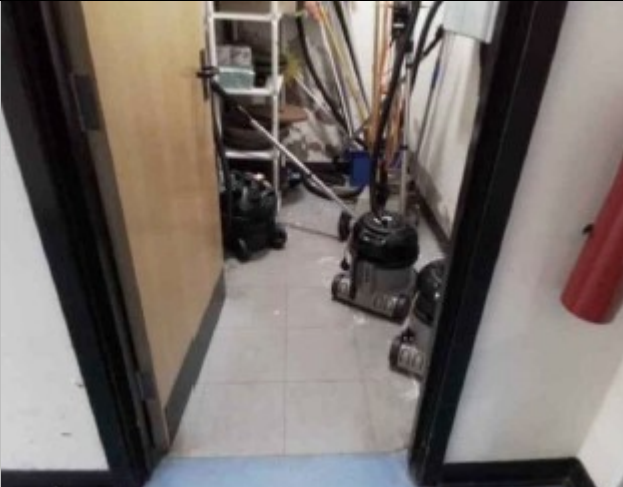
49	As OQ002235	Floor - Tile	Ground Floor G/051 Switch Room	No Risk

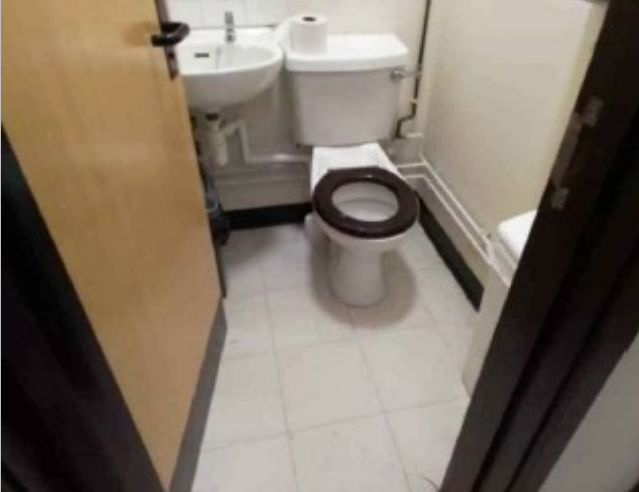
50	OQ002236	Floor - Tile - off white	Ground Floor G/052 Toilet(s) - Female	No Risk

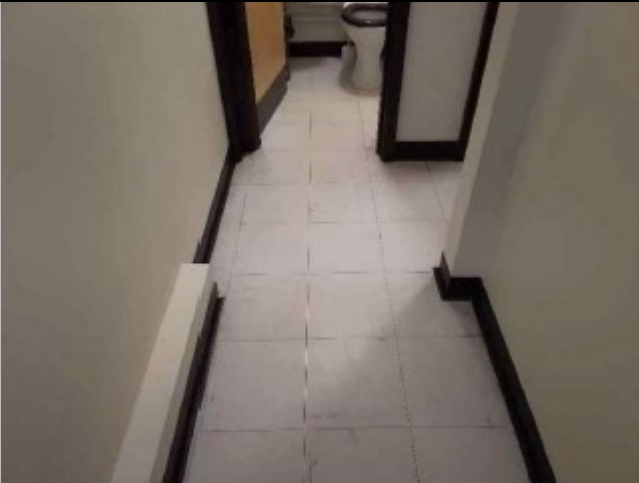
51	As OQ002236	Floor - Tile - off white	Ground Floor G/053 Hallway/passageway	No Risk

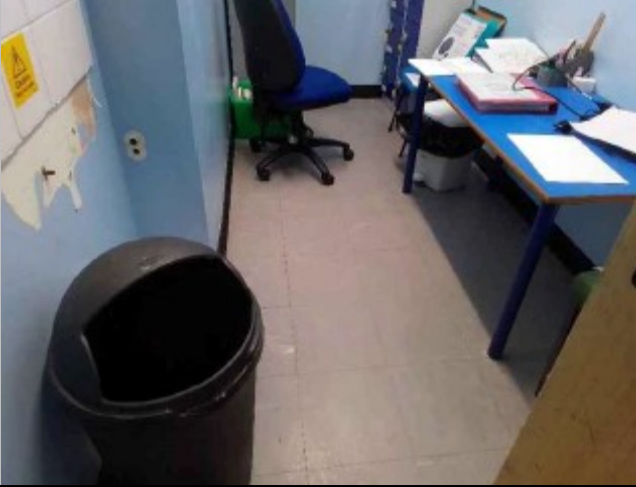
55	As OQ002235	Floor - Tile	Ground Floor G/062 Medical/First Aid Room	No Risk

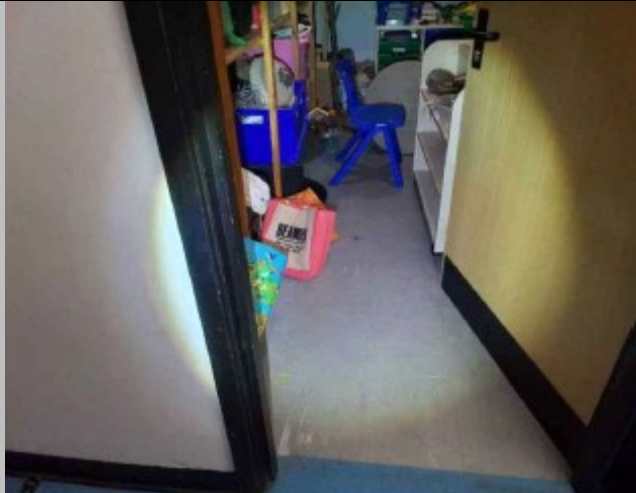
56	OQ002237	Floor - Tile - grey	Ground Floor G/063 Store Room	No Risk

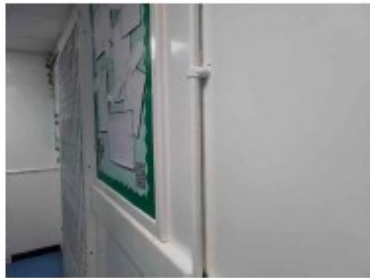
64	As OQ002242	Wall - behind plastic cladding	Ground Floor G/071 Hallway/passageway	Low Risk – Check every 6 months
Photo 1: Wide Angle			Photo 2: Close-up

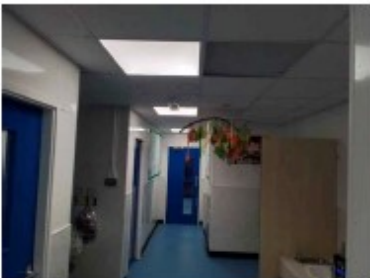
65	As OQ002242	Wall - all walls, beneath plastic and wood cladding	Ground Floor G/072 Hallway/passageway /cloakroom	Low Risk – Check every 6 months
Photo 1: Wide Angle			Photo 2: Close-up

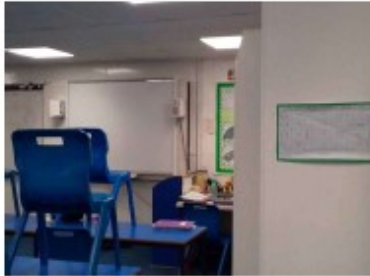
70	As OQ002242	Wall - behind plastic cladding and suspected behind window infill panels	Ground Floor G/076 Classroom - Year 6	Low Risk – Check every 6 months
Photo 1: Wide Angle		Photo 2: Close-up

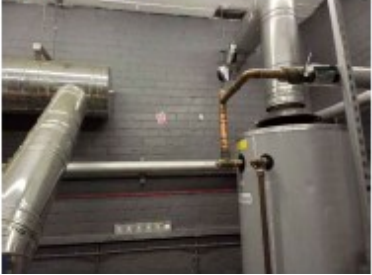
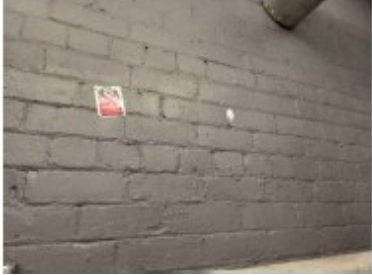
73	OQ002244	Debris/Residue - to rear wall. RHS	External E/001 Boiler Room	Low Risk – Check every 6 months
Photo 1: Wide Angle		Photo 2: Close-up

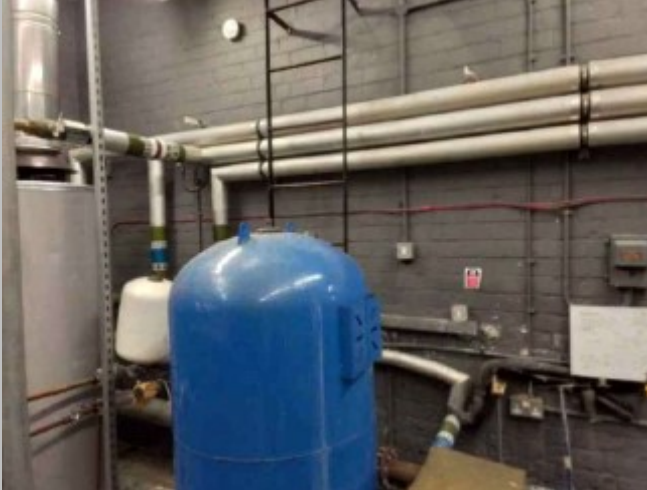
74	OQ002245	Debris/Residue - to RHS wall	External E/001 Boiler Room	No Risk

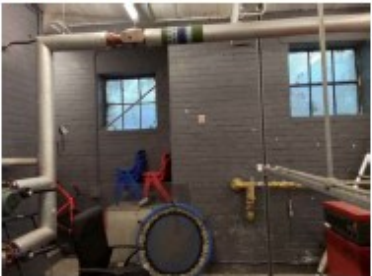
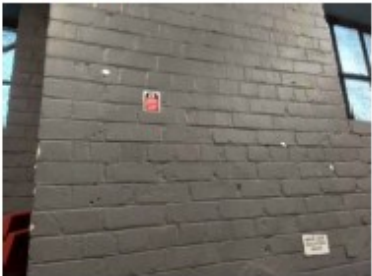
75	OQ002246	Debris/Residue - to RHS wall	External E/001 Boiler Room	Low Risk – Check every 6 months
Photo 1: Wide Angle		Photo 2: Close-up

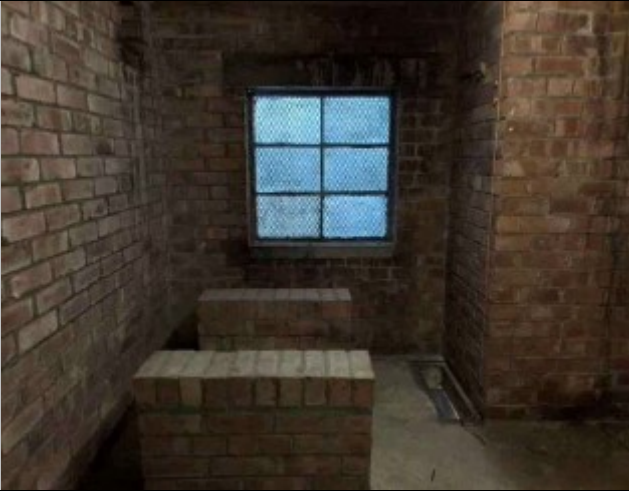
82	As OQ002251	Window Putty/seal	External E/002 Tank Room	No Risk

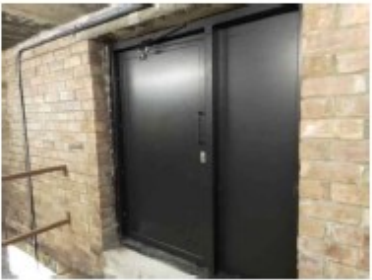
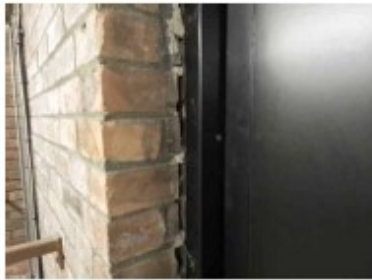
83	OQ002253	Wall - Lining - in wall cavity	External E/002 Tank Room	Very Low Risk – Check every 12 months
Photo 1: Wide Angle		Photo 2: Close-up

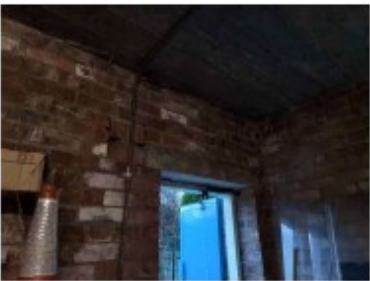
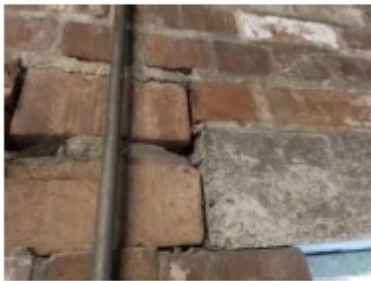
84	As OQ002253	Wall - Lining - in wall cavity	External E/003 Store Room	Very Low Risk – Check every 12 months
Photo 1: Wide Angle		Photo 2: Close-up

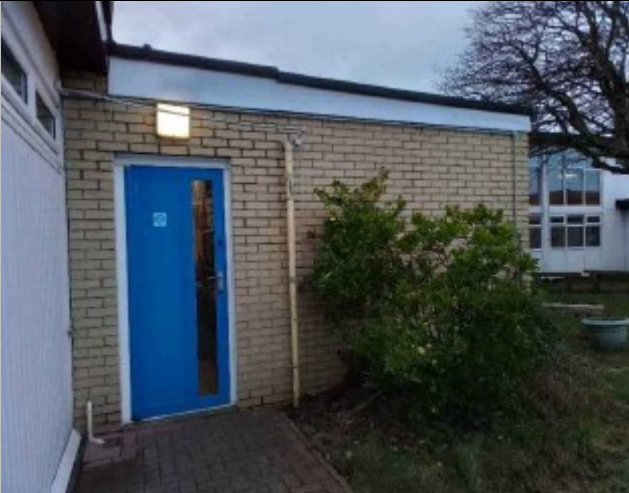
88	OQ002256	Wall - jointing compound, kitchen	External E/006 External	No Risk

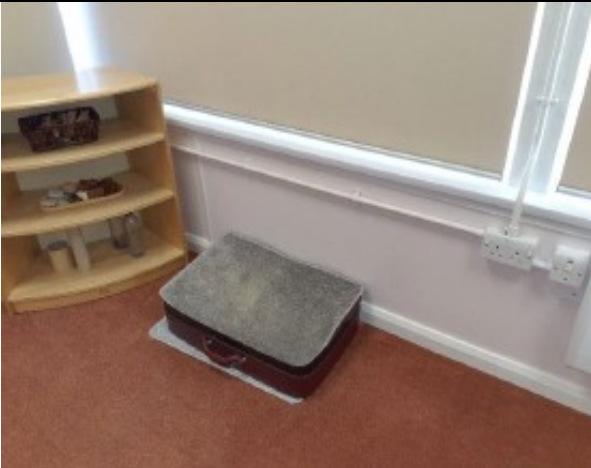
89	Presumed	Asbestos insulation board – low level walls behind wood	Daycare and Family Location 1/006 Family Room (G/01)	Low Risk – Check every 6 months

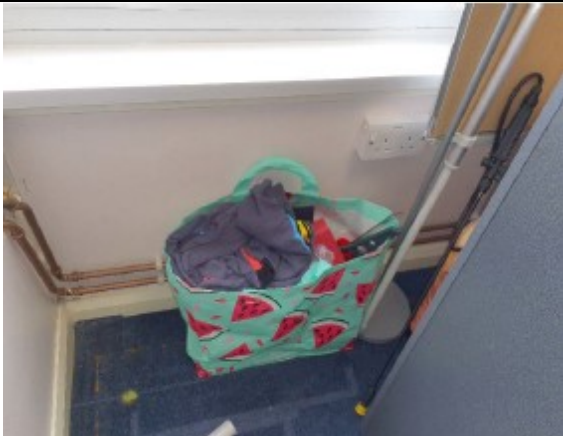
90	Presumed	Asbestos insulation board – low level walls behind wood	Daycare and Family Location 2/007 Store (G/02)	Low Risk – Check every 6 months

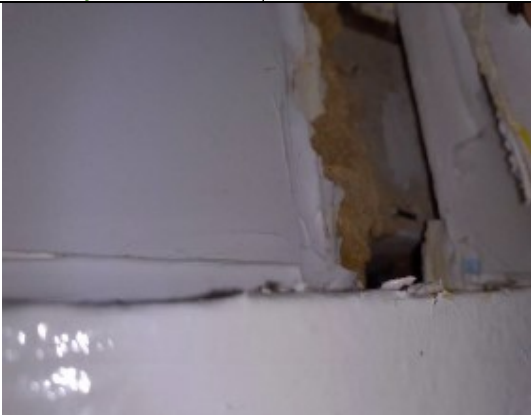
91	KG000830	Asbestos insulation board residue – in wall cavity above doorway to school	Daycare and Family Location 2/007 Daycare Room (G/03)	Medium Risk – check every 3 months
