ASBESTOS SURVEY REPORT FOR WHITBURN VILLAGE PRIMARY SCHOOL, CLEADON LANE, WHITBURN, SUNDERLAND, TYNE AND WEAR, SR6 7NS

Asbestos Register for

**Whitburn Village Primary School, Cleadon Lane, Whitburn,
Sunderland, Tyne and Wear, SR6 7NS**

Date: 12 February 2025

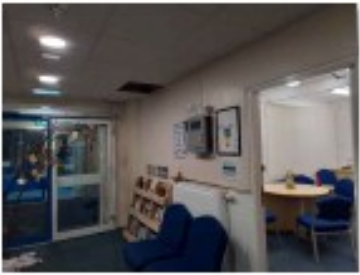
1	OQ002218	Wall - behind plasterboard, radiator and plastic, sampled in ceiling void	Ground Floor G/003 Hallway/passageway	Low Risk – Check every 6 months
Photo 1: Wide Angle		Photo 2: Close-up

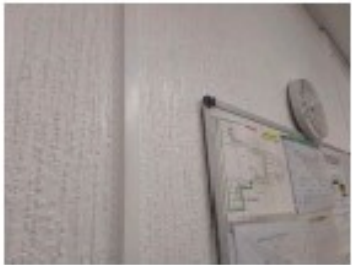
3	As OQ002218	Wall - covered in wallpaper	Ground Floor G/004 Office - Headteacher	Low Risk – Check every 6 months
Photo 1: Wide Angle		Photo 2: Close-up

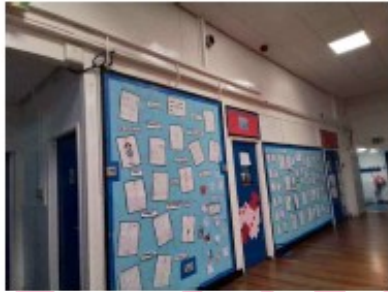
11	As OQ002222	Wall - beneath plastic cladding	Ground Floor G/011 Main Hall	Low Risk – Check every 6 months
Photo 1: Wide Angle		Photo 2: Close-up

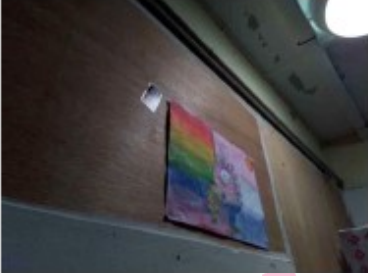
16	As OQ002223	Wall - all walls, protected by plywood	Ground Floor G/014 Cupboard - Store	Very Low Risk – Check every 12 months
Photo 1: Wide Angle		Photo 2: Close-up

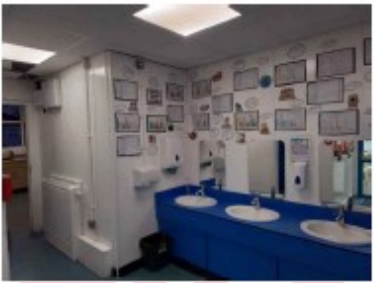
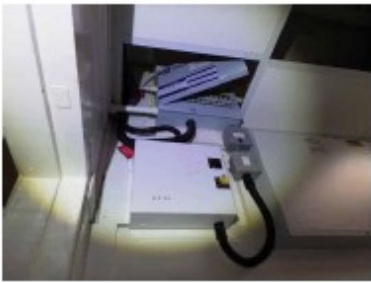
17	As OQ002223	Wall - all walls, beneath plastic cladding	Ground Floor G/015 Hallway/passageway /cloakroom	Low Risk – Check every 6 months
Photo 1: Wide Angle		Photo 2: Close-up

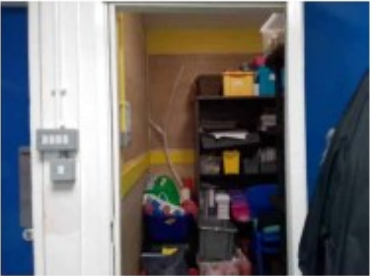
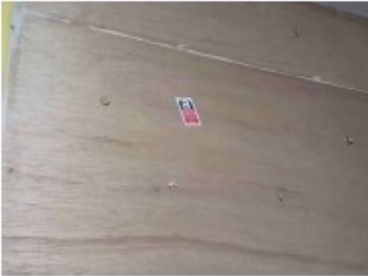
18	As OQ002223	Wall - all walls, protected by plywood	Ground Floor G/016 Cupboard - Store - Year 5 Classroom	Very Low Risk – Check every 12 months
Photo 1: Wide Angle		Photo 2: Close-up

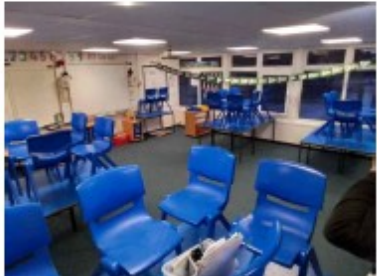
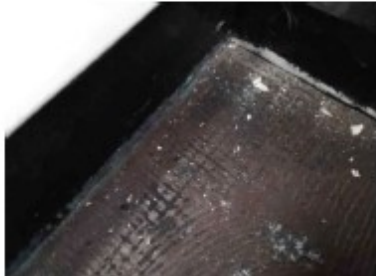
19	As OQ002220	Floor - former tile adhesive, beneath carpet	Ground Floor G/017 Classroom - Year 4	Very Low Risk – Check every 12 months
Photo 1: Wide Angle		Photo 2: Close-up

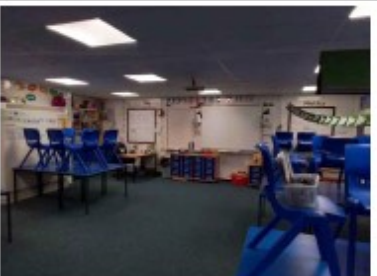
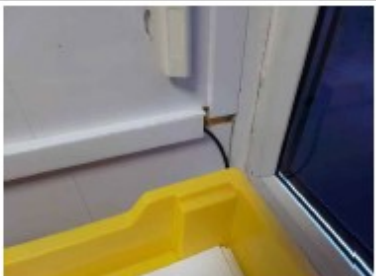
20	As OQ002223	Wall - behind plastic cladding and suspected behind window infill panels	Ground Floor G/017 Classroom - Year 4	Low Risk – Check every 6 months
Photo 1: Wide Angle		Photo 2: Close-up

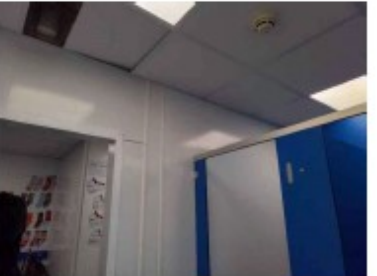
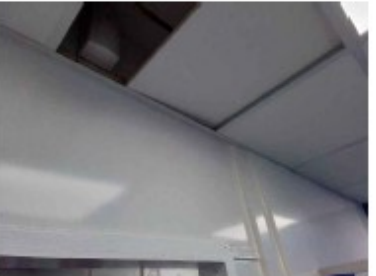
21	As OQ002223	Wall - all walls, beneath plastic cladding	Ground Floor G/018 Toilet(s)	Low Risk – Check every 6 months
Photo 1: Wide Angle		Photo 2: Close-up

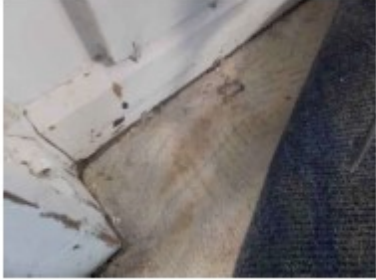
25	OQ002225	Floor - former tile adhesive, beneath carpet	Ground Floor G/023 Classroom - Breakfast	Very Low Risk – Check every 12 months
Photo 1: Wide Angle		Photo 2: Close-up

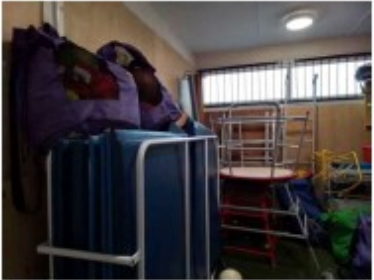
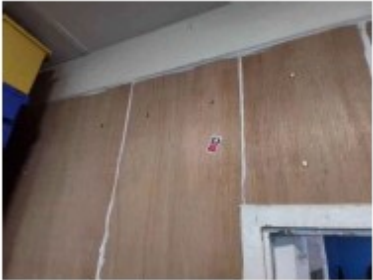
27	As OQ002219	Wall - all walls, protected by plywood	Ground Floor G/024 Cupboard - Store	Very Low Risk – Check every 12 months
Photo 1: Wide Angle		Photo 2: Close-up

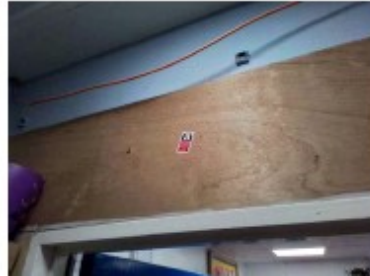
32	As OQ002226	Wall - all walls, protected by plywood	Ground Floor G/028 Cupboard - Store - Year 3 Classroom	Very Low Risk – Check every 12 months
Photo 1: Wide Angle		Photo 2: Close-up

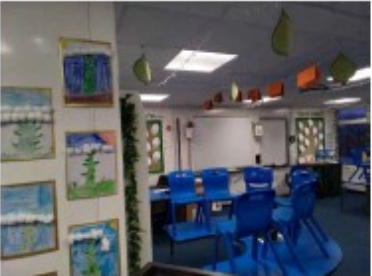
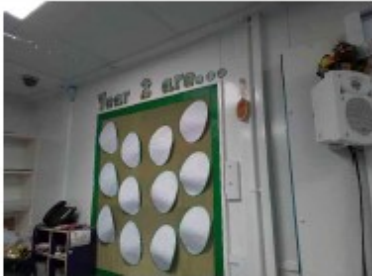
No Photog	
36	As OQ002226	Wall - behind plastic cladding and suspected behind window infill panels	Ground Floor G/031 Classroom - Year 2	Low Risk – Check every 6 months
Photo 1: Wide Angle		Photo 2: Close-up

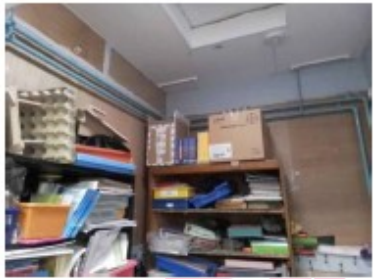
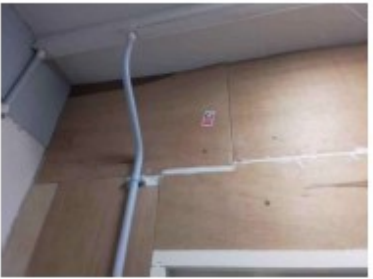
38	As OQ002226	Wall - all walls, protected by plywood	Ground Floor G/032 Cupboard - Store - Year 2 Classroom	Very Low Risk – Check every 12 months
Photo 1: Wide Angle		Photo 2: Close-up

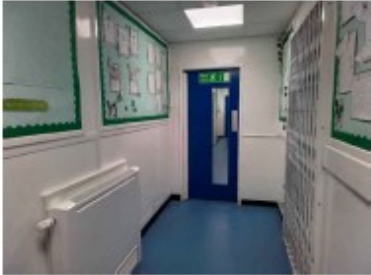
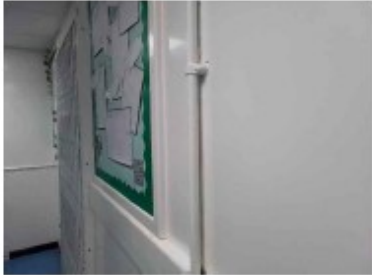
64	As OQ002242	Wall - behind plastic cladding	Ground Floor G/071 Hallway/passageway	Low Risk – Check every 6 months
Photo 1: Wide Angle		Photo 2: Close-up

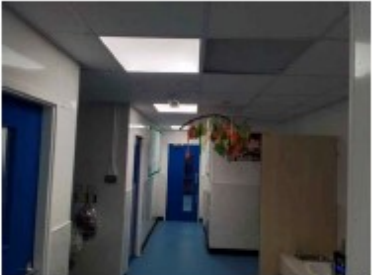
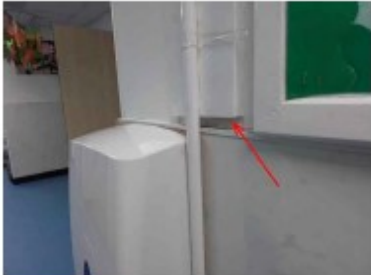
65	As OQ002242	Wall - all walls, beneath plastic and wood cladding	Ground Floor G/072 Hallway/passageway /cloakroom	Low Risk – Check every 6 months
Photo 1: Wide Angle		Photo 2: Close-up

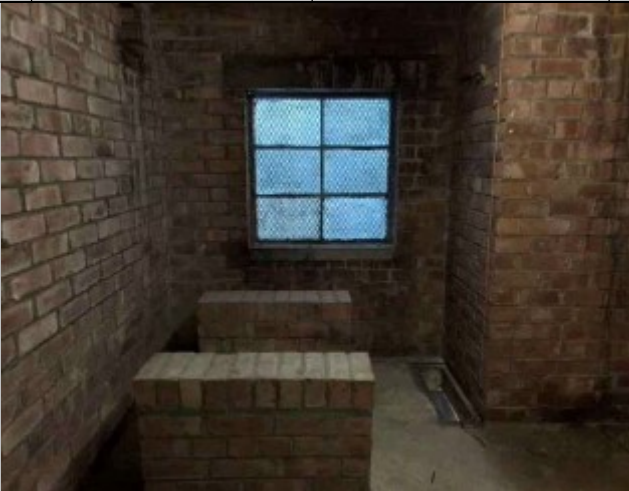
82	As OQ002251	Window Putty/seal	External E/002 Tank Room	No Risk

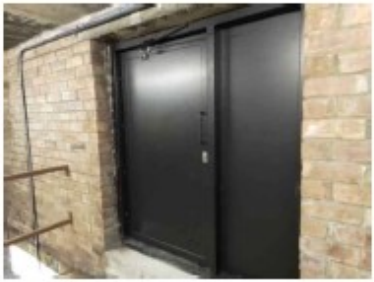
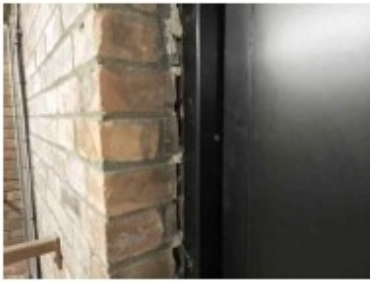
83	OQ002253	Wall - Lining - in wall cavity	External E/002 Tank Room	Very Low Risk – Check every 12 months
Photo 1: Wide Angle		Photo 2: Close-up

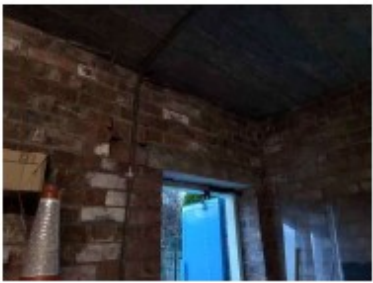
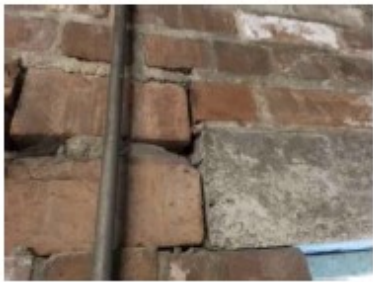
84	As OQ002253	Wall - Lining - in wall cavity	External E/003 Store Room	Very Low Risk – Check every 12 months
Photo 1: Wide Angle		Photo 2: Close-up
