ASBESTOS SURVEY REPORT FOR GREENFIELDS NURSERY AND PRE SCHOOL, TAYLOR AVENUE, WIDEOPEN, NEWCASTLE, NE13 6NB.

Asbestos Register for Greenfield Nursery and Pre School

Date: 06 August 2025

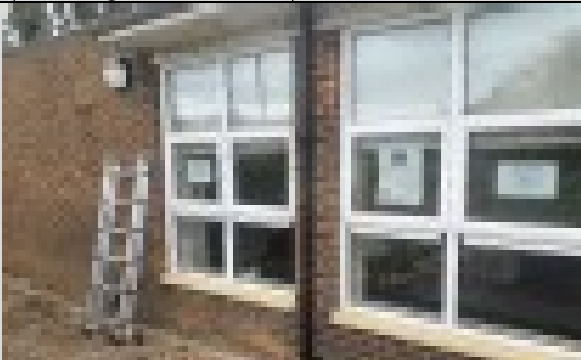
13	RC000241	Mastic to downpipe collars front of main building	External E/001	No Risk

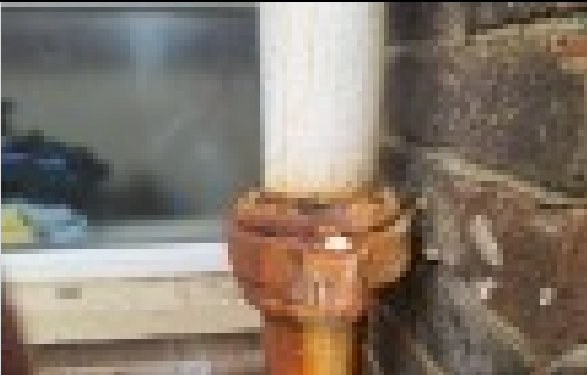
14	RC000242	Mastic to downpipe collars rear of main building	External E/001	No Risk

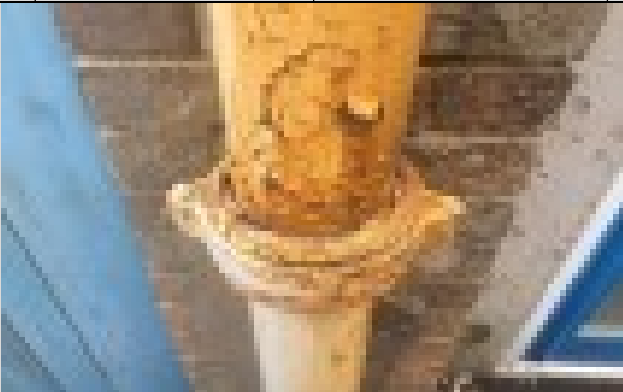
15	RC000243	Mastic to downpipe collars to front and rear of building near extension	External E/001	No Risk

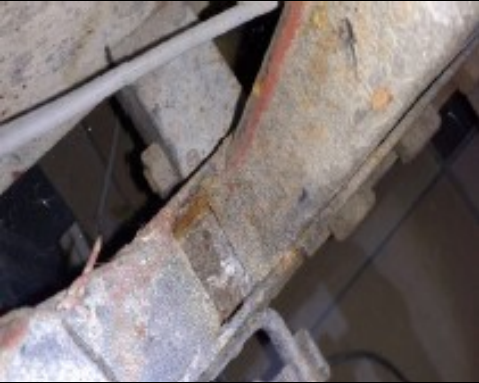
19	OU002881	Thermal insulation debris – between metal supporting beams	Loft R/01	Medium Risk – 3 monthly (advise to have inspected and removed)
