ASBESTOS SURVEY REPORT FOR GREENFIELDS COMMUNITY PRIMARY SCHOOL, WIDEPEN, NEWCASTLE, NE13 6NB.

Asbestos Register for Greenfields Community Primary School

Date: 28 May 2025

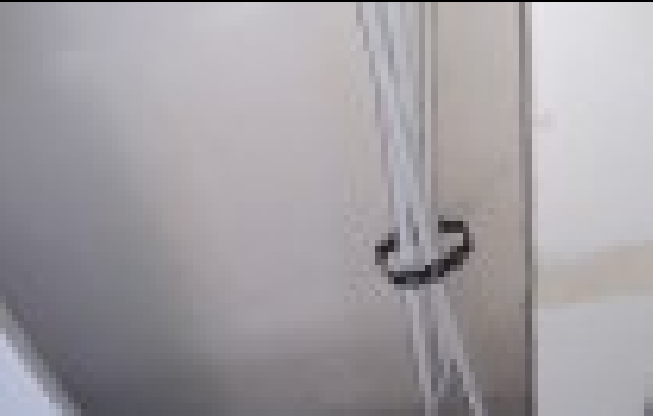
11	PK001266	Fire protection – metal beams and upper ceiling above suspended tiles	Main Kitchen G/009	Low Risk – 6 monthly

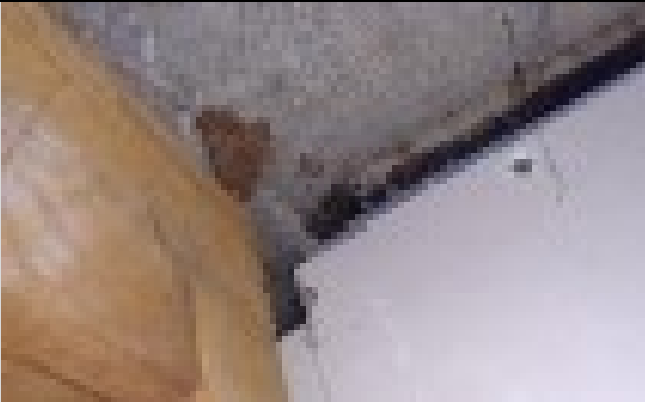
47	PK001284	Felt – metal structure and wall above windows within ceiling void	Early Years classroom 1 G/079	No Risk - Does not contain asbestos.

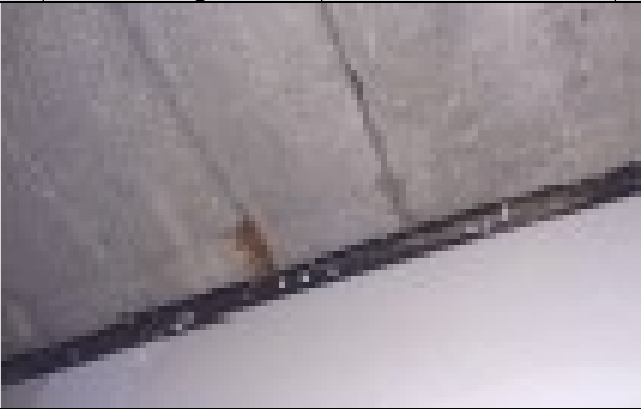
52	As PK001284	Felt – metal structure and wall above windows within ceiling void	Early years classroom 2 toilets G/083	No Risk - Does not contain asbestos.

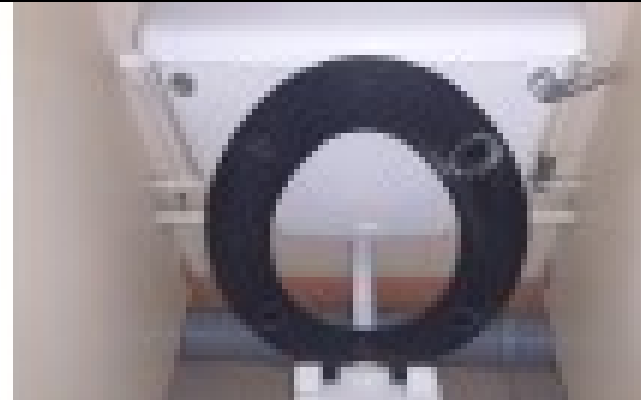
53	As PK001278	Composite toilet seat	Early years classroom 1 toilets G/085	No Risk - Does not contain asbestos.

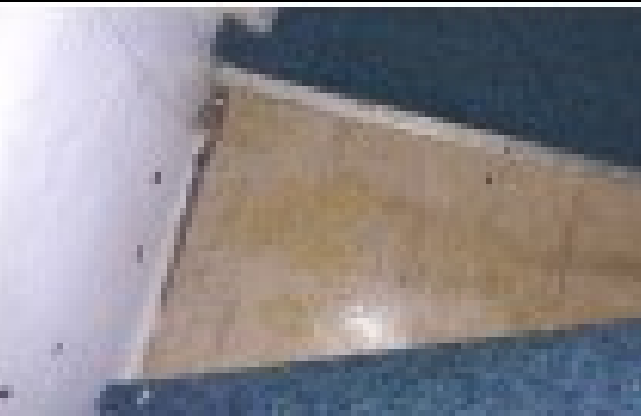
54	As PK001281	Vinyl floor tiles and adhesive – floor below carpet	Early years sensory room G/086	No Risk - Does not contain asbestos.

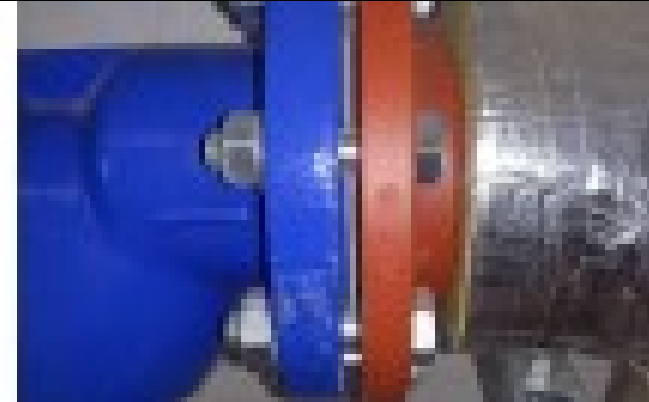
62	PK001295	Gasket pipework	Boiler Room G/101	No Risk - Does not contain asbestos.

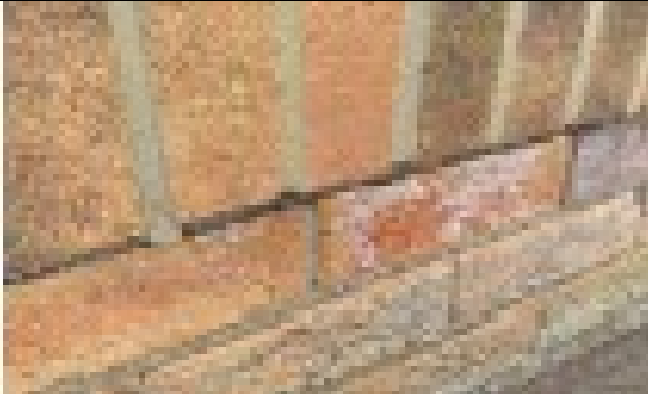
97	PK001294	Damp proof course - Walls	External	No Risk - Does not contain asbestos.
