ASBESTOS SURVEY REPORT FOR ROSEBERRY PRIMARY SCHOOL,
MARSH HOUSE AVENUE, BILLINGHAM, COUNTY DURHAM, TS23 2HJ

Asbestos Register for Roseberry Primary School

Date: 09 June 2025

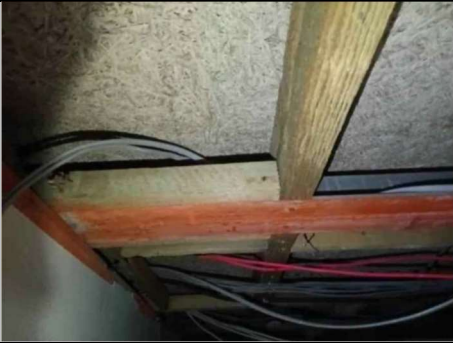
1	TL001085	Ceiling Void - Ceiling Above Wood wool Block/Stramit board	Store Room G/001	Does not contain asbestos.

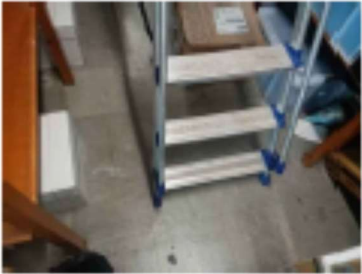
3	TL001087	Floor Covering beneath floor tiles Composite Bitumen	Store Room G/001	Low Risk – to be checked every 6 months
Photo 1: Wide Angle		Photo 2: Close-up

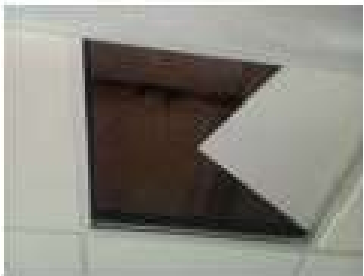
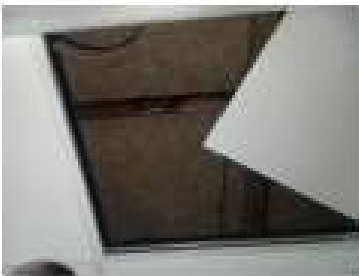
7	As TL001085	Ceiling Void - Ceiling Above Wood wool Block/Stramit board	Cupboard G/008	Does not contain asbestos.
<p align="center">NO PHOTOGRAPHIC EVIDENCE</p>				
8	As TL001086	Ceiling Void Residue to beams Composite Bitumen	Toilet(s) – Female G/009	Very Low Risk – to be checked every 12 months
Photo 1: Wide Angle			Photo 2: Close-up

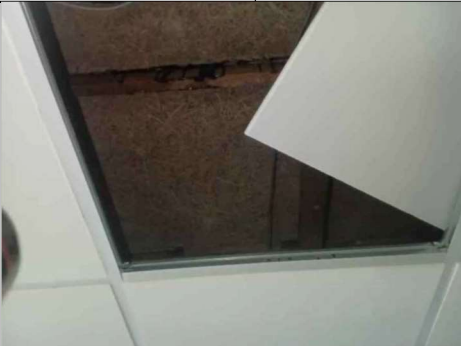
9	As TL001085	Ceiling Void - Ceiling Above Wood wool Block/Stramit board	Toilet(s) – Female G/009	Does not contain asbestos.

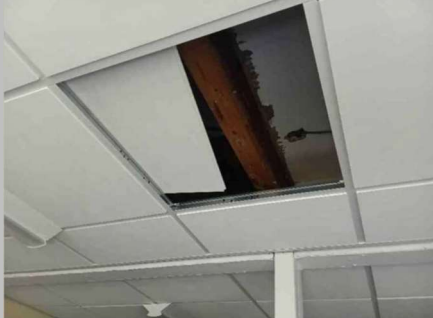
10	TL001088	Ceiling Void - Debris attached to cobwebs, presumed to remain throughout kitchen unit area above lino, former polythene enclosure likely to be contaminated Insulating Board	Staff Room G/010	Does not contain asbestos.

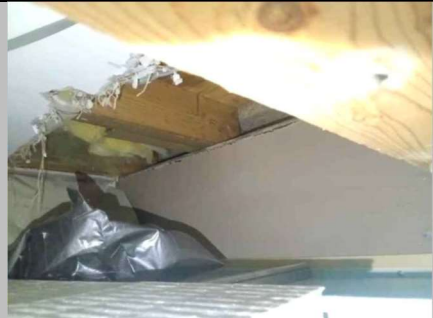
11	As TL001085	Ceiling Void - Ceiling Above Wood wool Block/Stramit board	Staff Room G/010	Does not contain asbestos.

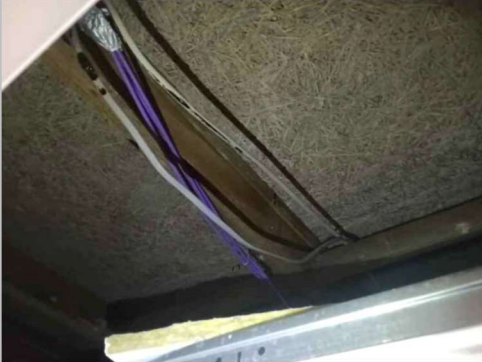
13	As TL001085	Ceiling Void - Ceiling Above Wood wool Block/Stramit board	Office G/011	Does not contain asbestos.

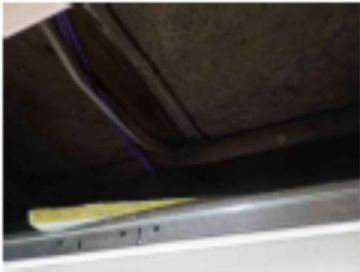
14	As TL001086	Ceiling Void Residue to beams Composite Bitumen	Office G/011	Low Risk – to be checked every 6 months
Photo 1: Wide Angle			Photo 2: Close-up

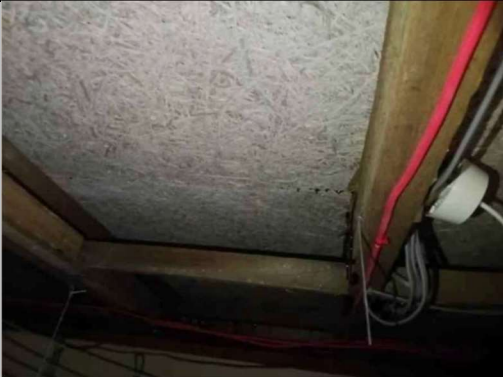
15	As TL001085	Ceiling Void - Ceiling Above Wood wool Block/Stramit board	Office G/012	Does not contain asbestos.

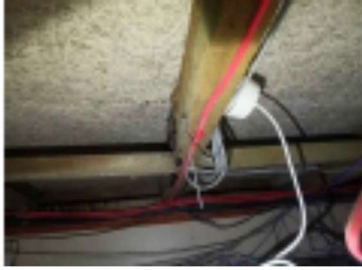
16	As TL001086	Ceiling Void Residue to beams Composite Bitumen	Office G/012	Low Risk – to be checked every 6 months
Photo 1: Wide Angle		Photo 2: Close-up

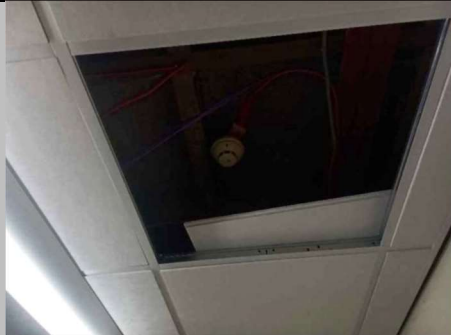
17	TL001089	Debris/Residue To beams and nail holes Insulating Board	Office G/012	Does not contain asbestos.

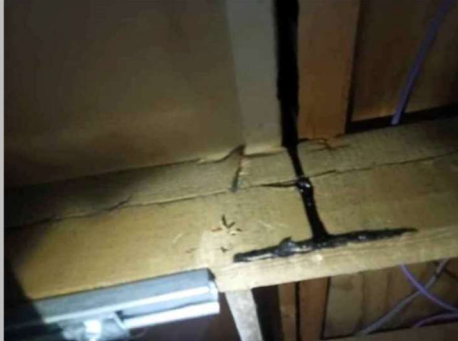
18	TL001090	Ceiling Void Residue to beams Composite Bitumen	Classroom G/013	Does not contain asbestos.

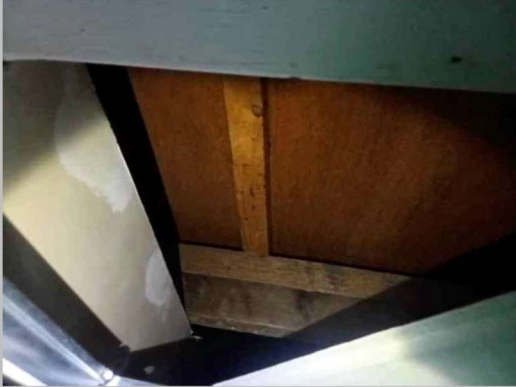
19	As TL001090	Ceiling Void Residue to beams Composite Bitumen	Corridor G/014	Does not contain asbestos.

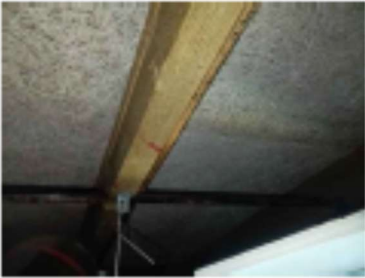
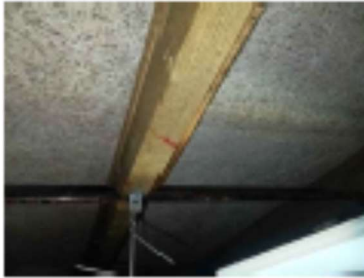
20	As TL001086	Ceiling Void Residue to beams Composite Bitumen	Classroom G/015	Low Risk – to be checked every 6 months
Photo 1: Wide Angle			Photo 2: Close-up

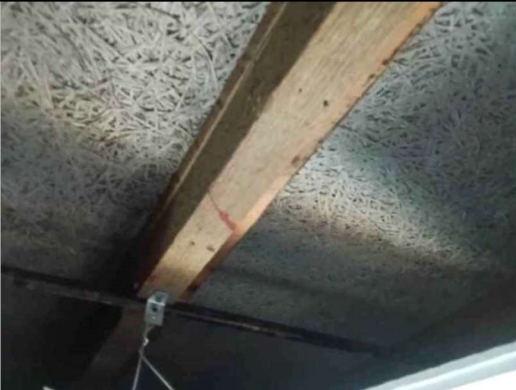
21	TL001091	Ceiling Void Wood wool Block/Stramit board	Classroom G/015	Does not contain asbestos.

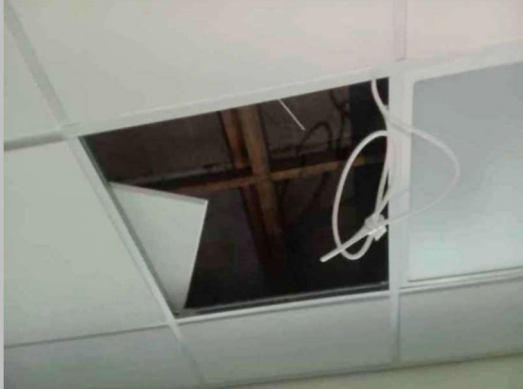
No Photographic Evidence Available		
23	As TL001085	Ceiling Void - Wood wool Block/Stramit board	Classroom G/016	Does not contain asbestos.

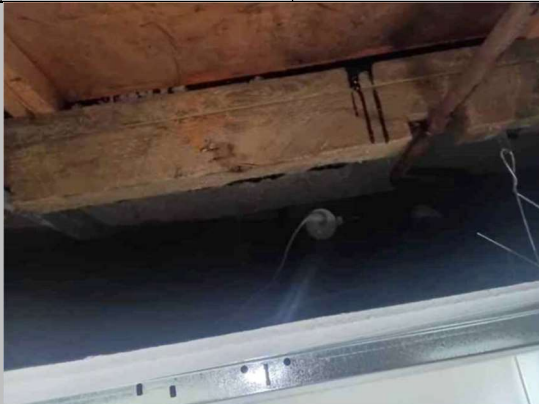
24	As TL001091	Ceiling Void Wood wool Block/Stramit board	Toilet(s) – Male G/017	Does not contain asbestos.

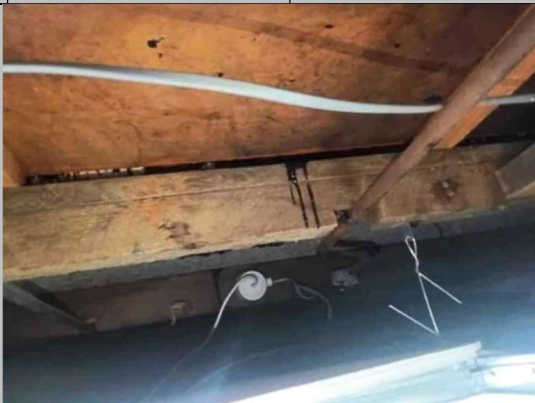
25	As TL001090	Ceiling Void Residue to beams Composite Bitumen	Toilet(s) – Male G/017	Does not contain asbestos.

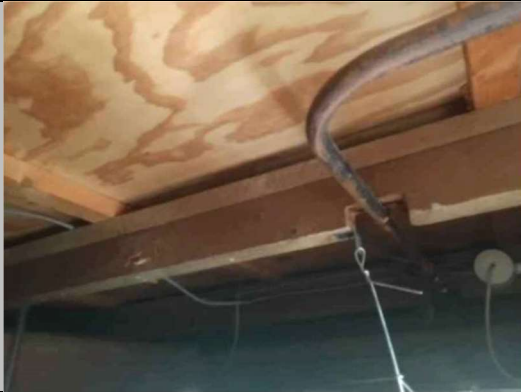
26	As TL001090	Ceiling Void Residue to beams Composite Bitumen	Toilet(s) – Female G/018	Does not contain asbestos.

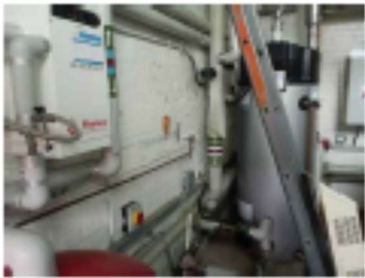
27	TL001092	Wall Possible residue, previously identified and Labelled (MIS 1364-6490-1) Thermal Insulation Lagging	Boiler Room G/023	Medium Risk – to be checked every 3 months
Photo 1: Wide Angle			Photo 2: Close-up

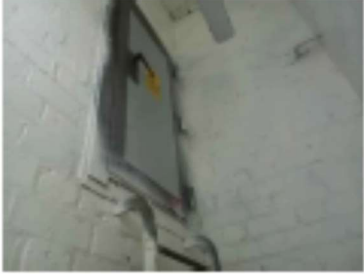
28	TL001093	Door - Firedoor, Inner Lining (MIS 1364-6490-2) Insulating Board	Boiler Room G/023	Low Risk – to be checked every 6 months
Photo 1: Wide Angle		Photo 2: Close-up

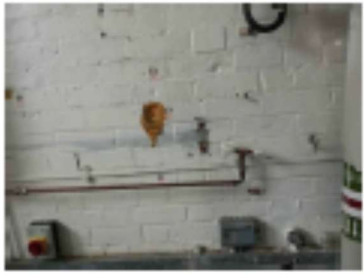
29	TL001092	Wall Pipe penetrations, foam sealed (As MIS 1364-6490-1) Thermal Insulation Lagging	Boiler Room G/023	Medium Risk – to be checked every 3 months
Photo 1: Wide Angle		Photo 2: Close-up

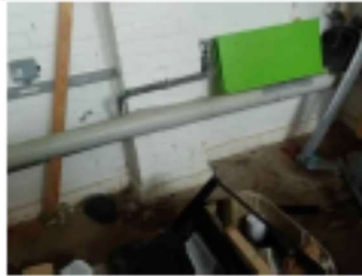
No Photographic Evidence Available		
30	TL001094	Damp Proof Course (Lucion 192754-1) Composite Bitumen	Boiler Room G/023	Very Low Risk – to be checked every 12 months
Photo 1: Wide Angle		Photo 2: Close-up

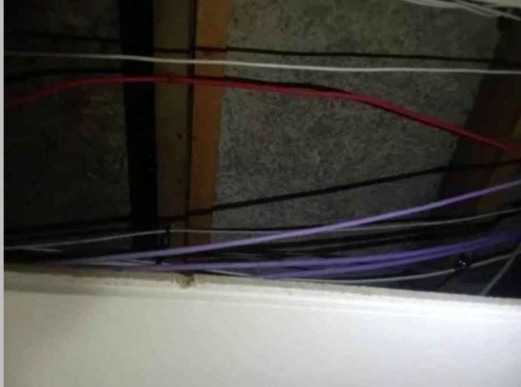
31	As TL001085	Ceiling Void - Wood wool Block/Stramit board	Corridor G/024	Does not contain asbestos.

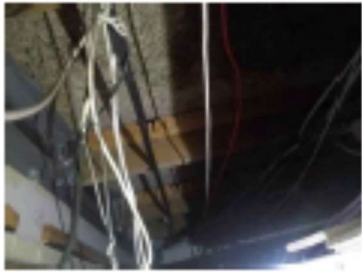
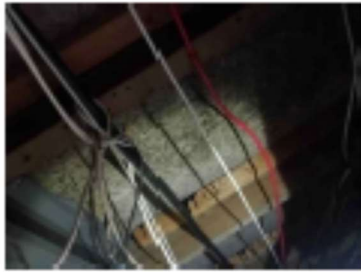
32	As TL001086	Ceiling Void Residue to beams Composite Bitumen	Corridor G/024	Low Risk – to be checked every 6 months
Photo 1: Wide Angle		Photo 2: Close-up

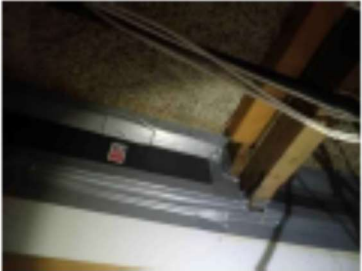
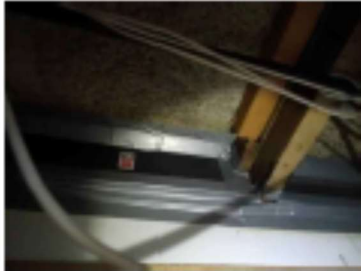
33	Presumed	Ceiling Cladding Enclosed behind polythene enclosure Insulating Board	Corridor G/024	Medium Risk – to be checked every 3 months
Photo 1: Wide Angle		Photo 2: Close-up

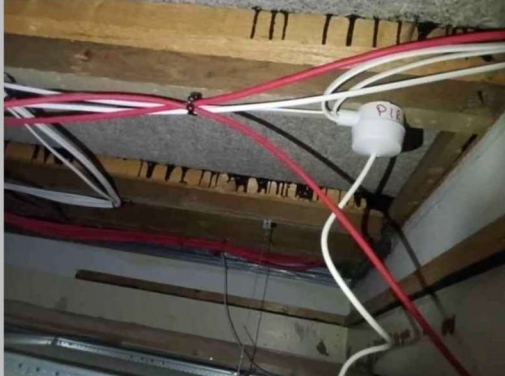
34	As TL001085	Ceiling Void - Wood wool Block/Stramit board	Entrance Hall/Foyer/Lobby G/025	Does not contain asbestos.

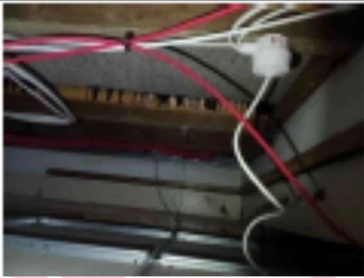
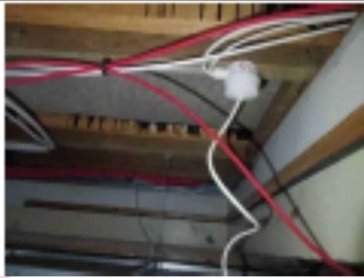
35	As TL001086	Ceiling Void Residue to beams Composite Bitumen	Entrance Hall/Foyer/Lobby G/025	Low Risk – to be checked every 6 months
Photo 1: Wide Angle		Photo 2: Close-up

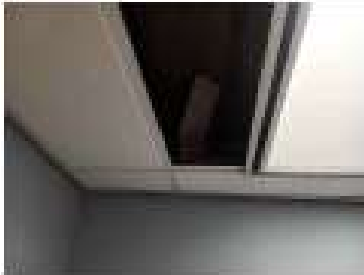
37	As TL001086	Ceiling Void Residue to beams Composite Bitumen	Store Room G/026	Low Risk – to be checked every 6 months
Photo 1: Wide Angle		Photo 2: Close-up

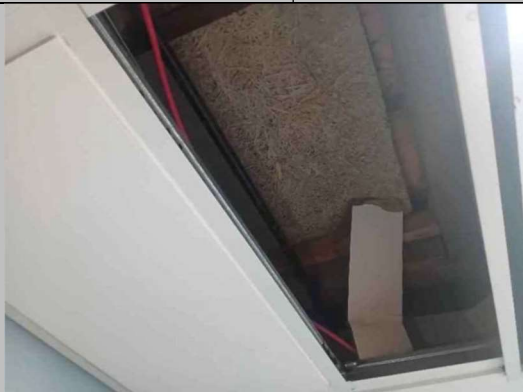
No Photographic Evidence Available		
38	As TL001085	Ceiling Void - Wood wool Block/Stramit board	Store Room G/026	Does not contain asbestos.

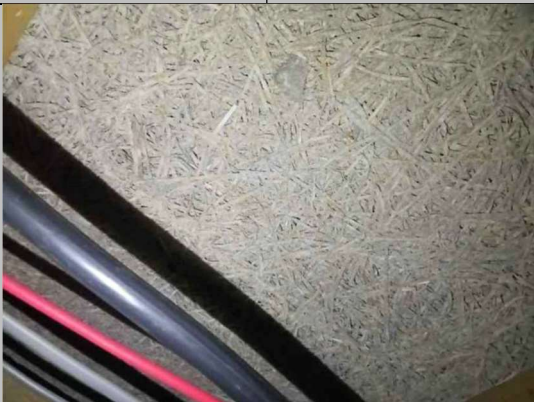
40	As TL001085	Ceiling Void - Wood wool Block/Stramit board	Corridor G/027	Does not contain asbestos.

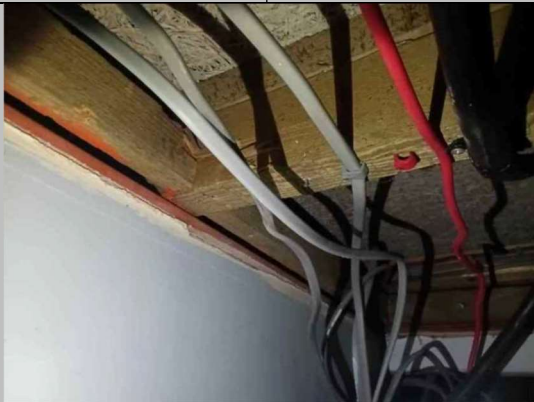
41	As TL001089	Debris Around nail Insulating Board	Corridor G/027	Does not contain asbestos.

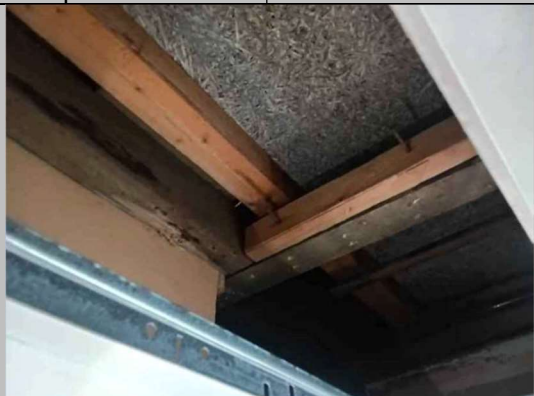
42	As TL001090	Ceiling Void Residue to beams Composite Bitumen	Toilet(s) – Female G/028	Does not contain asbestos.

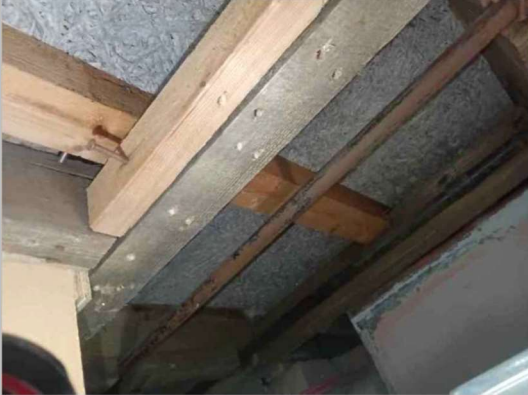
43	As TL001085	Ceiling Void – Ceiling Above Wood wool Block/Stramit board	Toilet(s) – Female G/028	Does not contain asbestos.

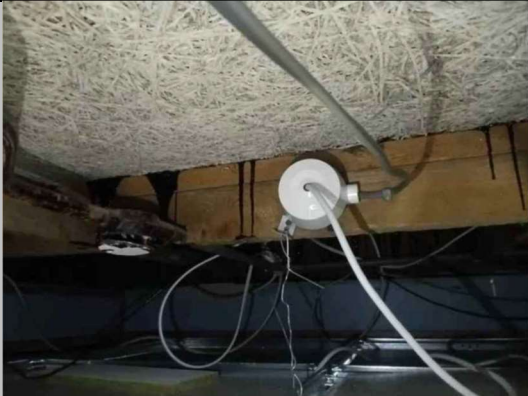
44	As TL001090	Ceiling Void Residue to beams Composite Bitumen	Toilet(s) – Male G/029	Does not contain asbestos.

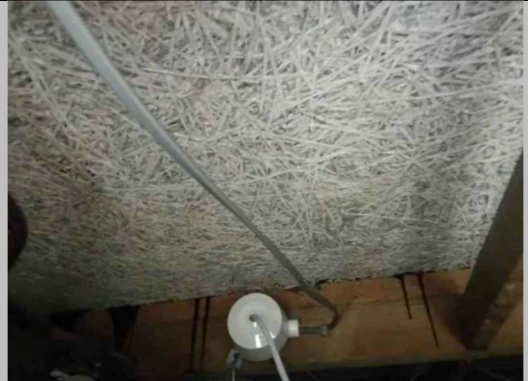
45	As TL001085	Ceiling Void – Ceiling Above Wood wool Block/Stramit board	Toilet(s) – Male G/029	Does not contain asbestos.

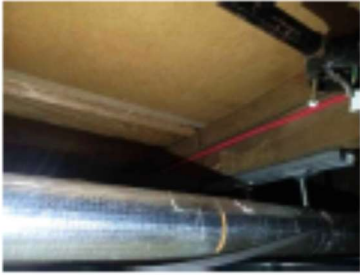
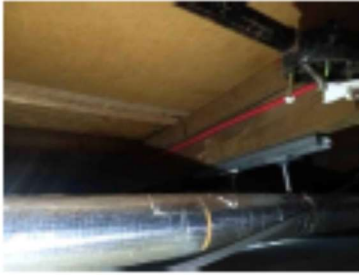
46	As TL001086	Ceiling Void Residue to beams Composite Bitumen	Classroom G/030	Low Risk – to be checked every 6 months
Photo 1: Wide Angle			Photo 2: Close-up

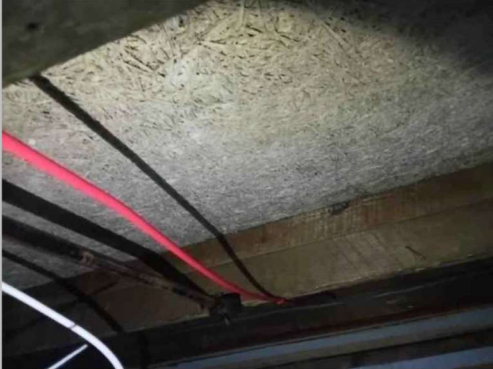
47	As TL001085	Ceiling Void – Wood wool Block/Stramit board	Classroom G/030	Does not contain asbestos.

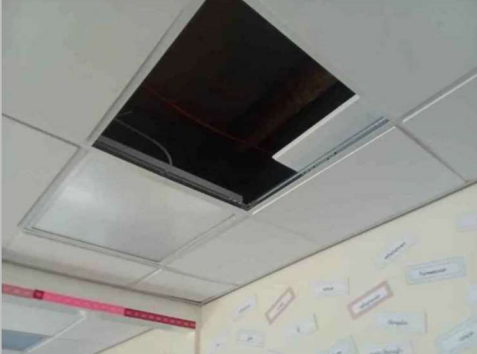
48	TL001095	Debris/Residue To beams Insulating Board	Classroom G/030	Does not contain asbestos.

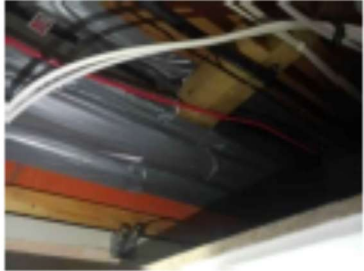
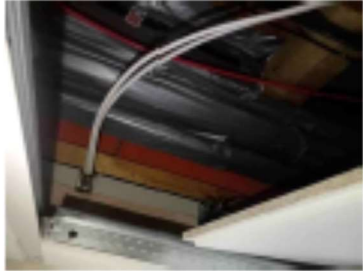
49	Presumed	Ceiling Cladding Enclosed behind polythene enclosure Insulating Board	Meeting Room G/031	Medium Risk – to be checked every 3 months
Photo 1: Wide Angle			Photo 2: Close-up

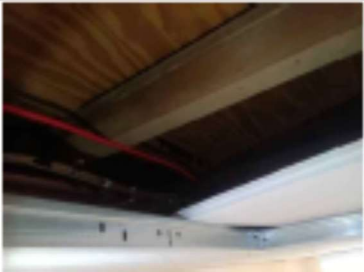
50	As TL001086	Ceiling Void Residue to beams Composite Bitumen	Toilet(s) – Female G/042	Low Risk – to be checked every 6 months
Photo 1: Wide Angle			Photo 2: Close-up

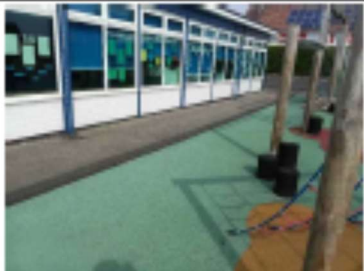
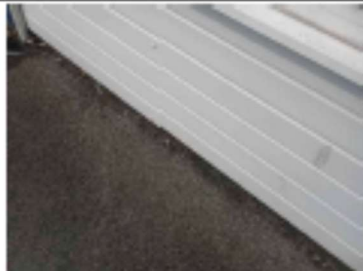
No Photographic Evidence Available	
51	TL001096	Damp Proof Course (AMS report 0073 28.6.07)	External E/001	Very Low Risk – to be checked every 12 months
Photo 1: Wide Angle			Photo 2: Close-up

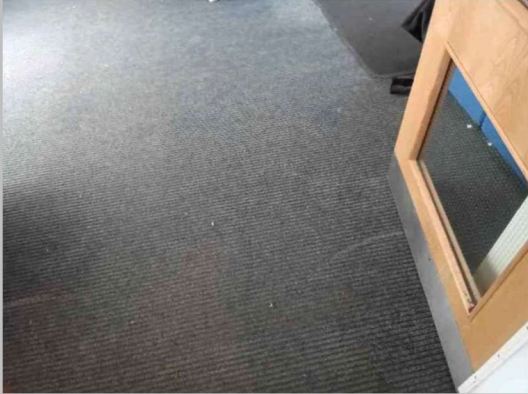
52	TL001097	Floor - Covering Beneath screed Composite Bitumen	Lower School Entrance Hall/Foyer/Lobby 60	Does not contain asbestos.

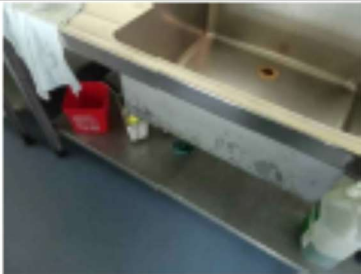
54	As TL001098	Under Sink Mat Composite Bitumen	Lower School Kitchen 31	Low Risk – to be checked every 6 months
Photo 1: Wide Angle			Photo 2: Close-up

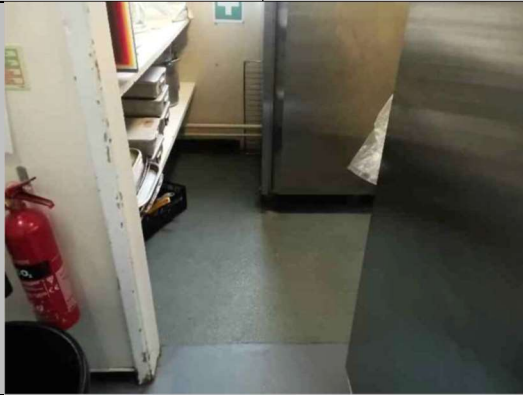
55	TL001099	Wall – Skirting Cement Products	Lower School Kitchen 31	Does not contain asbestos.

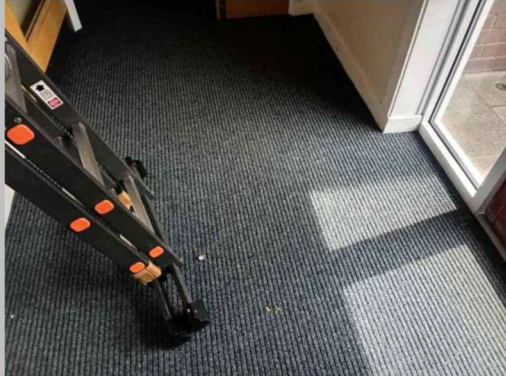
56	As TL001097	Floor - Covering Beneath screed Composite Bitumen	Entrance Hall/Foyer/Lobby 58	Does not contain asbestos.

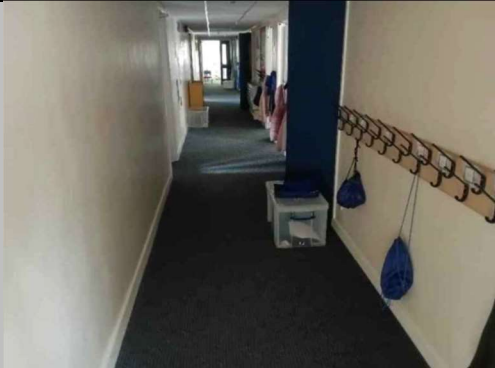
57	As TL001097	Floor - Covering Beneath screed Composite Bitumen	Lower School Corridor 57	Does not contain asbestos.

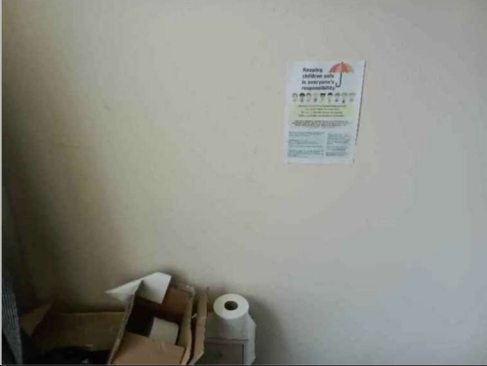
58	TL001100	Wall – Coating Composite Decorative Finish	Lower School Toilet(s) Staff 37	Does not contain asbestos.

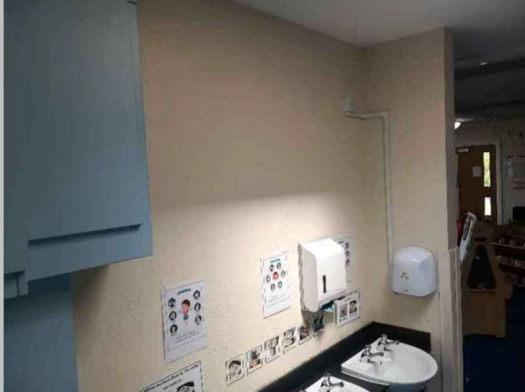
59	As TL001100	Wall – Coating Composite Decorative Finish	Lower School Toilet(s) 43	Does not contain asbestos.

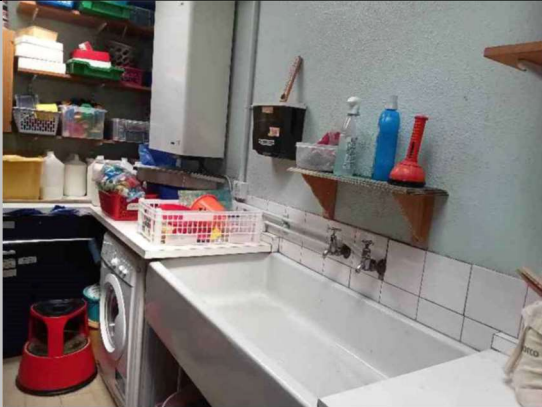
60	TL001101	Wall – Coating Composite Decorative Finish	Lower School Utility Room 42	Does not contain asbestos.

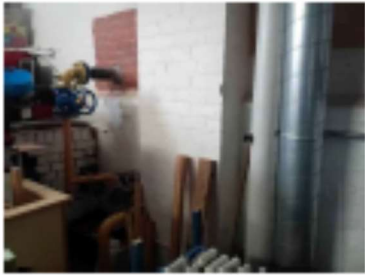
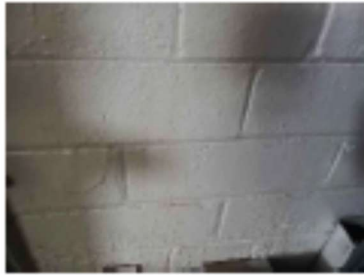
61	TL001102	Wall (Lucion report 330293 28.5.19) Thermal Insulation Lagging	Lower School Boiler Room 61	Medium Risk – to be checked every 3 months
Photo 1: Wide Angle		Photo 2: Close-up

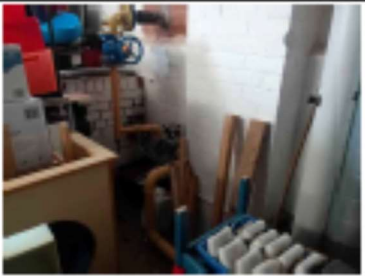
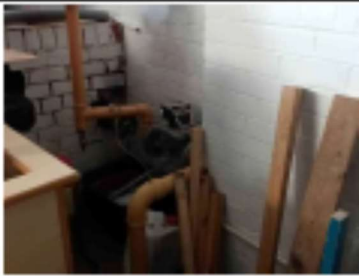
62	TL001103	Pipework Gasket(s) (Lucion report 330293.1 28.5.19) Joint/Gasket	Lower School Boiler Room 61	Low Risk – to be checked every 6 months
Photo 1: Wide Angle		Photo 2: Close-up

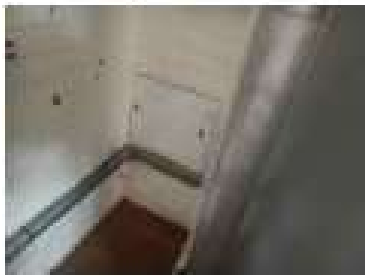
63	TL001104	Flue Pipe (Lucion 330293 28.5.2019) Cement Products	Lower School Boiler Room 61	Low Risk – to be checked every 6 months
Photo 1: Wide Angle		Photo 2: Close-up

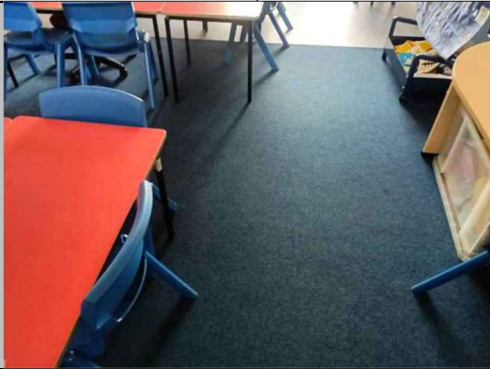
67	TL001107	Floor – Covering Composite Bitumen	Lower School Classroom 10	Does not contain asbestos.

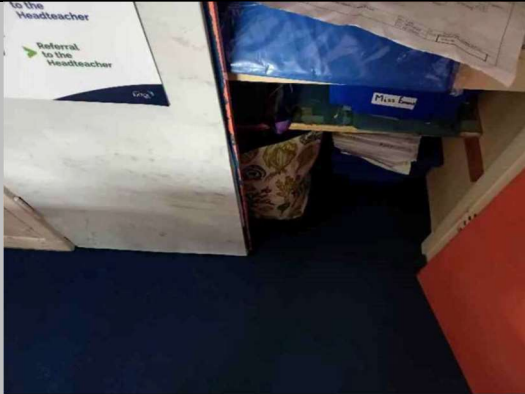
68	As TL001107	Floor – Covering Composite Bitumen	Lower School Cupboard 8	Does not contain asbestos.

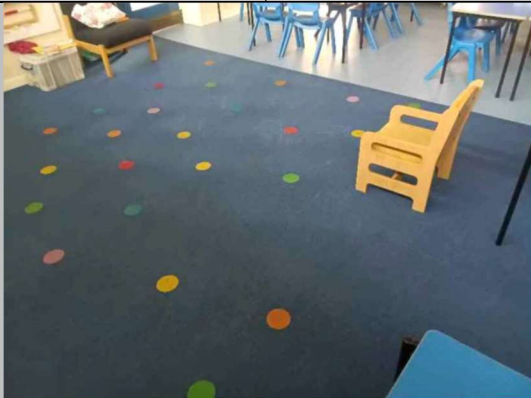
69	As TL001107	Floor – Covering Composite Bitumen	Lower School Classroom 12	Does not contain asbestos.

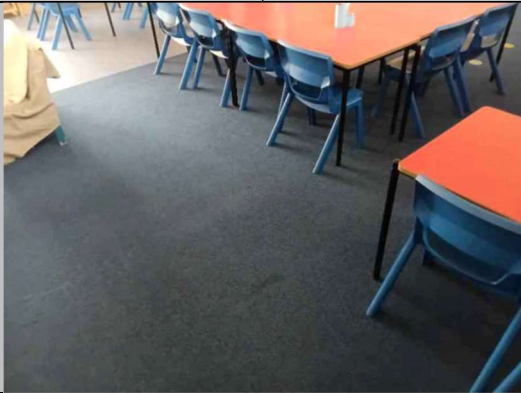
70	As TL001107	Floor – Covering Composite Bitumen	Lower School Classroom 15	Does not contain asbestos.
