ASBESTOS SURVEY REPORT FOR 259 HIGH STREET WEST,  
SUNDERLAND, SR1 3DH

**259 High Street West, Sunderland, SR1 3DH**

**Date: 15 July 2026**

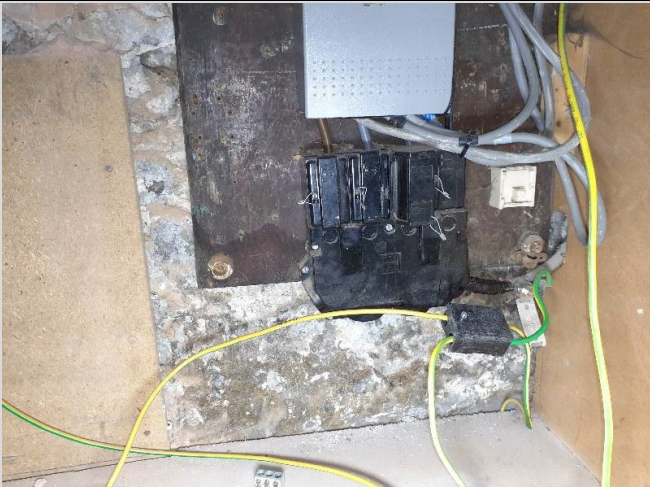
| 1 | Presumed | Textiles – Live<br>Electrics | Store Z1/001 | Very Low Risk – 12<br>monthly |

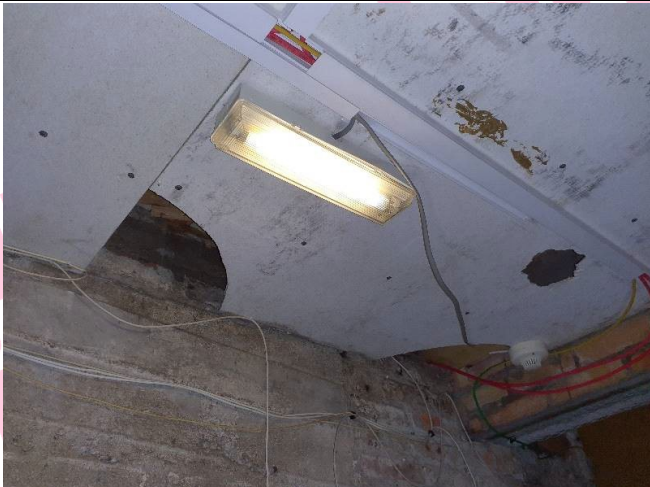
| 2 | RO002912 | Insulating Board –<br>ceiling | Store Z1/002 | No Risk |

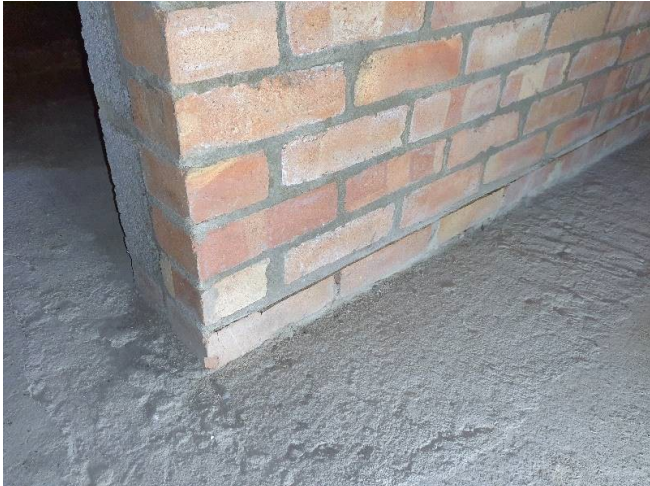
| 3 | RO002913 | Bitumen damp proof<br>course - wall | Store Z1/002 | Very Low Risk – 12<br>monthly |

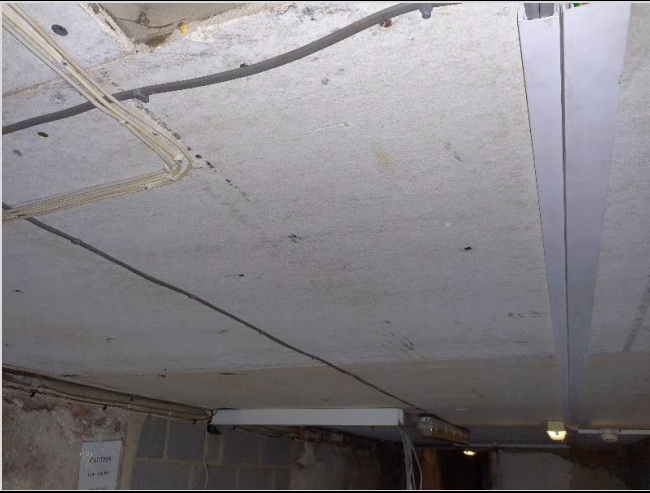
| 4 | As<br>RO002912 | Insulating Board –<br>ceiling | Store Z1/003 | No Risk |

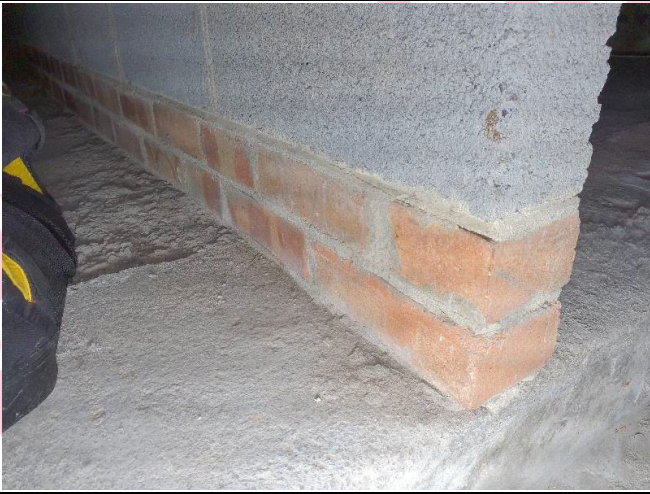
| 5 | As<br>RO002913 | Bitumen damp proof<br>course - wall | Store Z1/003 | Very Low Risk – 12<br>monthly |

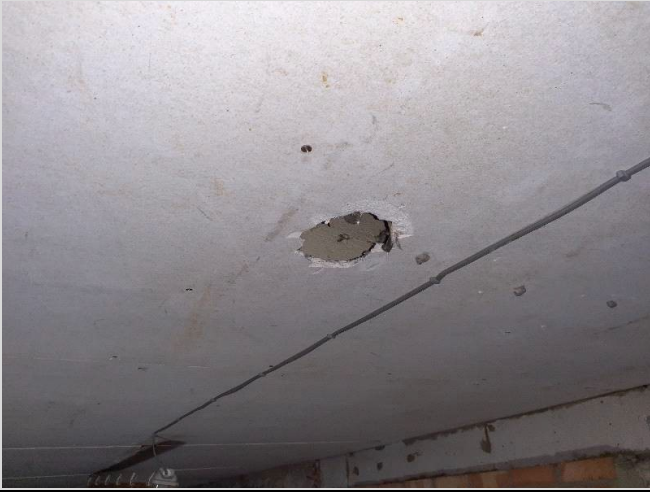
| 6 | As<br>RO002912 | Insulating Board –<br>ceiling | Store Z1/004 | No Risk |

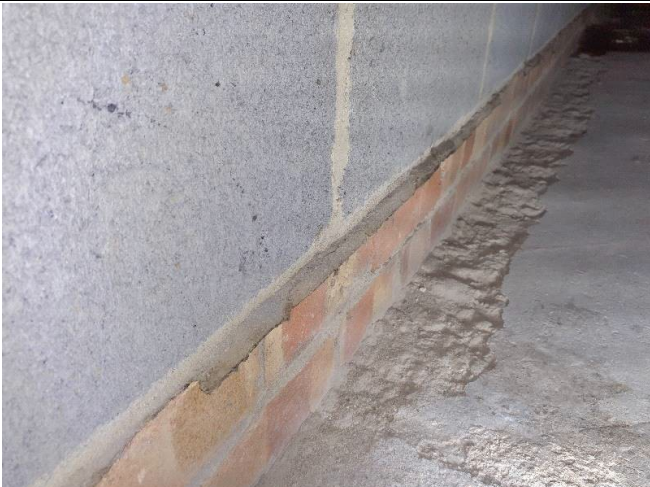
| 7 | As<br>RO002913 | Bitumen damp proof<br>course - wall | Store Z1/004 | Very Low Risk – 12<br>monthly |

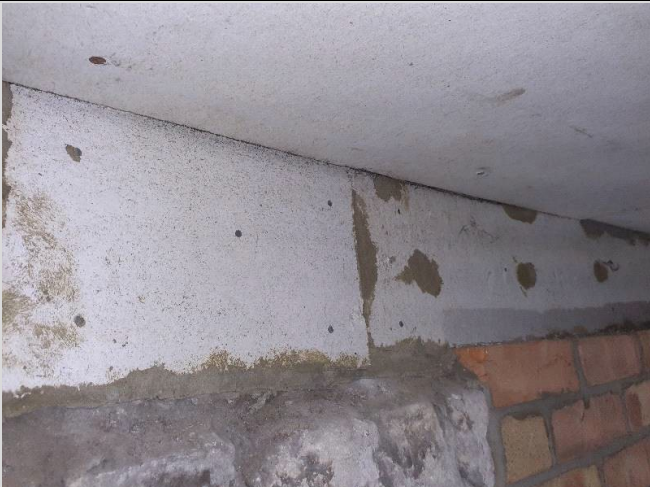
| 8 | RO002914 | Insulating board –<br>wall | Store Z1/004 | No Risk |

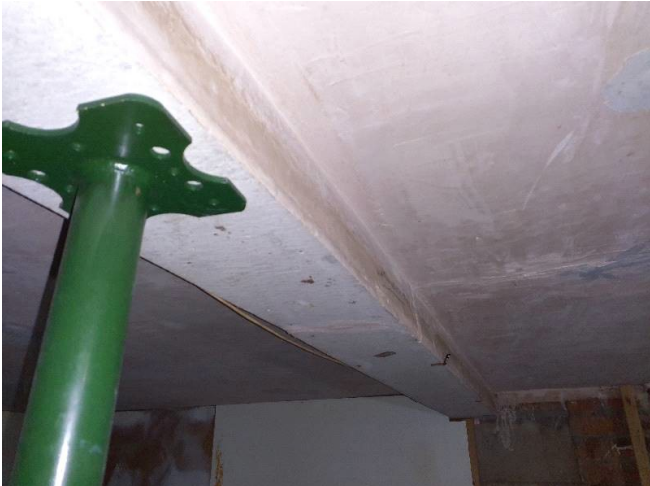
| 9 | RO002915 | Insulating Board –<br>beams | Store Z1/005 | Low Risk - 6 monthly |

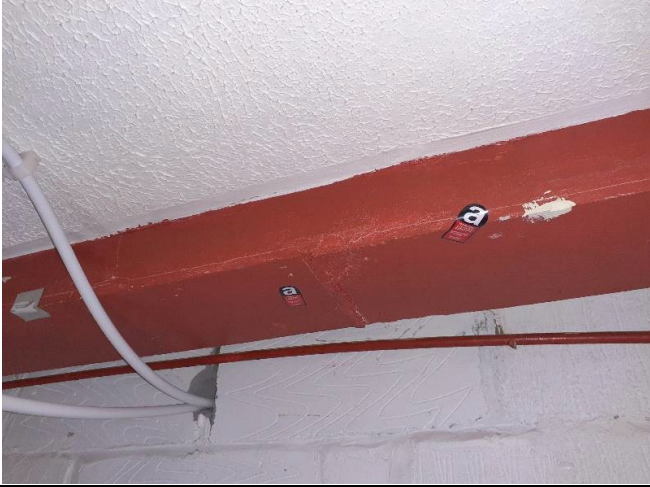
| 10 | As<br>RO002915 | Insulating Board –<br>beams | Store Z1/006 | Very Low Risk – 12<br>monthly |

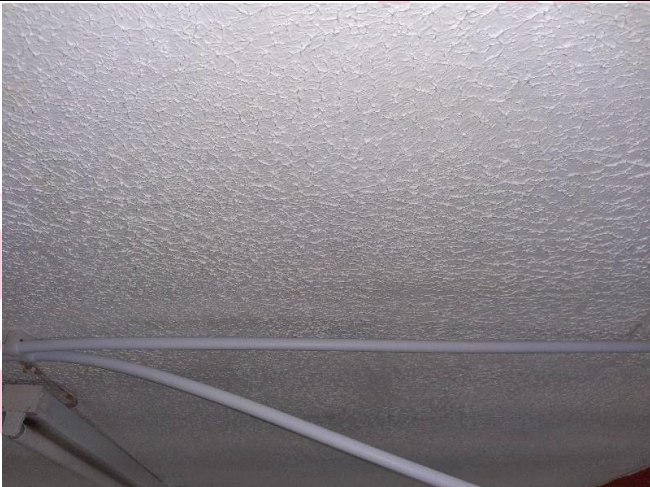
| 11 | RO002916 | Decorative finish –<br>ceiling | Store Z1/006 | Very Low Risk – 12<br>monthly |

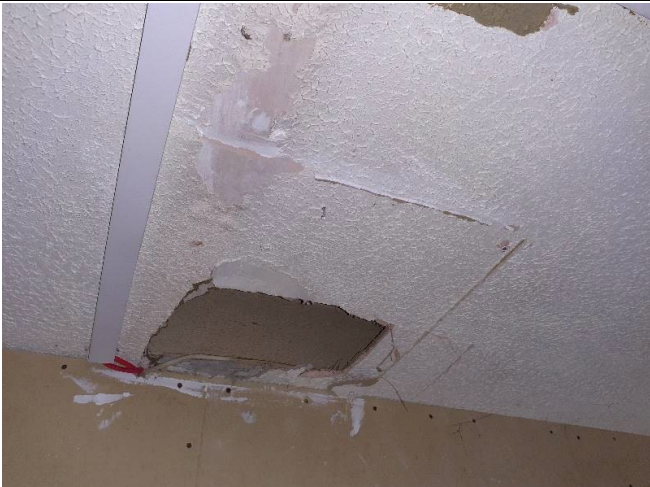
| 13 | As<br>RO002916 | Decorative finish –<br>ceiling | Corridor Z1/007 | Very Low Risk – 12<br>monthly |

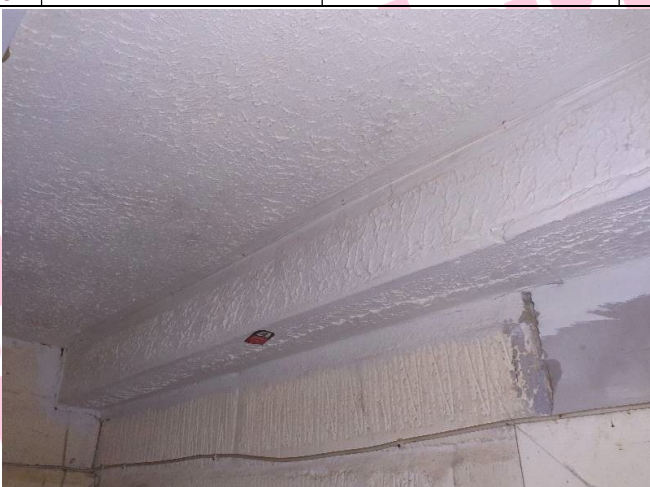
| 14 | As<br>RO002915 | Insulating Board –<br>beams | Lobby Z1/008 | Very Low Risk – 12<br>monthly |

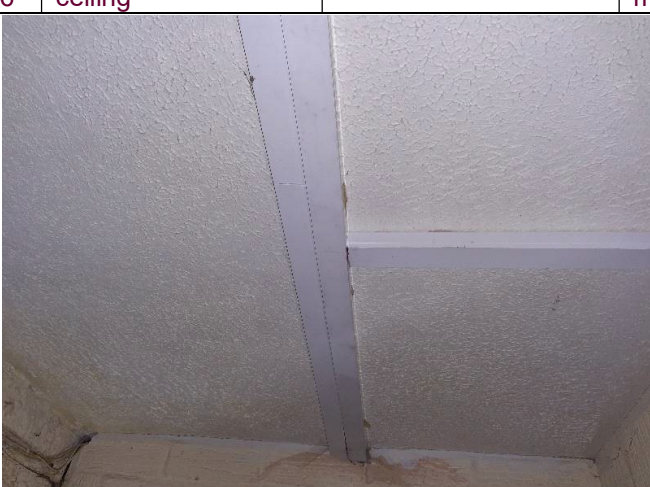
| 15 | As<br>RO002916 | Decorative finish –<br>ceiling | Lobby Z1/008 | Very Low Risk – 12<br>monthly |

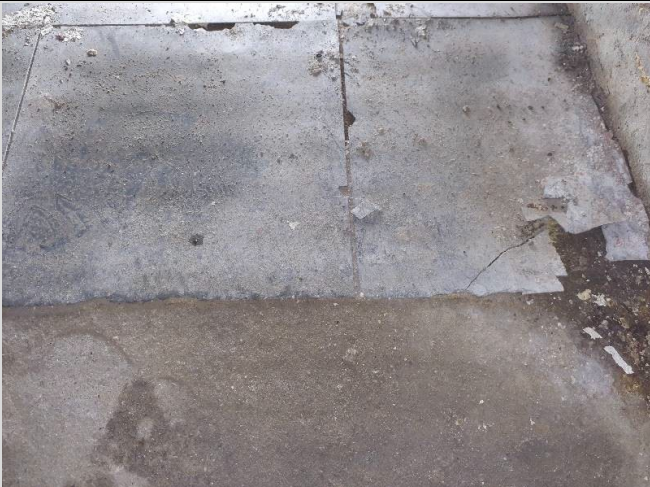
| 16 | RO002917 | Composite tiles – floor | Lobby Z1/008 | No Risk |

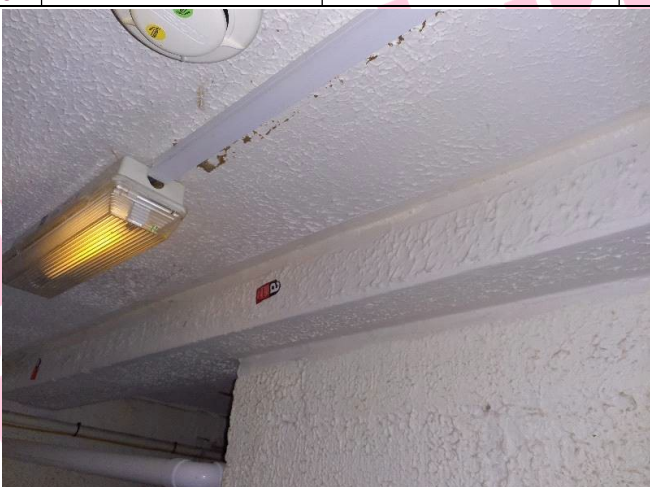
| 17 | As RO002915 | Insulating Board – beams | Office Z1/009 | Very Low Risk – 12 monthly |

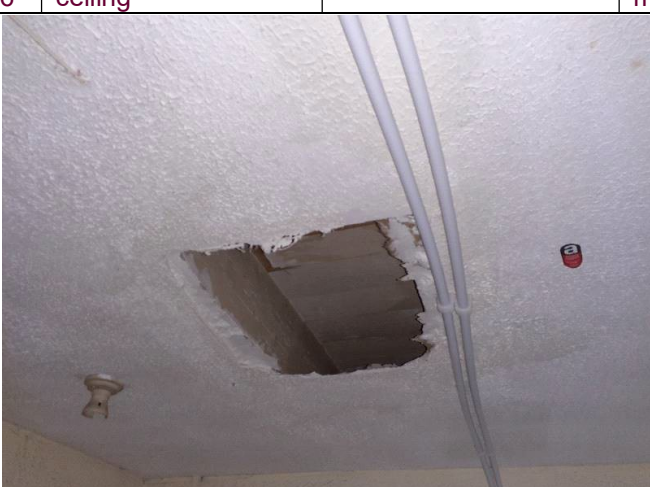
| 18 | As RO002916 | Decorative finish – ceiling | Office Z1/009 | Very Low Risk – 12 monthly |

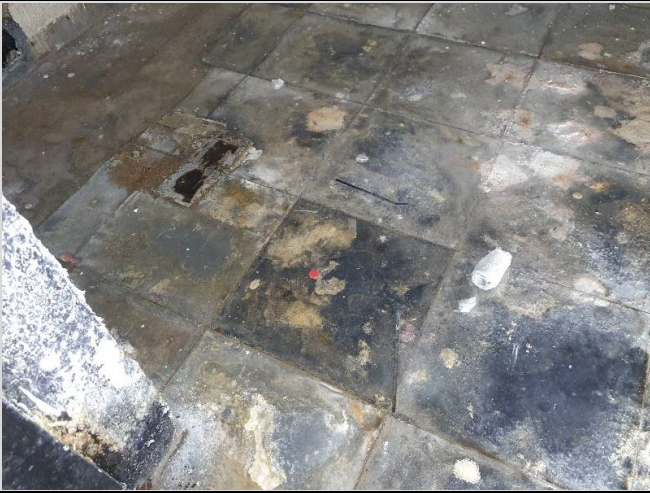
| 19 | As<br>RO002917 | Composite tiles –<br>floor | Office Z1/009 | No Risk |

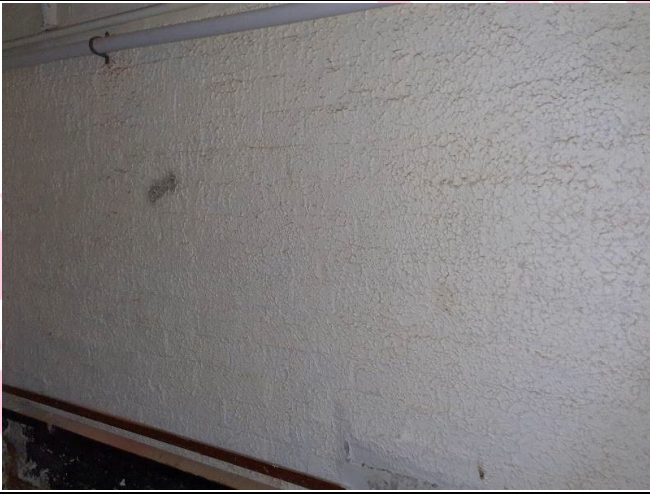
| 20 | RO002918 | Decorative finish –<br>walls | Office Z1/009 | Very Low Risk – 12<br>monthly |

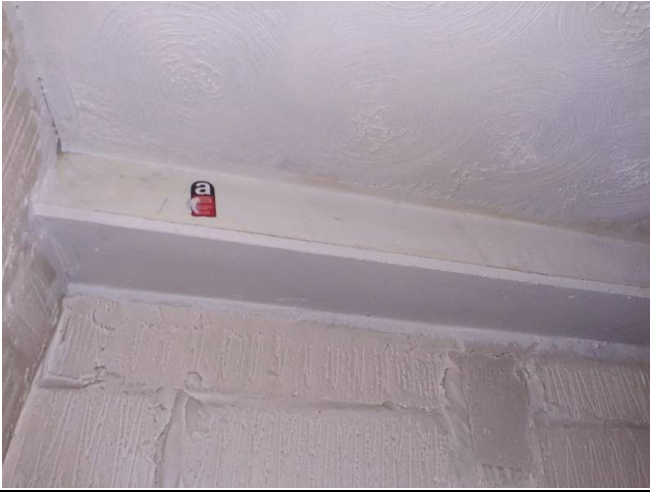
| 21 | As<br>RO002915 | Insulating Board –<br>beams | Boiler Room Z1/010 | Very Low Risk – 12<br>monthly |

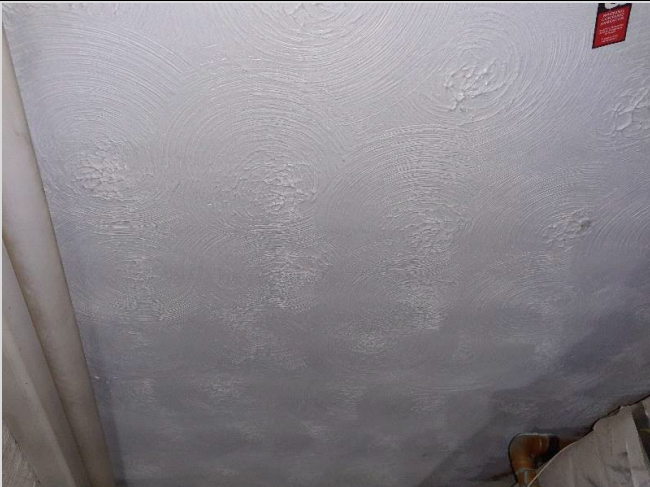
| 22 | RO002919 | Decorative finish - ceiling | Boiler Room Z1/010 | No Risk |

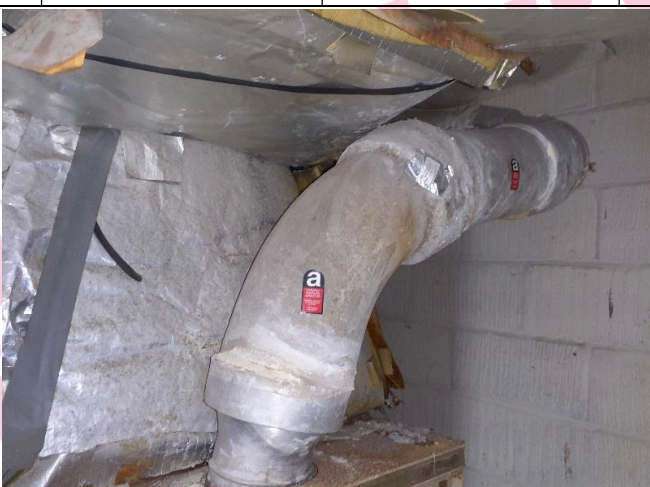
| 23 | RO002920 | Cement – flue pipe | Boiler Room Z1/010 | Very Low Risk – 12 monthly |

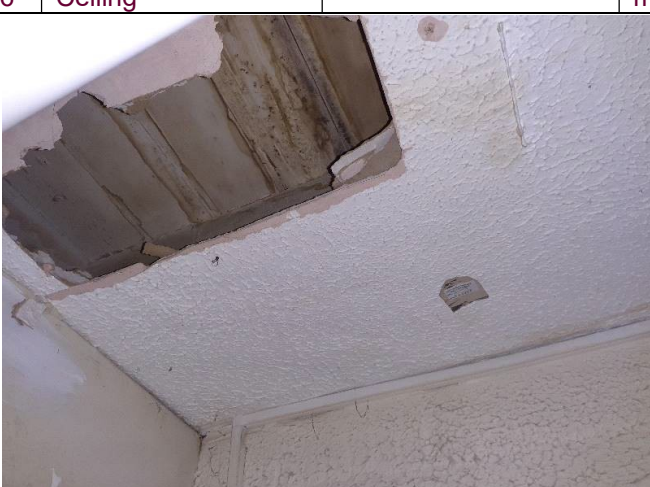
| 24 | As RO002916 | Decorative finish – Ceiling | WC Z1/011 | Very Low Risk – 12 monthly |

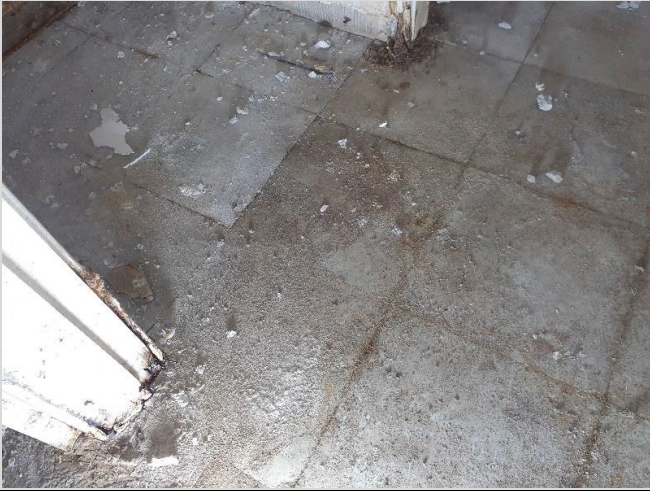
| 25 | RO002921 | Composite tiles and bitumen adhesive – floor | WC Z1/011 | No Risk |

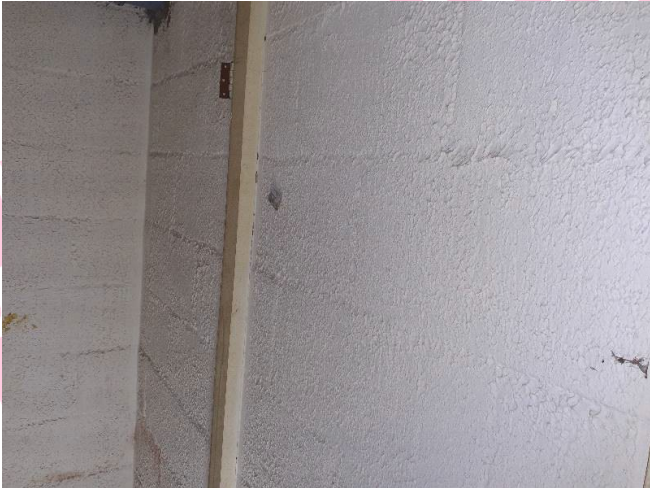
| 26 | As RO002918 | Decorative finish – walls | WC Z1/011 | Very Low Risk – 12 monthly |

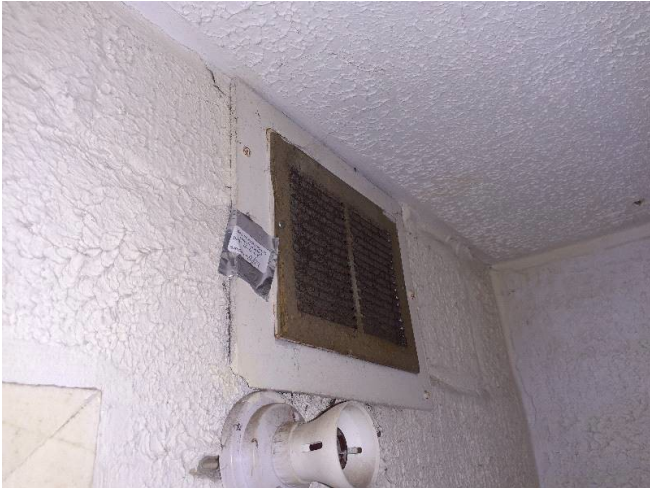
| 27 | RO002922 | Insulating board – walls | WC Z1/011 | Low Risk – 6 monthly |

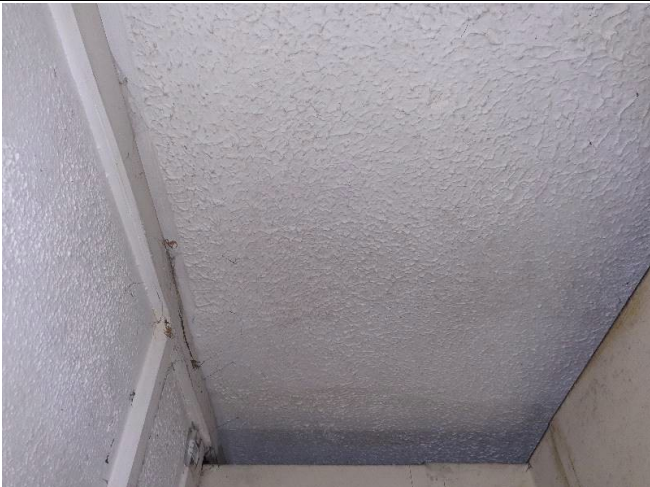
| 28 | As<br>RO002916 | Decorative finish –<br>Ceiling | WC Z1/012 | Very Low Risk – 12<br>monthly |

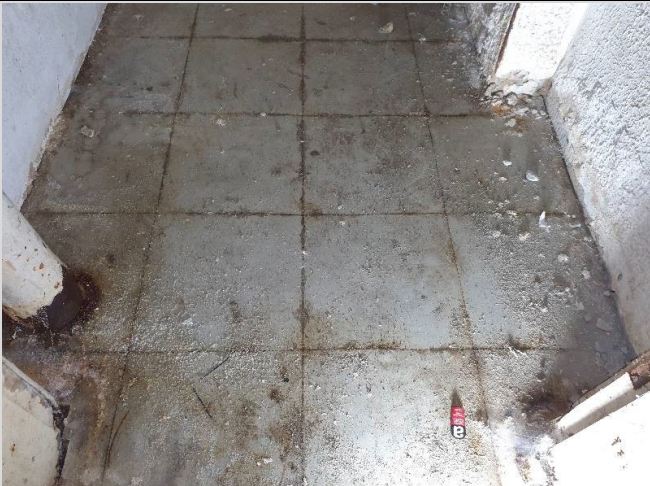
| 29 | As<br>RO002921 | Composite tiles and<br>bitumen adhesive –<br>floor | WC Z1/012 | No Risk |

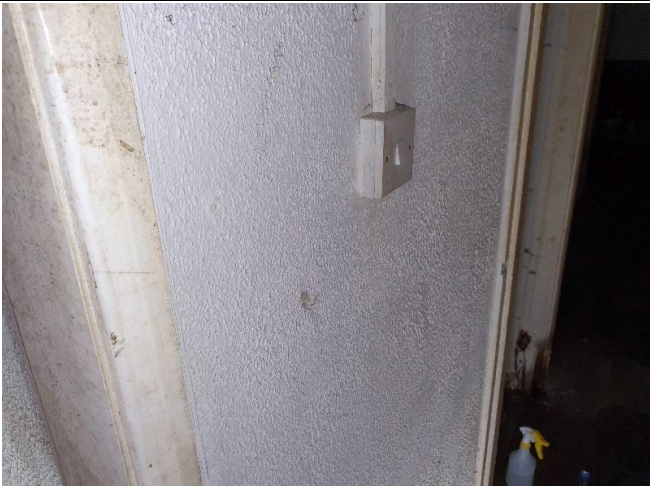
| 30 | As<br>RO002918 | Decorative finish -<br>walls | WC Z1/012 | Very Low Risk – 12<br>monthly |

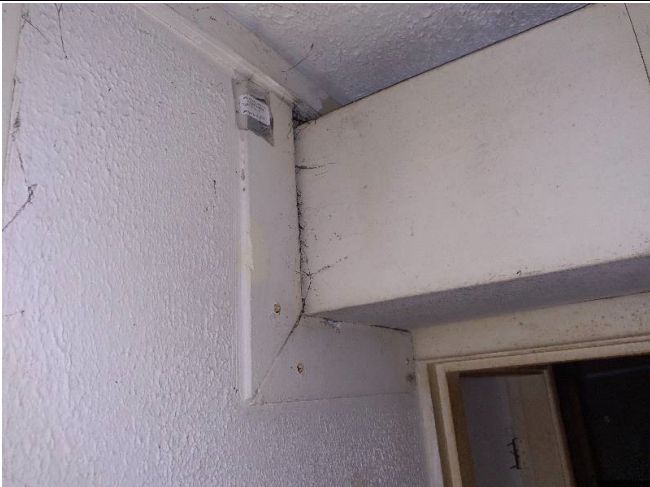
| 31 | As<br>RO002922 | Insulating board –<br>walls | WC Z1/012 | Low Risk – 6 monthly |

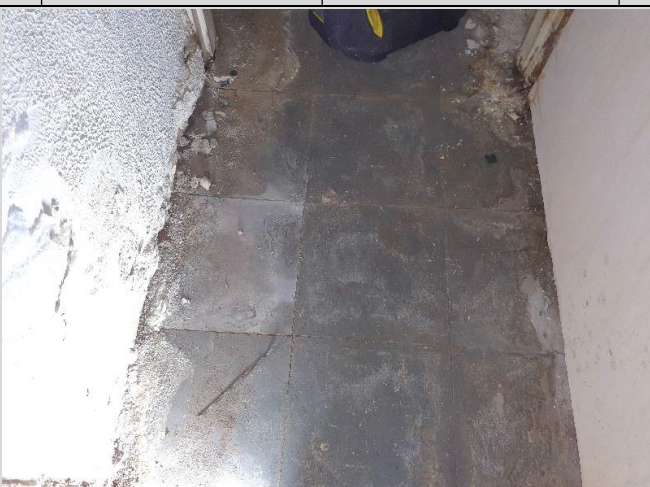
| 32 | As<br>RO002917 | Composite tiles –<br>floor | WC Z1/012 | No Risk |

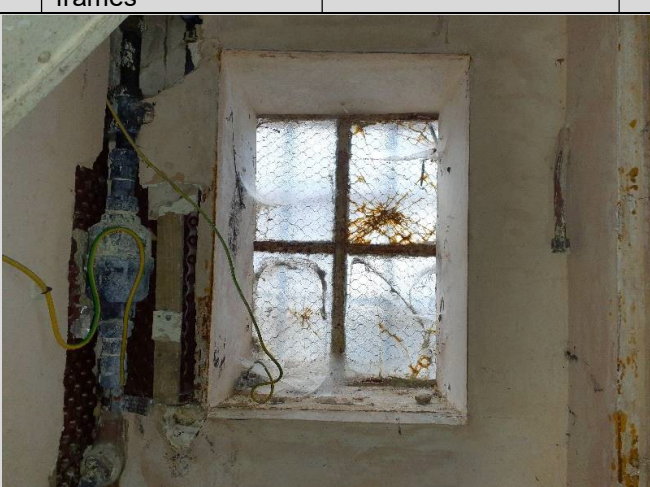
| 33 | RO002923 | Putty – window<br>frames | WC Z1/012 | No Risk |

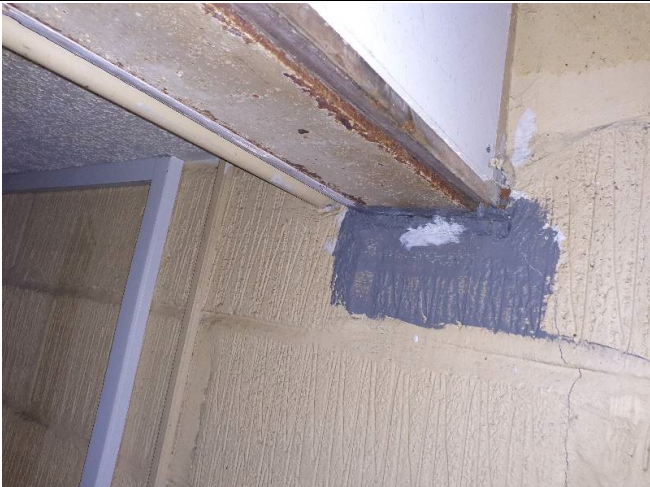
| 34 | As<br>RO002915 | Insulating Board –<br>wall | Stairs Z1/014 | Very Low Risk – 12<br>monthly |

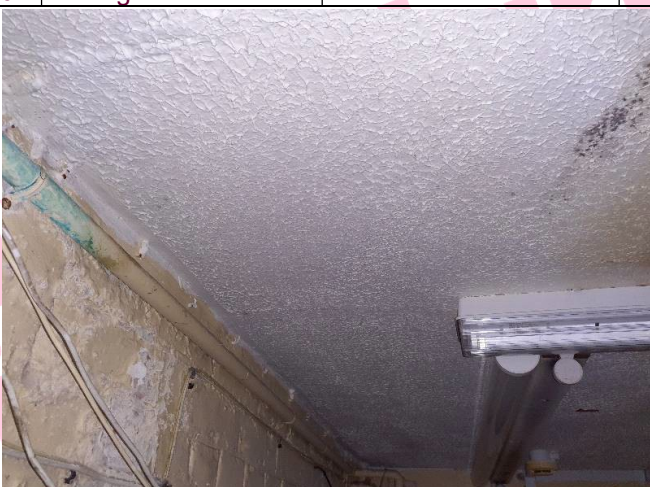
| 35 | As<br>RO002916 | Decorative finish –<br>ceiling | Stairs Z1/014 | Very Low Risk – 12<br>monthly |

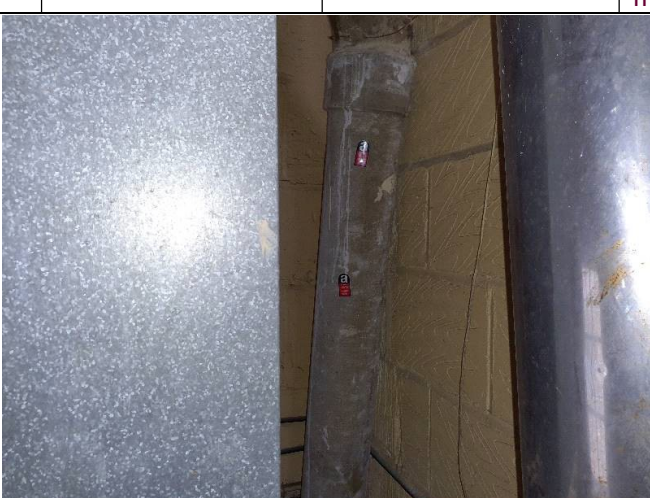
| 36 | RO002924 | Cement – flue | Stairs G/001 | Very Low Risk – 12<br>monthly |

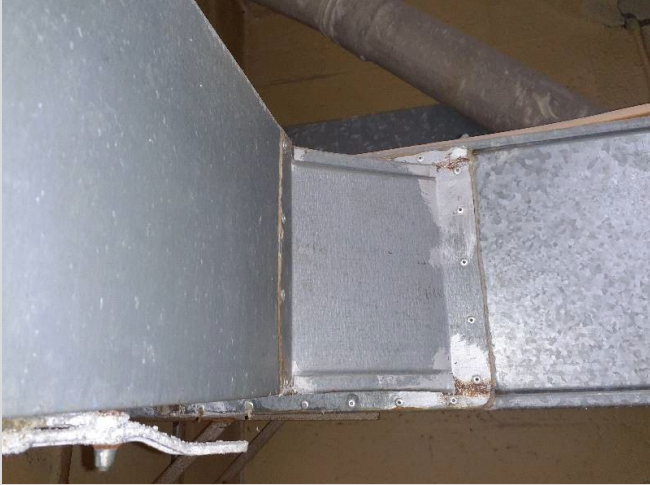
| 37 | RO002925 | Mastic – Ducting | Stairs G/001 | No Risk |

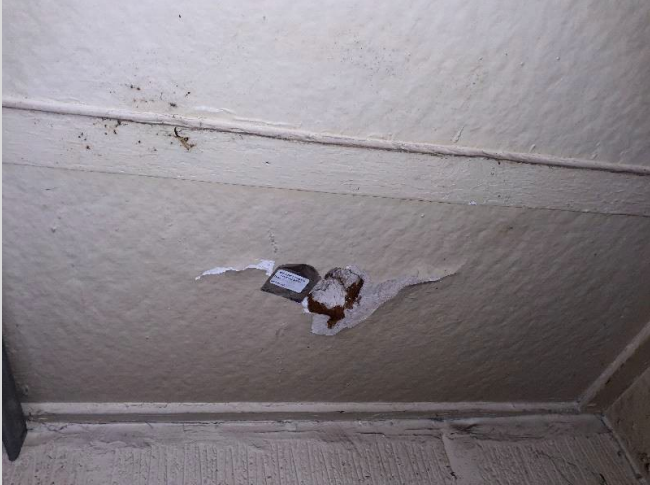
| 38 | RO002926 | Paper – ceiling | Stairs G/001 | No Risk |

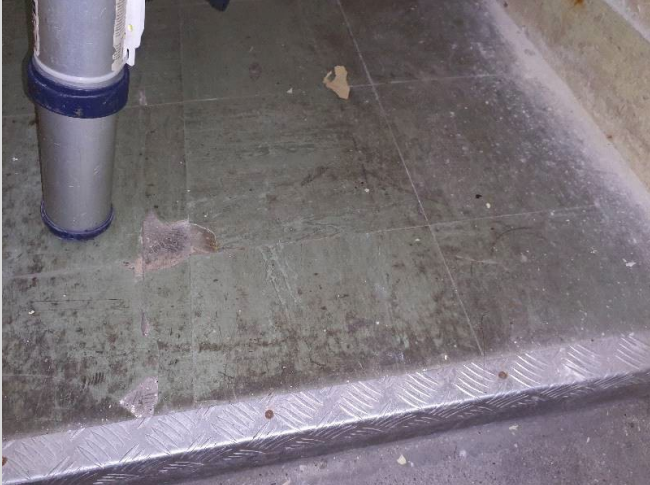
| 39 | RO002927 | Vinyl tiles – floor | Stairs G/001 | No Risk |

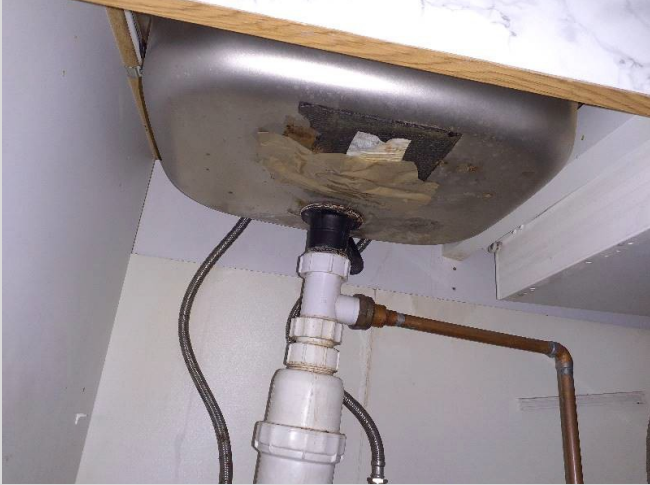
| 40 | RO002928 | Bitumen – sink pad | Kitchen G/003 | No Risk |

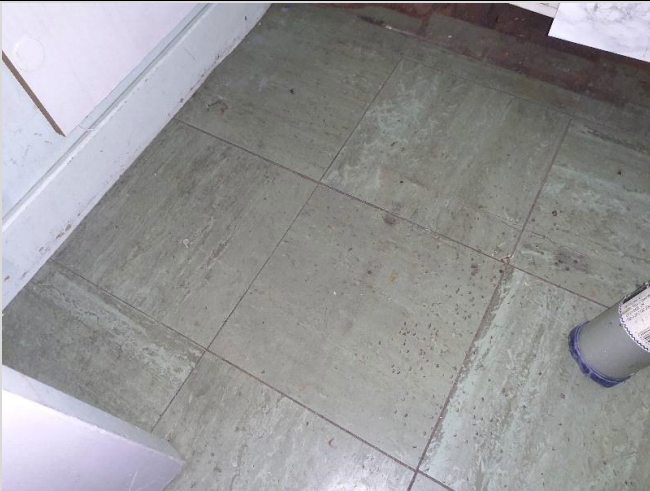
| 41 | As<br>RO002927 | Vinyl tiles – floor | Kitchen G/003 | No Risk |

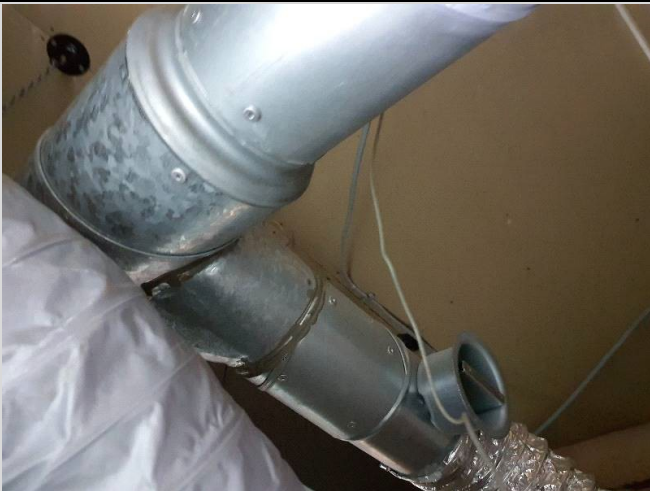
| 42 | As<br>RO002925 | Mastic – Ducting | Kitchen G/003 | No Risk |

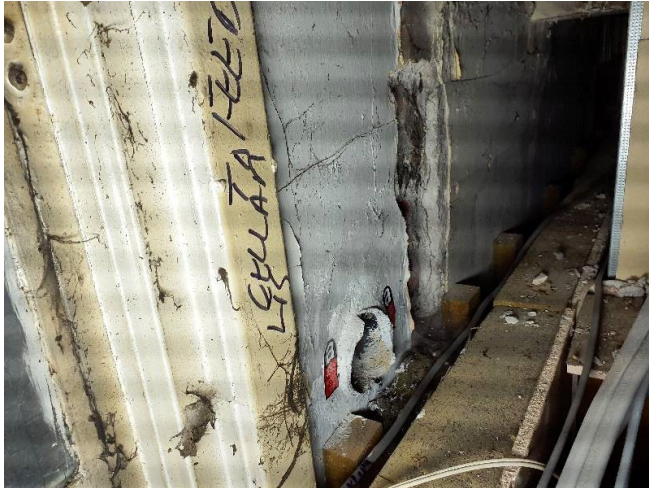
| 43 | RO002929 | Cement – wall | Office G/005 | Very Low Risk – 12 monthly |

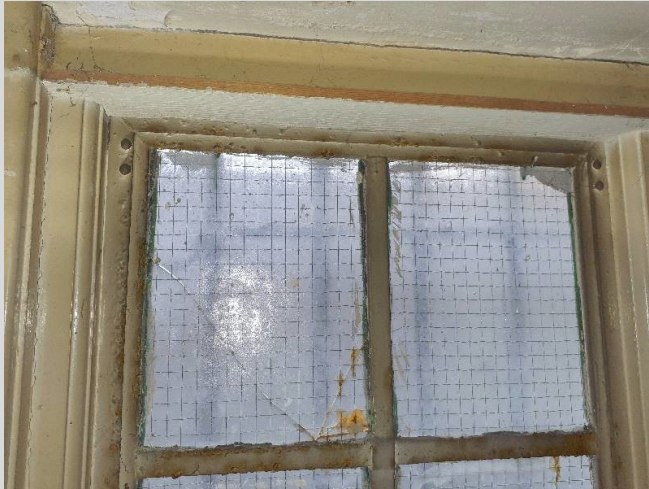
| 44 | RO002930 | Putty – windows | Shop Unit G/008 | No Risk |

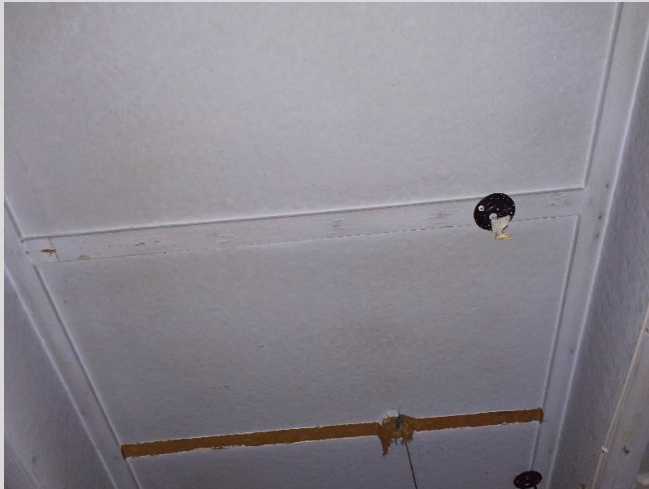
| 45 | As RO002926 | Paper- Ceiling | Shop Unit G/008 | No Risk |

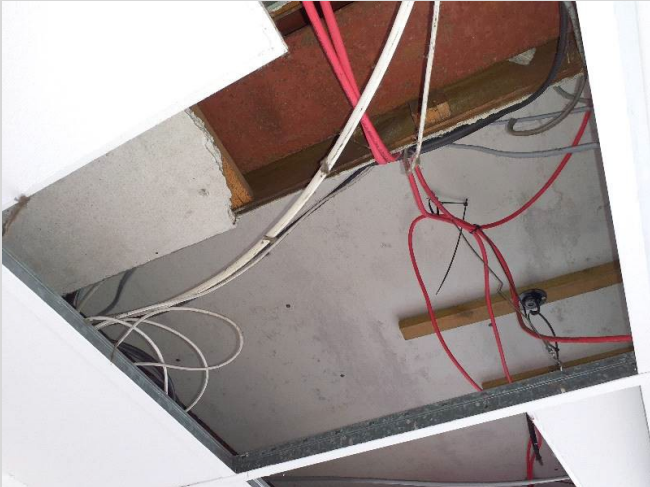
| 46 | RO002931 | Insulating board – ceiling | Shop unit G/008 | No Risk |

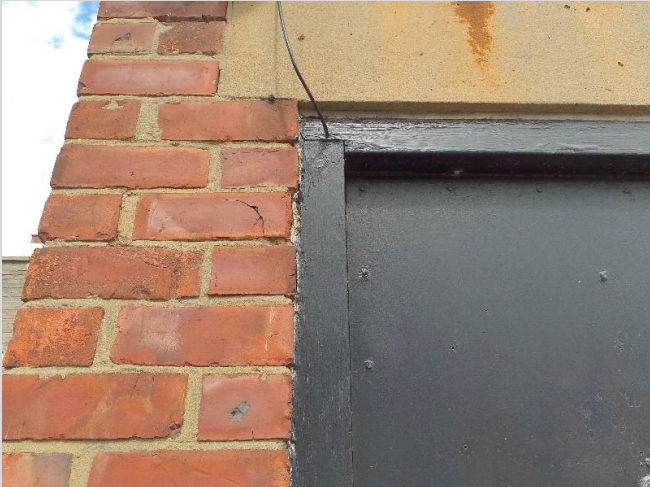
| 47 | RO002932 | Mastic – door frame | External E/001 | No Risk |

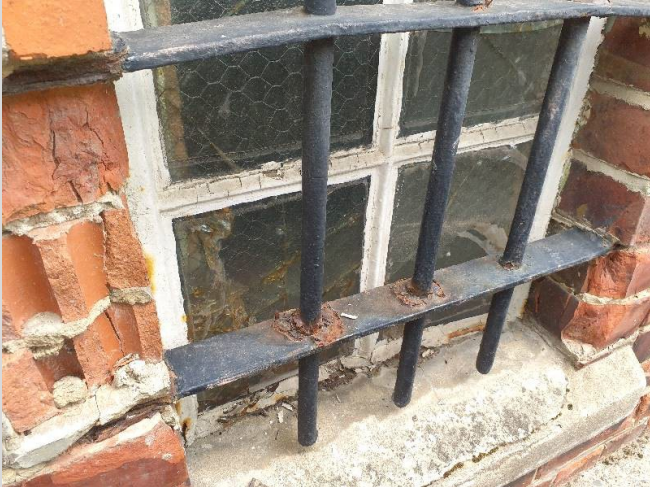
| 48 | RO002933 | Putty – window frame | External E/001 | No Risk |

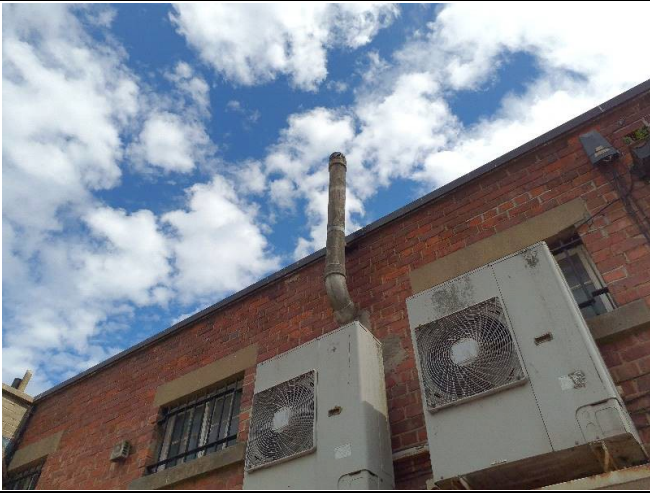
| 49 | As<br>RO002924 | Cement – flue | External E/001 | Very Low Risk – 12<br>monthly |

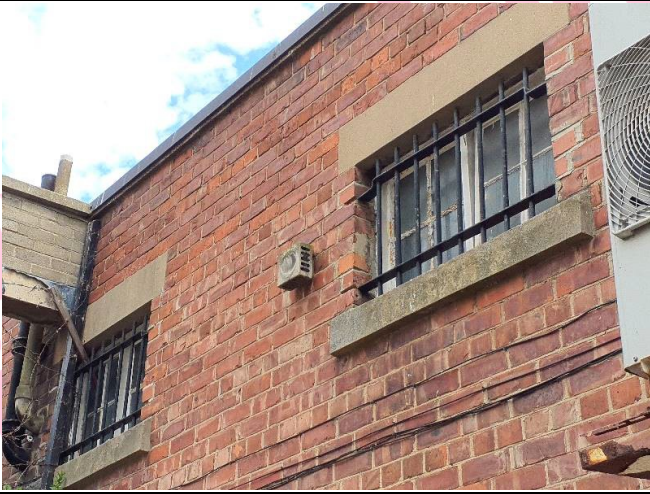
| 50 | As<br>RO002929 | Cement – cowl | External E/001 | Very Low Risk – 12<br>monthly |

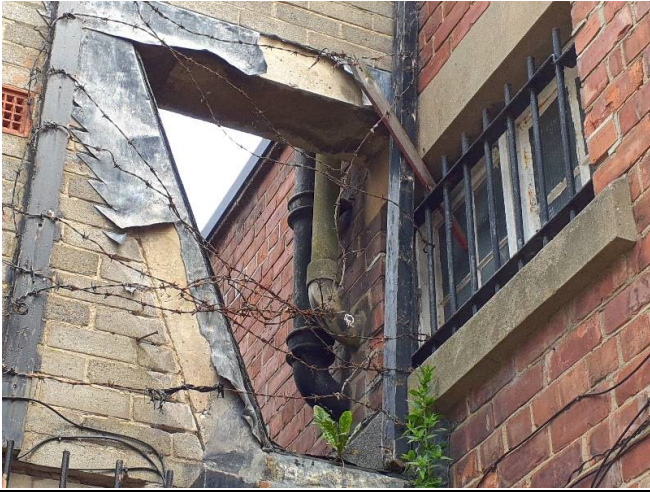
| 51 | As<br>RO002929 | Cement – flue | External E/001 | Very Low Risk – 12<br>monthly |
