ASBESTOS SURVEY REPORT FOR VALLEY ROAD PRIMARY SCHOOL, SUNDERLAND

**Asbestos Register for
VALLEY ROAD PRIMARY SCHOOL**

UPRN: - J509183

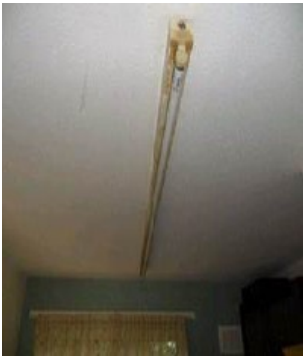
Item 2 - Ref: VP003739

The textured coating to the ceiling in the kitchen contains asbestos.

Demolished 2014.

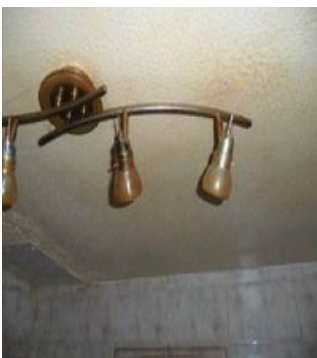
Item 3 - Ref: VP003740

The textured coating to the ceiling in the bathroom contains asbestos.

Demolished 2014

The textured coating to the ceilings throughout the house are presumed to contain asbestos. Any change in its appearance should be recorded, and passed to Property Services.
